Loss of Control While Maneuvering  
Pilatus PC-12/45, N128CM  
Butte, Montana  
March 22, 2009

NTSB/AAR-11/05  
PB2011-910405

**LOSS OF CONTROL WHILE MANEUVERING  
PILATUS PC-12/45, N128CM  
BUTTE, MONTANA  
MARCH 22, 2009**

**Abstract:** This accident report discusses the March 22, 2009, accident in which a Pilatus PC-12/45, N128CM, was diverting to Bert Mooney Airport (BTM), Butte, Montana, when it crashed about 2,100 feet west of runway 33 at BTM. The safety issues discussed in the report address fuel system limitations, requirements for fuel filler placards, and guidance on fuel system icing prevention. Safety recommendations concerning these issues are addressed to the Federal Aviation Administration (FAA) and the European Aviation Safety Agency. Previous safety recommendations concerning crash protection for airplane occupants and flight recorder systems were addressed to the FAA.

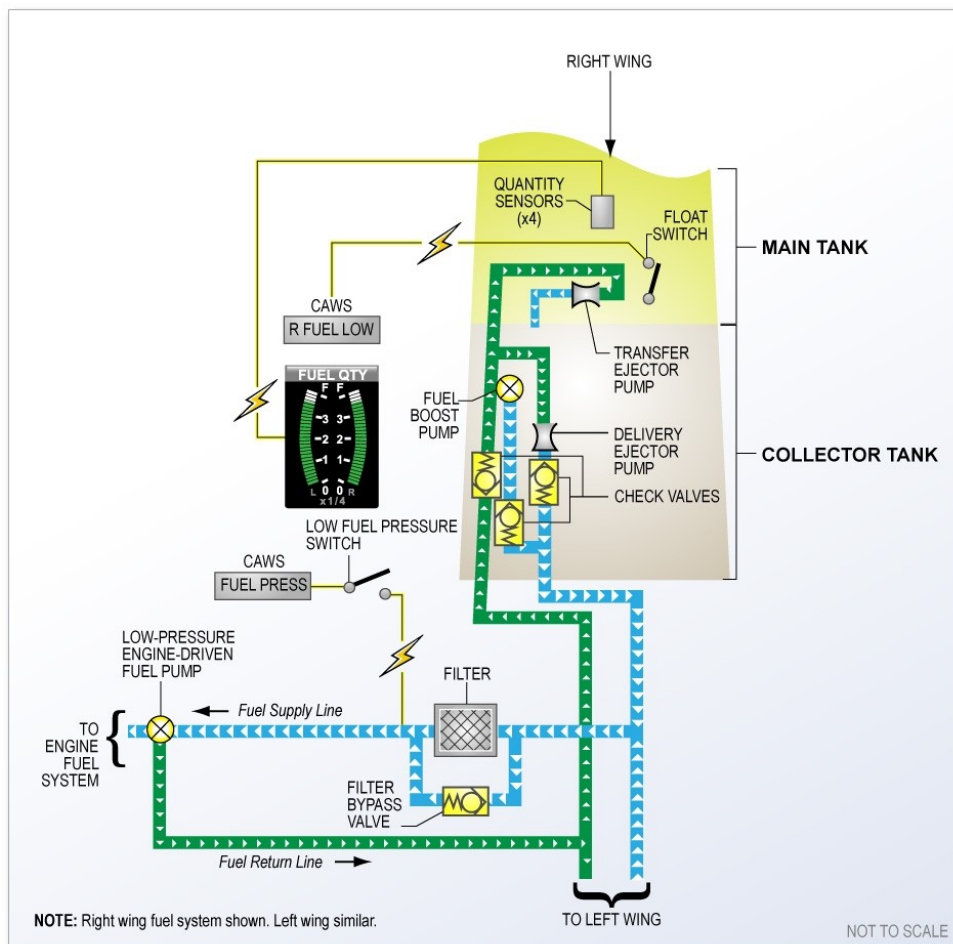
**Figure 3.** PC-12 fuel system.

About 1331, the right fuel boost pump resumed cycling. The operation of the right fuel boost pump indicated that (1) the fuel pressure output of the left-side fuel system had degraded to less than 2 psi, even with the left fuel boost pump on continuously; (2) the required fuel system pressure could no longer be maintained through the operation of the left fuel boost pump; and (3) the right fuel boost pump was needed to maintain fuel system pressure to the engine. Also, the fuel system configuration (which ensured a continuous, one-way flow of fuel to the engine, as shown in figure 3), along with the relatively high output pressure of the right-side fuel system,

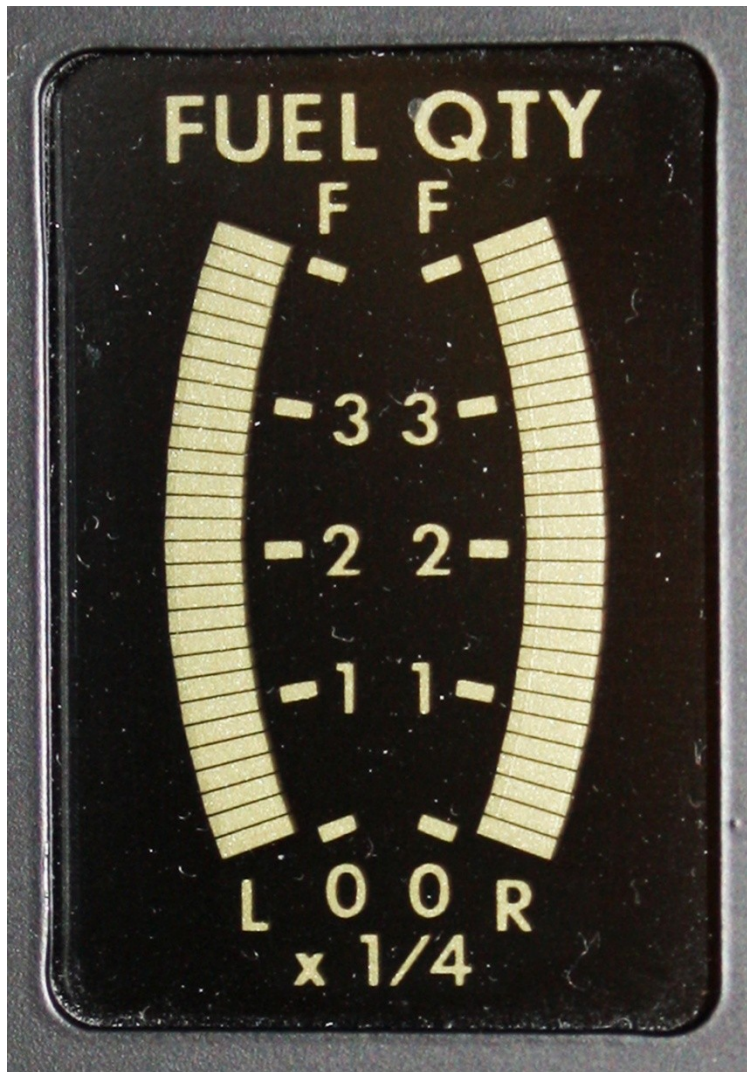
**Figure 4.** Fuel quantity indicator.

After both fuel boost pumps had cycled for 15 minutes, the left fuel boost pump was on continuously, and the right fuel boost pump was off. This change in status occurred because, as the fuel boost pumps operated to correct the low fuel pressure situation, a left-wing-heavy fuel imbalance of about 70 pounds was created. According to Pilatus, when a fuel imbalance of about 70 pounds (5 percent of each wing’s total fuel capacity) occurs, the fuel boost pump in the tank with the higher fuel quantity operates automatically, and the fuel boost pump continues to operate until the fuel levels in both tanks are equalized. Pilatus also stated that a single fuel boost pump operating continuously could simultaneously correct a fuel imbalance and a low fuel pressure state. A fuel imbalance of about 70 pounds is displayed on the EIS fuel quantity indicator (see figure 4) by a two-bar differential between the fuel tanks.
