## **NATIONAL TRANSPORTATION SAFETY BOARD**

# **AIRFRAME AND ENGINE EXAMINATION SUMMARY**

<b>NTSB Number:</b>	<b>ANC19FA019</b>
<b>Location:</b>	Metlakatla, Alaska
<b>Date:</b>	May 20, 2019
<b>Aircraft:</b>	N67667 de Havilland DHC-2
<b>Investigator-in-Charge (IIC):</b>	Noreen Price
<b>Parties to the Investigation:</b>	Jon Percy, FAA Aviation Safety Inspector IIC Michael O'Brien, Taquan Party Coordinator

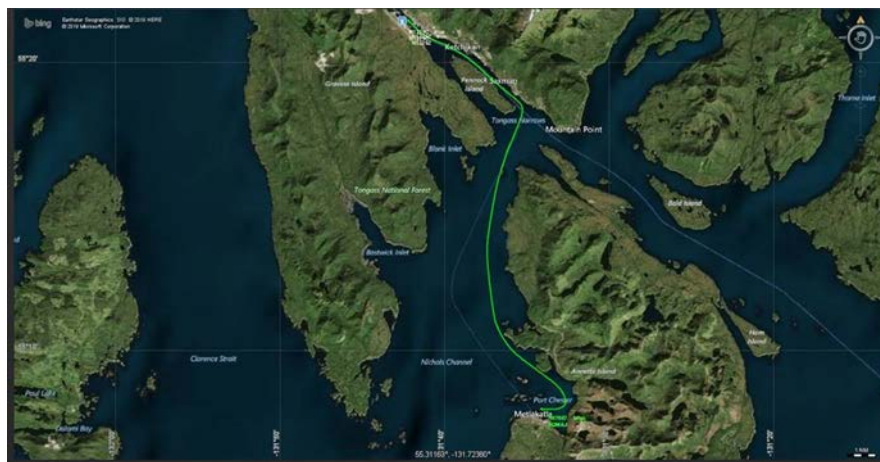
According to company dispatch documents, Flight 20 was a scheduled flight with one passenger, mail, freight and UPS packages destined for Metlakatla, which is about 16 miles south southeast of Ketchikan. Preliminary air traffic control data indicated a track to the southeast, south and then to the southeast for a right turning track into the harbor in a westward direction. Refer to figure 1.

Figure 1. Preliminary air traffic control track
