NATIONAL TRANSPORTATION SAFETY BOARD
Office of Aviation Safety

STRUCTURES GROUP CHAIRMAN'S RUDDER LOADS STUDY

ANC20LA059

Operator: Private
Location: Anchorage, Alaska
Date: June 8, 2020
Time: 0945 Alaska Daylight Time (ADT)
Aircraft: Piper PA-12
Registration: N3188M

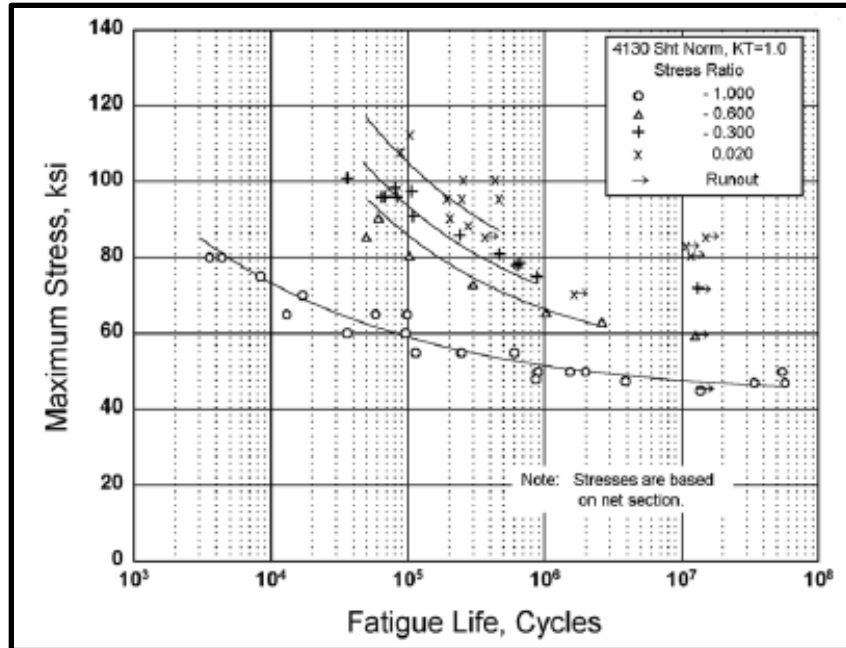
Figure 3-MMPDS-04 Figure 2.3.1.2.8(a) Best fit S-N curves for unnotched AISI 4130N sheet.

The relationship between ultimate strength and endurance limit is evident in the data of Figure 3, however, it only applies to pristine (or unnotched) material. Localized stress concentrations in the form of holes, changes in cross sectional area, notches, scratches, or corrosion will have a significant effect on the fatigue life of any material resulting in a decrease in fatigue life. In addition, standard industry practice would incorporate a scatter factor on test data such as that in Figure 3 since the data was gathered in controlled tests and is not representative of actual in-service conditions.

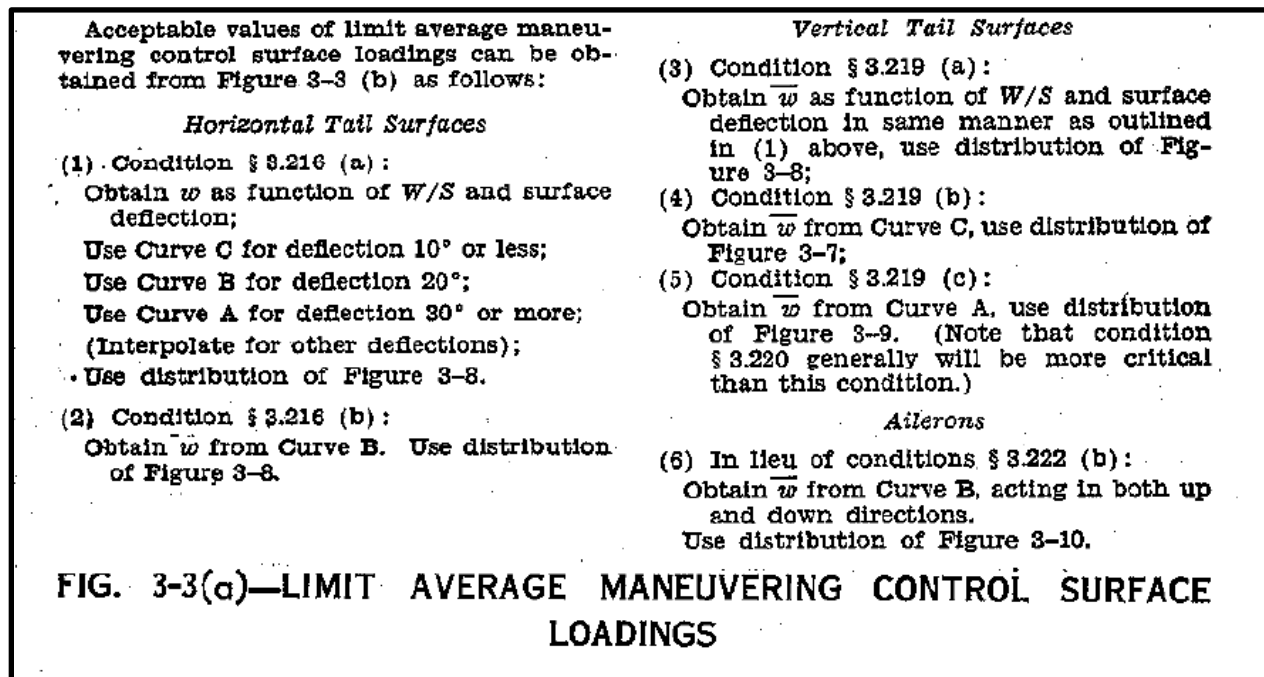
Figure 4-CAM 3 Figure 3-3(a).

The method in Figure 4 above (Fig 3-3(a)(3) from CAM 3) was used. For each of the airplane configurations listed, the value of $K\bar{w}$ was obtained from the graph at 20° rudder deflection for

The method in Figure 4 above (Fig 3-3(a)(4) from CAM 3) was used. For each of the airplane configurations listed, the value of $K\bar{w}$ was obtained from the graph using curve C. The specific dimensions of three failed rudders (A, B, and C) were used for each of the airplane configurations to calculate the rudder post loads at the failure location. The calculations were not performed for Rudder D.

The method in Figure 4 above (Fig 3-3(a)(5) from CAM 3) was used. For each of the airplane configurations listed above, the value of $K\bar{w}$ was obtained from the graph using curve A. The specific dimensions of three failed rudders (A, B, and C) were used for each of the airplane configurations to calculate the rudder post loads at the failure location. The calculations were not performed for Rudder D.

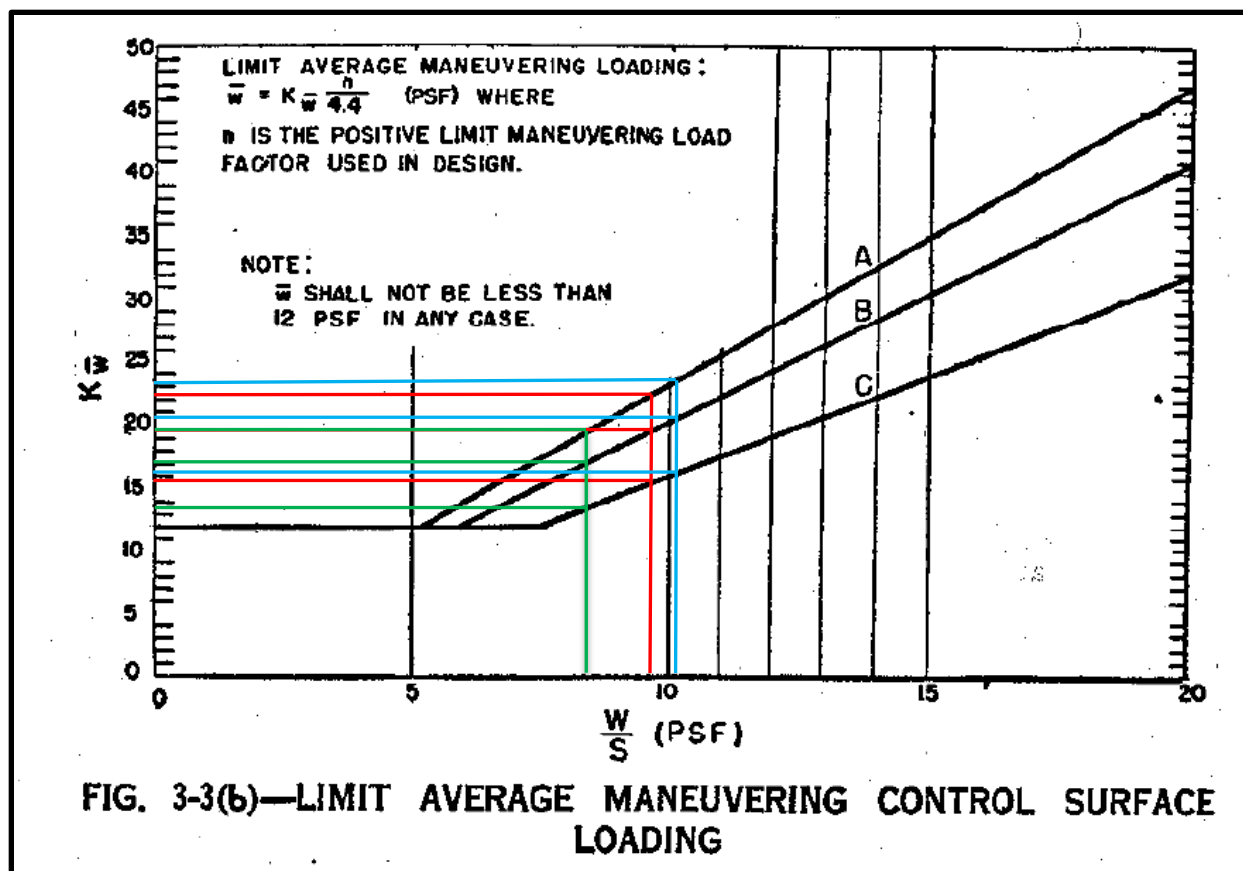
Figure 5-CAM 3 Figure 3-3(b).

The red lines in Figure 5 will be used for the PA-12, PA-18, and PA-18 seaplane normal category airplanes with average wing loadings about 9.8 psf. The green lines will be used for the PA-12 and PA-18 utility category airplanes with average wing loading about 8.4 psf. The blue lines will be used for the PA-12 seaplane normal category airplane with average wing loading about 10.2 psf. The following data for the limit average maneuvering control surface loading, $K\bar{w}$, is taken from the graph in Figure 5 for curves A, B, and C at the various W/S conditions.
