NATIONAL TRANSPORTATION SAFETY BOARD

Group Chairman's Factual Report

OPERATIONAL FACTORS / HUMAN PERFORMANCE

ANC20MA010

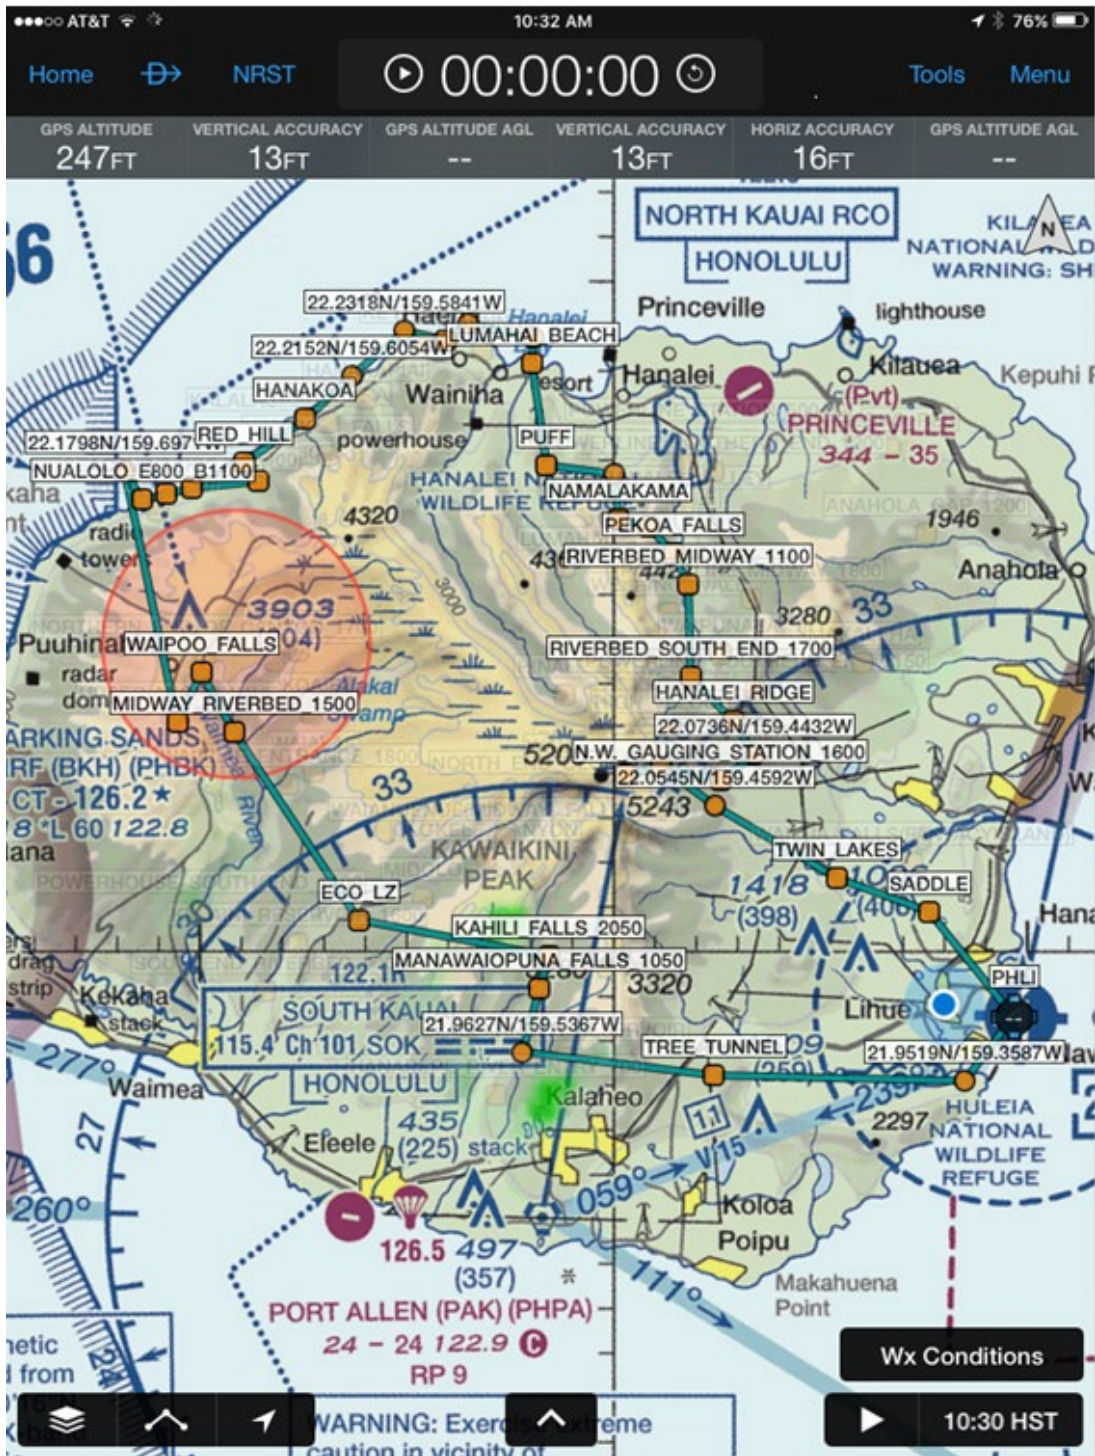
The tour route is depicted in Figure 1, and an enlarged view showing the location of Upper Microwave is depicted in Figure 2.

Figure 1: Depiction of air tour route provided by Safari Helicopters.

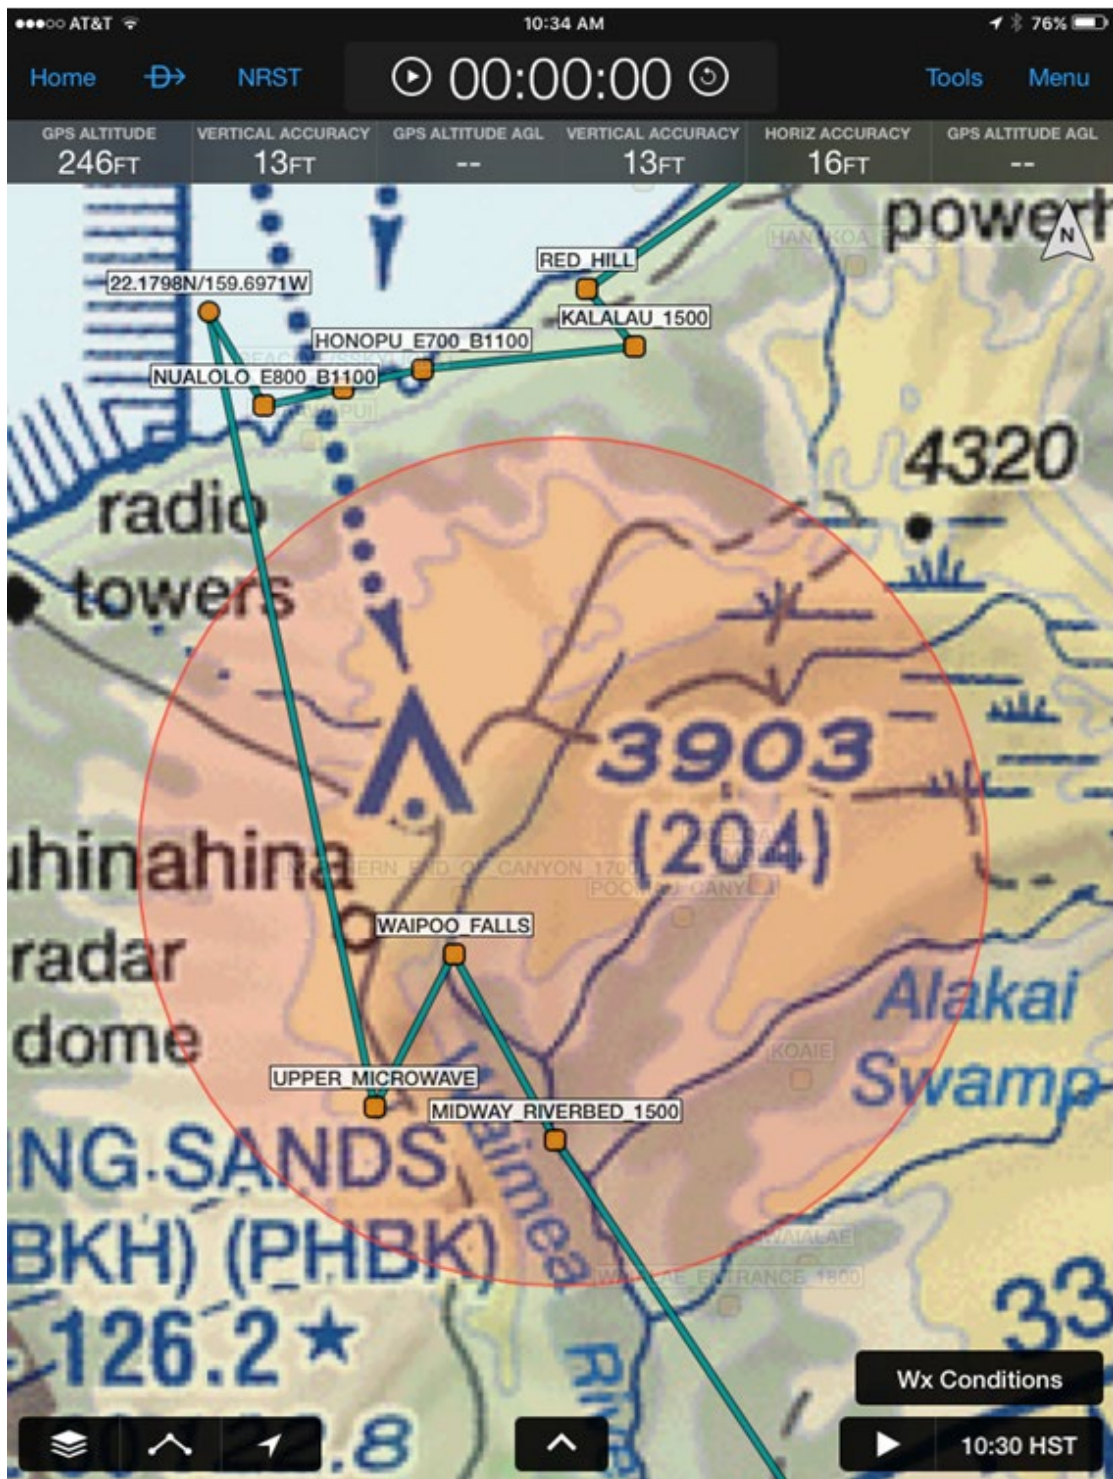
The Blue Hawaiian pilot told investigators he observed a reporting point on the northwest rim of Waimea Canyon called “Upper Microwave” (located at 22° 04’ 46.58” N, 159° 40’ 00.33” W, elevation 3,490 feet msl) was obscured, and a nearby secondary reporting point called “Lower Microwave” (22° 03’ 10.69” N, 159° 39’ 42.09” W, elevation 2,922 feet msl) that was also located on the northwest rim was nearly obscured.³

Figure 2: Close-up of air tour route showing the location of Upper Microwave.

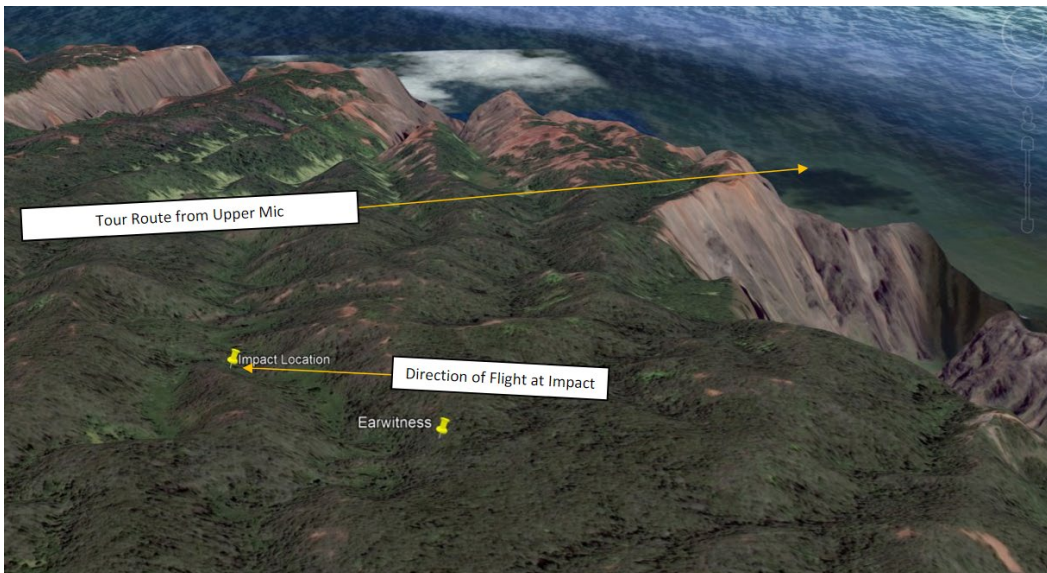
Figure 4. Terrain between the accident location and the Na Pali Coast.

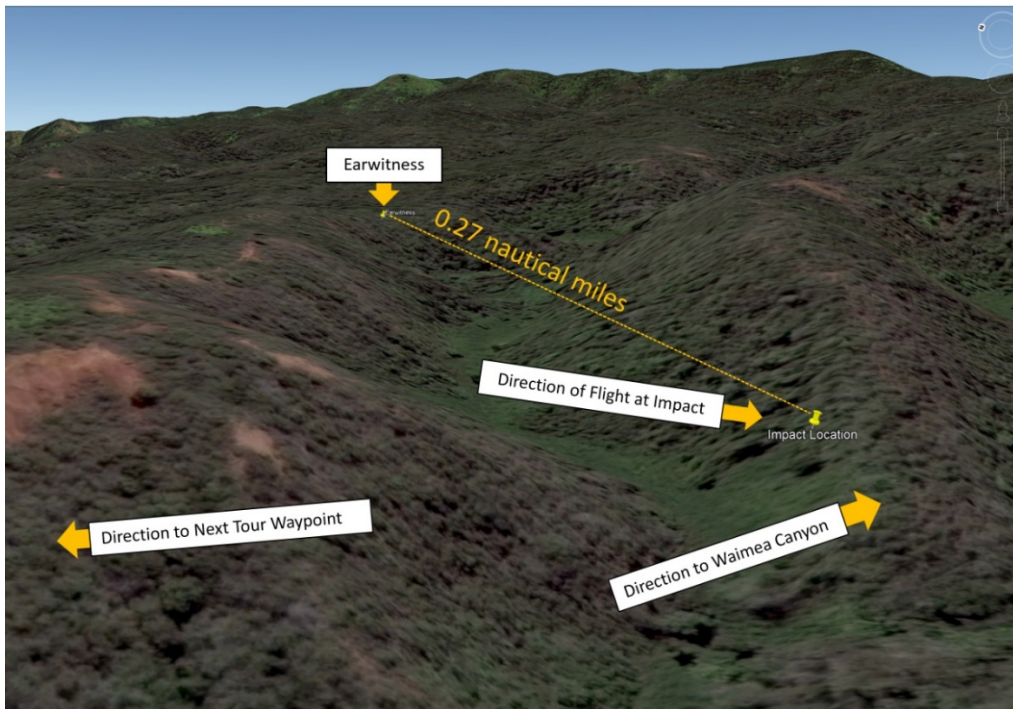
Figure 5. Terrain in the vicinity of the accident site.

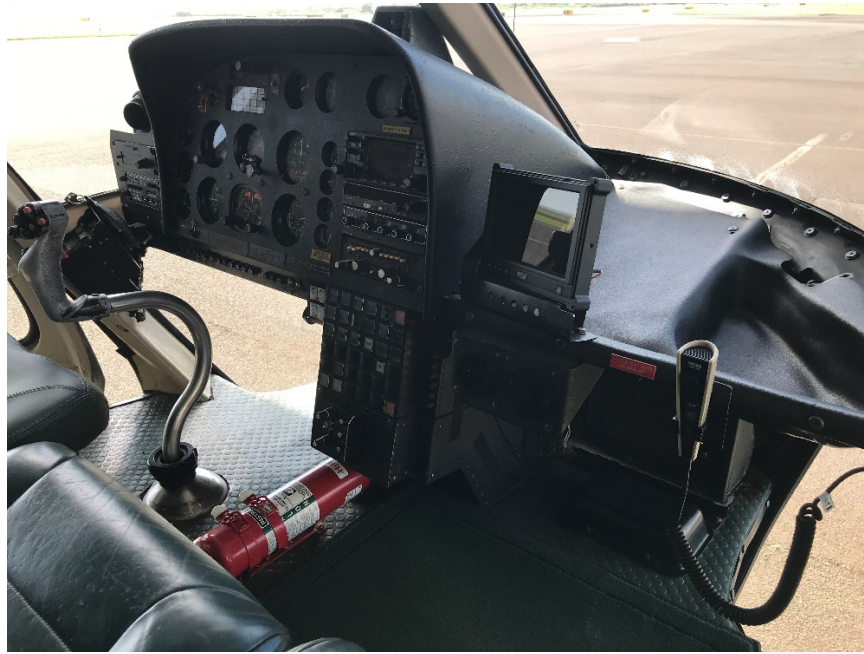
Company managers told investigators that the helicopter's Aircraft Daily Log page for the day of the accident was carried aboard the helicopter and investigators were unable to recover it. The most recent previous log page, dated December 24, 2019, indicated that the helicopter had no open maintenance discrepancies. Maintenance records indicated that the pilot controls had been relocated from the front right to the front left seat under a supplemental type certificate. The director of operations stated that the company had made this modification to reduce the likelihood of passenger interference. Similarly relocated flight controls in a sister ship are shown in Figure 10.

Figure 10: Supplemental type certificate modification to flight controls in N702SA.

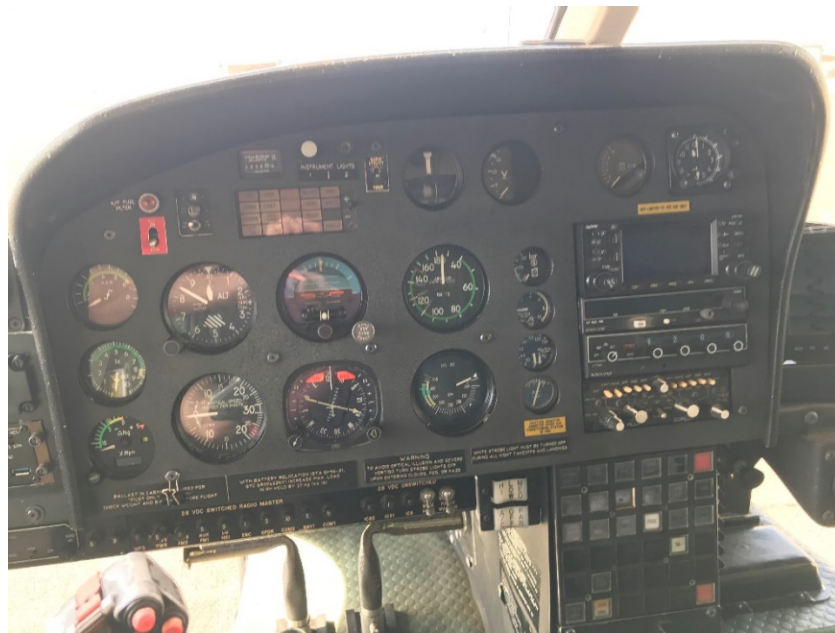
The helicopter was equipped with the following flight instruments: altimeter, radar altimeter, attitude indicator with slip indicator, airspeed indicator, vertical speed indicator, a horizontal situation indicator, a turn and slip indicator, and a magnetic compass (figure 11).

Figure 11: N702SA instrument panel.

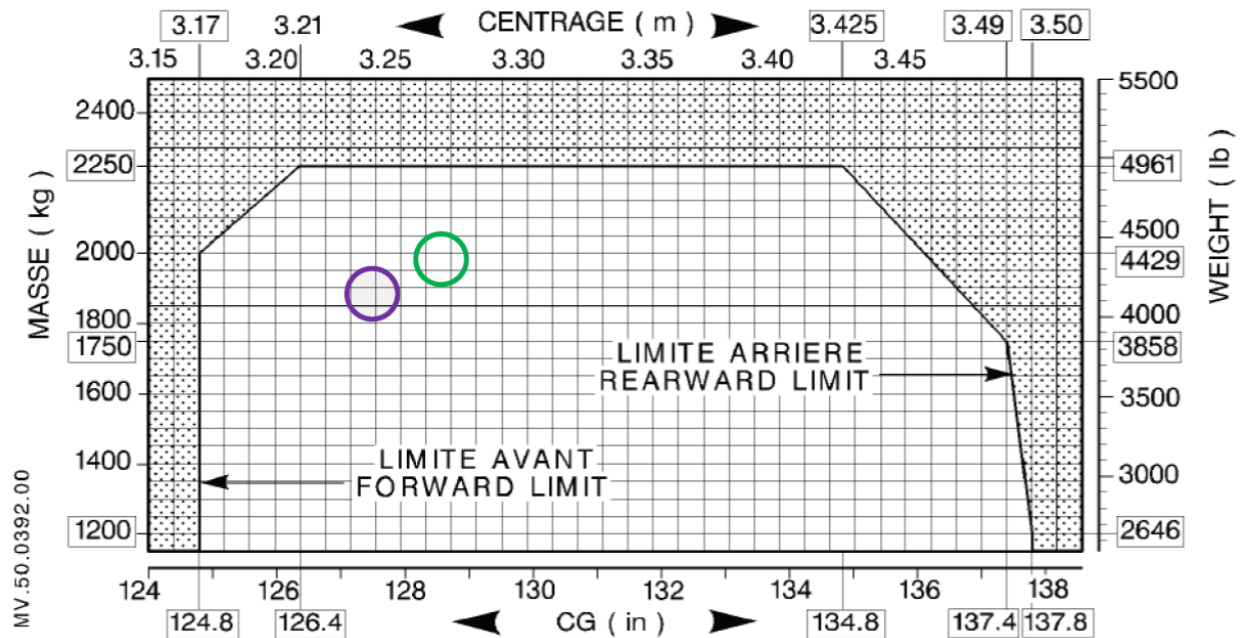
The accident helicopter was last weighed April 2, 2018, and it was within the 36-calendar month currency requirement specified in Part 135.185. The company used actual passenger weights obtained using a scale located at the front desk where customers checked in for flights. Table 1 shows weight and balance calculations. Figure 13 shows planned weight and center of gravity (CG) for the accident flight.

Figure 13: Estimated takeoff CG (green circle) and landing CG (purple circle).

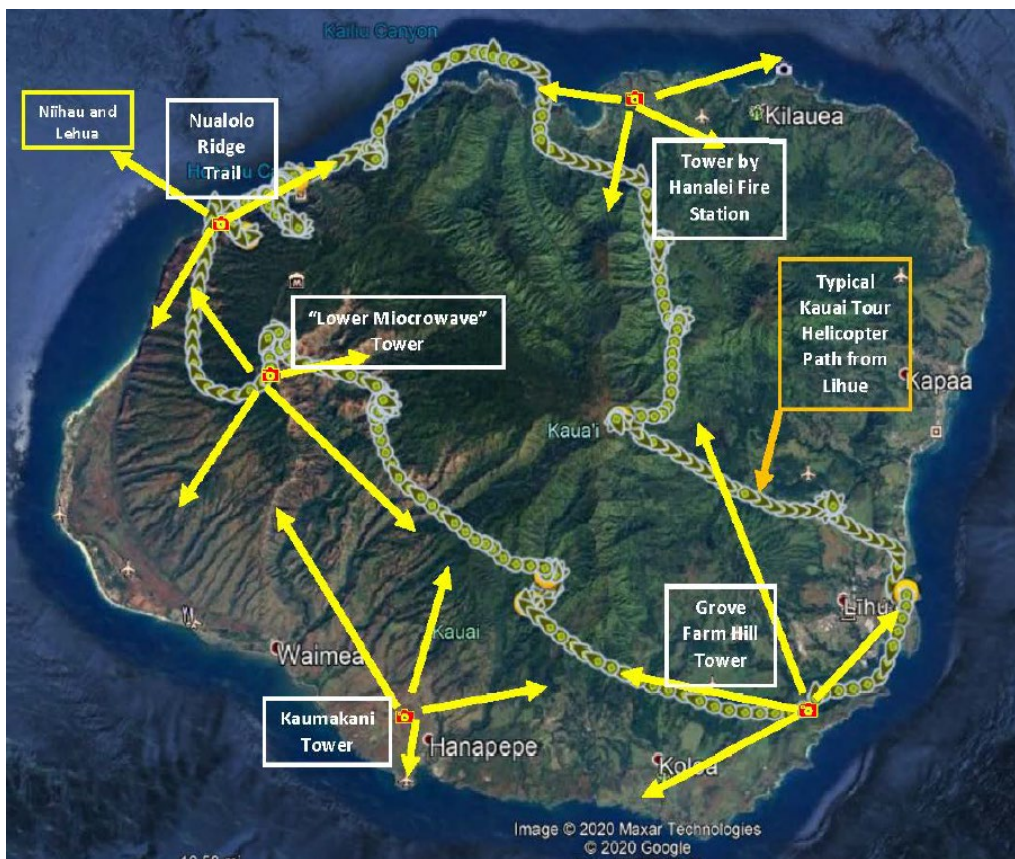
On January 29, 2021, the FAA manager of this program briefed NTSB staff that the FAA planned to install 23 weather camera installations in the state of Hawaii, with construction planned to begin April 2021 and be completed by September 2022. A planning map shared with

NTSB staff indicated that the FAA planned to install five of the weather camera systems on island of Kauai (figure 14).

Figure 14. Map of planned FAA weather camera installation sites on Kauai.

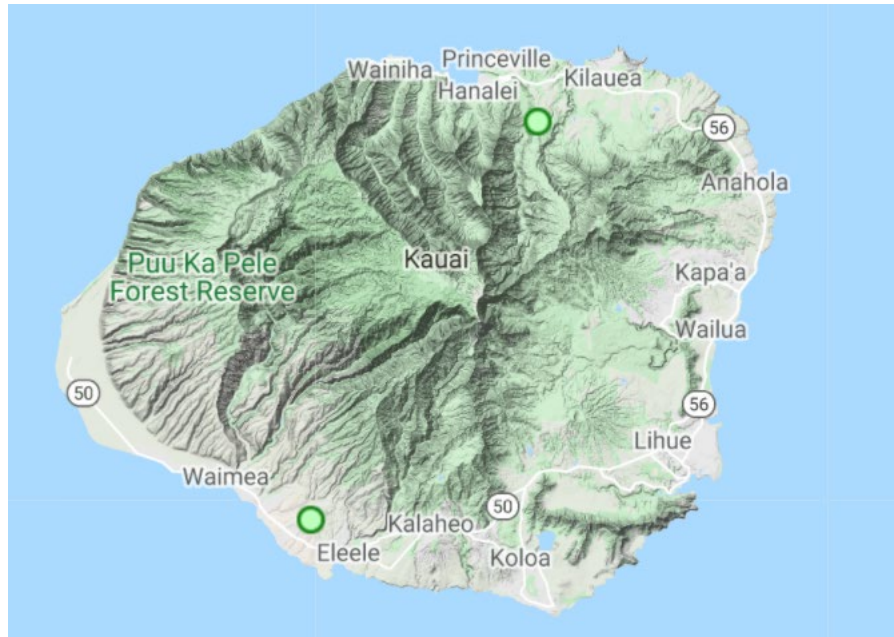
The FAA manager of the Weather Camera program informed NTSB staff that this project was on schedule, funding was available, and he did not anticipate any obstacles to its completion. During a follow-up discussion on August 24, 2021, the FAA program manager reported that one of the weather cameras was already operational on the southwest side of the island. NTSB examination of the FAA weather camera web site on October 8, 2021, revealed that a second camera located on the northeast side of the island had also become operational (see figure 15).¹⁹

Figure 15. Location of weather cameras that were providing images to the FAA weather camera web site as of October 8, 2021.

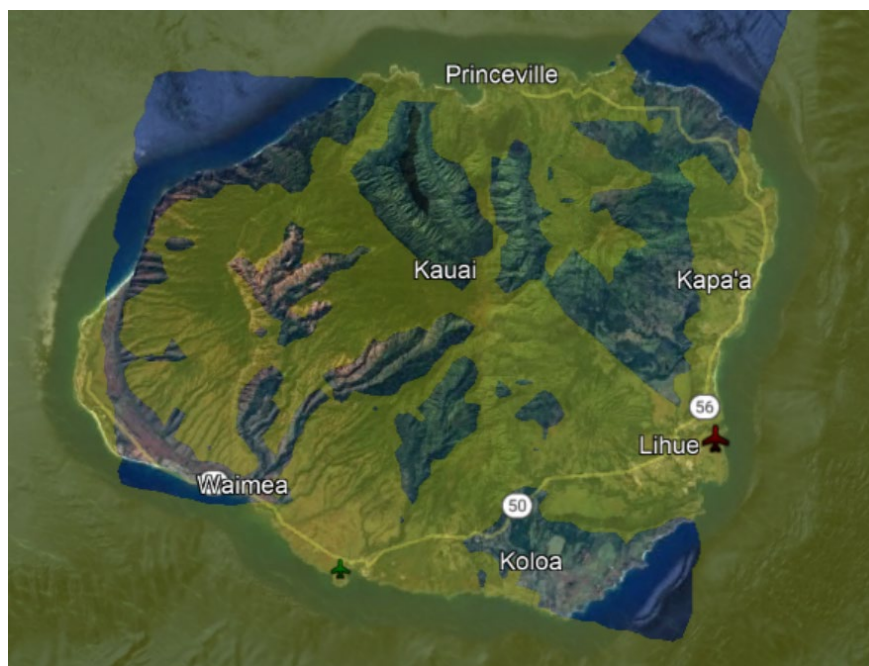
An FAA data file describing ADS-B service in the National Airspace System indicated that existing ADS-B infrastructure could receive ADS-B signals broadcast by aircraft flying at 500 feet agl or higher in some but not all areas above or near the island of Kauai (figure 16).²¹

Figure 16. ADS-B service for aircraft at 500 feet agl or higher, above or near Kauai.

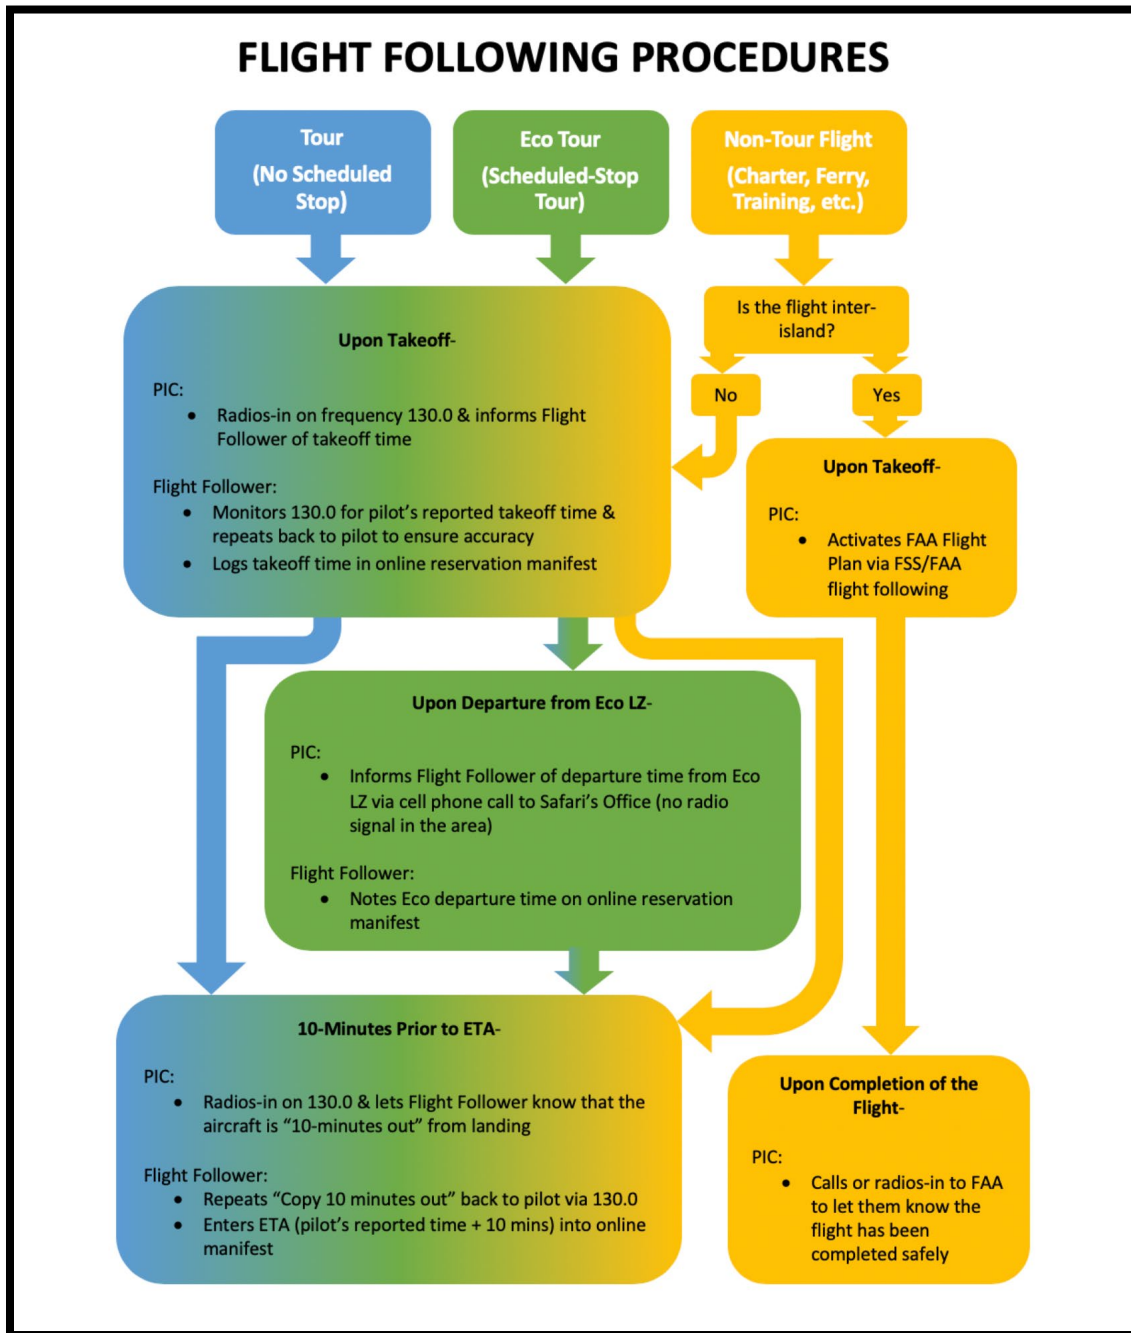
Figure 18. Diagram of company flight following practices.

In addition, Safari had developed a flow chart describing the company’s flight following practices and included it in a revised version of the company’s operations manual (figure 18).

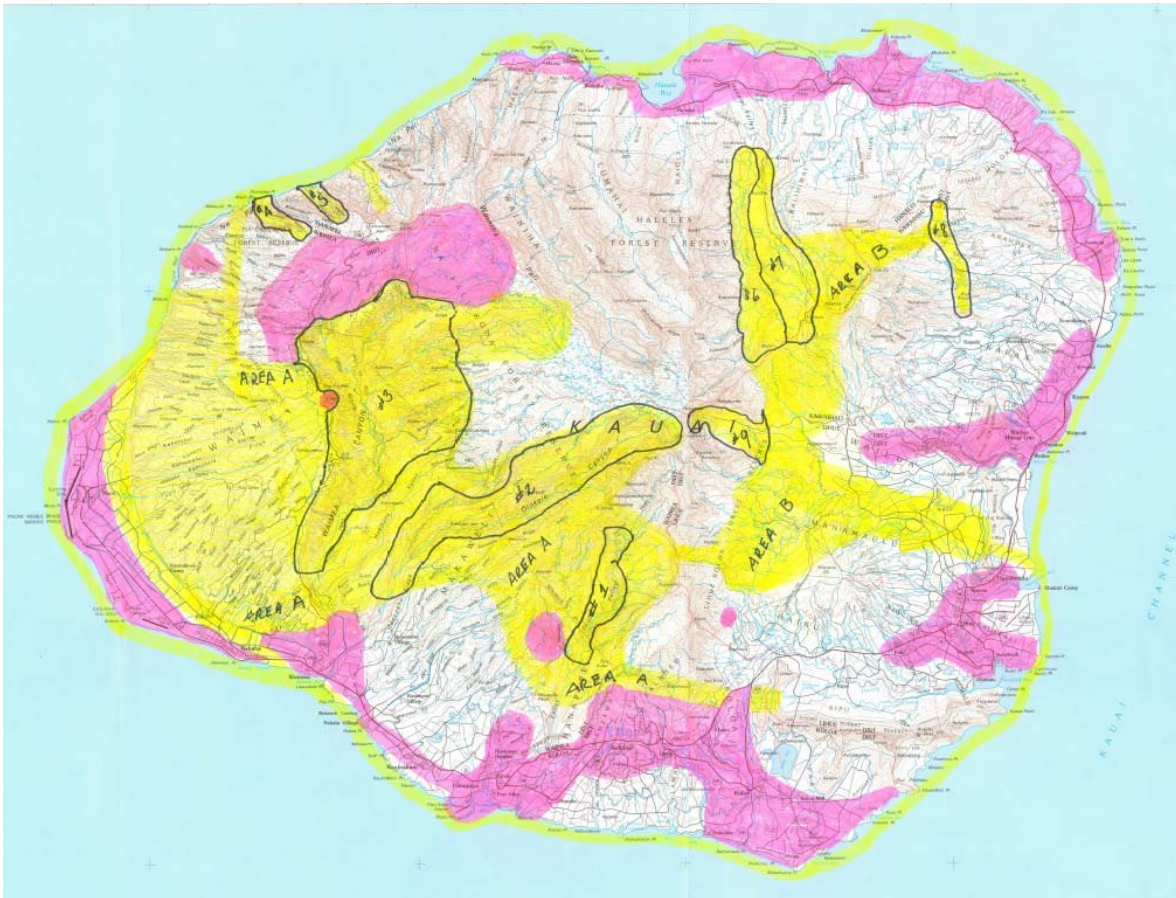
The HATCPM Appendix F, Island of Kaua'i, contained the color-coded map of Kauai reproduced in figure 19. It also provided the following map legend:

Figure 19: Color-coded map of Kauai in Appendix F of the HATCPM.
