NATIONAL TRANSPORTATION SAFETY BOARD

Group Chairman's Factual Report

METEOROLOGY

ANC21FA069

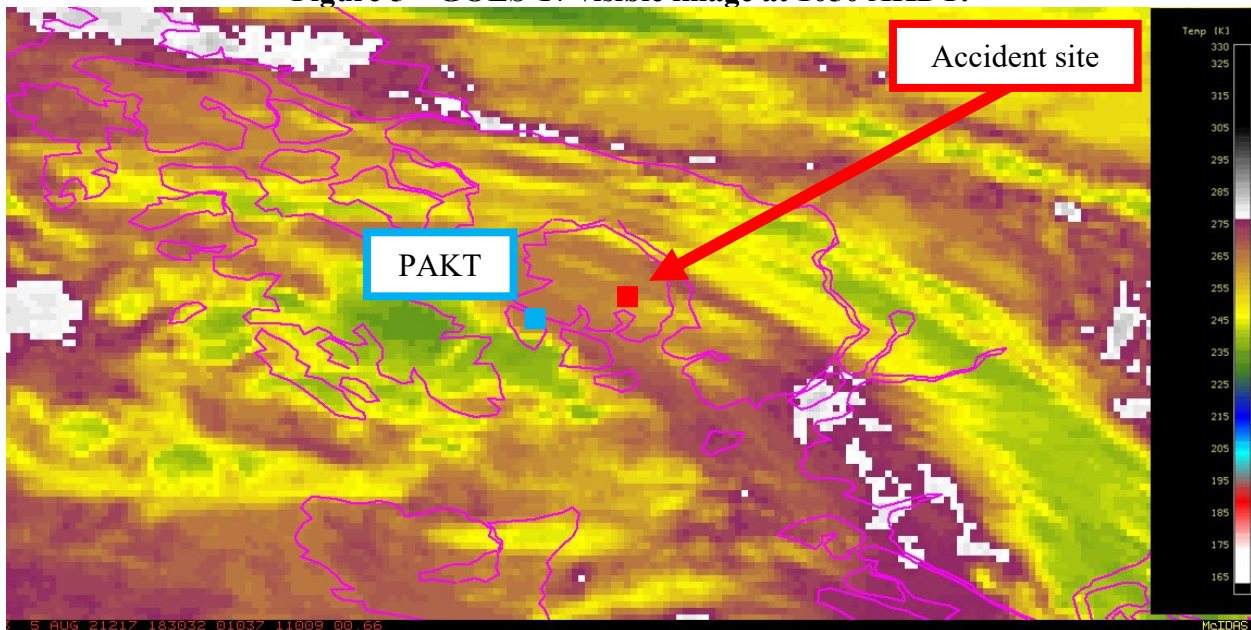
Figures 4 and 5 present the GOES-17 visible imagery from 1040 and 1050 AKDT at 2X magnification with the accident site highlighted with a red square. There was cloud cover above the accident site at the accident time with the cloud cover moving north-northeastward. Figures 6 and 7 present the GOES-17 infrared imagery from 1030 and 1050 AKDT at 6X magnification with the accident site highlighted with a red square. The lower brightness temperatures (green colors; higher cloud tops) were located near to and southwest of PAKT and east of the accident site in British Columbia. A band of lower brightness temperatures (yellow colors) increased in coverage and moved across the accident site between 1030 and 1050 AKDT. The brightness temperature of about 254 Kelvin would have been near 17,000 ft based on the vertical temperature profile provided by the 1600 AKDT PANT sounding (not shown in Figure 3). It should be noted these figures have not been corrected for any parallax error.

Figure 6– GOES-17 infrared image at 1030 AKDT.

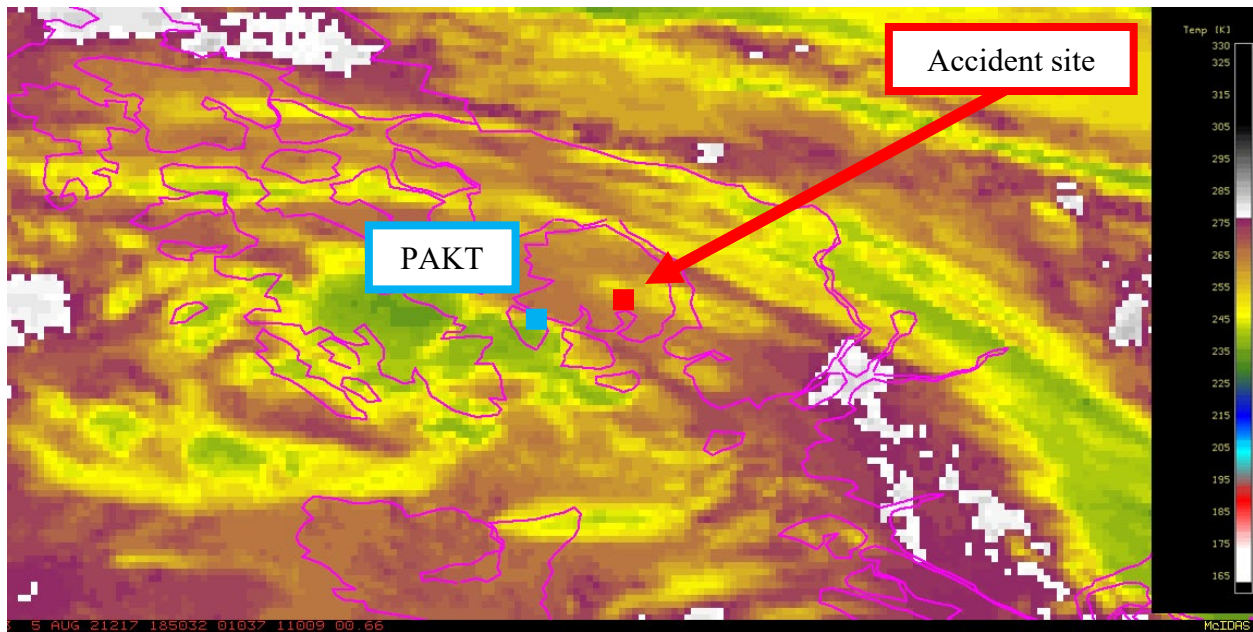
Figure 7– GOES-17 infrared image at 1050 AKDT.

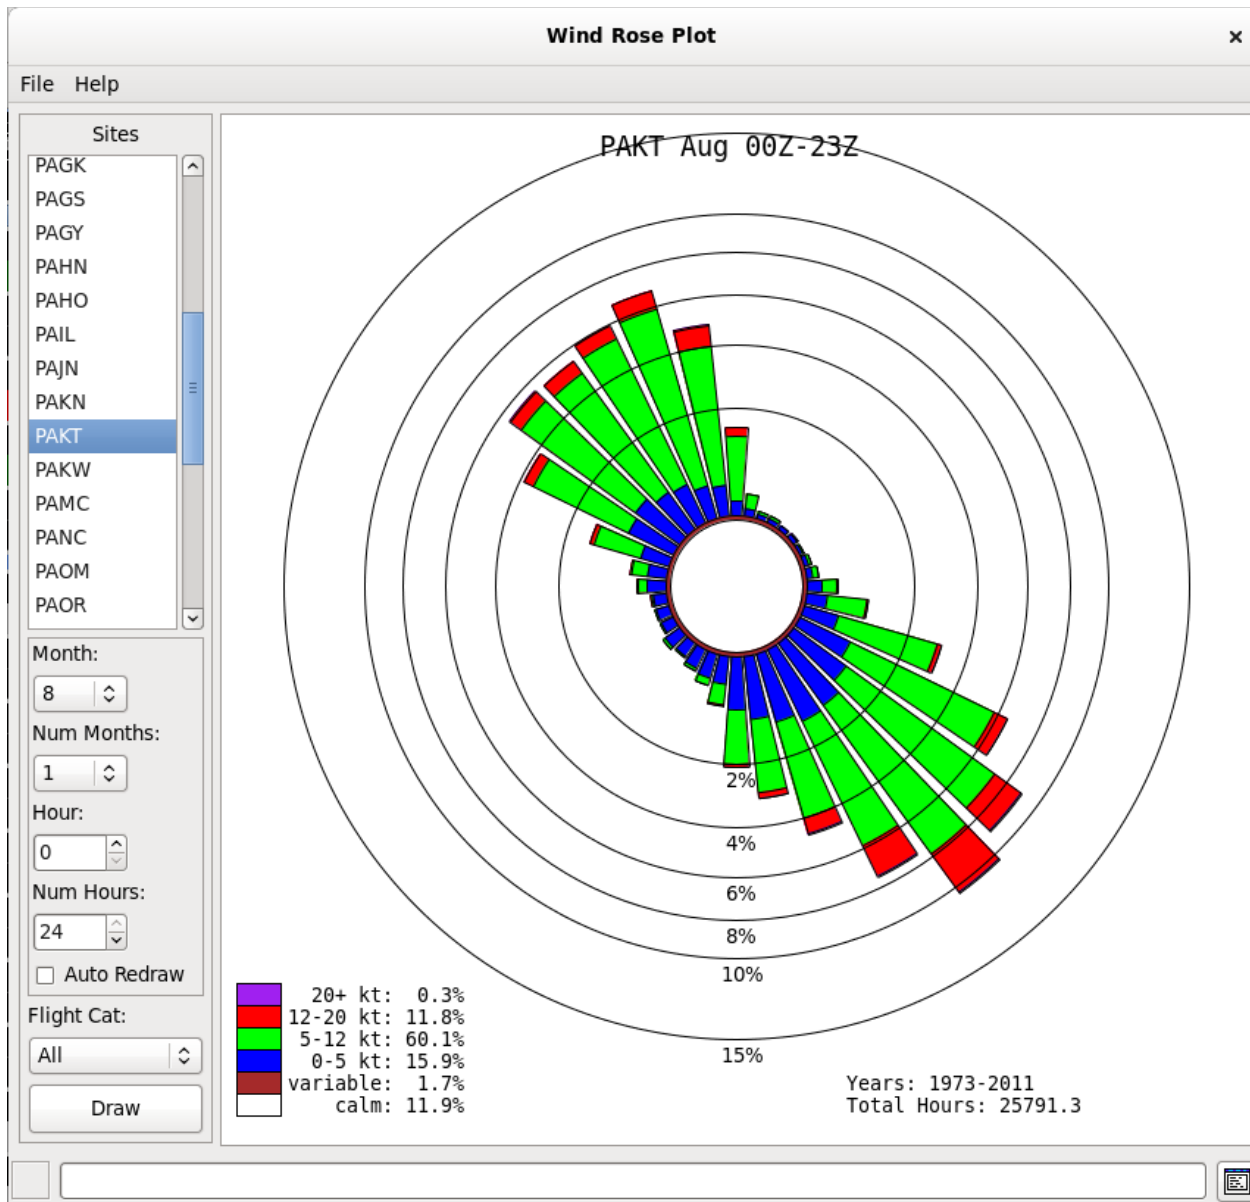
Figure 8 – PAKT Wind Rose Information from 1973 to 2011

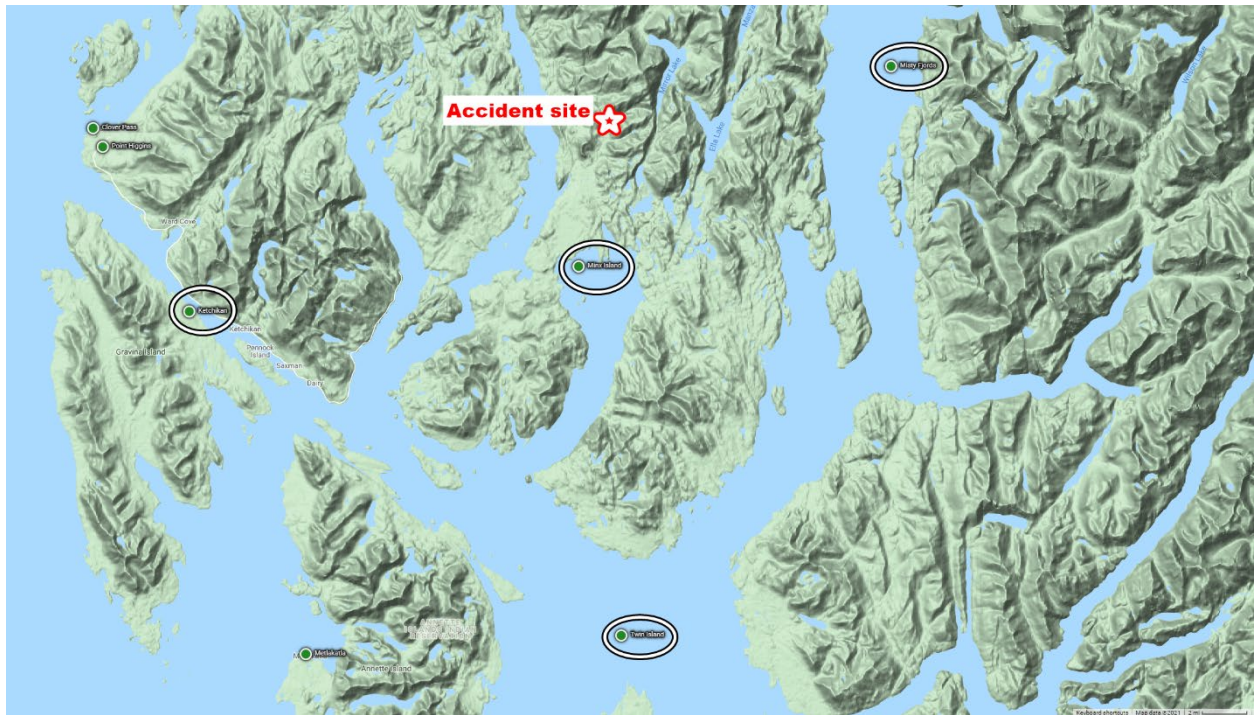
Images from the FAA’s Aviation Weather Cameras are shown in figures 13 through 20 and provide pictures of the weather conditions surrounding the accident site at the accident time. Figures 11 and 12 identify the web camera locations included in attachment 2.

Figure 11 – Map of the closest FAA weather camera sites and the accident site.

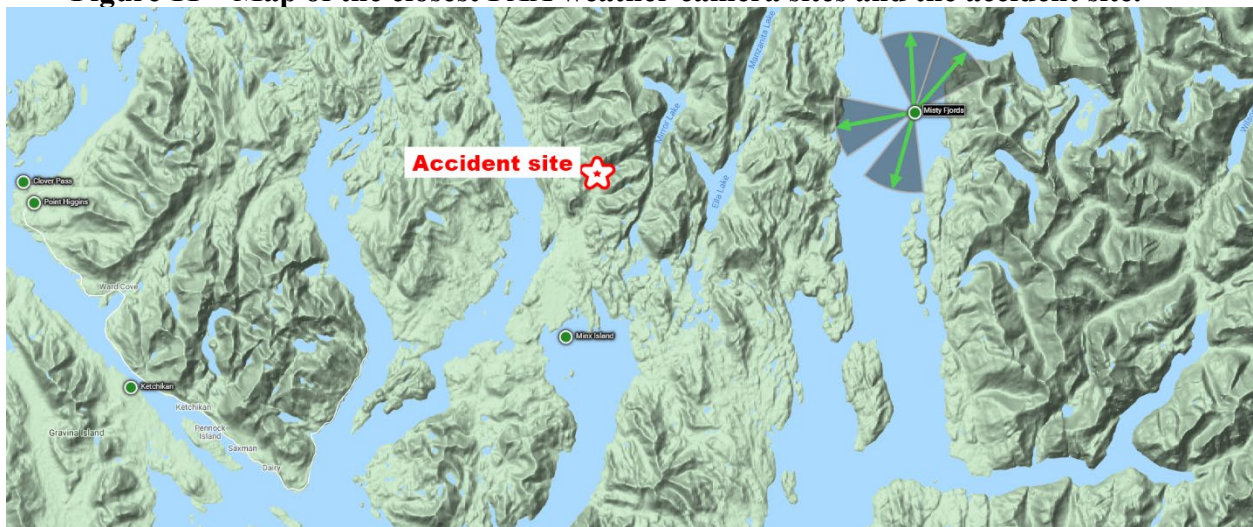
Figure 12 – FAA weather camera Misty Fjords location on sectional chart with the direction the different camera angles with the accident site marked.

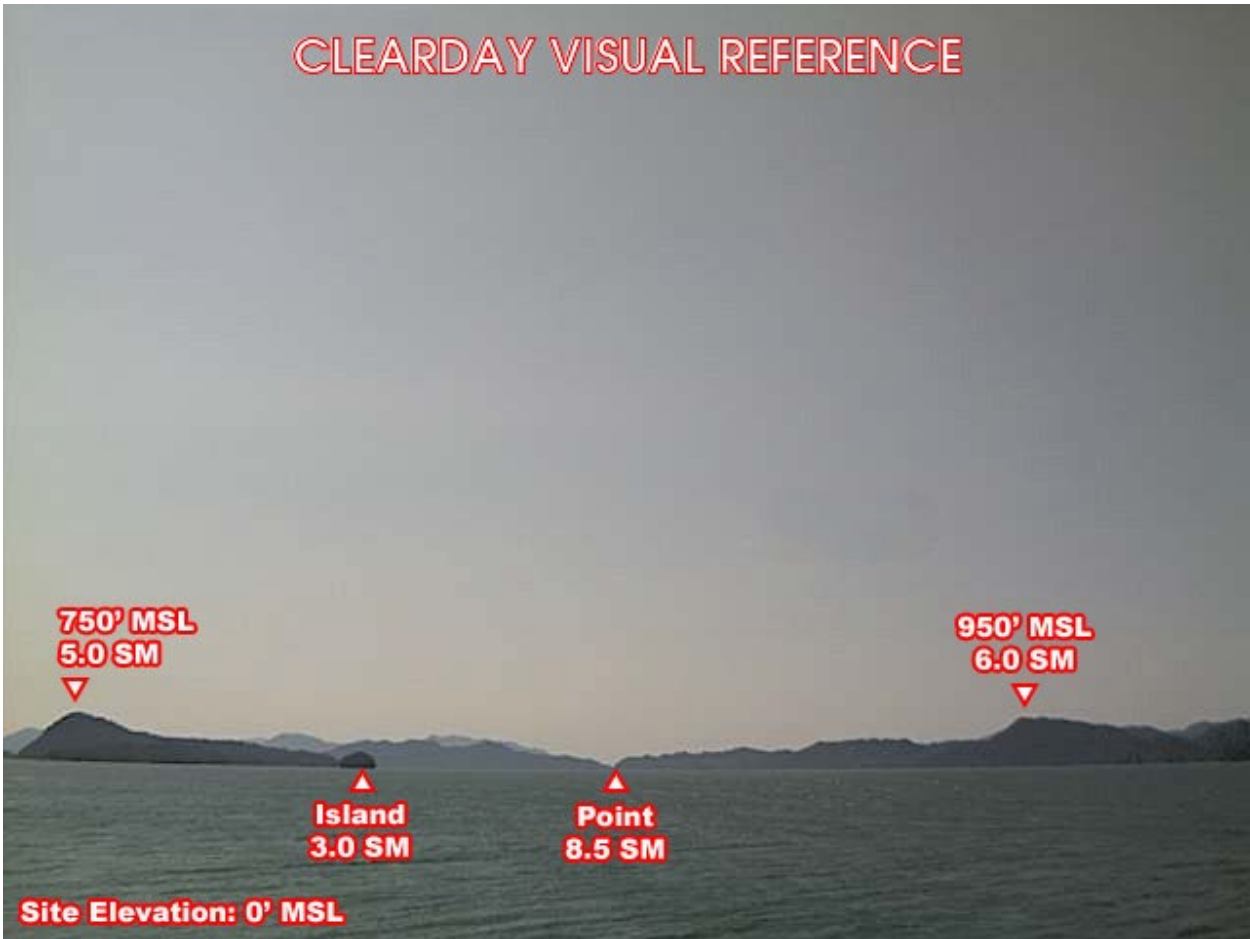
The weather cameras (figures 13 through 20) from Misty Fjords, located 11 miles east-northeast of the accident site, showed the weather conditions surrounding the accident time with the south-facing camera images provided in figures 14 through 16 with times at 1034, 1054, and 1114 AKDT. The south-facing camera images from Misty Fjords depicted a large amount of cloud cover with bases above the 750 ft msl hilltop, but the visibility below the cloud cover was less than 8.5 miles at 1034 AKDT, less than 6.0 miles at 1054 AKDT, and the visibility was less than 3 miles by 1114 AKDT (figure 16) as noted when compared with clear day visual reference markers (figure 13). The west-facing camera images are provided in figures 18 through 20 with times at 1041, 1051, and 1101 AKDT. The west-facing camera images from Misty Fjords also depicted a large amount of cloud cover with cloud bases near mountain tops at 2,000 ft msl. In addition, the visibility was greater than 5.0 miles at 1041 and 1051 AKDT, but the visibility dropped to between 2.5 and 1.0 miles between 1051 and 1101 AKDT (figure 19 and 20) as noted when compared with clear day visual reference markers (figure 17). Similar weather conditions were observed at the Ketchikan, Minx Island, and Twin Island weather cameras, with visibility and ceiling reductions observed as earlier as 0937 AKDT on the Twin Island weather cameras. Based on the southeast-facing camera images from PAKT between 0932 and 0952 AKDT, the accident pilot departed on the accident flight in visibility conditions less than 2.5 miles and precipitation (attachment 2, as noted when compared with clear day visual reference markers). For more information, images, and camera locations please see attachment 2.

Figure 13 – FAA weather camera from Misty Fjords south view from a standard clear sky weather day.

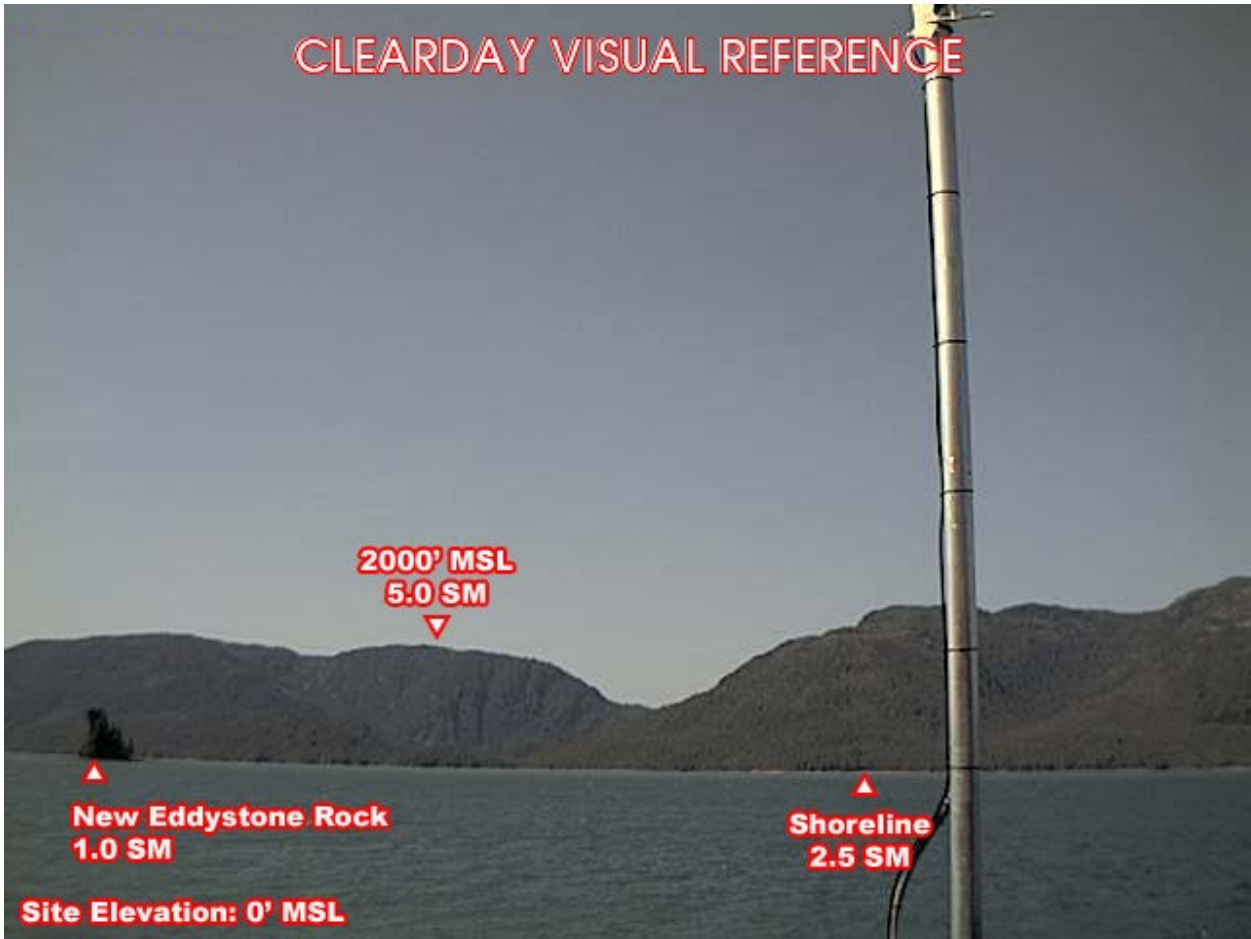
Misty Fjords (W)

Figure 17 – FAA weather camera from Misty Fjords west view from a standard clear sky weather day.
