National Transportation Safety Board

ANC22FA047

AIRWORTHINESS

Group Chair's Factual Report

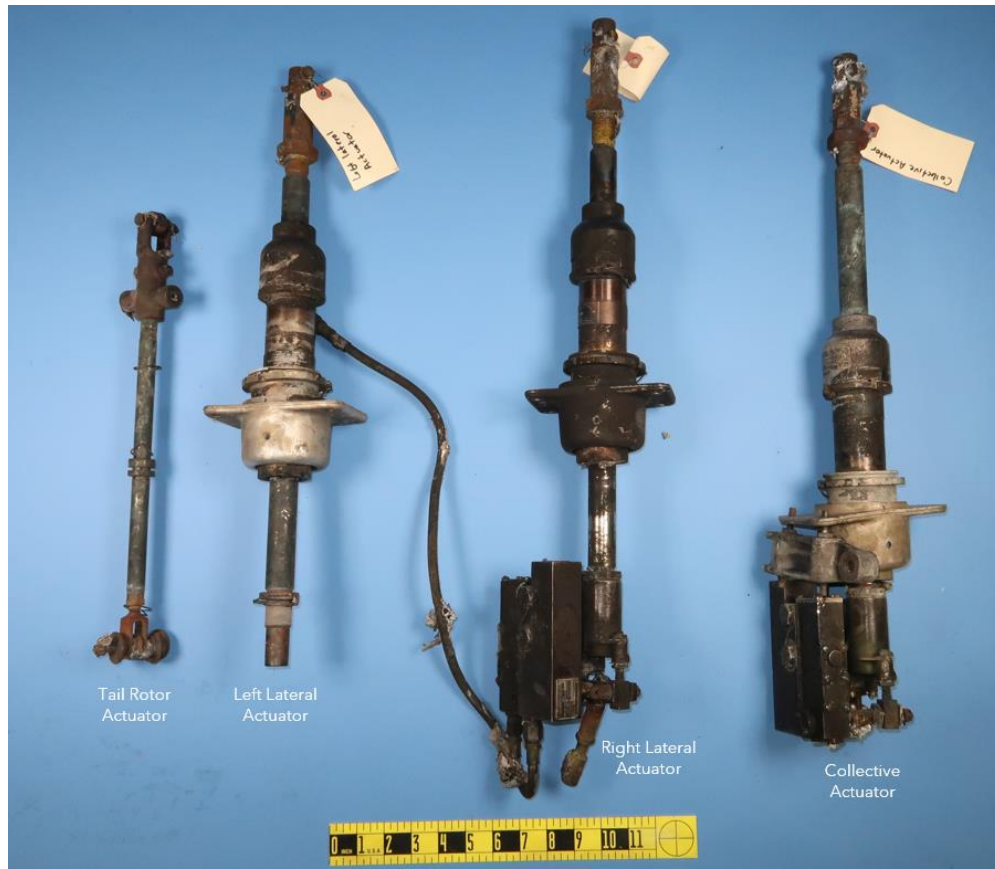
Figure 15. Flight control actuators.

All four flight control actuators were recovered from the wreckage (Figure 17). Each actuator position in the flight control system were identified by serial number and verified by entries in the maintenance records. The collective and right lateral servos had retained their hydraulic servo valves and irreversible valves, the left lateral actuator was missing its hydraulic servo valve and irreversible valve. However, the left actuator's irreversible valve was located within the helicopter wreckage and recovered. The three main rotor actuators were subjected to computed tomography (CT) examination⁶. The examination did not identify any significant foreign material that could have interfered with the proper function of the servo or irreversible valves, confirmed that all internal components were configured properly, and showed no evidence of preexisting damage of internal components. Bulging of the cover plates over the sequence valve were attributed to heat from the post-crash fire.
