FIELD NOTES

SUBJECT Bombardier Field Notes - Accident Site Visit - Challenger 605 N605TR (MSN 5715) - Impact with Terrain on Approach to Runway 11 at Truckee Tahoe Airport (KTRK) on July 26th, 2021

FROM Bombardier Air Safety Investigation Office (ASIO)

ASIO CASE REF. NO. CL600-2B16 (604 Variant).5715.26-7-21

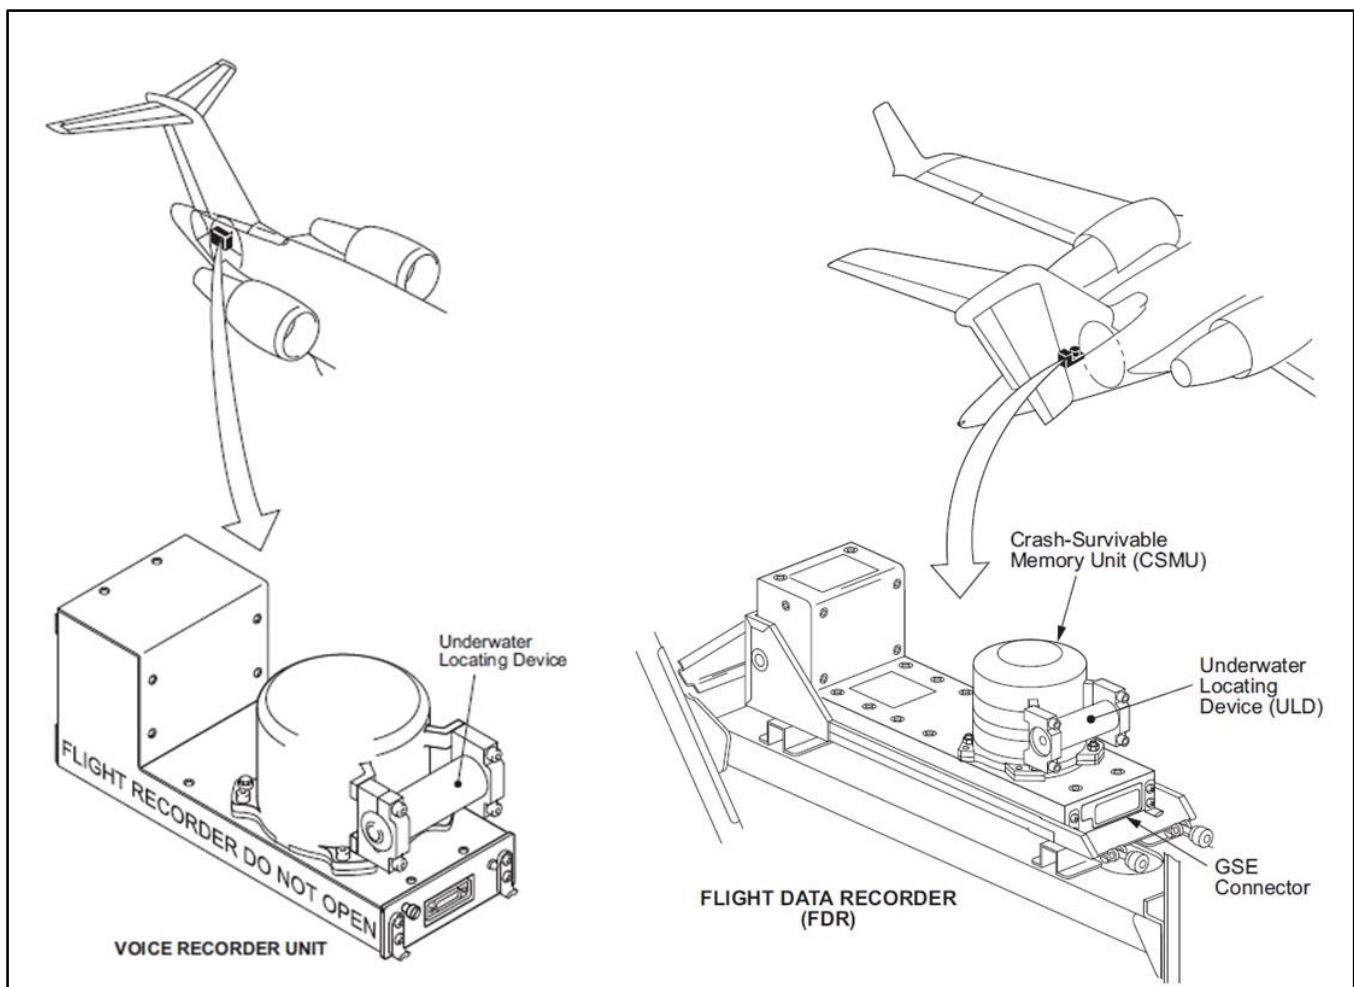
Figure 4: Normal Installation of CVR and FDR

The FDR and CVR were found in the vicinity of the tail section, approximately in the area outlined in red in Figure 3. The FDR and CVR are normally installed in the tail section of the aircraft (Figure 4).

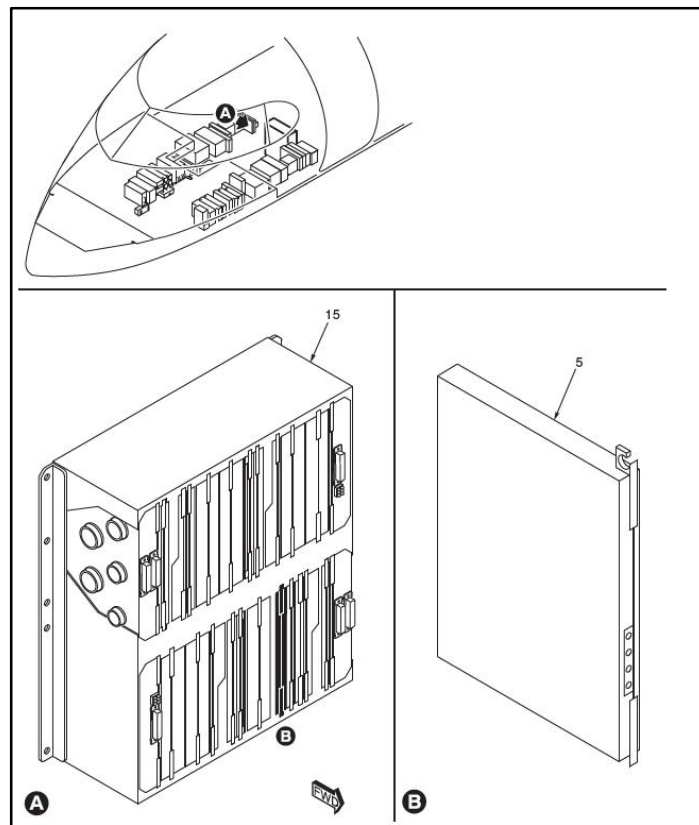
Figure 7: Normal Installation of IAPS and MDC

The IAPS, P/N 822-0781-001, was found on the road at the top of the wreckage site (Figure 6). The IAPS contains a card which holds the Maintenance Diagnostic Computer (MDC), item 5 in Figure 7. The MDC retains maintenance fault history and a log of flight deck effects messages, among other things, which may be useful for the investigation. While not intended to be crash-protected, the data may still be recoverable. The IAPS was shipped to the NTSB recorder laboratory in Washington D.C. Bombardier recommends that the IAPS be sent to Rockwell Collins for examination and attempted retrieval of data from the MDC.

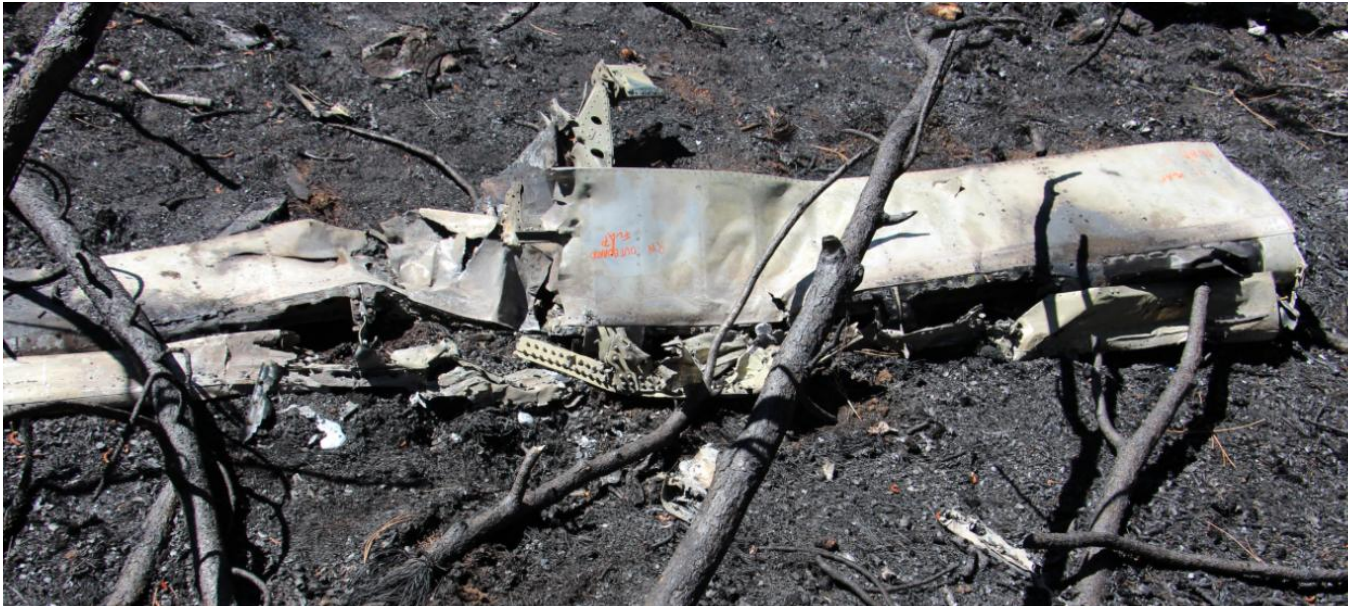
Figure 13: Right Outboard Flap

1. Left outboard wing - 12-foot section, starting 15 feet outboard (Figure 8)
2. Left winglet (Figure 8)
3. Left outboard flap (Figure 9)
4. Left Aileron (Figure 8)
5. Right wing - 8 feet, from mid outboard flap to aileron (Figure 10)
6. Right winglet (Figure 11)
7. Right inboard flap (Figure 12)
8. Right outboard flap (Figure 13)
9. Right aileron - outboard two feet - still attached to right wing (Figure 14)
10. Left outboard horizontal stabilizer - 3.5 feet (Figure 15)
11. Left outboard elevator - approximately half span (Figure 16)
12. Right horizontal stabilizer (Figure 17)
13. Right elevator - still attached to the right horizontal stabilizer (Figure 17)
14. Vertical stabilizer (Figure 18)
15. Rudder - bottom 18 inches - still attached to vertical stabilizer (Figure 19)

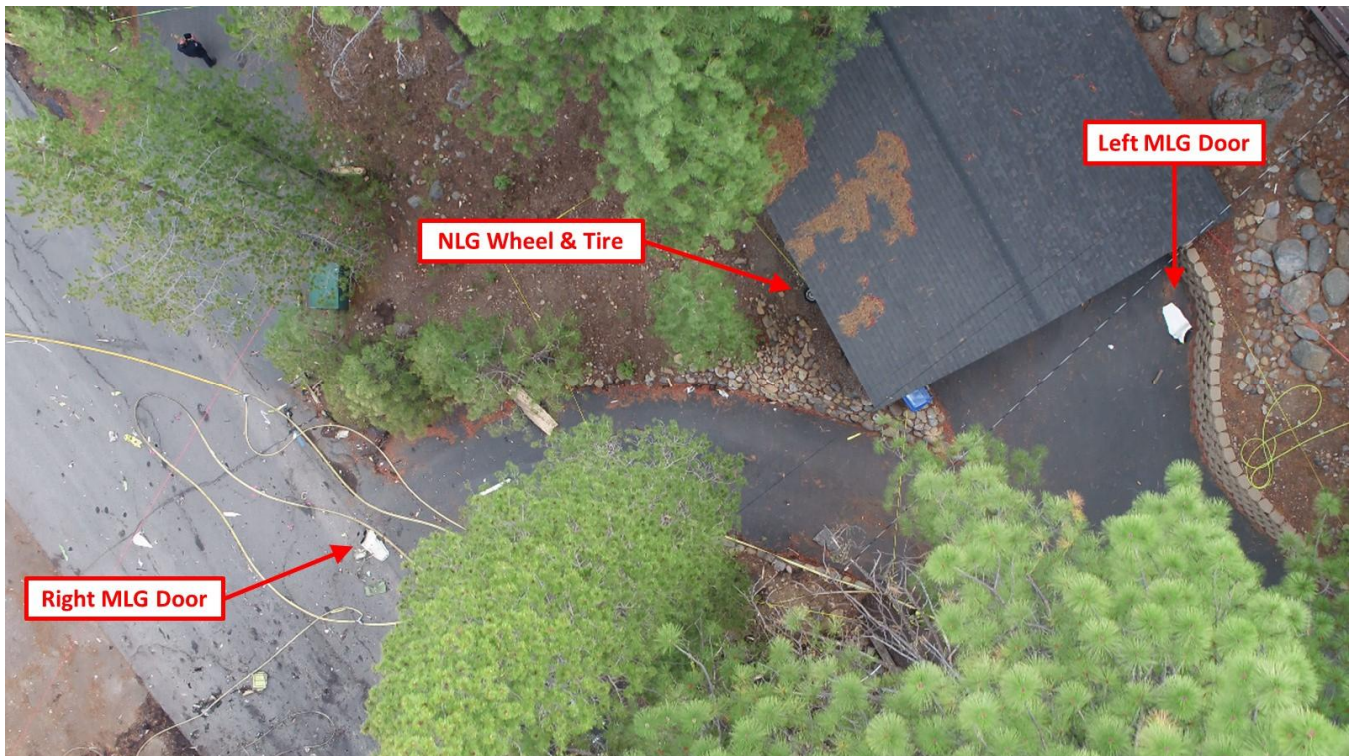
Figure 31: Screenshot 6 of 6 - Overhead Drone Video - Moving Forward along Flight Path

Major aircraft components are identified on Figure 25 through Figure 31. Figure 25 is a view of the wreckage site from the ground, looking forward along the flight path. Figure 26 through Figure 31 are a series of consecutive screenshots taken from drone video looking down at the wreckage site and moving forward along the flight path. The drone video was provided to the ASIO by the NTSB and had been recorded the day before (July 27th) the ASIO arrived on site.

The damage to the trees around the wreckage site indicates that the aircraft entered the trees at a fairly steep angle, most likely 30 degrees nose-down or more, and at a very high bank angle, most likely somewhere between 60 and 120 degrees. As the aircraft entered the trees, it continued to roll until inverted or nearly inverted.
