# National Transportation Safety Board

DCA23LA185

## **AIR TRAFFIC CONTROL**

Group Chair's Factual Report

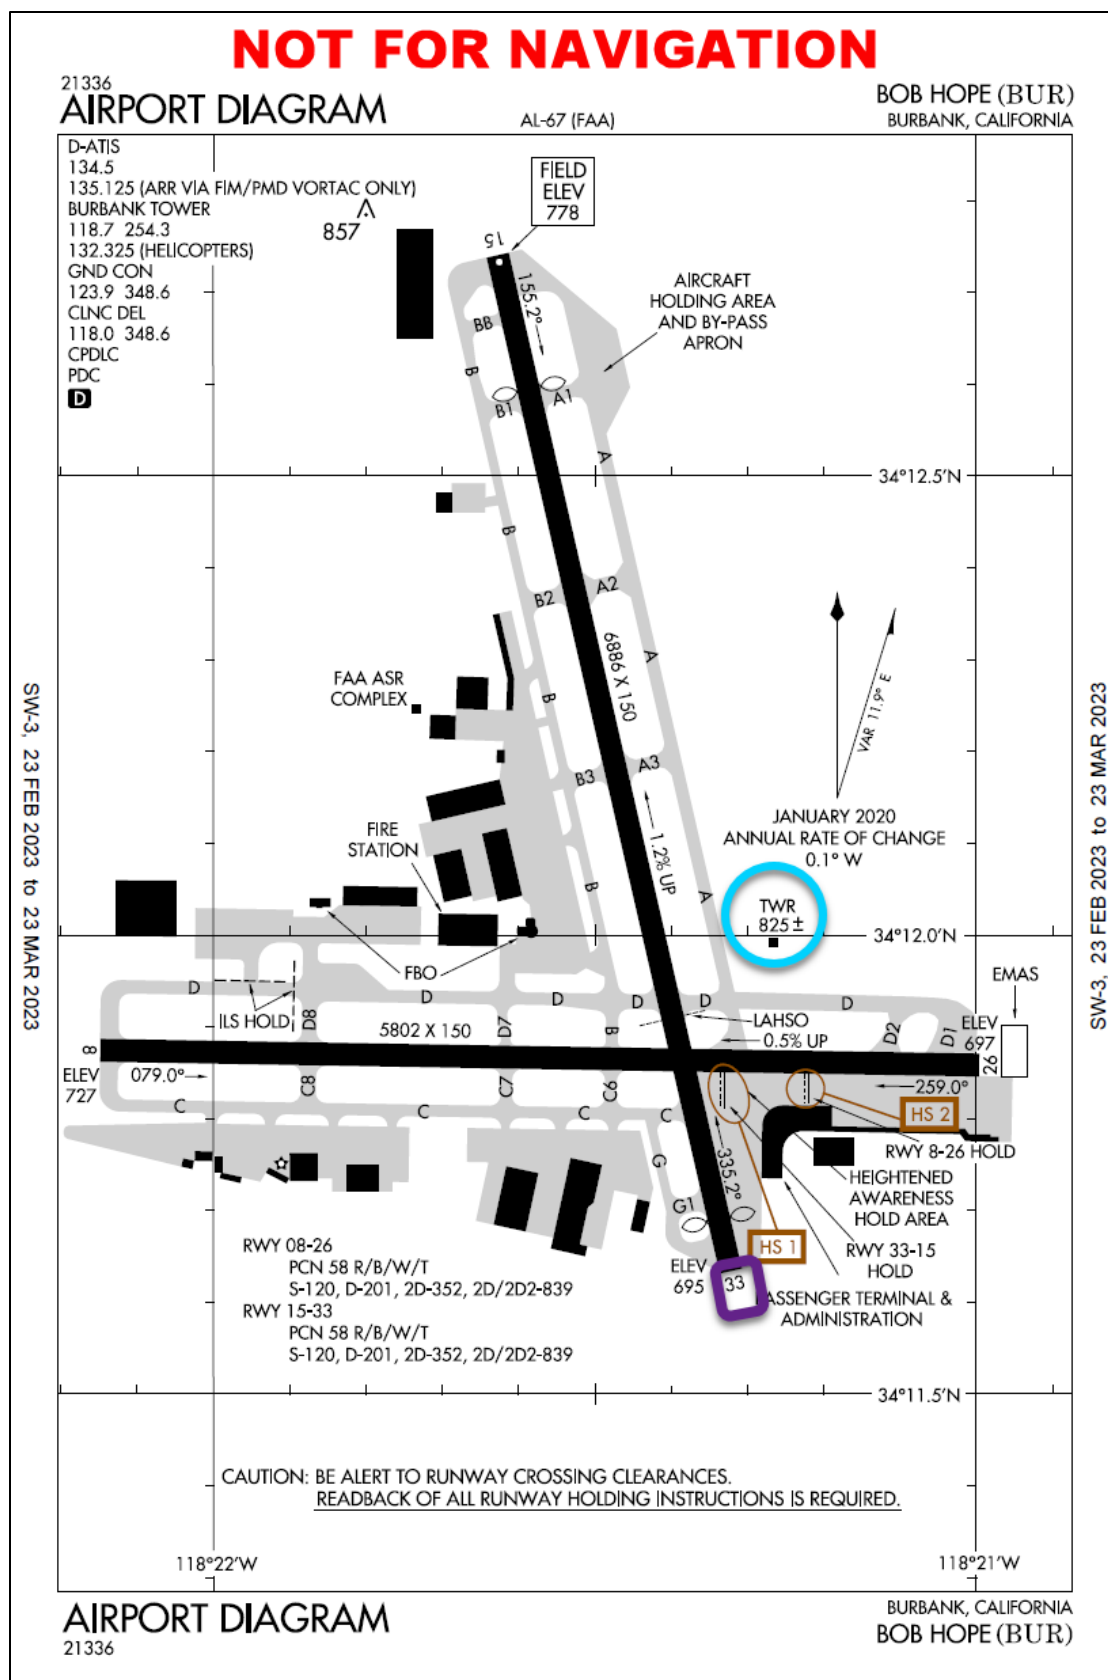
Figure 1 is the BUR airport diagram that depicts the locations of runway 33, purple rectangle) and the air traffic control tower (light blue circle)

**Figure 1. BUR Airport diagram depicts location of runway 33 and the ATC tower.**

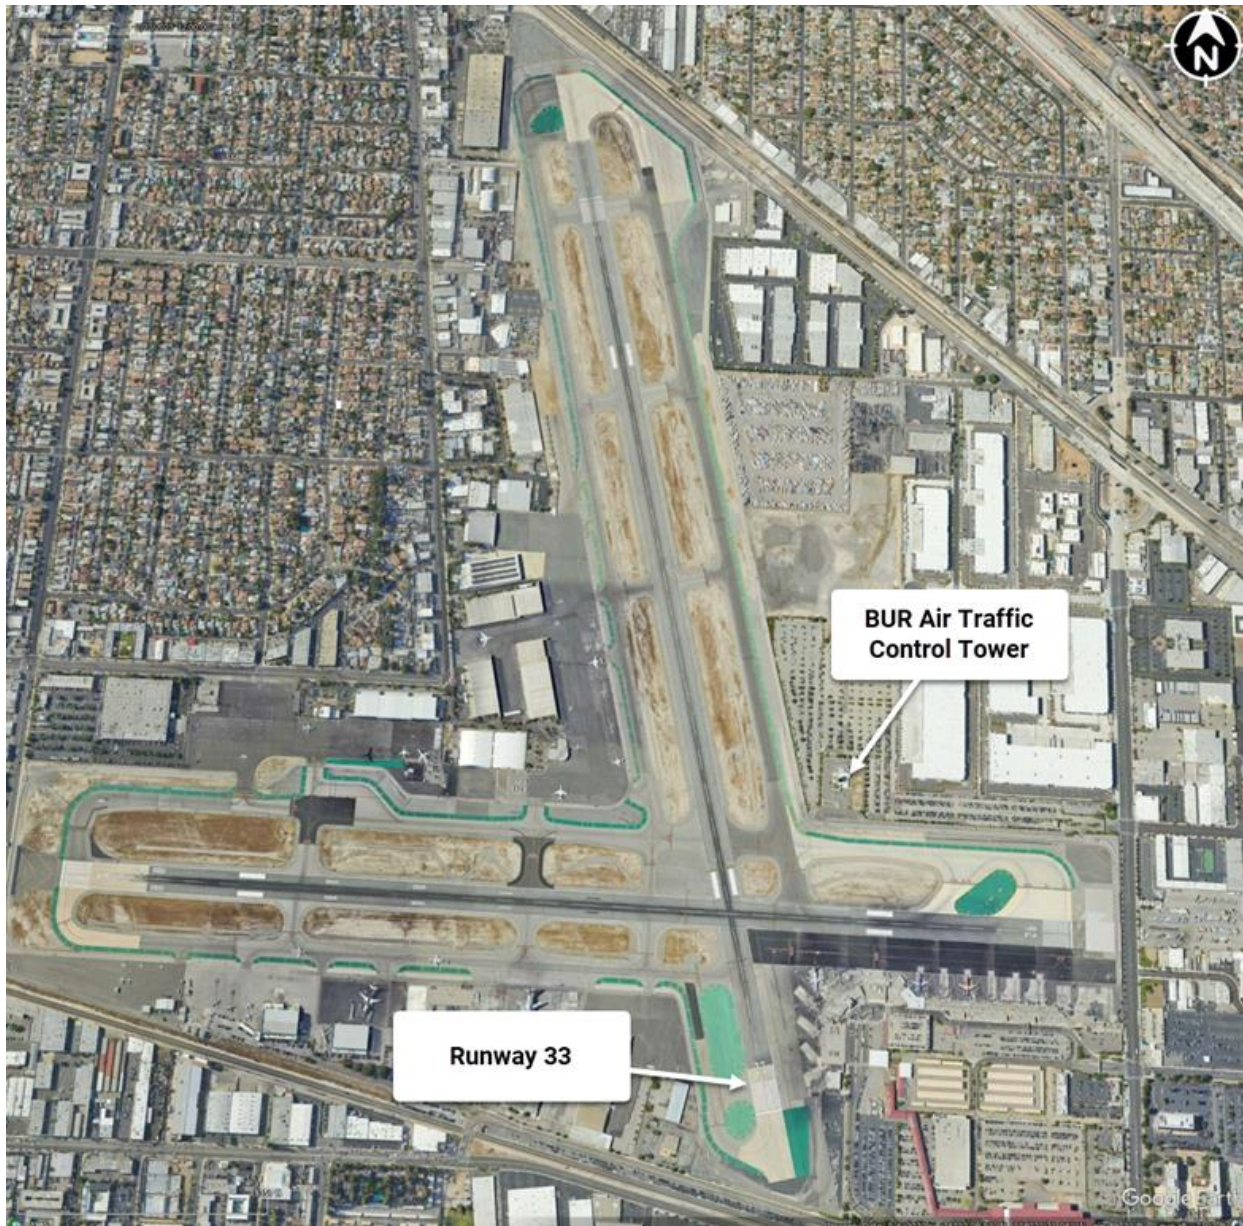
Figure 4 is a google earth aerial view screenshot of BUR airport. Runway 33 and the BUR air traffic control tower are pointed out.

**Figure 4. Google Earth aerial view of BUR; ATC tower and Runway 33 depicted.**

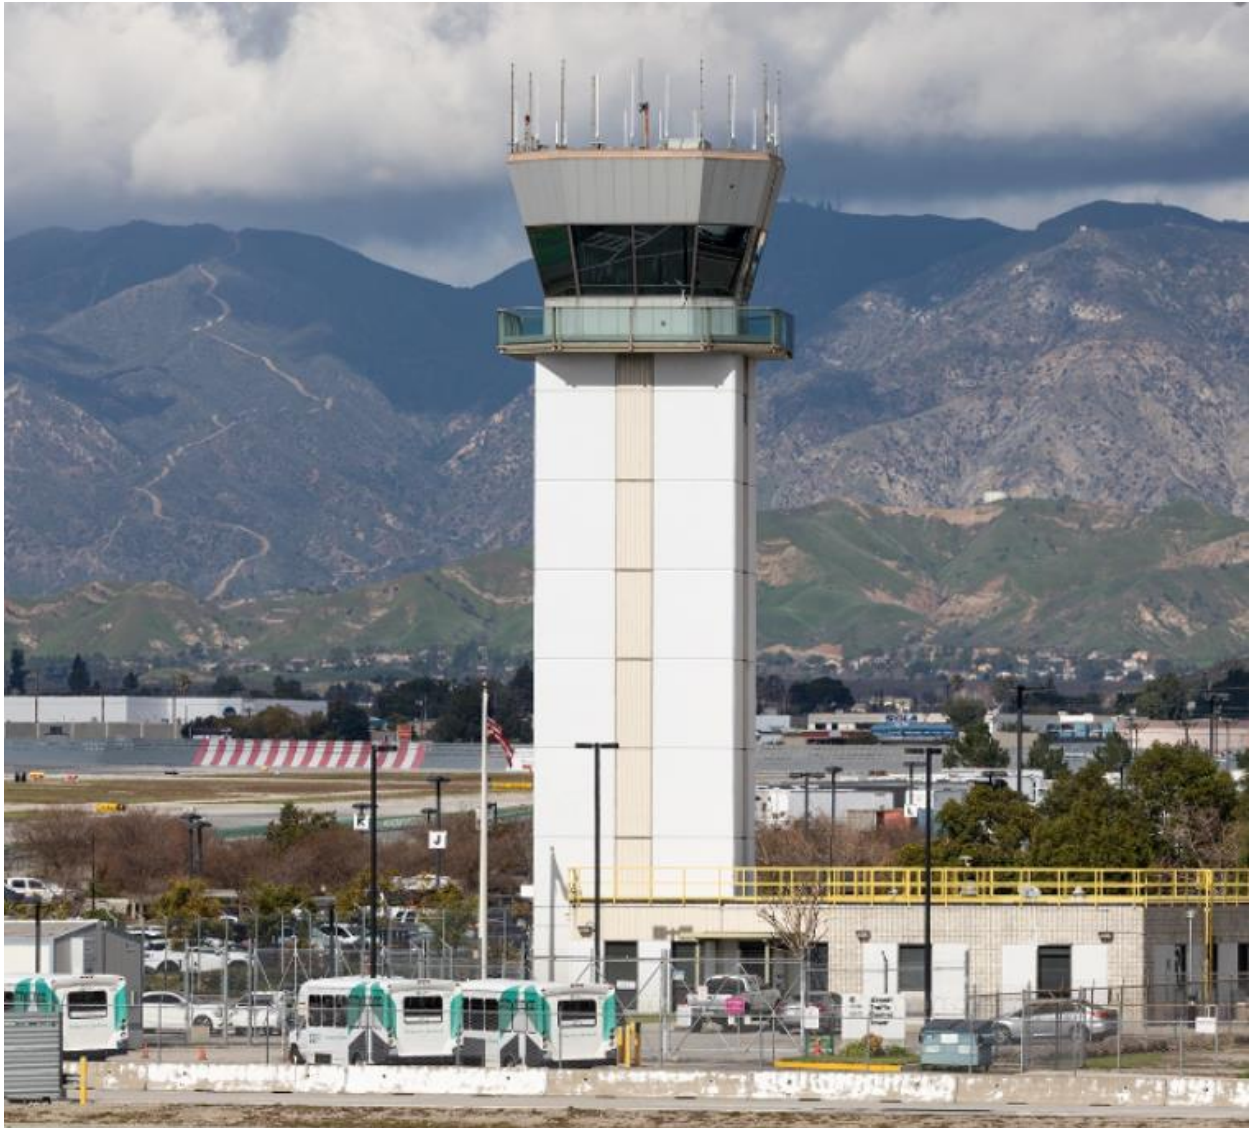
Figure 5 is a photo of the BUR airport traffic control tower.

**Figure 5. Photo of BUR air traffic control tower. Credit: JetPhotos.com**

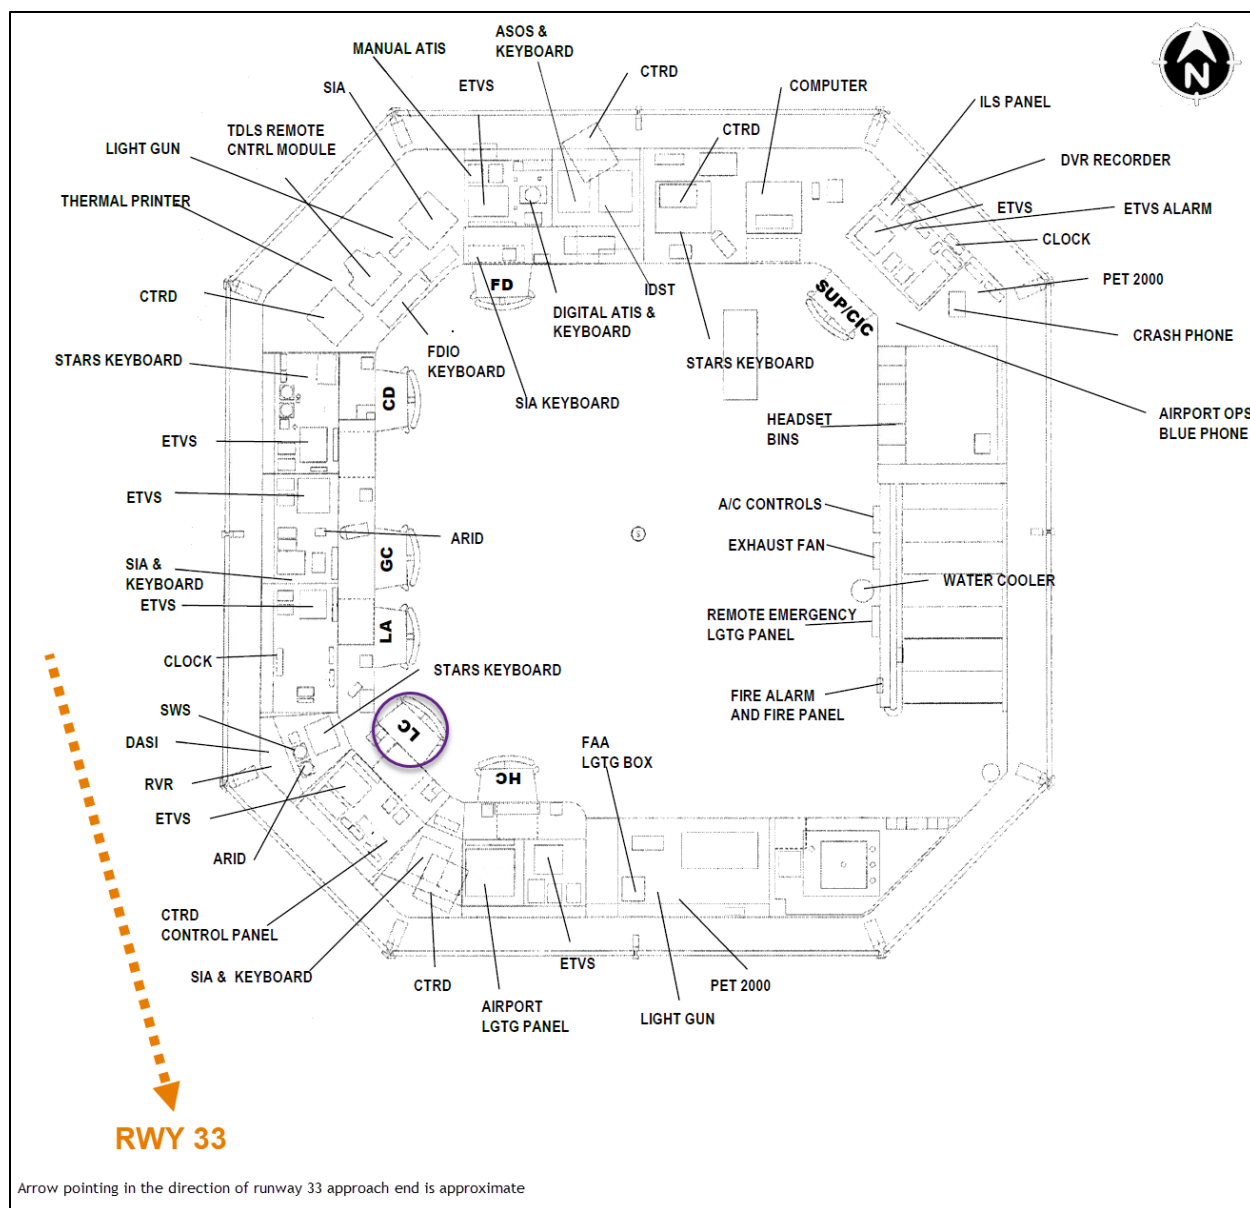
Figure 6 is the tower cab layout depicting the location of the workstations and the location of the LC position.
