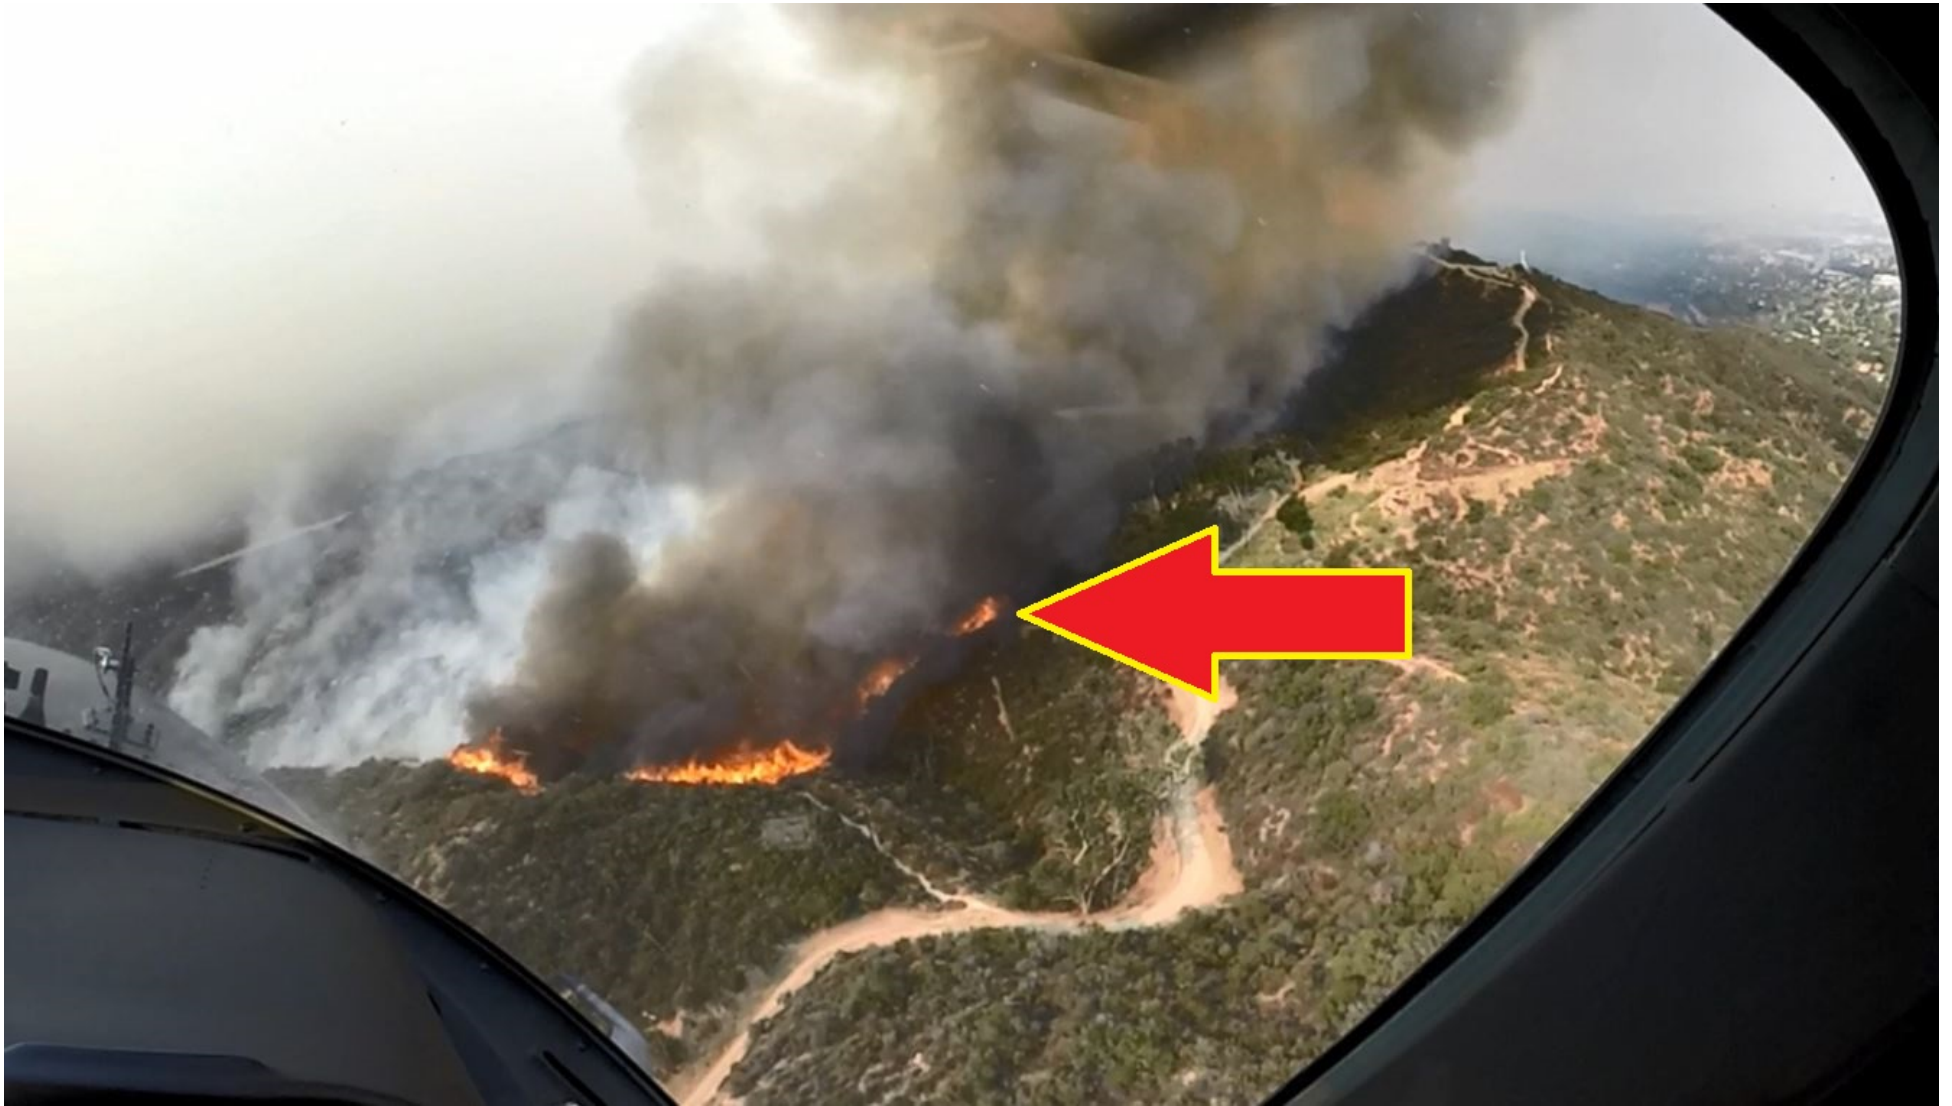
**Photo 1 – Aerial view from Fire 2 just prior to the time of the accident, looking to the west, of the residential complex during aerial firefighting operations (courtesy of the LAFD). The residential complex is marked with the red arrow.**

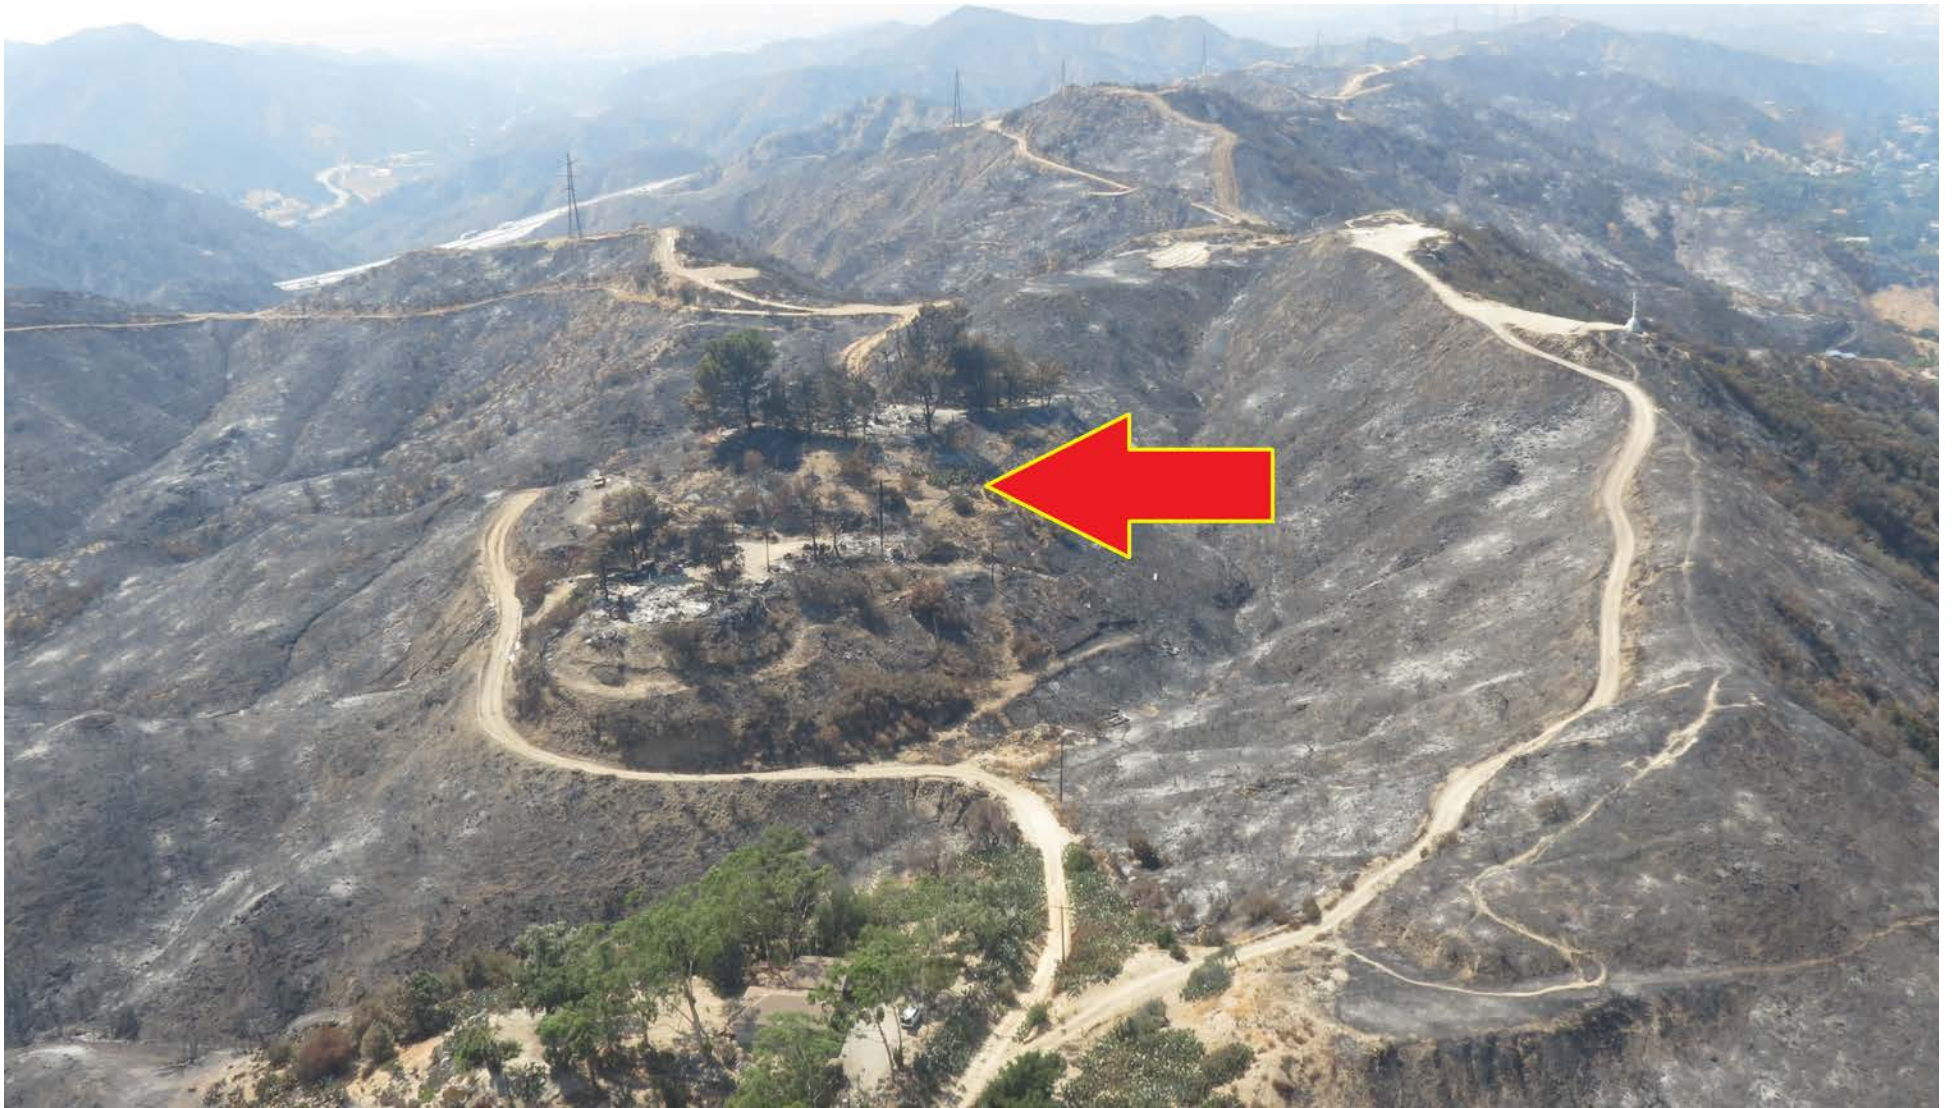
**Photo 2 – Aerial view, looking to the west, of the residential complex after the fire was contained (courtesy of the LAFD).  
The residential complex is marked with the red arrow.**
