NATIONAL TRANSPORTATION SAFETY BOARD

ACCIDENT SITE EXAMINATION SUMMARY

WPR21FA272

Location: Dinsmore, CA
Date: July 15, 2021
Aircraft: Mooney M20J, N4474H
NTSB Investigator-in-Charge: Maja Smith

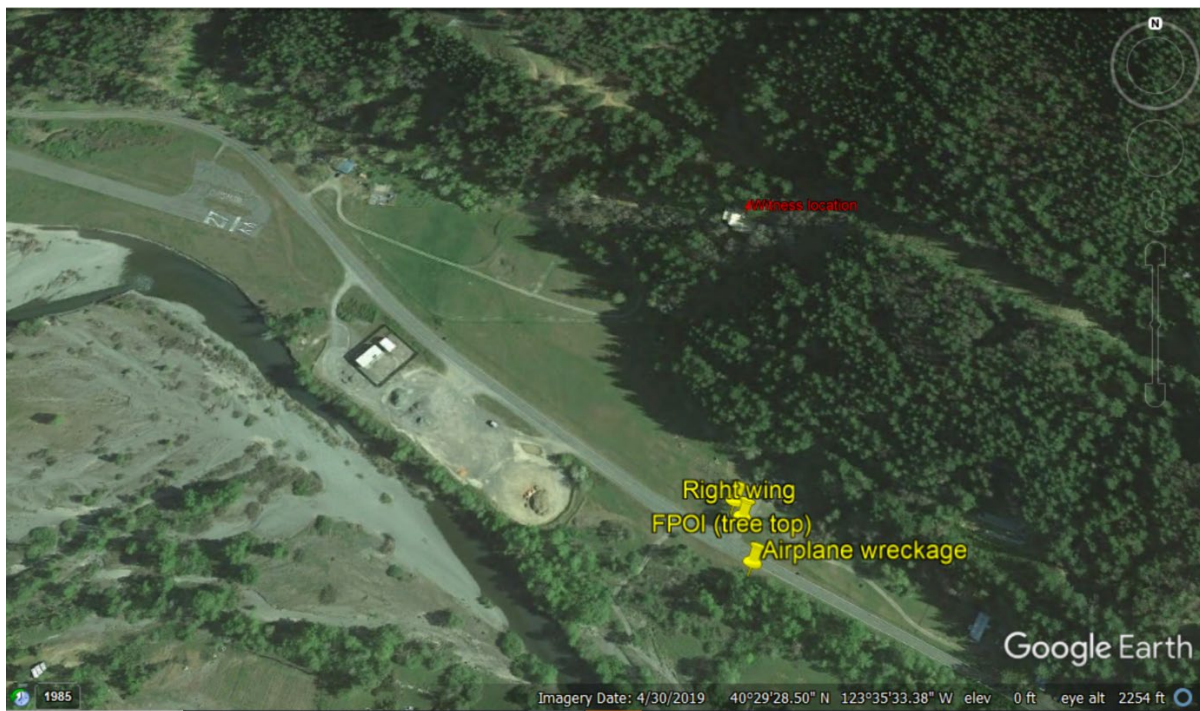
The accident site was located next to highway 36; about 1,600 ft from the departure end of runway 09 at Dinsmore Airport (D63), Dinsmore, California and on a heading of 126°.

Image 1-Satellite View of the accident location

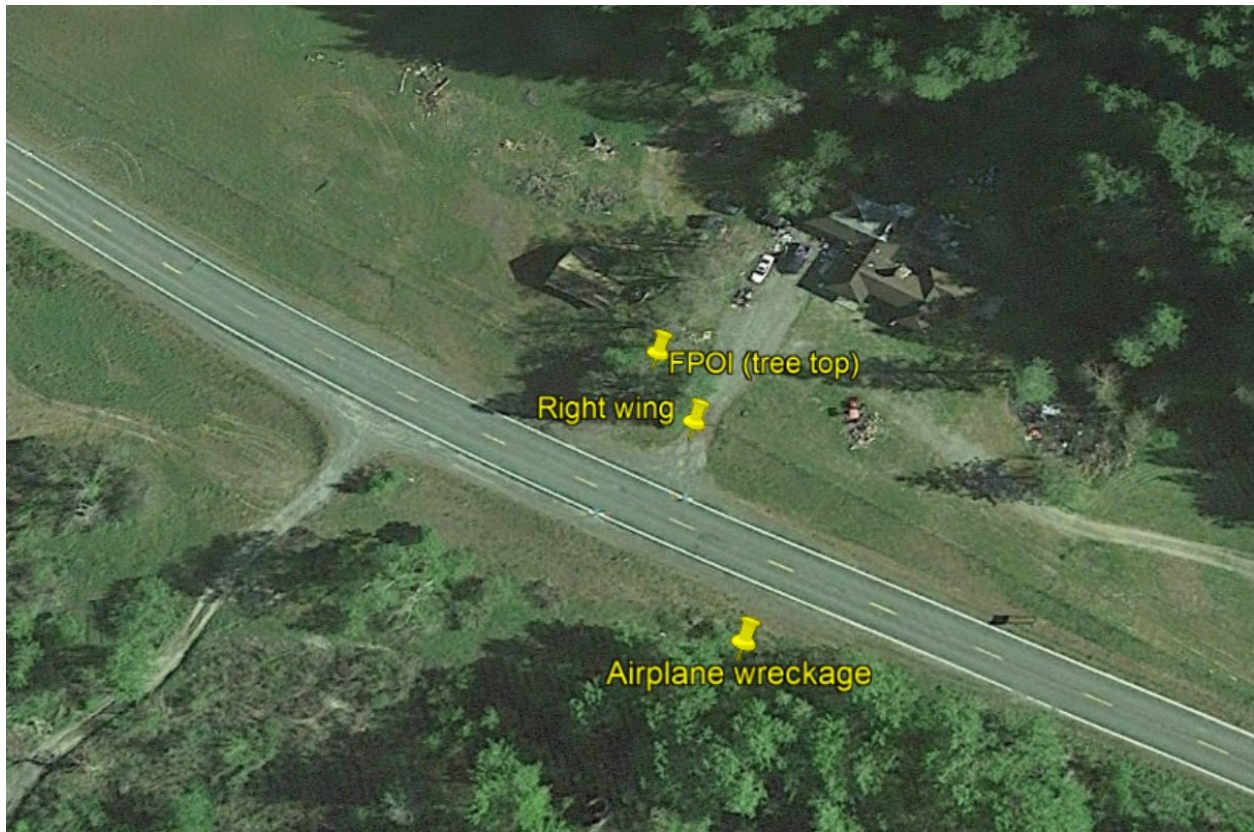
Image 2-Satellite view of the accident location (zoomed in)
