## **NATIONAL TRANSPORTATION SAFETY BOARD**

# **ACCIDENT SITE EXAMINATION SUMMARY**

**WPR22FA011**

Location:	Reserve, New Mexico
Date:	October 15, 2021
Aircraft:	Cessna 175, N7584M
NTSB Investigator-in-Charge:	Maja Smith

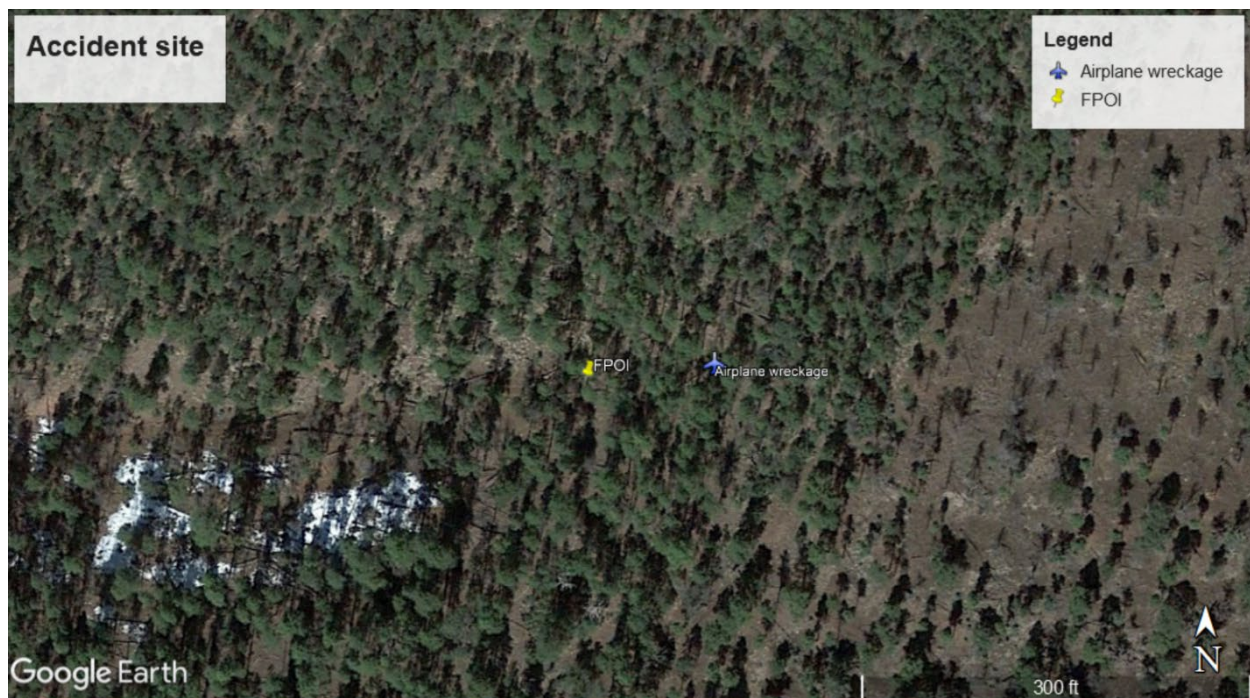
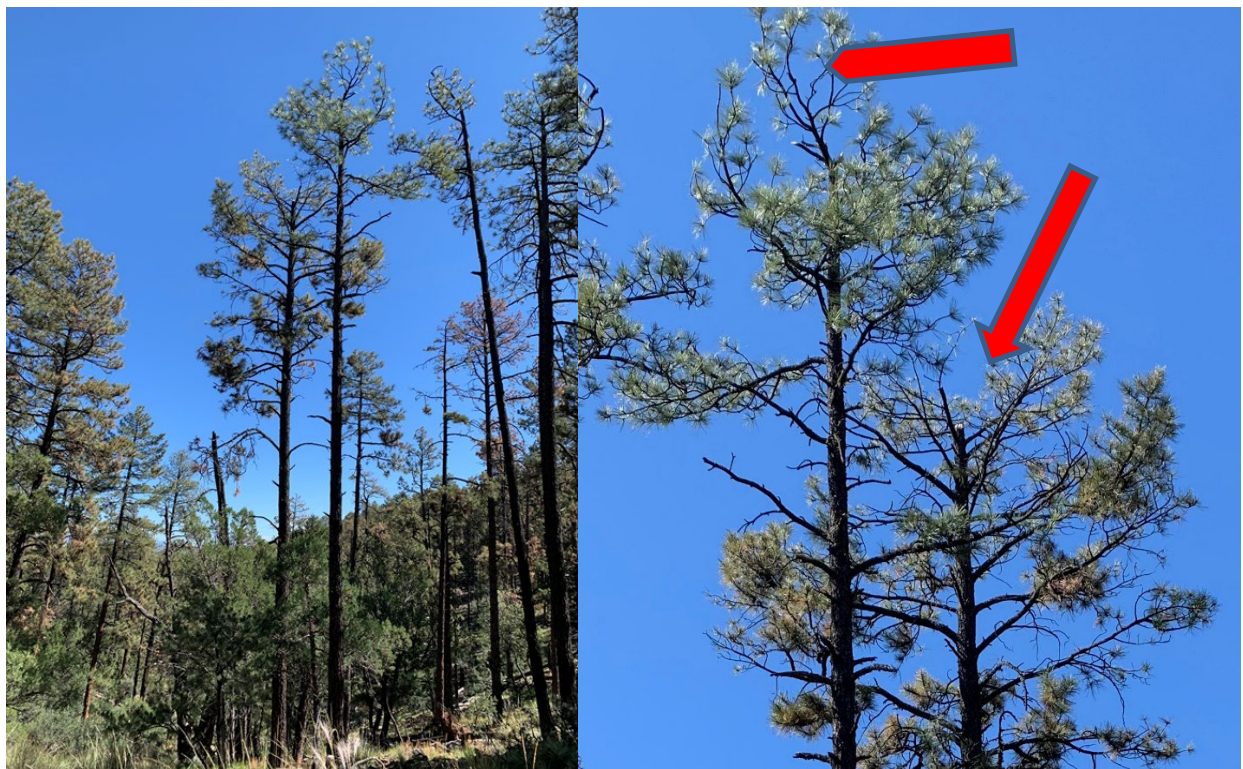
The accident site was located near Russ Mountain in the Gila Mountains, New Mexico. Gila Mountains. The Gila Mountain range is located in southwest New Mexico, north of Silver City and east of Reserve. The accident site was located about 7 nautical miles south of Reserve, NM.

The first point of impact (FPOI) was identified as the top of a pine tree located about 100 ft downhill from the airplane wreckage. The tree height after the impact was estimated to be about 70 ft.
