NATIONAL TRANSPORTATION SAFETY BOARD
Office of Aviation Safety
Washington, DC 20594

SURVIVAL FACTORS SPECIALIST'S FACTUAL REPORT

Airplane : Textron Aviation B300 [N534FF]
Location : Addison, TX
Date : June 30, 2019
Time : 0911 central daylight time (CDT)¹
NTSB # : CEN19MA190

On June 30, 2019, about 0911 central daylight time, a Textron Aviation B300, N534FF, was destroyed when it was involved in an accident near Addison, Texas. The airline transport pilot, the commercial co-pilot, and eight passengers sustained fatal injuries. The airplane was operated as a Title 14 Code of Federal Regulations Part 91 personal flight.

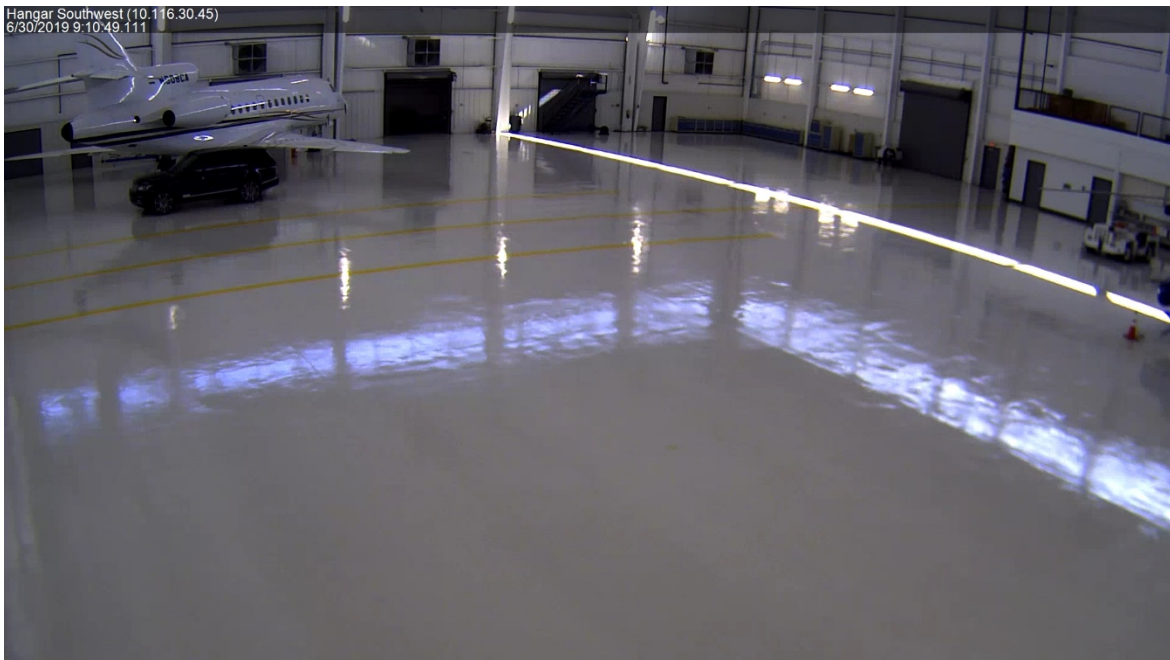
Photo 8. Interior view of hangar just prior to impact.

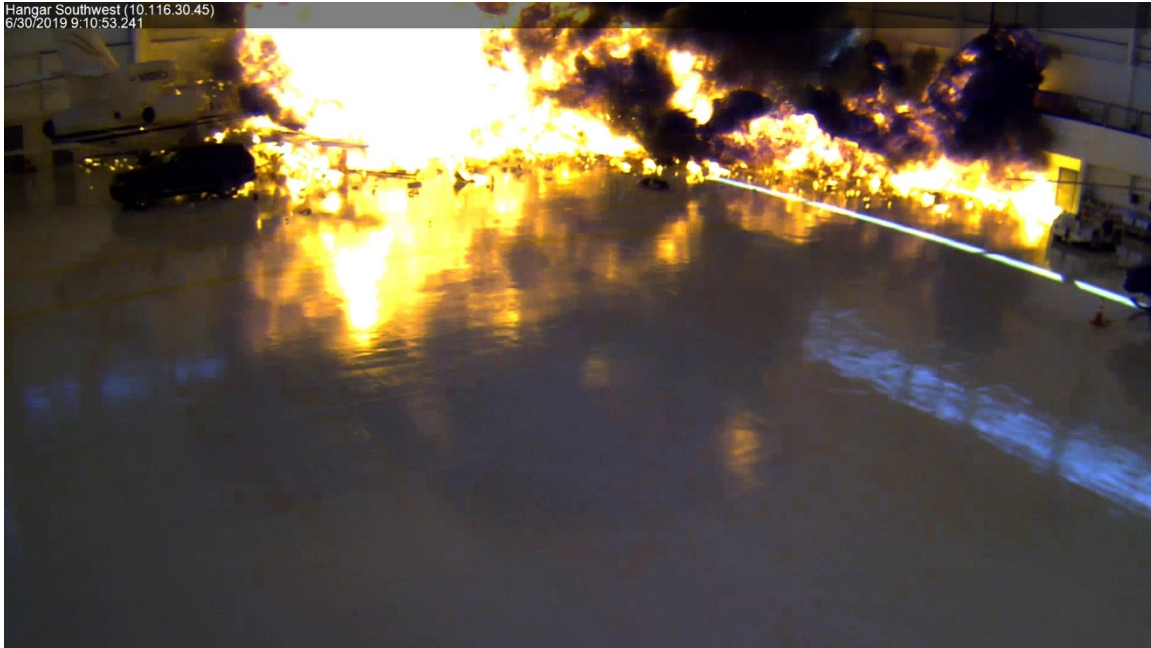
Photo 11. Interior view of hangar about three seconds after impact.

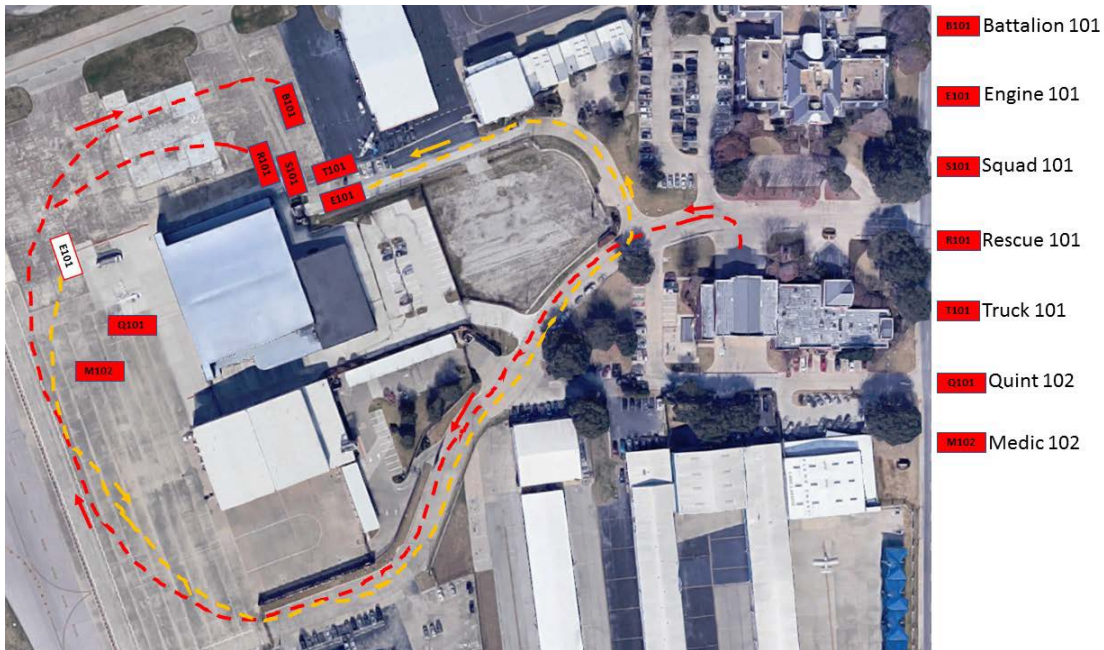
Figure 3. Response routes taken by AFD vehicles responding from Fire Station 1.

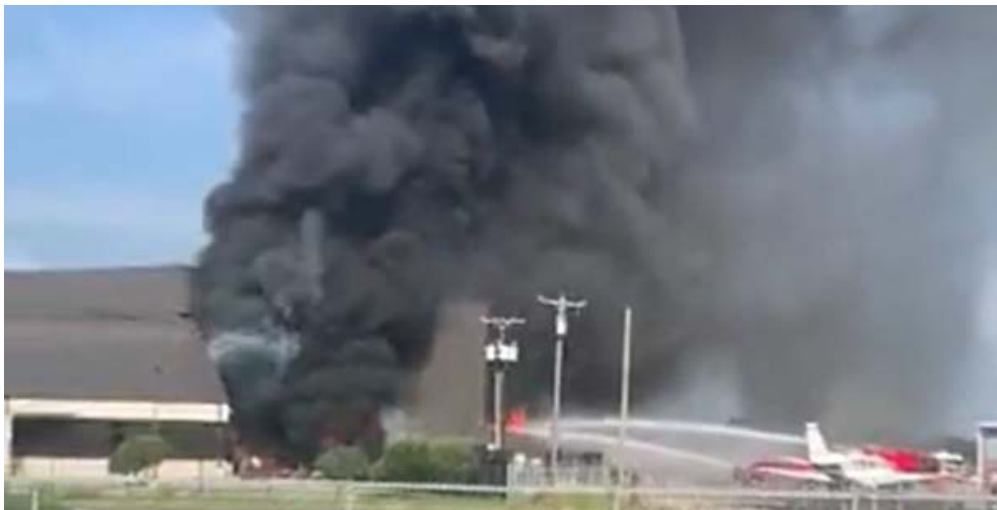
Photo 20. Internet photo showing the initial attack on the hangar fire by Squad 101 (bumper turret) and Rescue 101 (roof turret).

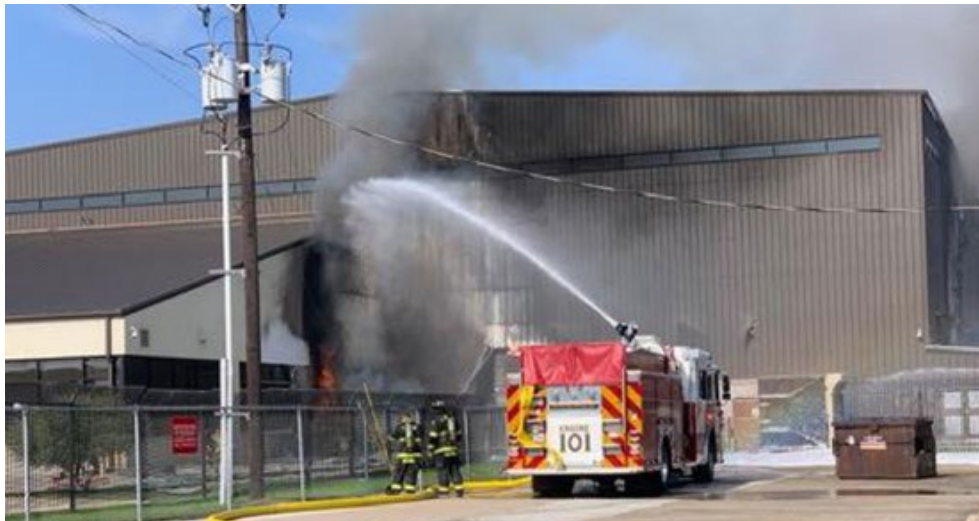
Photo 21. Internet photo showing Engine 101 using its roof turret to extinguish residual fire near the accident airplane.

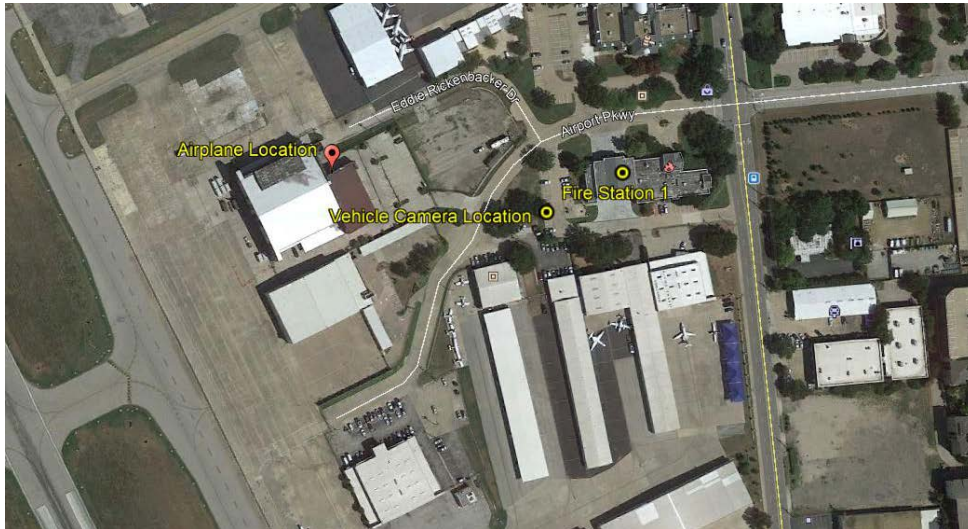
Figure 4. Google Earth image with the relative locations of the accident airplane, Fire Station 1, and the camera vehicle.
