NATIONAL TRANSPORTATION SAFETY BOARD
Office of Aviation Safety
Washington, D.C. 20594

MAINTENANCE RECORDS AND POWERPLANT GROUPCHAIRMAN'S FACTUAL REPORT

NTSB No: ERA17MA316

Operator: Air Methods Corporation
Aircraft: Airbus Helicopters Deutschland GmbH MBB-BK 117 C-2, registration number N146DU
Location: Hertford, North Carolina
Date: September 8, 2017
Time: 1120 Local Time

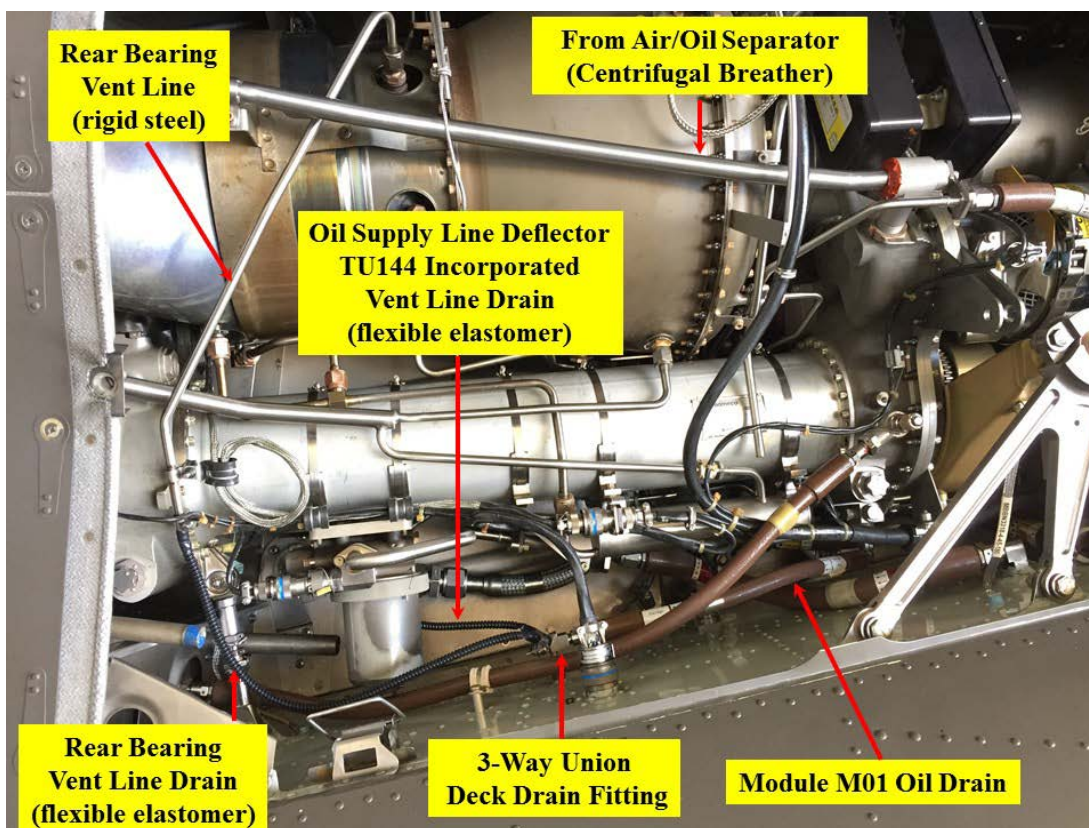
PHOTO 1: PHOTO OF DRAINS ATTACHED TO 3-WAY UNION DECK DRAIN FITTING

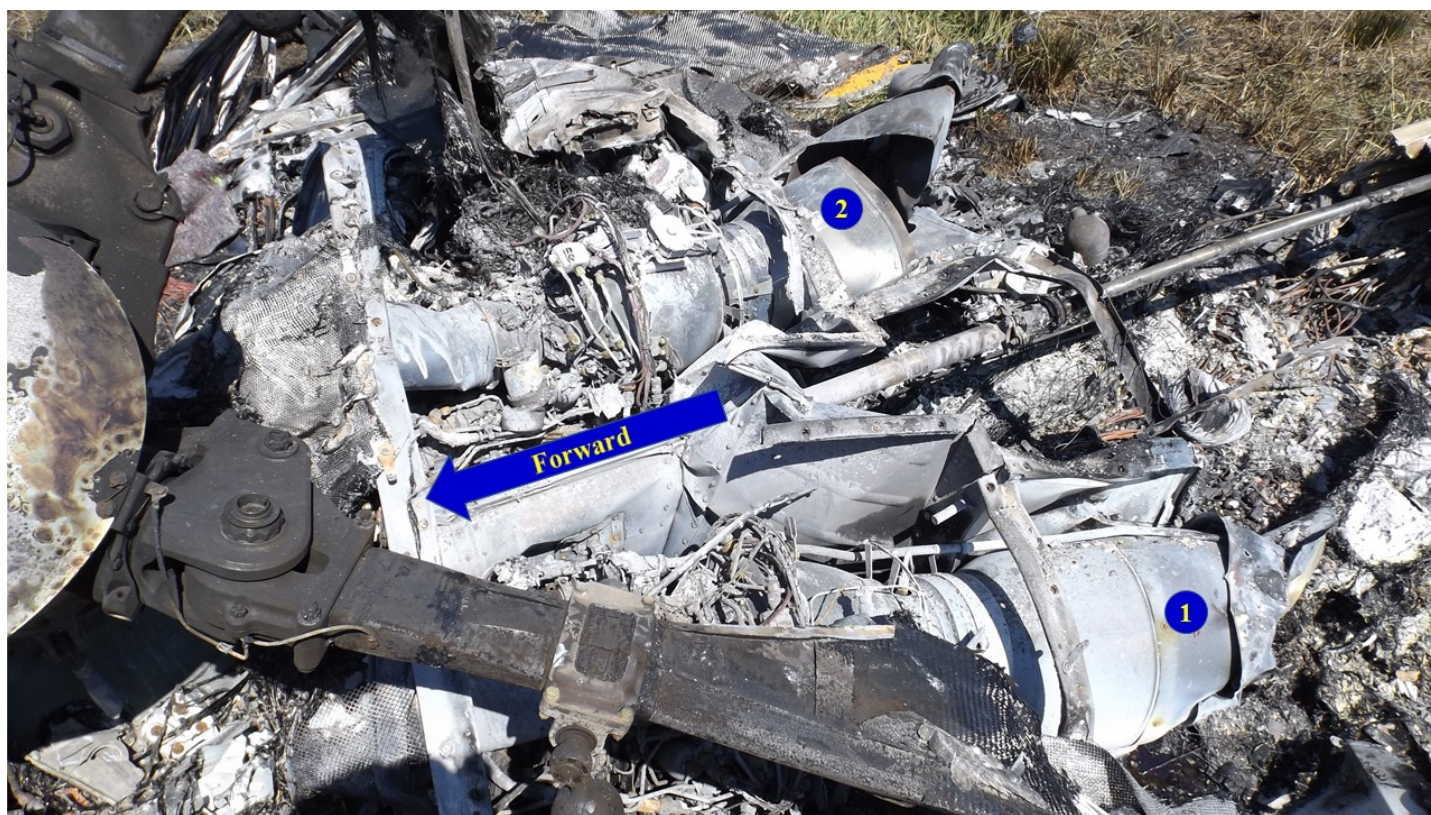
PHOTO 2: ON-SCENE ENGINE LOCATIONS

General observations for both engines were as follows: 1) engines were found in the correct orientation in the helicopter in relation to the transmission deck, 2) the outside of the engines were thermally damaged consistent with the post-crash fire; the engine thermal damage was greater near the top half of the engines (**PHOTO 2**), 3) no uncontainments or case breaches were observed, 4) input shaft was continuous and still attached to engine’s accessory gearbox and the airframe’s main transmission; no visual rotational scoring was noted on the input shaft, 5) the tail rotor drive shaft was continuous and was connected to the airframe’s main transmission and tail rotor intermediate gearbox, 6) all the axial compressor blades were present, full length, and no leading edge impact damage was observed (**PHOTOS 3 and 4**), and 7) all the power turbine blades were present, full length, and no visible damage was observed (**PHOTOS 5 and 6**).

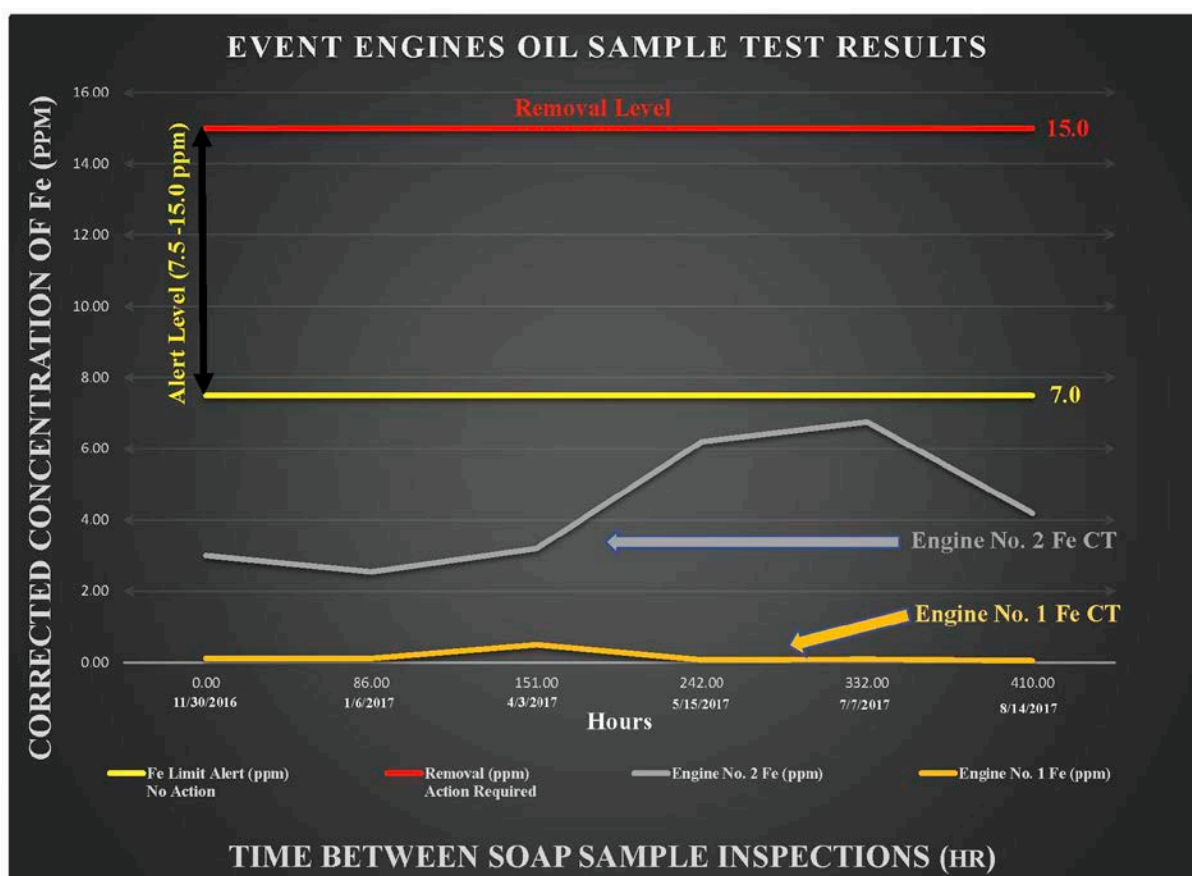
2016 through August 2017¹⁷ for both engines, ESN 47292 (No. 1) and ESN 47346 (No. 2), indicated that the No. 1 engine had what was considered normal/low levels of trace particulates and that the No. 2 engine was consistently higher in reported Fe than the No. 1 engine even though both engines had same installation date, operational flight hours and flight cycles, and the same amount of oil added. **FIGURE 17** provides a graphical representation of the SOAP sample results for both accidents engines from the data provided in **FIGURES 15** and **16**. For both engines, the note in the SOAP test report evaluation section stated, “Normal Wear”; which is inferred as referring to the last test result dated August 2017. The Fe concentration levels for the No. 2 engine oscillated up and down and ranged as low as 2.55 ppm to a high of 6.75 ppm during the reported period from November 2016-August 2017. For an incipient and progressive bearing failure, a steady and/or rapid increase in Fe concentration would be expected instead of oscillating up and down of the concentration level. Of note, between the May 2017 and the July 2017, the Fe concentration almost doubled from 3.20 ppm to 6.20 ppm; however, neither the rate of accumulation nor the cumulative Fe concentration was sufficient to trigger an alert ($7.5 \leq \text{Fe} \leq 15.0$ ppm) that would have required a maintenance action (oil sample inspection at a more frequent basis) nor did it reach the $\text{Fe} \geq 15.0$ ppm level and contamination rate $m \geq 0.5$ that would be required the engine to undergo a maintenance procedure removal according to the Turbomeca criteria (See **FIGURE 4**). **FIGURE 14** also shows criteria for Copper (Cu), Chromium (Cr), and Nickel (Ni); for both engines, the SOAP reports do not show any appreciable concentration of these elements. It should be noted that in the SOAP test reports for both engines, concentration levels for the various elements are provided but no contamination rates; Fe and Cr are considered the good markers of an impending bearing failure.

FIGURE 17: GRAPHICAL REPRESENTATION OF SOAP SAMPLE RESULTS

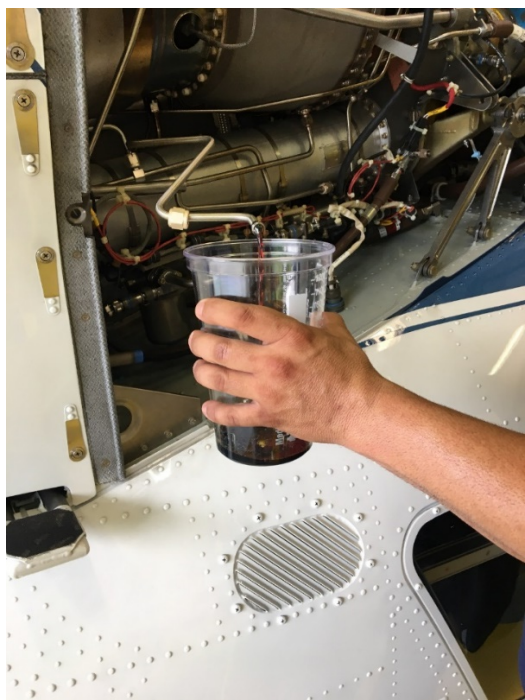
PHOTO 22: ENGINE NO. 2 FLOW TEST

The No. 2 (right) was tested first. The Turbomeca procedure is to first remove the oil scavenge line of the rear bearing which the technicians did (TASK 79-29-00-900-803-A01). The procedure states to put a vessel below the oil scavenge line of the rear bearing in preparation for collecting the oil that flows during the 15 second engine motoring. There is little to no room to place a vessel under the oil scavenge line union. The technicians removed the steel oil scavenge line, ensured there was no residual oil in the line and reattached one end to the union with the opposite end facing outboard, so the collection vessel could easily be put in place to collect the oil (**PHOTO 22**). The technicians explained that they had tried various methods such as attaching a length of plastic tubing to the union to reach the collection vessel, but this proved inefficient, messy and the negative effect hot oil had the tubing. In addition, the scavenge line needed to be removed for cleaning per the routine task.

The No. 2 was motored for 15 seconds and oil started to flow approximately five seconds after initial engine rotation. The collection vessel was held in place until the engine rotation spooled down after the motoring and no additional oil was flowing from the oil scavenge line. The oil scavenge line was disconnected and placed vertically above the collection vessel to ensure no residual oil remained. No additional oil remained. Approximately 145ml (4.9 oz) of oil was collected (**PHOTO 23**).

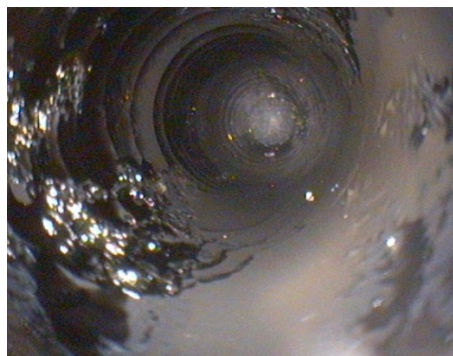
PHOTO 27: OIL SUPPLY LINE

With the rear bearing showing signs of black-coke like material during the examination at SafranHE in Grand Prairie, the rear bearing oil supply, scavenge, and vent lines and drains were examined for any obstructions or coke building up (**PHOTOS 27-29**). All the lines were clean with no obstructions but a thin layer of coke was observed on intern walls of the lines; the amount of build-up was according to SafranHE within their in-service experience. The rear bearing itself was in good condition and met the material specifications. Examination of the magnetic plugs and the oil strainer found no metallic particles and were clean. The oil pump

was seized so it could not be tested; however, disassembly found all the gears and drive shaft to be in good condition. All the oil supply and scavenge lines were x-rayed and no obstructions were observed.
