NATIONAL TRANSPORTATION SAFETY BOARD

AIRFRAME AND ENGINE EXAMINATION

WPR18FA013

Location: Four Corners, CA
Date: October 21, 2017.
Aircraft: Extra 330/LC, Registration N414MT, Serial: 1300
NTSB IIC: Elliott Simpson

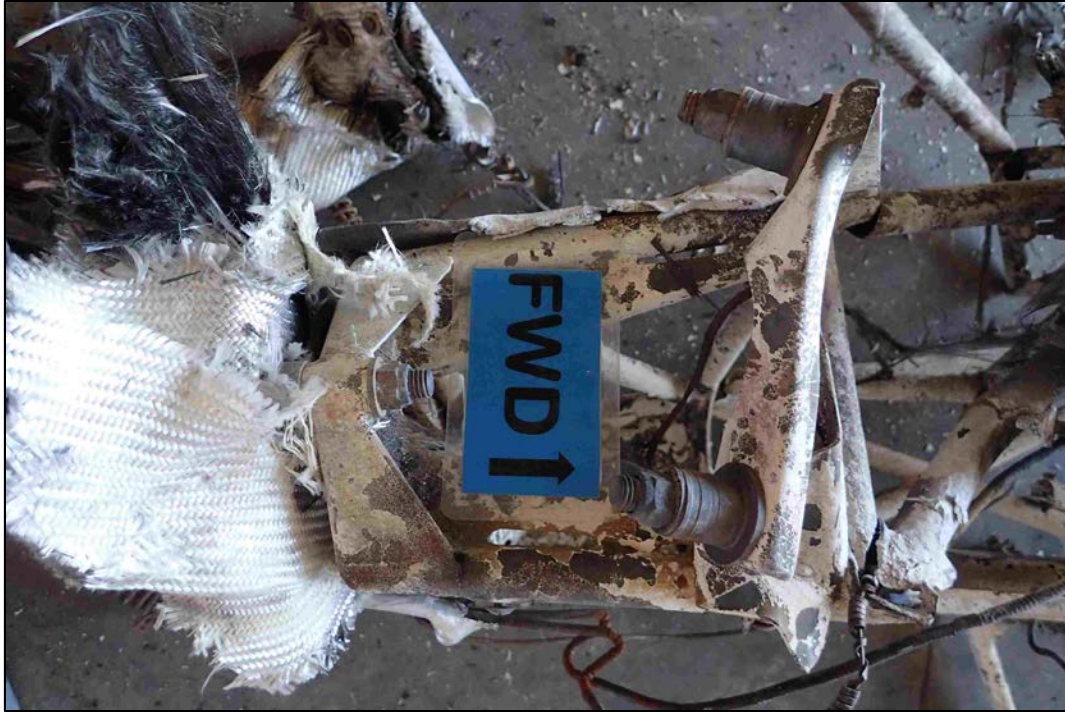
Photo 4 – Vertical and Horizontal Stabilizer Attachments

The last 24 inches of the tubular steel tail section was crushed, but largely intact, with fire consuming most of the alloy and plastic components attached to it (Photo 2). Two parachute “pilot” springs were found entangled in the forward section of the frame members. (Photo 3). Remnants of the vertical stabilizer aft spar remained attached to the upper airframe attachment bracket and the lower mounting bolts. The vertical stabilizer forward spar attachment bolt was in place at the airframe member (Photo 4). The horizontal stabilizer forward and aft spar attachment members were intact but bent, with all four attachment bolts in place. Remnants of the forward spar were still present sandwiched against their respective fittings (Photo 5).

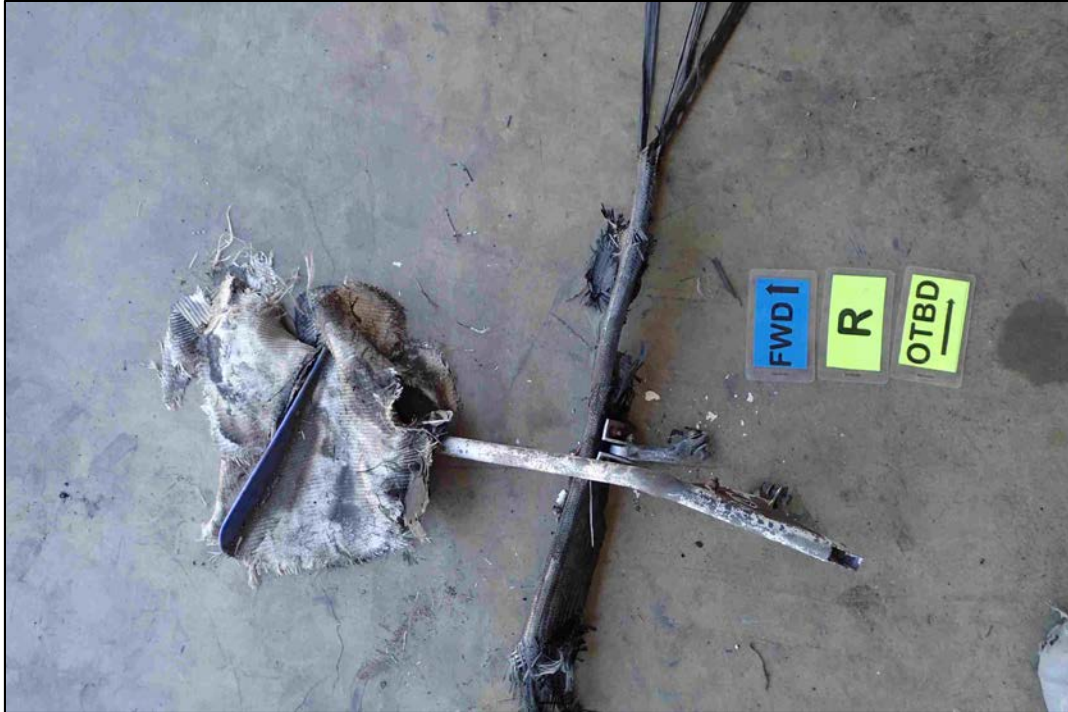
Photo 16 – Right Aileron Spade

Sections of burnt carbon fiber remnants of both wing trailing edge spars were located, along with the left aileron tip cap (Photo 15). All aileron hinge bars were located, and each exhibited a combination of bending and thermal damage. The right aileron spade assembly was bent and intact, with burnt remnants of the composite spade remaining (Photo 16). The left spade arm had broken away from the hinge, and the smaller quantities of spade remnants remained, along with a section of the aileron (Photo 17).

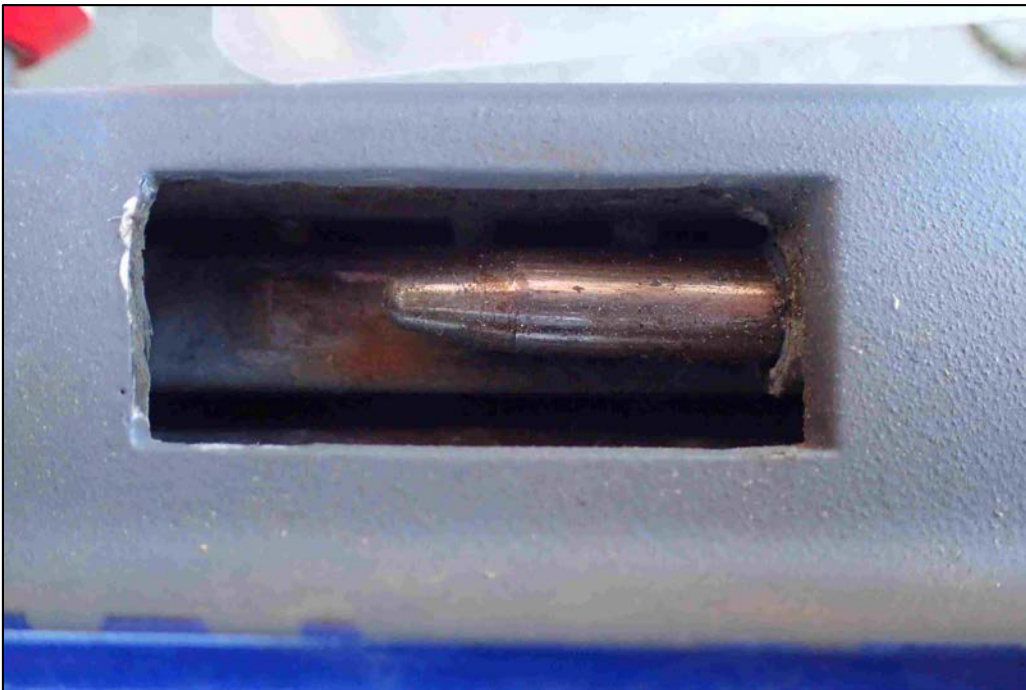
Photo 33 – Canopy Center Locking Pin

The left frame had fractured mid-span, revealing the canopy lock interconnect components. The rear latch was 1/2 inch short of the “LOCK” position (Photo 36), and the forward latch was in the “UNLOCK” position (Photo 32). The forward locking pin was completely retracted, consistent with the “UNLOCK” position (Photo 32). The center locking pin was in the midway position (Photo 33). The aft pin was 3/8 in short of the “LOCKED” position (Photo 34). The forward locking barrel remained attached to the airframe; the chamfered channel appeared undamaged, although it was coated in thermal deposits and corrosion (Photo 35).
