National Transportation Safety Board

CEN22FA317

AIRWORTHINESS

Group Chair's Factual Report

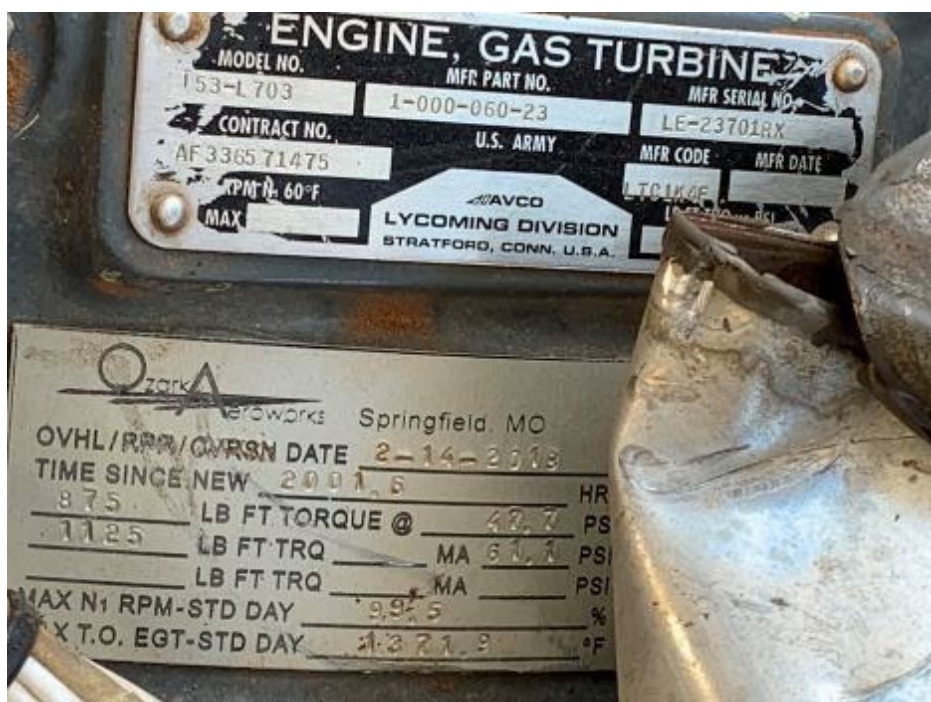
PHOTO 1: ENGINE DATA PLATE

According to the engine data plate, the engine serial number (ESN) was LE-23701RX (**Photo 1**).

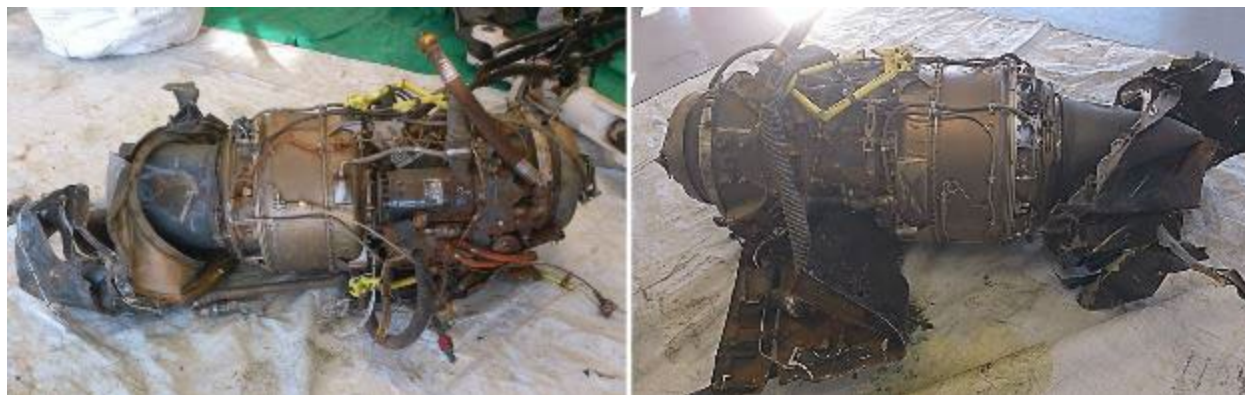
PHOTO 3: ENGINE AS UNPACKED

On October 11, 2022, the engine was examined at Beegles Recovery & Storage in Greeley, Colorado, with representatives from the NTSB, Bell Textron Inc. and Ozarks Aeroworks LLC being present. There was no evidence of uncontainment or external fire (**Photo 3**). There was minimal foreign debris, primarily dirt, in the intake and exhaust.

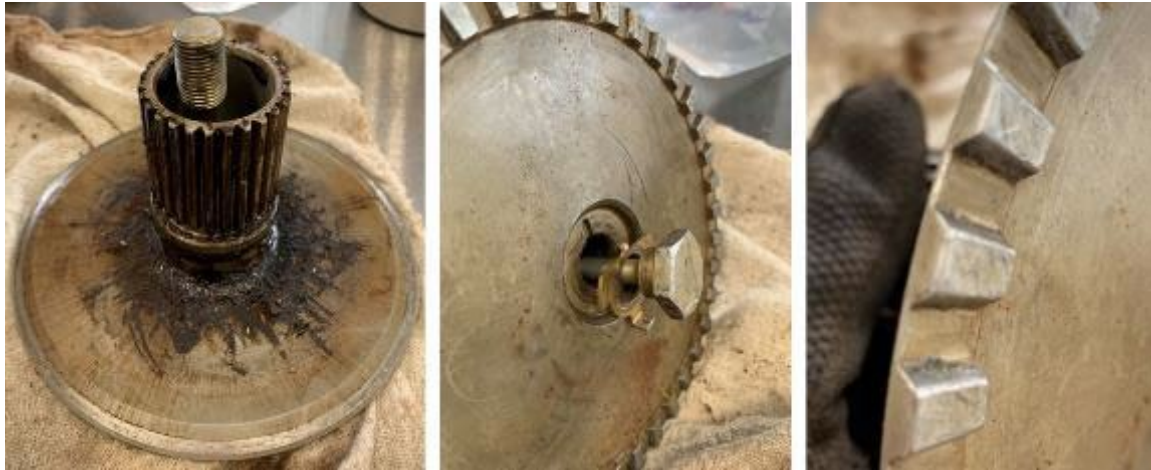
PHOTO 15: ENGINE-KAFLEX COUPLING ADAPTER PLATE

The adapter plate from the Kaflex driveshaft coupling to the engine was intact, properly torqued, safety wired, and otherwise unremarkable (**Photo 15**). It remained attached to the engine during the impact.

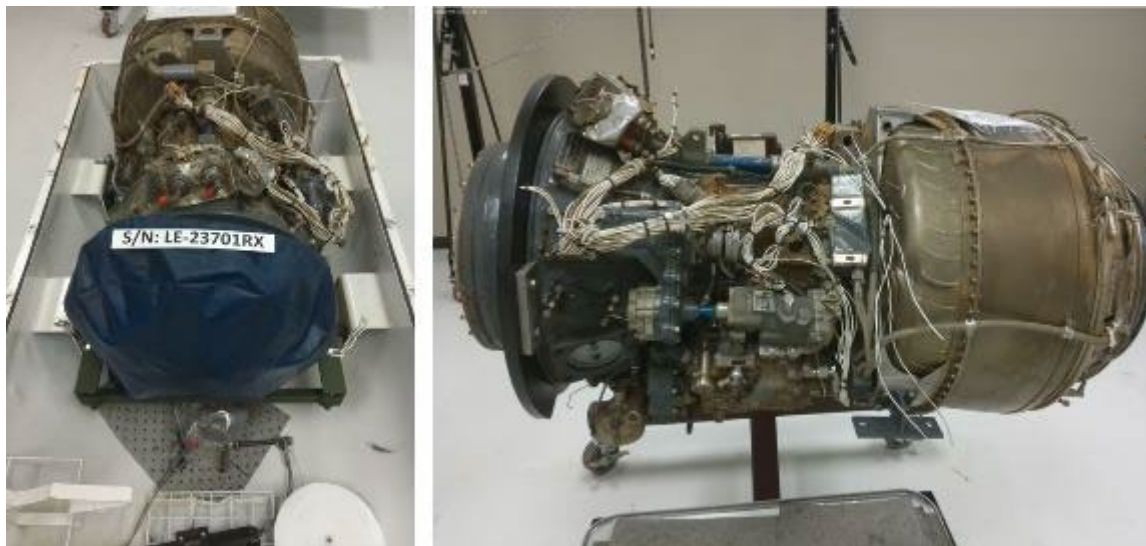
PHOTO 21: IN THE SHIPPING CONTAINER (LEFT) AND IN THE STAND (RIGHT)

The accident engine was examined and disassembled at the Ozark Aeroworks LLC facility in Springfield, Missouri on November 16, 2022, with persons from the NTSB and Ozark Aeroworks LLC present. The engine was removed from the shipping container and placed on an engine stand (**Photo 21**).

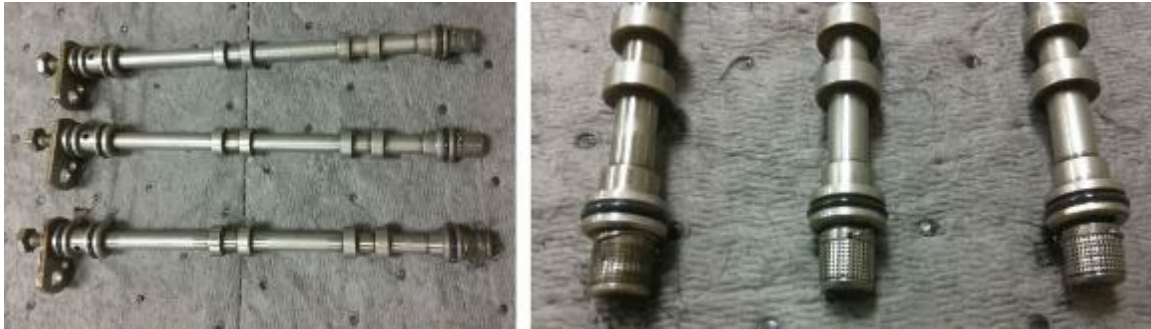
PHOTO 22: RGB ACR INDUSTRIES INC OIL TRANSFER TUBES AND FILTERS

All required safety wire for the reduction gearbox was intact and in-place. The reduction gearbox (RGB) oil transfer tubes and filters were clean and oil wetted (**Photo 22**).

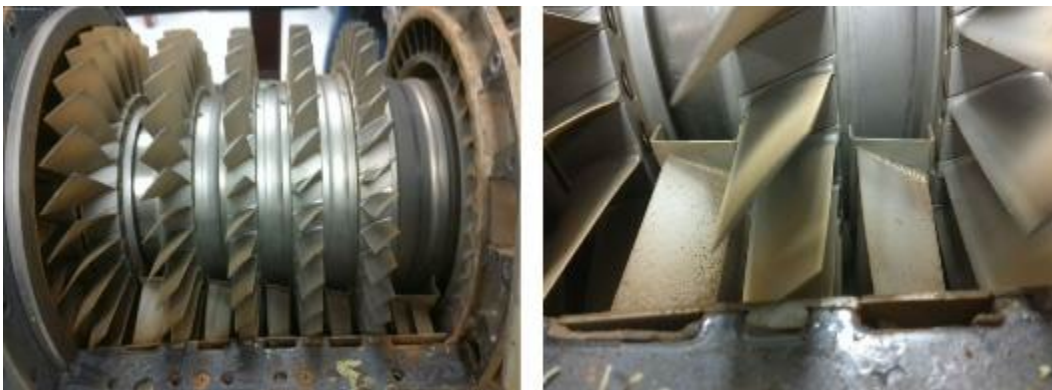
PHOTO 28: COMPRESSOR SECTION

Dirt was found throughout the compressor section, but the all the blades were present, intact, and appeared undamaged (**Photo 28**).

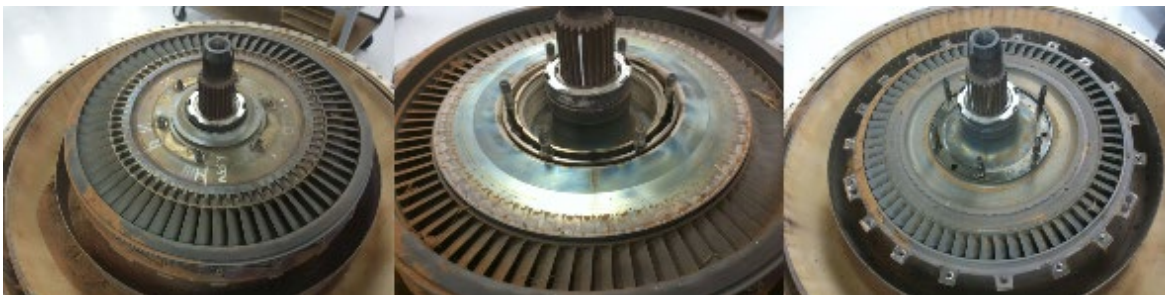
PHOTO 30: 2ND STAGE GP ROTOR (L), 2ND STAGE NOZZLE (C), 1ST STAGE ROTOR (R)

The 1st and 2nd stage GP wheels showed no evidence of rubbing. A blade tip clearance check of the 1st stage GP rotor and the 2nd stage GP nozzle was performed and found to meet the minimum specification of 0.020 inches. The 1st and 2nd stage GP nozzles were undamaged (**Photo 30**). Seeing no damage, the gas generator was not disassembled further.

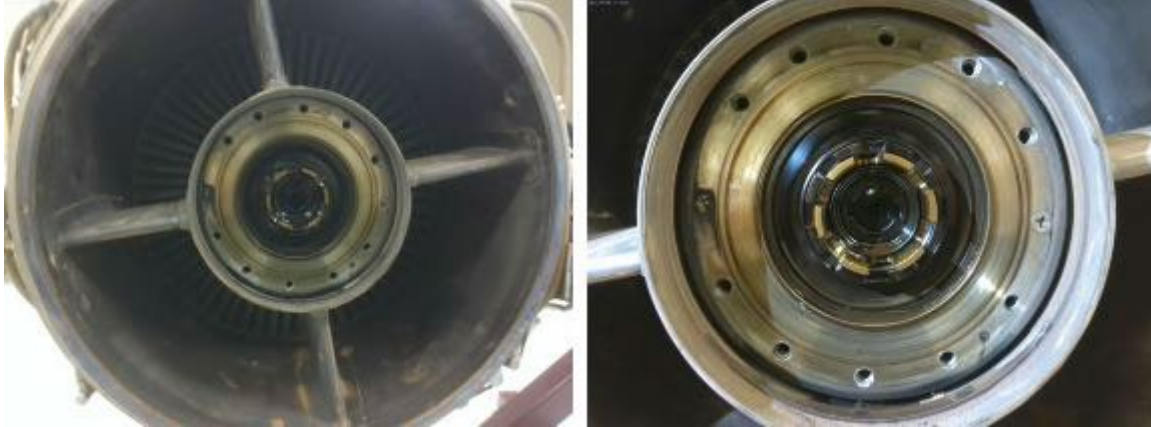
PHOTO 31: EXHAUST DIFFUSER HOUSING, SUPPORTS, AND RETAINING CUP

The dust cover was intact and otherwise unremarkable. The exhaust diffuser and diffuser support cone were intact, with no signs of corrosion (**Photo 31**).

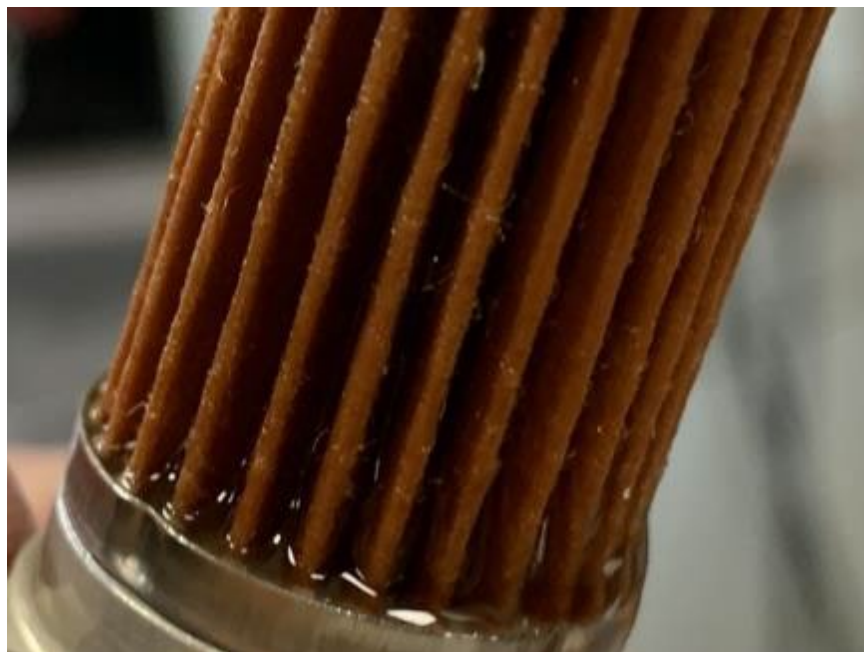
PHOTO 32: FCU FILTER

After separating the FCU from the engine, the FCU filter was inspected and found to be clean (**Photo 32**).

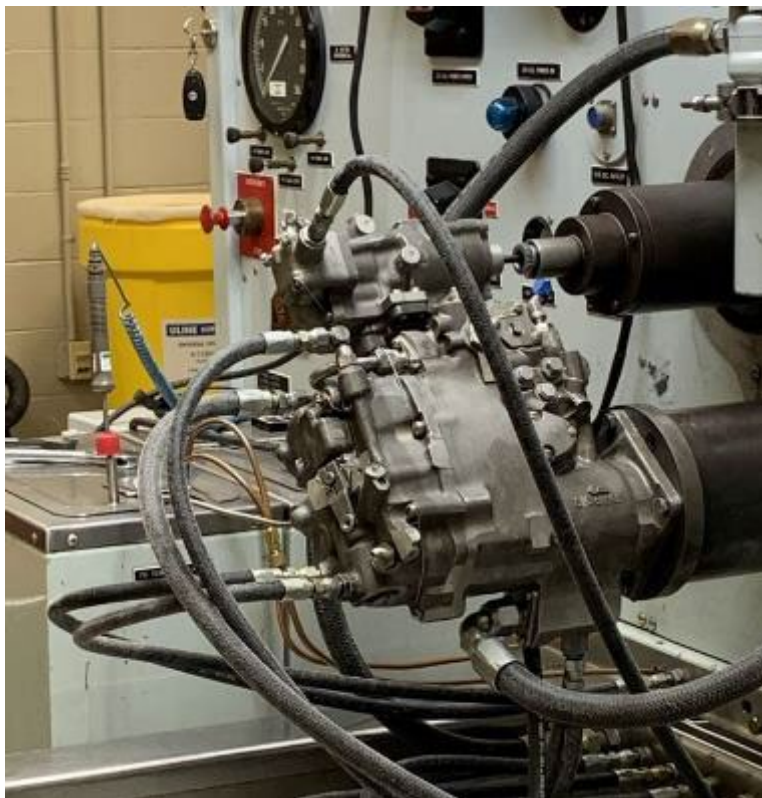
PHOTO 33: FCU ON THE TEST BENCH

An Acceptance Test Procedure (ATP) was conducted on the FCU and PT governor at the Ozark Aeroworks LLC facility (**Photo 33**). The fuel line, which provides boost pump pressure to the FCU, was not safety wired. The FCU and the PT governor were placed on the test bench at the Ozark Aeroworks LLC facility for operational checks, both were found to be operating within limits. A copy of the completed test cards is included in Attachment 4.
