NATIONAL TRANSPORTATION SAFETY BOARD
Office of Aviation Safety
Washington, D.C. 20594

AIRWORTHINESS GROUP CHAIRMAN'S FACTUAL REPORT

NTSB No: ERA17MA316

Operator: Duke University Health System
Aircraft: N146DU / Eurocopter Deutschland GMBH MBB-BK-117-C2
Location: Herford, NC
Date: September 8, 2017
Time: 1120 EDT

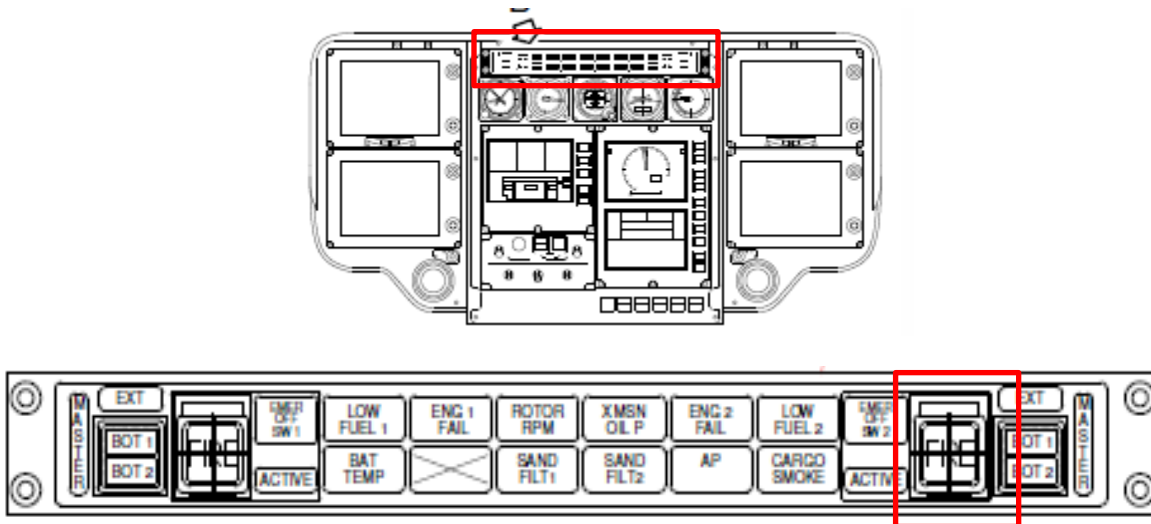
Figure 2 - Caution and Warning Unit⁵

A recovered portion of the warning unit was submitted to the Materials Laboratory for examination. The four light bulbs for the engine #2 fire indicator were x-rayed to examine the filament in each bulb. The radiographs for the FIRE annunciator bulbs showed that the filaments for all the light bulbs were stretched. The radiographs also showed that all but one of the bulb filaments were intact. The bulb 1 filament was broken and stretched while bulbs 2-4 filaments were intact and stretched. The bulb numbering is arbitrary because the bulb positioning could not be determined due to fire damage. Radiograph images of all four bulbs are contained in the official docket. No light bulbs were identified by radiograph in the BOT 1 & BOT 2 button located next to the FIRE light/button.

The No. 1 FIRE light/button was not located during the wreckage examination, and therefore the light bulbs on that side were not available to be examined.
