NATIONAL TRANSPORTATION SAFETY BOARD
Office of Aviation Safety
Ashburn, Virginia 20147

Airworthiness Group Chairman's Factual Report

WPR09MA159

Operator:	Eagle Cap Leasing Inc.
Location:	Butte, Montana
Date:	March 22, 2007
Time:	1430 Mountain Daylight Time (MDT)
Aircraft:	Pilatus PC12/45, N128CM

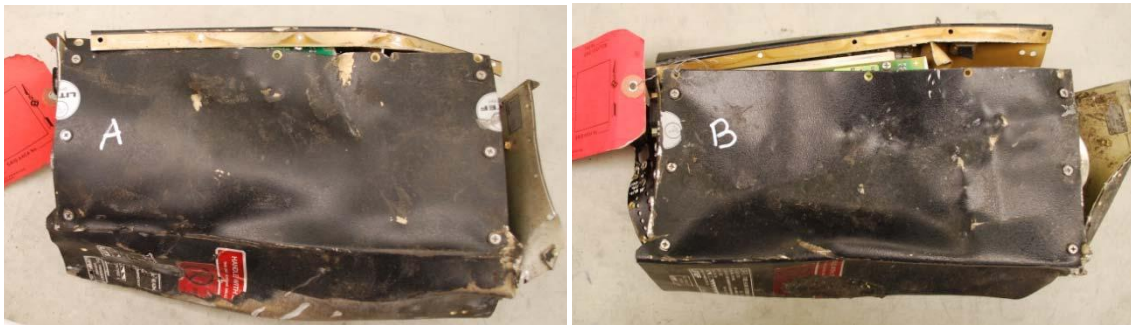
Figure 11 - Photos showings 'A' and 'B' AHRS units

Both of the AHRS units were impact-damaged. Fastening hardware was removed and/or drilled so that the component PCBs within the respective cases could be accessed. Four PCBs were contained within, with the memory located on the “processor module” board. Each of the processor modules was damaged, and data could not be downloaded with the memory chips in-situ. The decision was made to de-solder both of the memory chips (U12 and U13) from the processor modules, and re-solder them onto surrogate processor module boards.

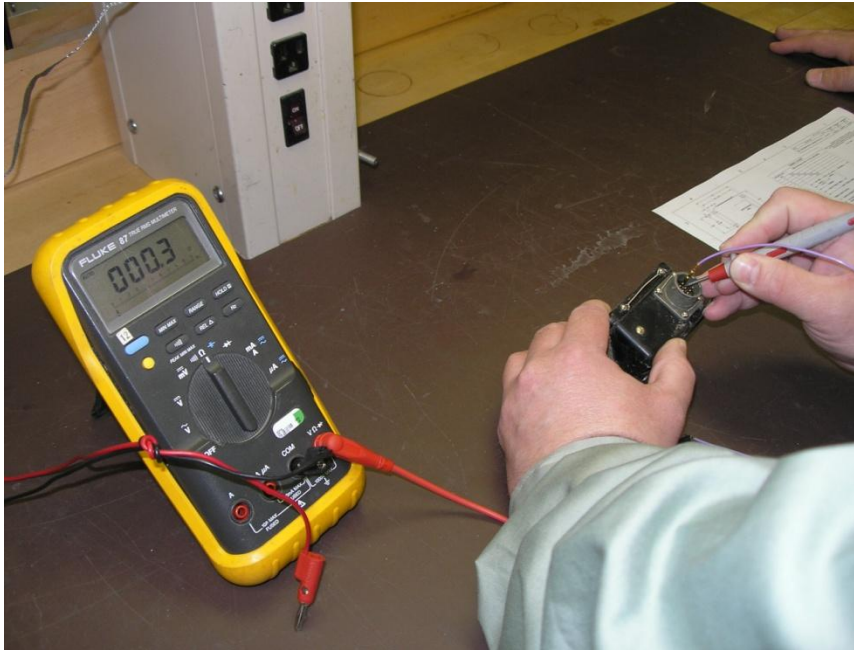
The de-icing boots timer was damaged, with the top and two sides of the case were dented inward, but the unit remained intact. The unit was not fire-damaged. The safety wiring retaining the cover screws and connector receptacle was intact, as was the unit seal (although it appeared that the seal had been compromised).

A multi-meter was connected to the various electrical connector pins on the unit. The power pin (pin B) was tested against the solenoid activation pins (output pins E, F, G, H, and J). Each of the pins E, F, G, and H indicated no electrical connection (open), while pin J, indicated electrical continuity (short). According to a diagram for the unit provided by Goodrich, the results corresponded to one unit applying power to a de-ice valve solenoid at the time power was lost. Specifically, it was the final sequential solenoid, the “wing top outboard” de-icing boot.

Figure 24 – Photo of Electrical Continuity Check of the Boots Deicing Timer Pin B to Pin J
