NATIONAL TRANSPORTATION SAFETY BOARD

Airworthiness Group Chairman's Factual Report

NTSB ID No.: DCA17FA021

NTSB Accident Number: DCA17FA021
Location: Chicago, Illinois
Date: October 28, 2016
Time of Accident: About 1432 Central Daylight Time
Aircraft: Boeing 767-323(ER)
Registration Number: N345AN

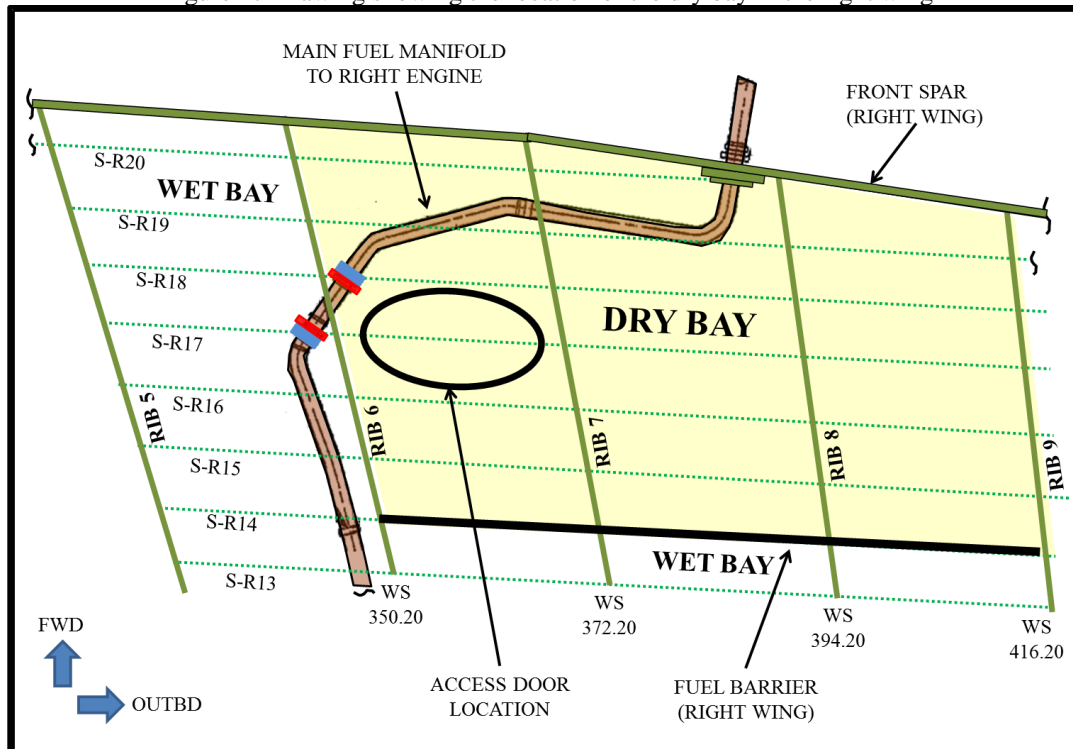
Figure 17 Drawing showing the location of the dry bay in the right wing

Each main fuel tank contained a fuel-free compartment, identified as a “dry bay”, that was located directly above the engine in the forward part of the fuel tank (Reference Figure 17). The incorporation of the dry bay was one of the major precautions taken on the fuel system to minimize the hazard to the airplane in the event of an engine non-contained failure.

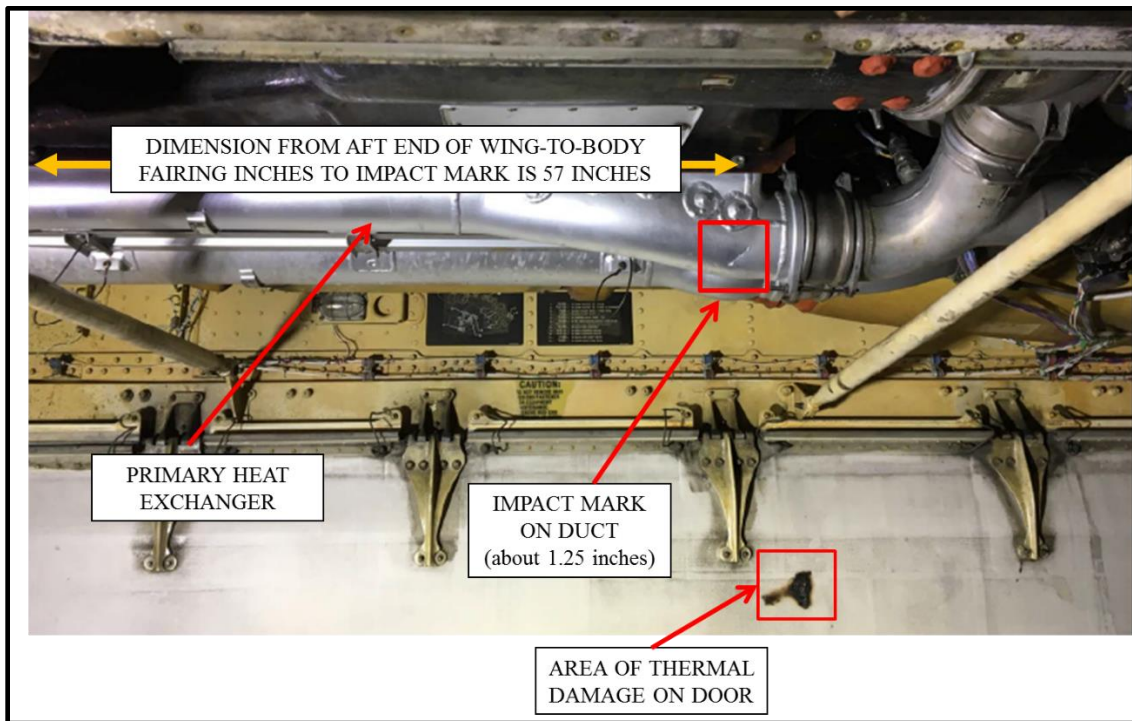
Figure 31 View of inside of right ECS bay showing impact mark on duct

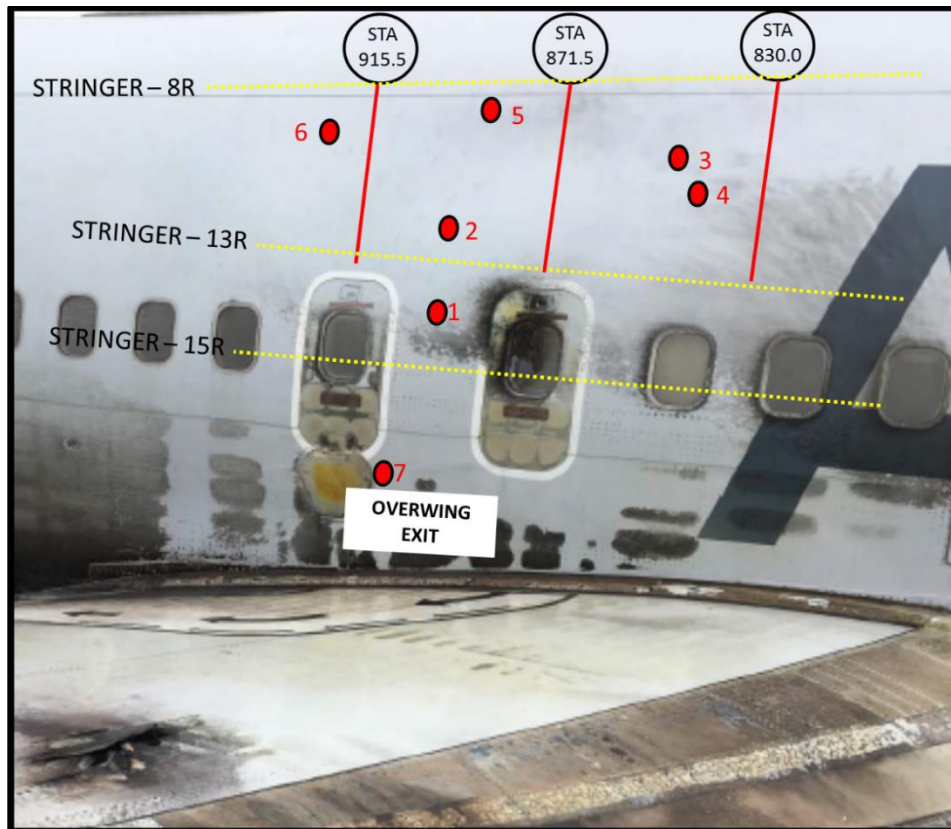
Visual examination revealed small, non-penetrating, impact marks on the fuselage in several locations above the right wing and near the over-wing emergency exit. Reference Figure 33 and Table 4.

Figure 32 Drawing showing the location of impact marks above emergency exits

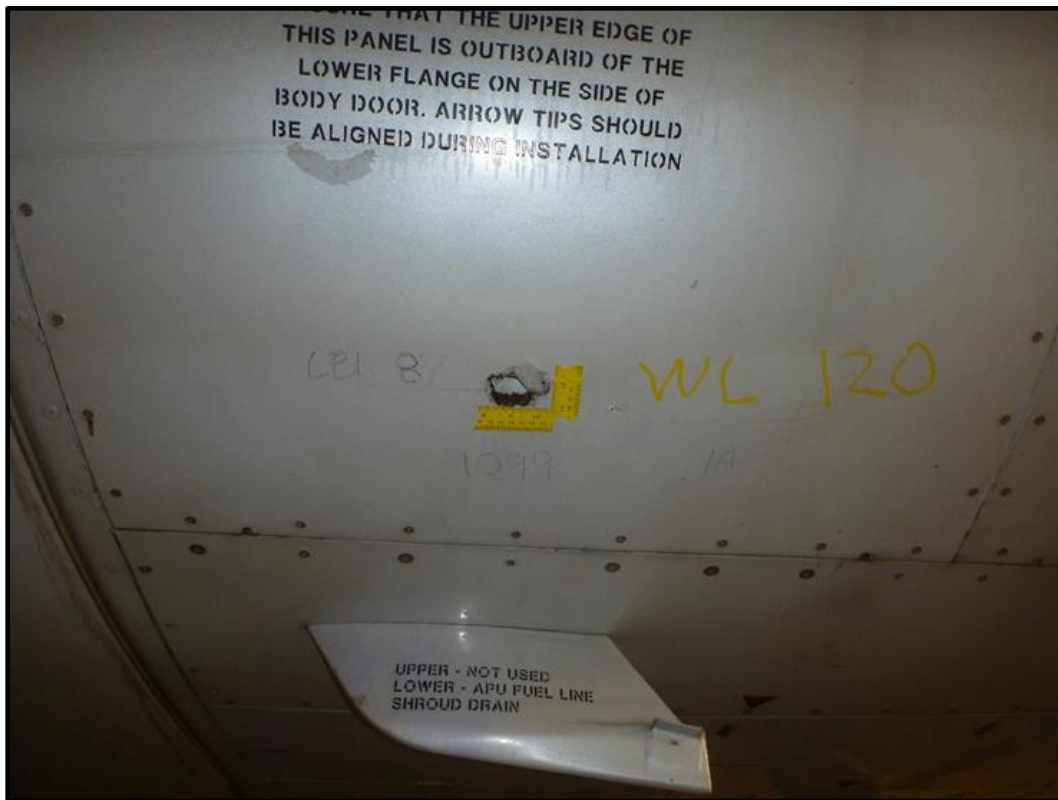
Figure 36 Impact K, Left side of body door

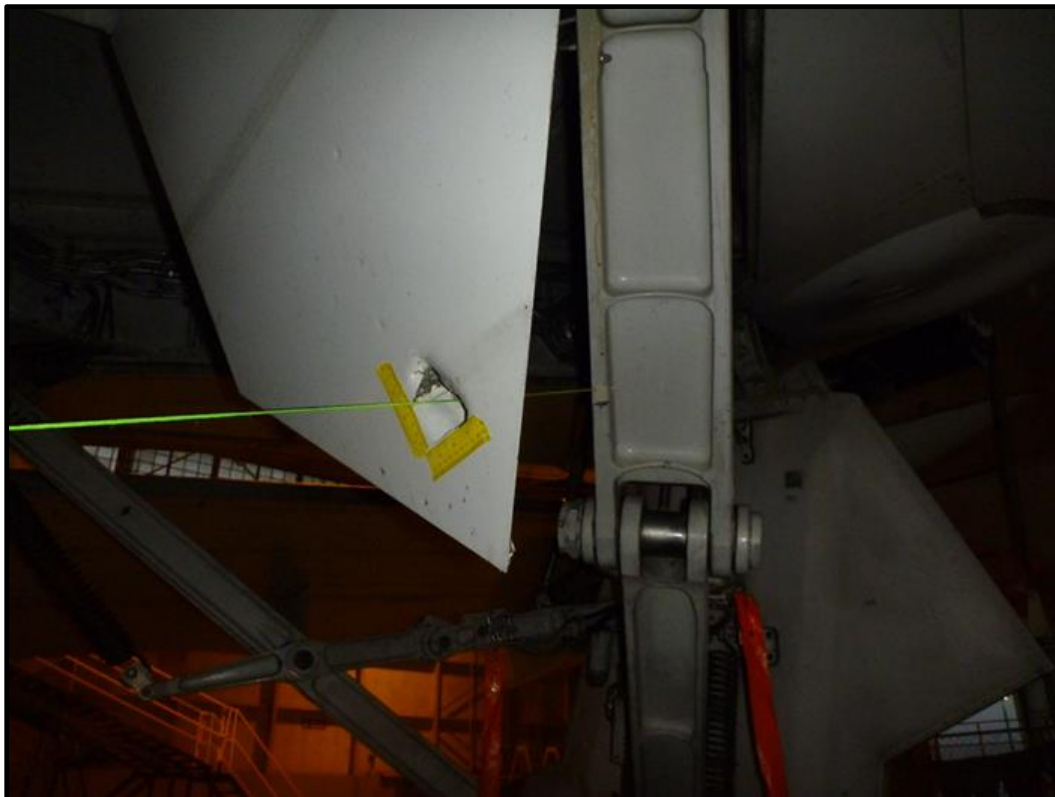
Figure 37 Impact L, Left main gear drag strut door

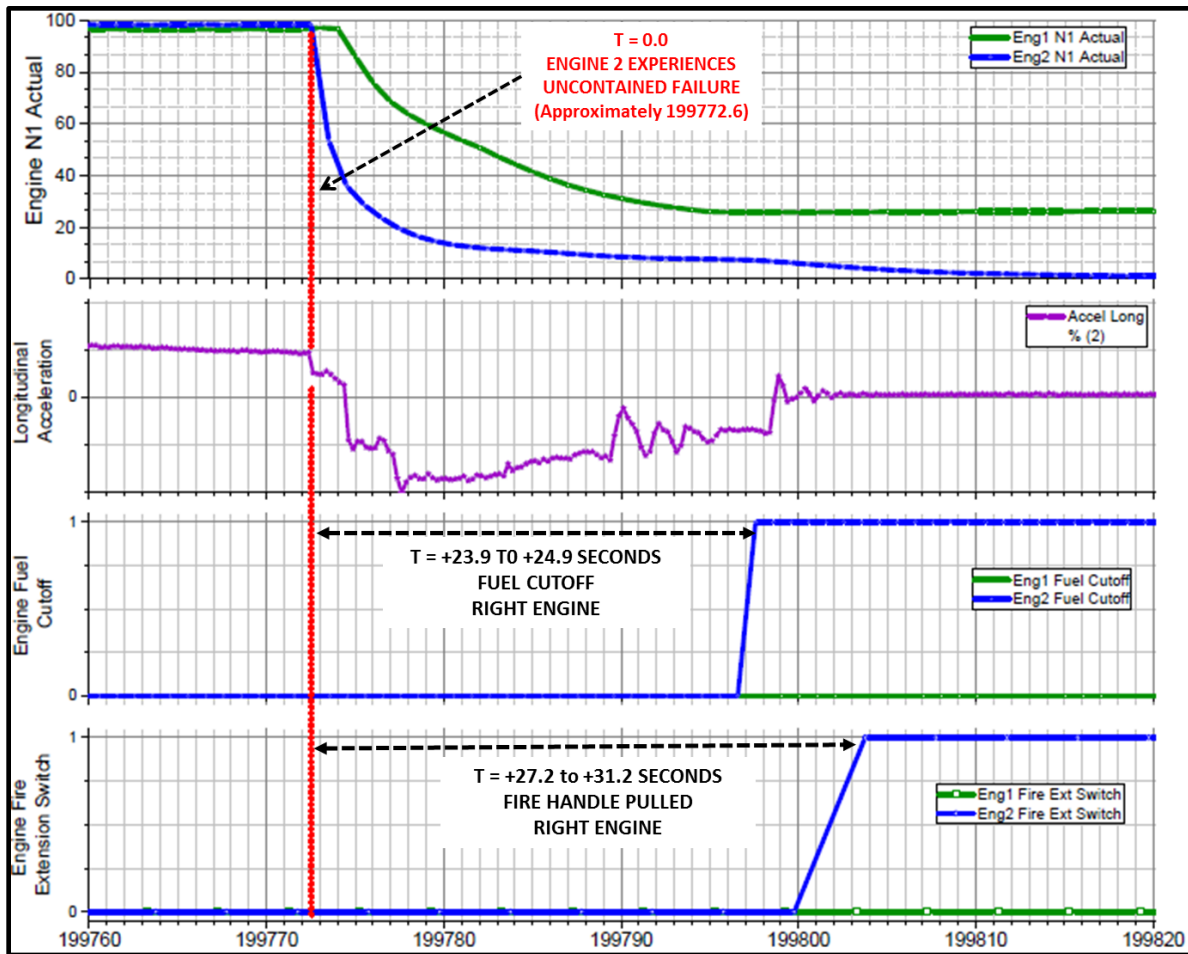
Figure 41 FDR data showing engine fuel-cutoff information

For the right engine, FDR data revealed that its engine fuel cutoff discrete transitioned from zero (ON) to 1 (OFF) approximately 25 seconds after the engine experienced an uncontained failure. Shortly thereafter, the data revealed that the engine's fire handle discrete transitioned from zero (non-activated) to 1 (activated or "pulled"). Figure 41 provides a graph showing these transitions.

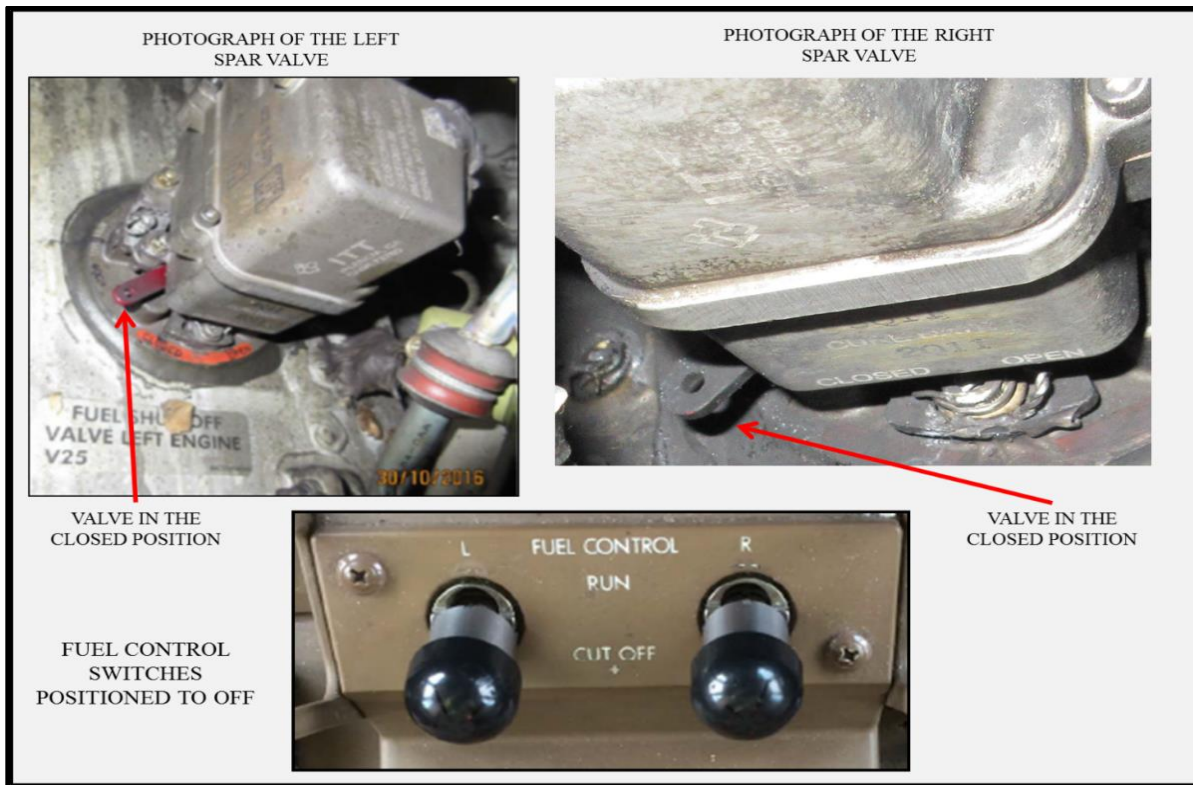
Figure 42 Spar valve positions

While the airplane was in the American Airlines hangar, each spar valve was visually confirmed to be in its CLOSED position (reference Figure 42).

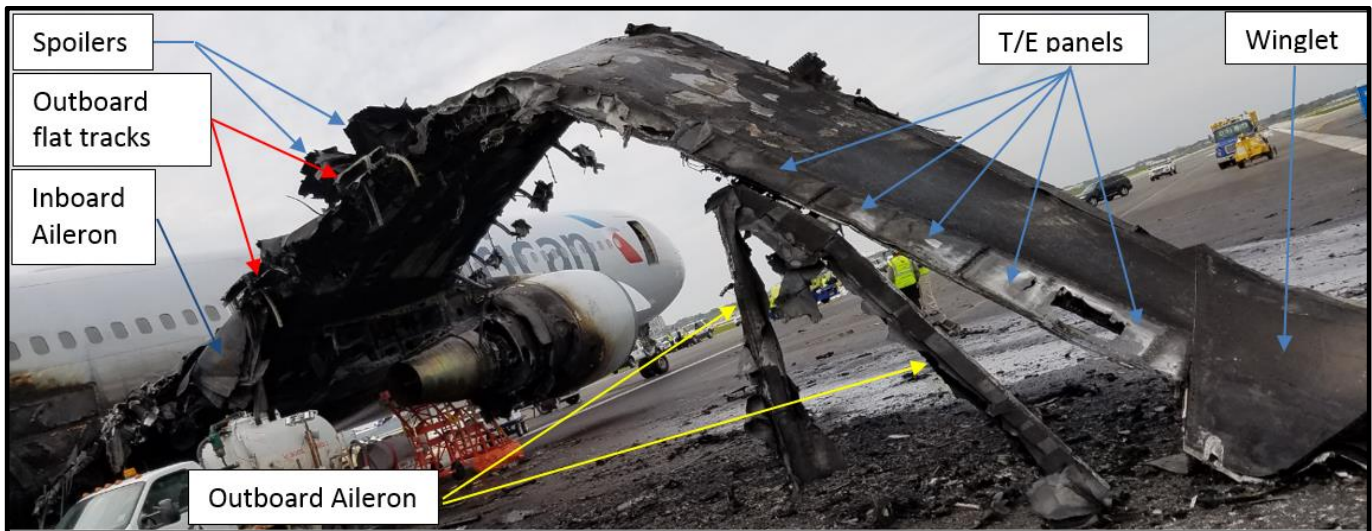
Figure 49 View of right wing looking forward and inboard at outboard bend section

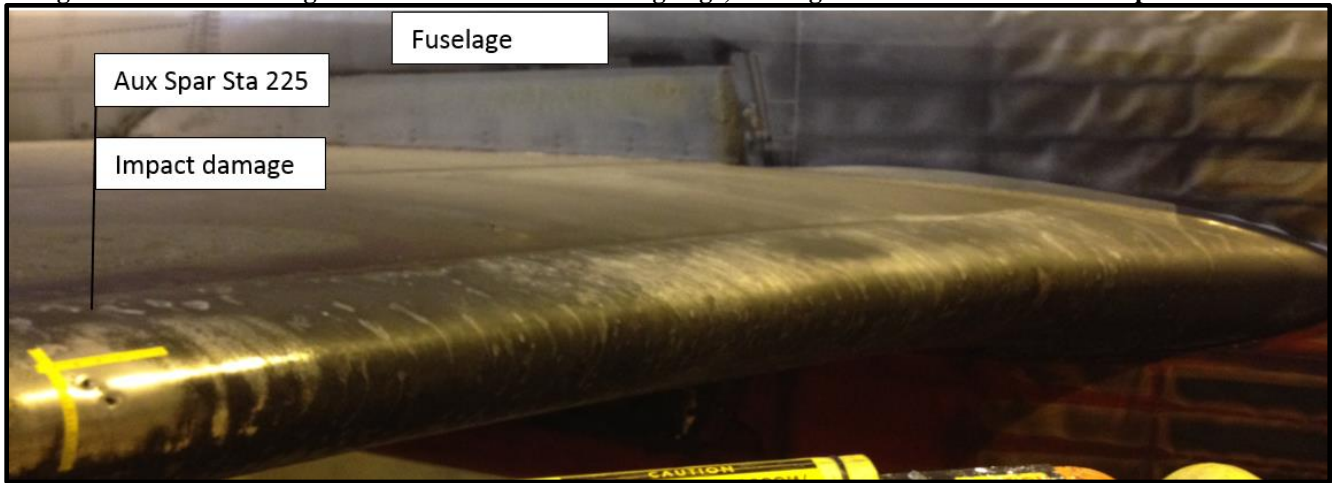
Visual examination revealed that the right horizontal stabilizer had impact damage on its leading edge surface; the stabilizer also appeared to be slightly sagging. Reference Figure 51. The stabilizer lower in-spar skin had been consumed outboard of stabilizer auxiliary spar station number 290 and the upper in-spar skin was found warped and upper stringers were found cracked and split in some areas, the ribs were found intact.

Figure 51 View of the right horizontal stabilizer leading edge, looking aft and inboard from aux spar station 230

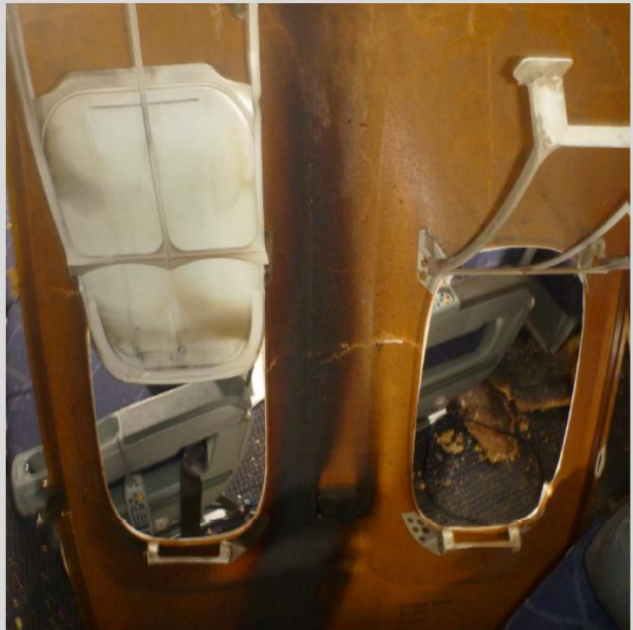
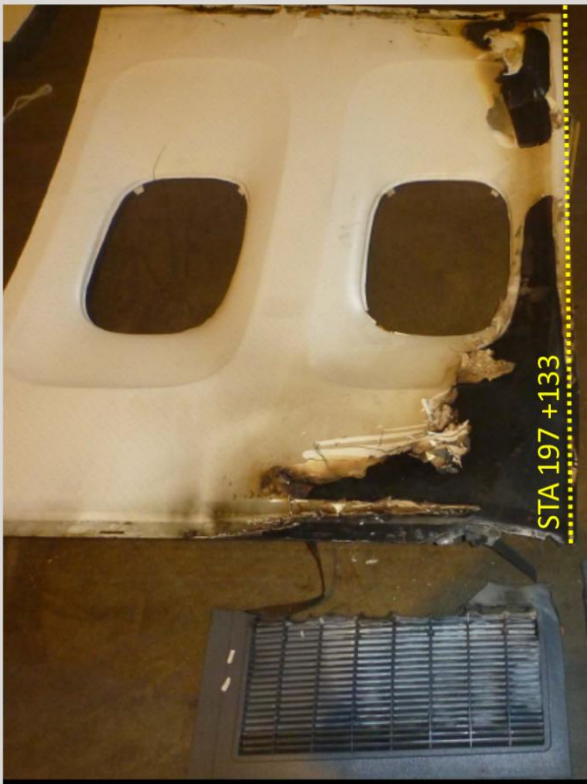
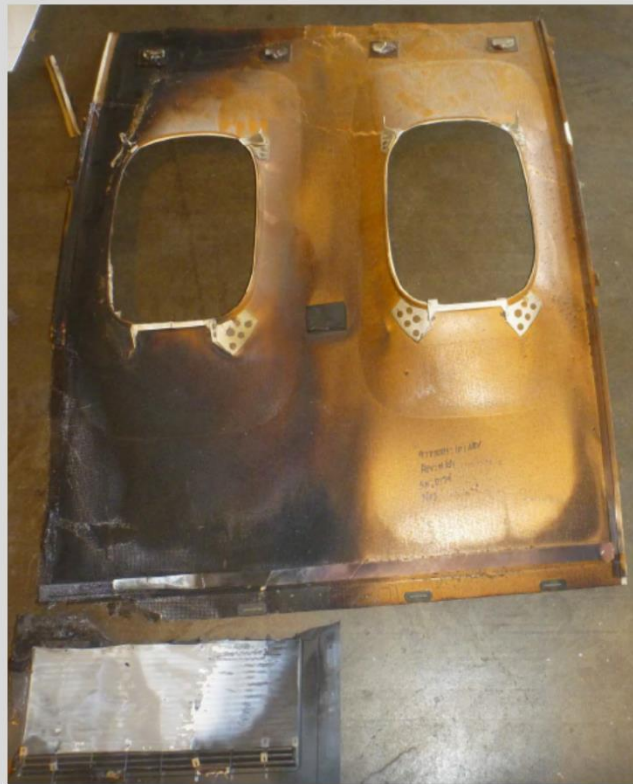
Visual inspection revealed that the most significant damage occurred at seat 33/34 (station 1197+110 to 1197+132). There was thermal damage to the interior sidewall consisting of melting of laminate and charring of the panel (inboard and outboard sides) and consumption of the majority of the resin along the aft edge of the panel. The top row of louvers on the plastic air grill (below the bottom of the panel) was charred and melted. There was a slight amount of soot on the sidewall panel above it and on the outboard surface of the seat armrest. The outboard edge of the bottom seat cushion fabric was charred, exposing the foam fire-blocking material, reference Figure 57. The insulation blanket behind the stowage bins was charred, and the cover film was gone. The char extended up into the crown. There were some wires above the stowage bins that had their insulation burned off, indicating the cover film had burned. The cover film self-extinguished at approximately stringer 6R. Reference Figure 58.

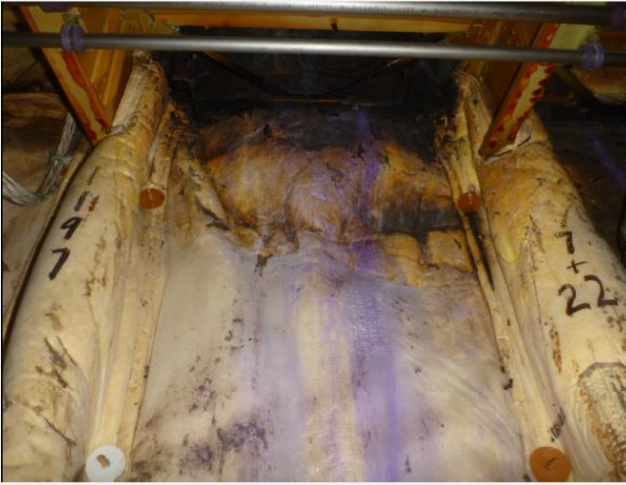
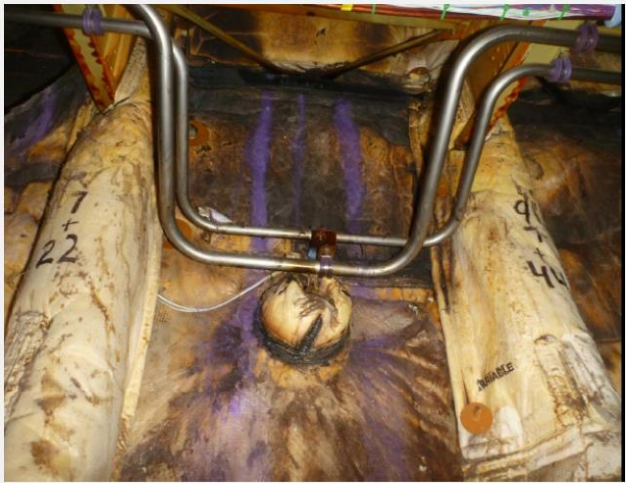
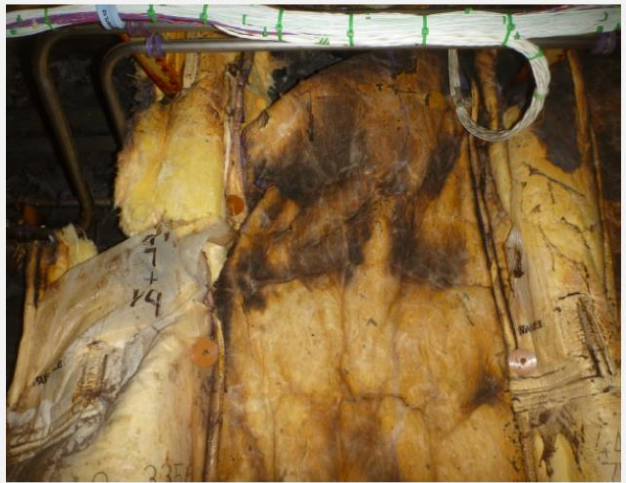
Figure 64 Insulation blanket damage

The blankets were pulled back to reveal the damage on the backside and on the skin. The backside of the insulation blankets, between stations 1197 and 1197+132 were all charred to varying degrees, with the heaviest damage between stations 1197+22 and 1197+132. The skin was heavily charred, there were multiple cracks through the skin and several stringers were twisted and stringer 25R was cracked at station 1197+120. The frame at station 1197+44 was twisted over a length of five stringers. The insulation blanket between stations 1197+22 and 1197+44 (at the location of the hole in the skin) was charred around the hole, but was grey/white at the hole. Reference Figures 64 through 66.

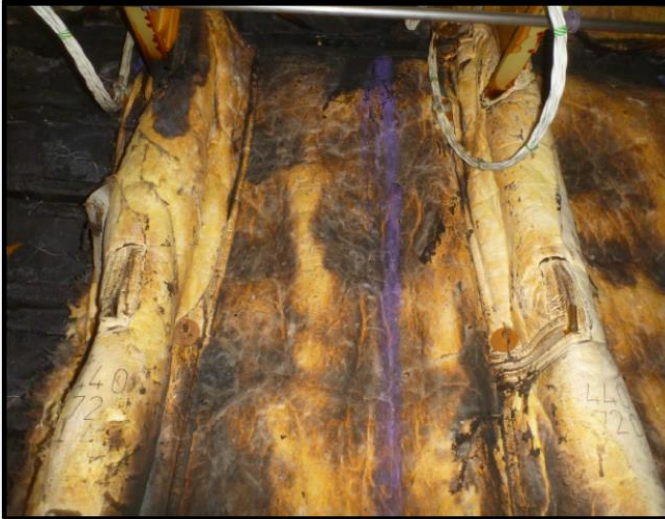
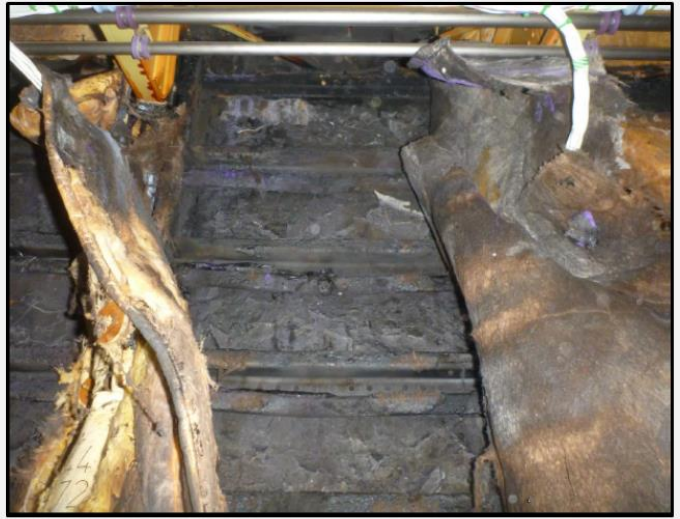
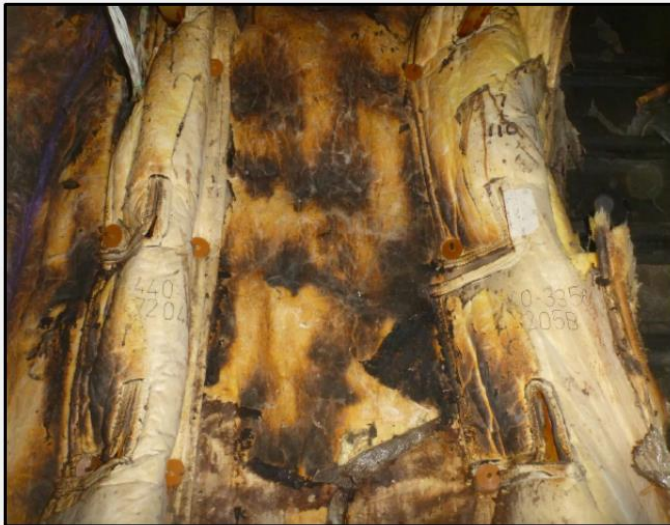
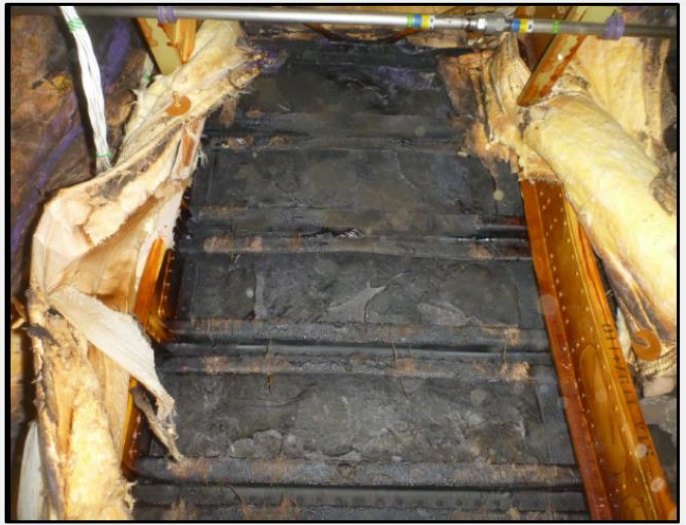
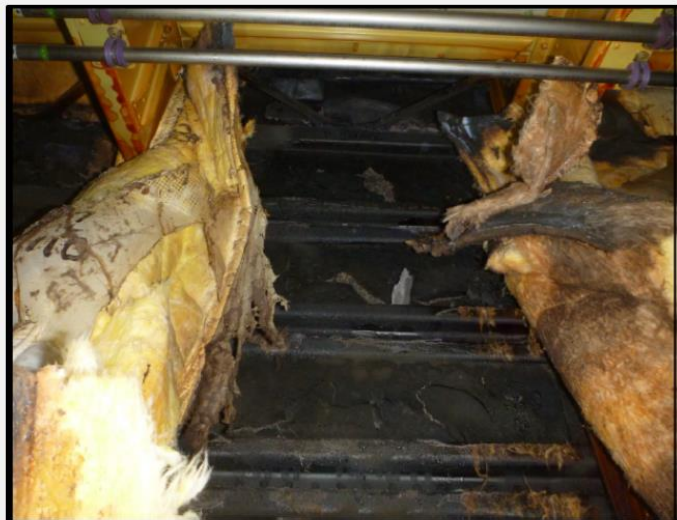
Figure 65 Insulation blanket damage

The liners on the right side were removed so that the insulation blankets could be inspected. The insulation blankets from station 1153 to 1241 had varying degrees of thermal damage with the greatest damage between station 1197+22 and 1197+132. The damage consisted of charring of the blanket and cover film. Reference Figures 65 through 67.

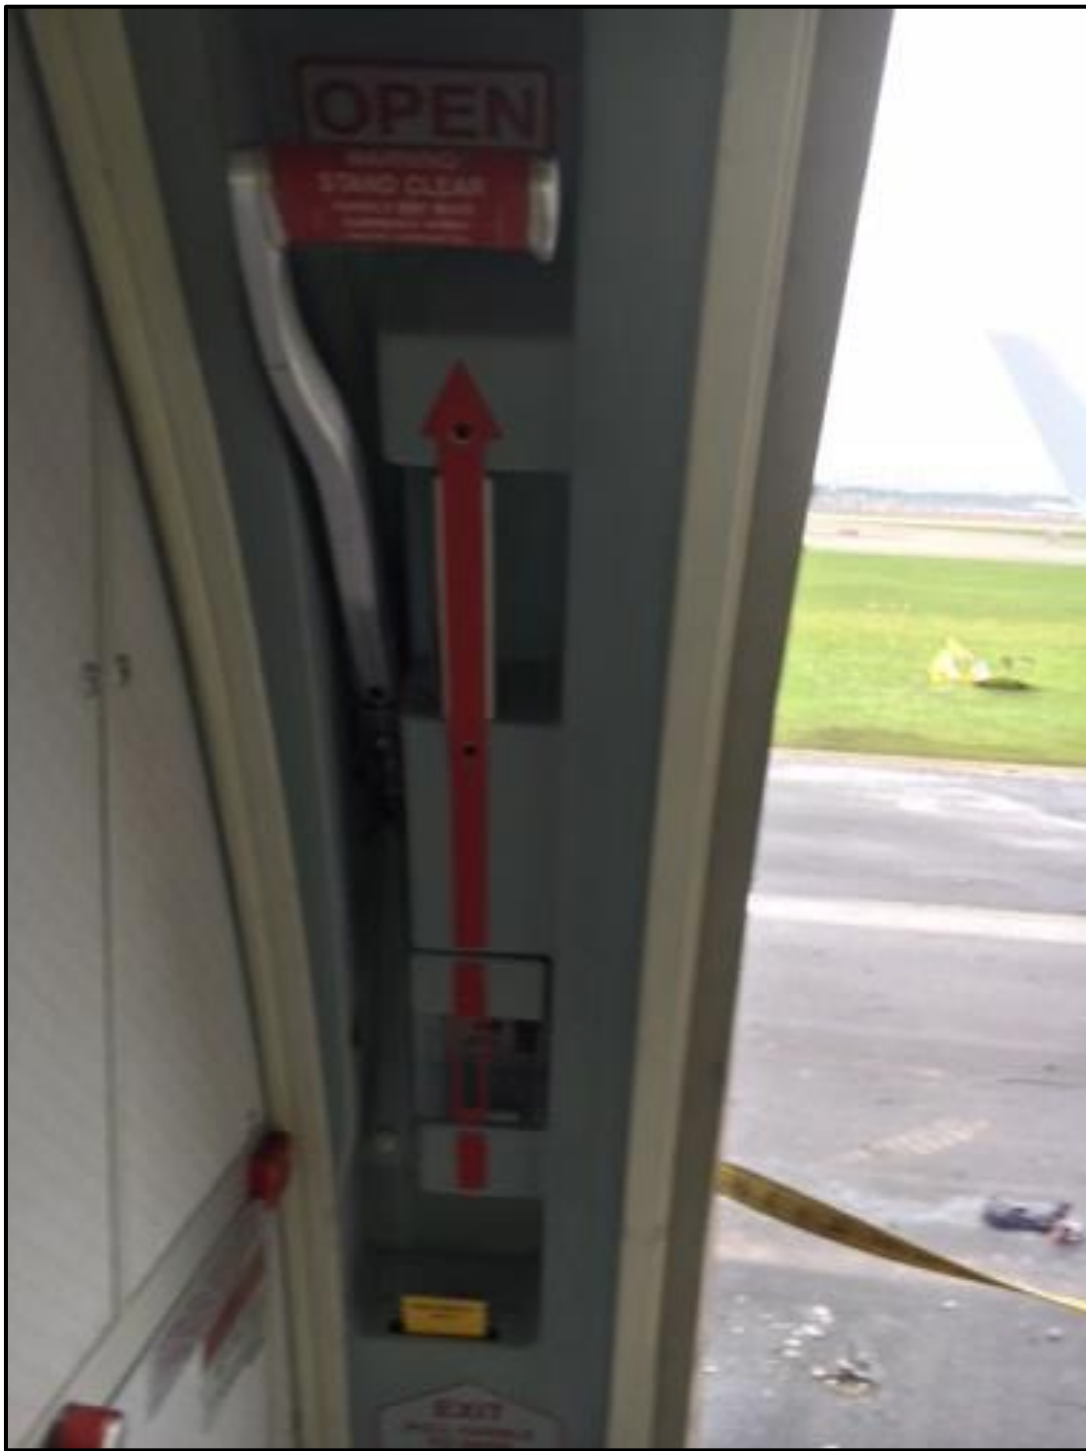
Figure 69 Door 4L

1. Door 1L was found armed and open with its ramp stand in place. Reference Figure 67.
2. Door 1R was found open and in a disarmed position. Reference Figure 68.
3. Door 4L was found open and in an armed position. Reference Figure 69.
4. Door 4R was found closed and in an armed position. Reference Figure 70.
5. Door 2L and 3L (over wing exits) were found removed and placed on the passenger seats. Reference Figure 71
6. The manual inflation handle (at door 2L and 3L) cover remained snapped closed (indicating slides deployed automatically) Reference Figure 72.
7. Over wing exits 2R and 3R were found closed. Reference Figure 73
8. A check of emergency equipment at flight attendant (FA) jump seats showed that only FA #3 at 4R door removed flashlight prior to evacuation.
9. All other emergency equipment remained in original stowage locations including megaphones.

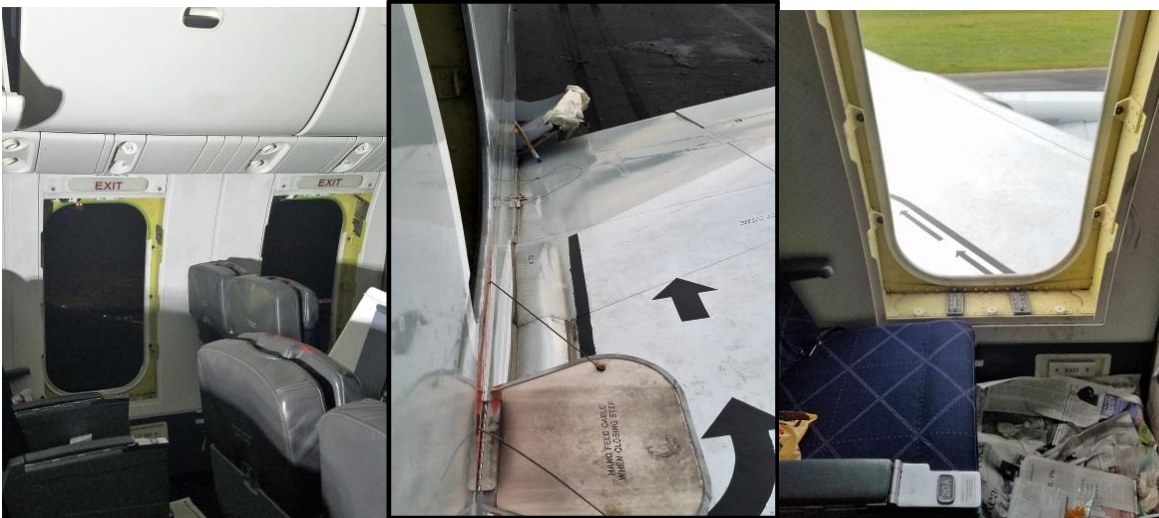
Figure 71 Doors 2L/3L Over Wing Exits (OWE) open

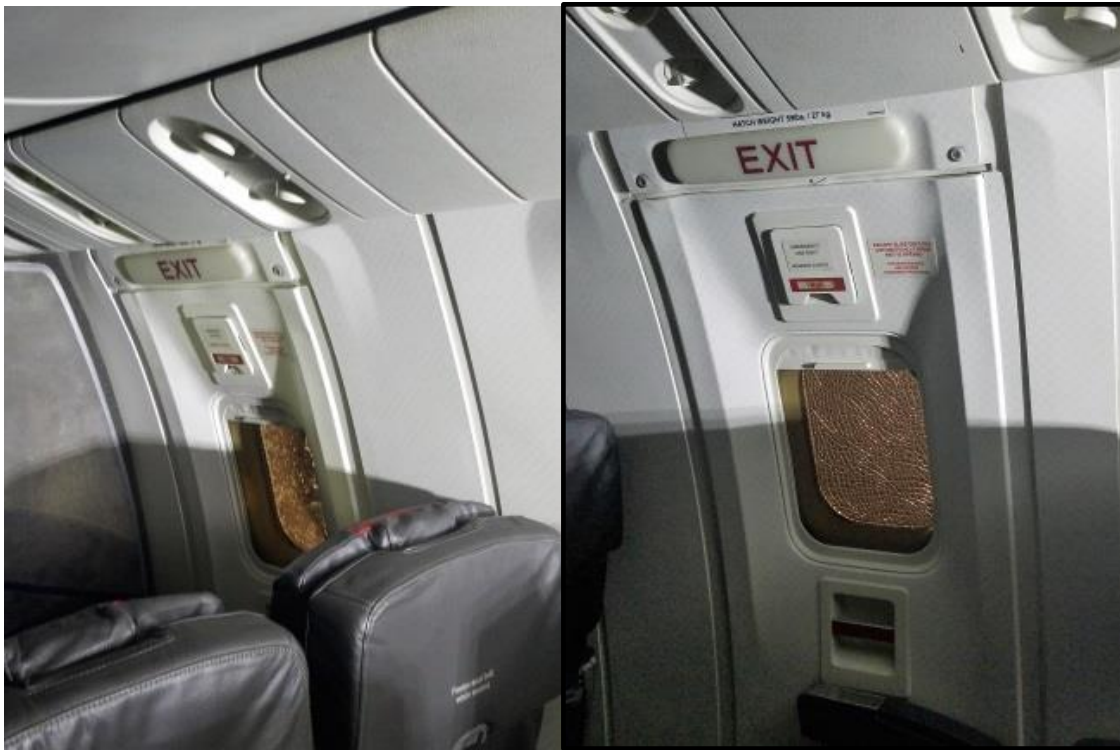
Figure 73 Doors 2R/3R OWE closed
