National Transportation Safety Board

ANC22FA041

AIRWORTHINESS

Group Chair's Factual Report

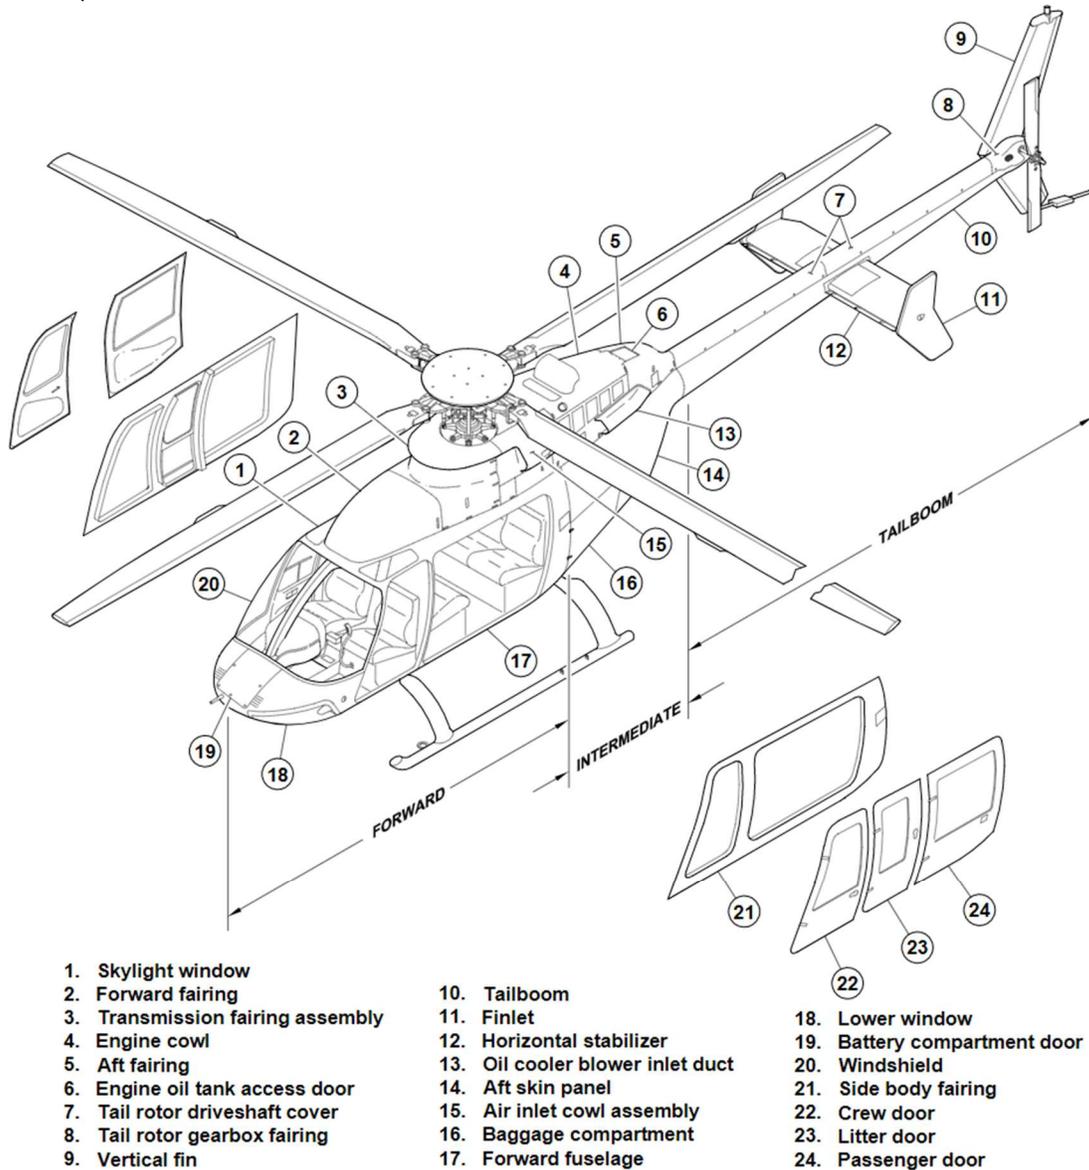
Figure 1. A diagram showing the locations of the forward fuselage, intermediate fuselage, and tail boom. (Image courtesy of Bell.)

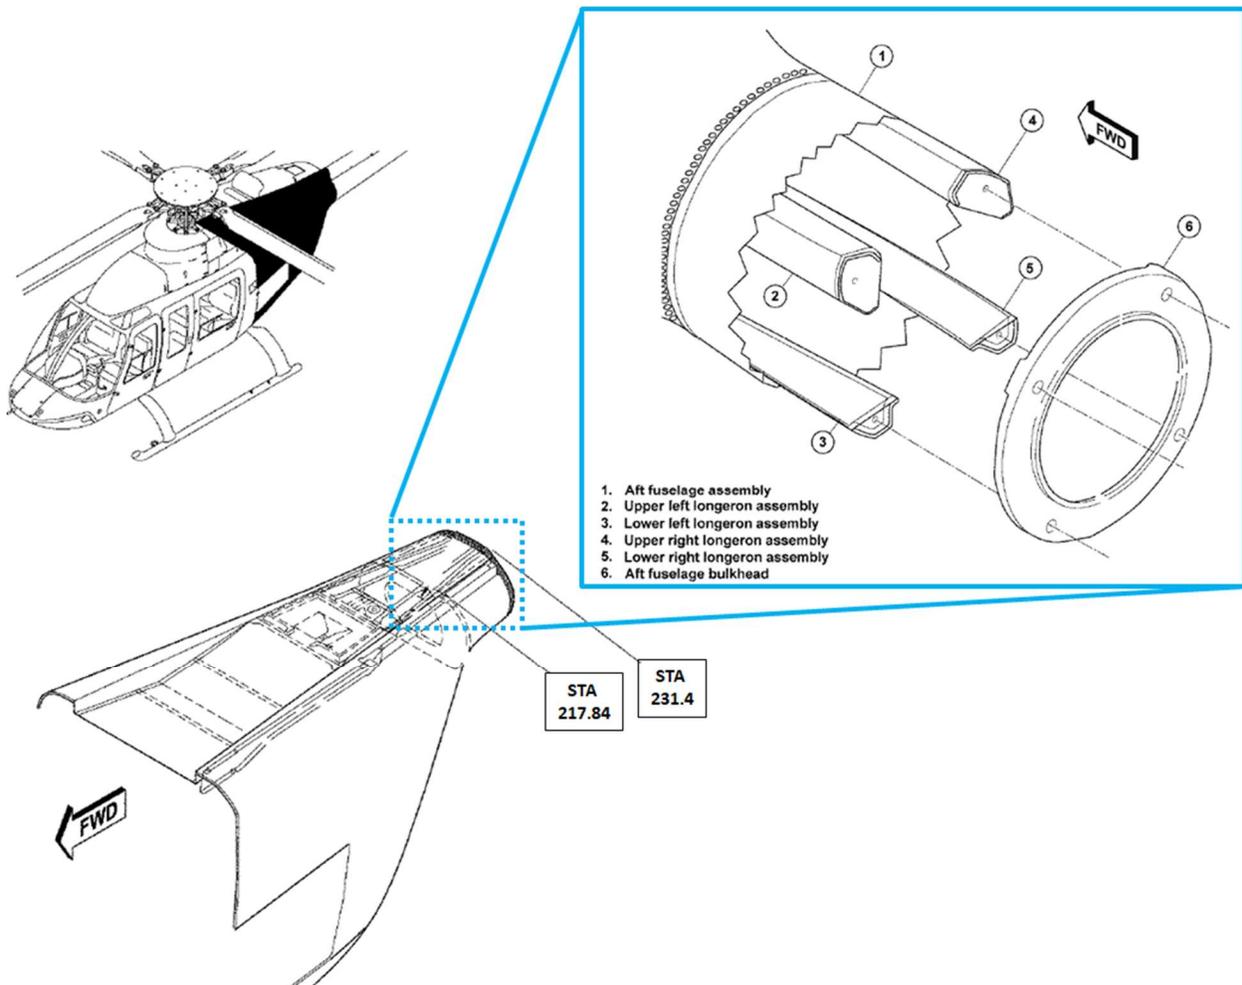
The intermediate fuselage is composed of bulkheads, longerons, and composite skins. The aft portion of the intermediate fuselage, from about STA 192 to STA 231, is referred to as the aft fuselage. Four aft fuselage longerons, identified in this report as upper-left, upper-right, lower-left, and lower-right, are attached to the aft fuselage bulkhead, located at the aft-most portion of the intermediate fuselage (**Figure 2**). To install the tail boom to the intermediate fuselage, fasteners (bolts, washers, and nuts) are used to connect the four aft fuselage longerons to four corresponding longerons located at the forward end of the tail boom (**Figure 3**).

Figure 2. A diagram showing the location of the four aft fuselage longerons and the aft fuselage bulkhead. (Images courtesy of Bell and edited by the NTSB.)

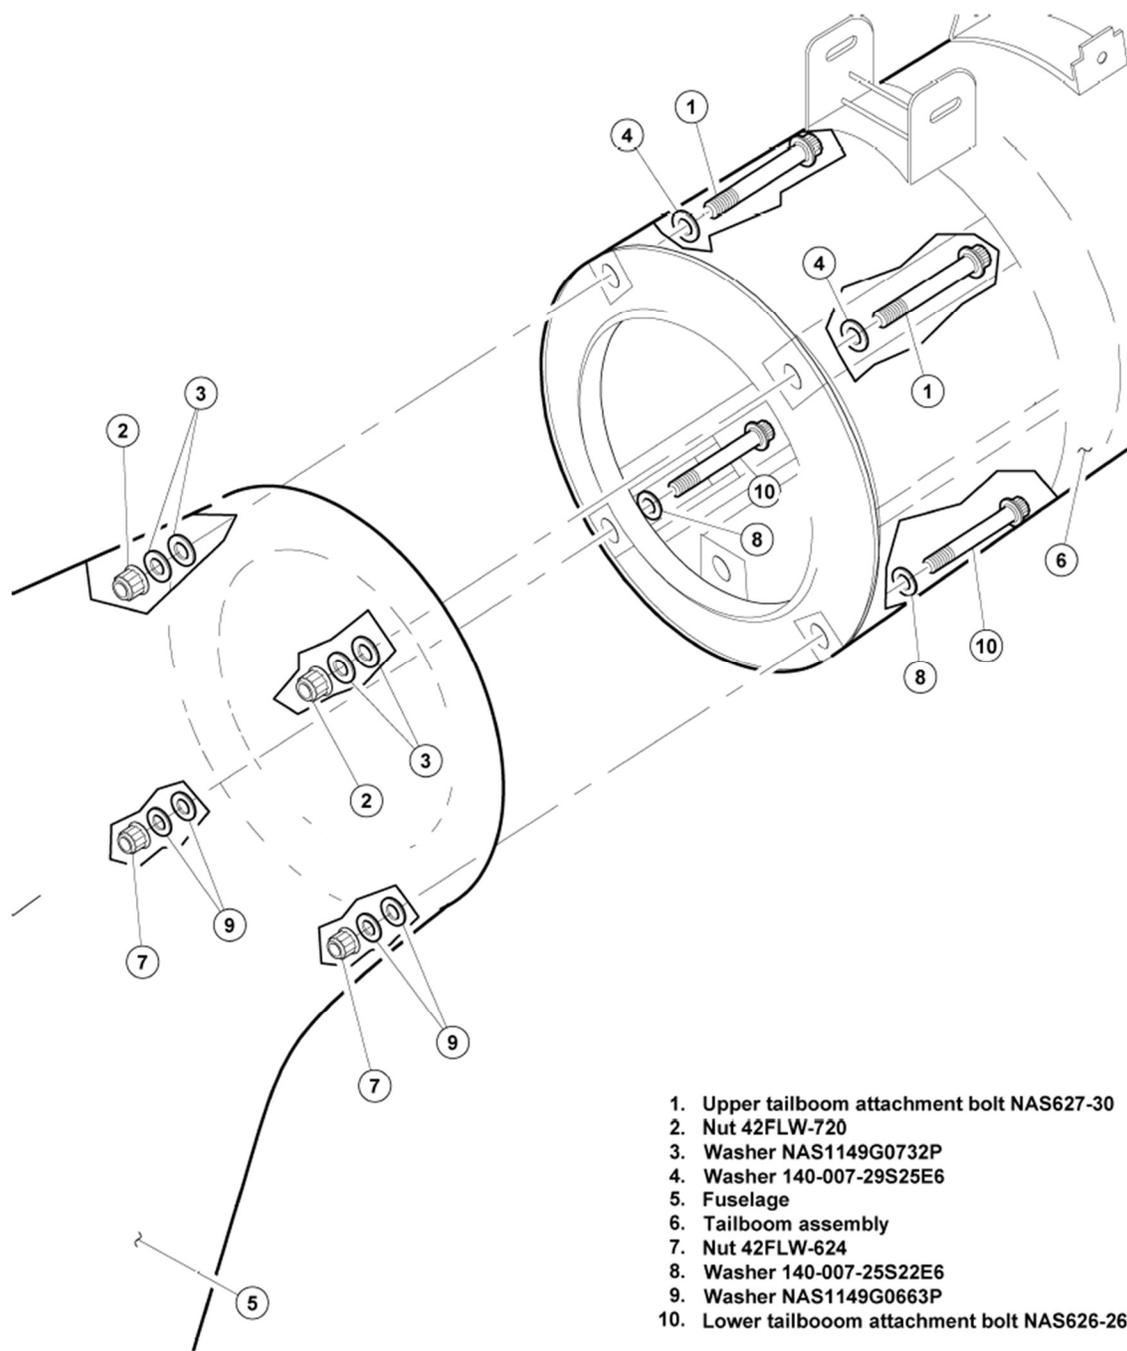
Figure 3. The hardware used to attach the tail boom to the aft fuselage. (Image courtesy of Bell and edited by the NTSB.)

According to Bell, tail rotor thrust results in tension loads on the two left attachment points and compression loads on the two right attachment points. The weight of the tail boom puts tensions loads on the two upper attachment points and compression loads on the two lower attachment points. Therefore, the upper-left attachment point has the highest tension loading of the four attachment points.

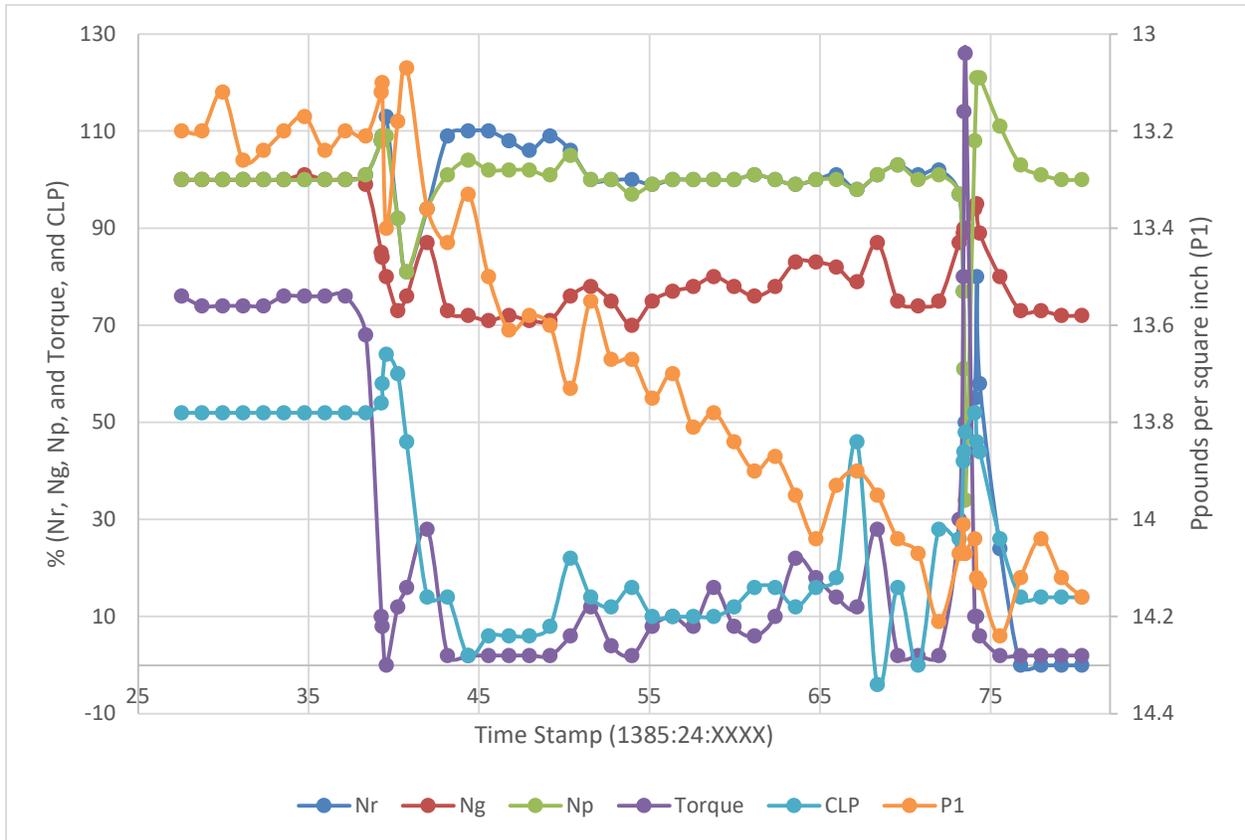
Figure A-1. Graph showing selected parameters during the accident flight.
