NATIONAL TRANSPORTATION SAFETY BOARD
Office of Aviation Safety
Washington, D.C. 20594

AIRWORTHINESS GROUP CHAIRMAN'S FACTUAL REPORT

NTSB No: DCA20LA100

Operator: Construction Helicopters, Inc.
Aircraft: Sikorsky S-61N, registration N908CH
Location: Camp Dwyer, Afghanistan
Date: April 20, 2020
Time: 0800 local time

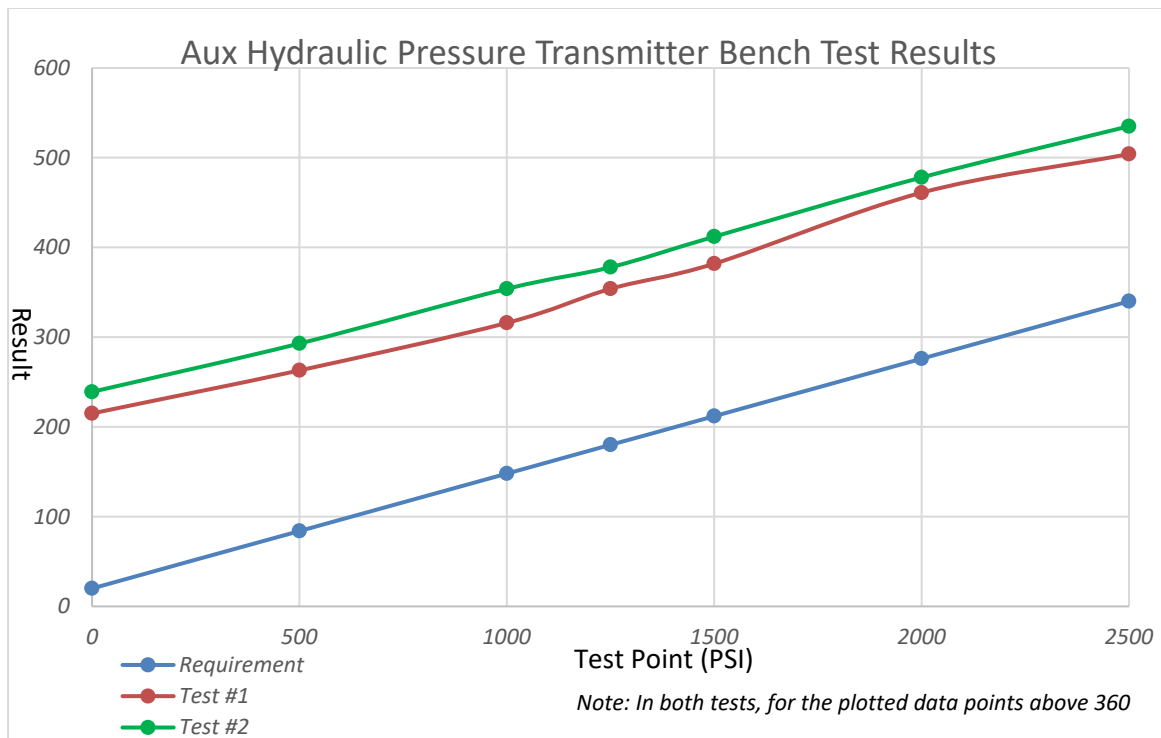
The electrical plug was removed from the transmitter, revealing a four-prong plug. The prongs were undamaged. A fitting was removed from the hydraulic port of the transmitter and there was no evidence of obstruction within the hydraulic port or the fitting. The transmitter was installed on a test bench and compressed air was applied to the test bench to detect evidence of leaks, none of which were found. The test bench compressed air pressure was increased to 2500 psi, the maximum pressure per the test data sheet, and the transmitter still did not exhibit evidence of leaks. The transmitter was tested through different pressure data points per the test data sheet. A second iteration of the test was performed to evaluate the consistency of the bench test results. **Table 1** shows the results of the bench test and **Figure 20** shows a graph of these results.⁷

Test Point (psi)	Required Autosyn Indication (degrees)	Actual Autosyn Indication Test #1 (degrees)	Actual Autosyn Indication Test #2 (degrees)
0	20	215	239
500	84	263	293
1000	148	316	354
1250	180	354	18
1500	212	22	52
2000	276	101	118
2500	340	144	175

Figure 20. Graphical bench test results of the auxiliary hydraulic pressure transmitter.
