# National Transportation Safety Board

ERA22FA279

Group Chair's Factual Report

Location: Amherstdale, West Virginia  
Date: June 22, 2022  
Time: 1645 eastern daylight time  
Helicopter: Bell UH-1B, registration N98F

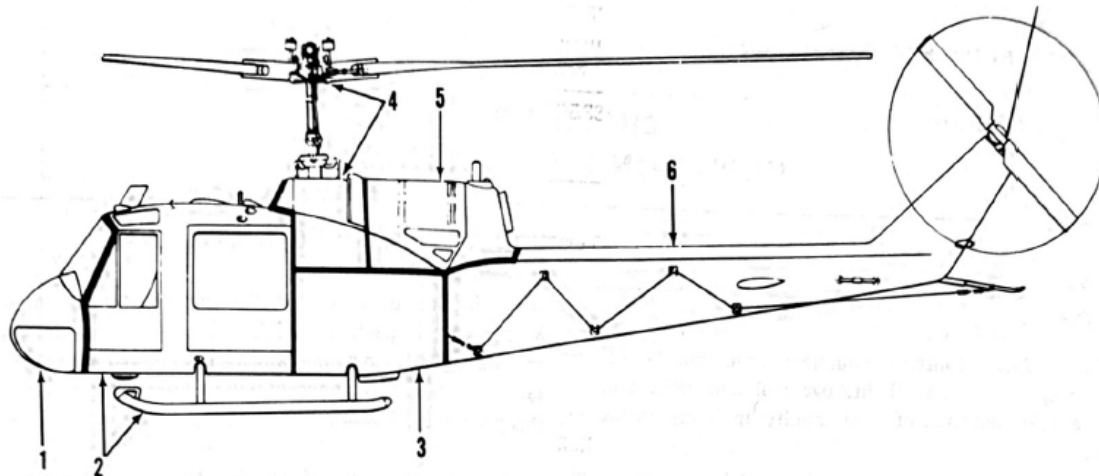
AREA No. 1	Nose Area	All surfaces, components, and equipment in nose compartment and on exterior ahead of crew doors.
AREA No. 2	Cabin and Landing Gear	All surfaces, components, and equipment inside cabin and on cabin exterior between forward sides of crew doors and cabin bulkhead at Station 123. Includes complete landing gear.
AREA No. 3	Center Fuselage Area	All surfaces, components, and equipment in fuselage below engine deck level, between cabin aft bulkhead and tail boom attachment bulkhead. Includes fuel cells, compartment below main transmission, and compartments accessible through side doors on fuselage.
AREA No. 4	Pylon Area	All surfaces, components, and equipment of the main rotor pylon group, from top of mast to bottom of transmission and work deck area under forward cowling. Includes main rotor, mast and rotating controls, transmission with accessories and mounts, and main (input) drive shaft.

**Figure 15.** The inspection areas of the UH-1B.

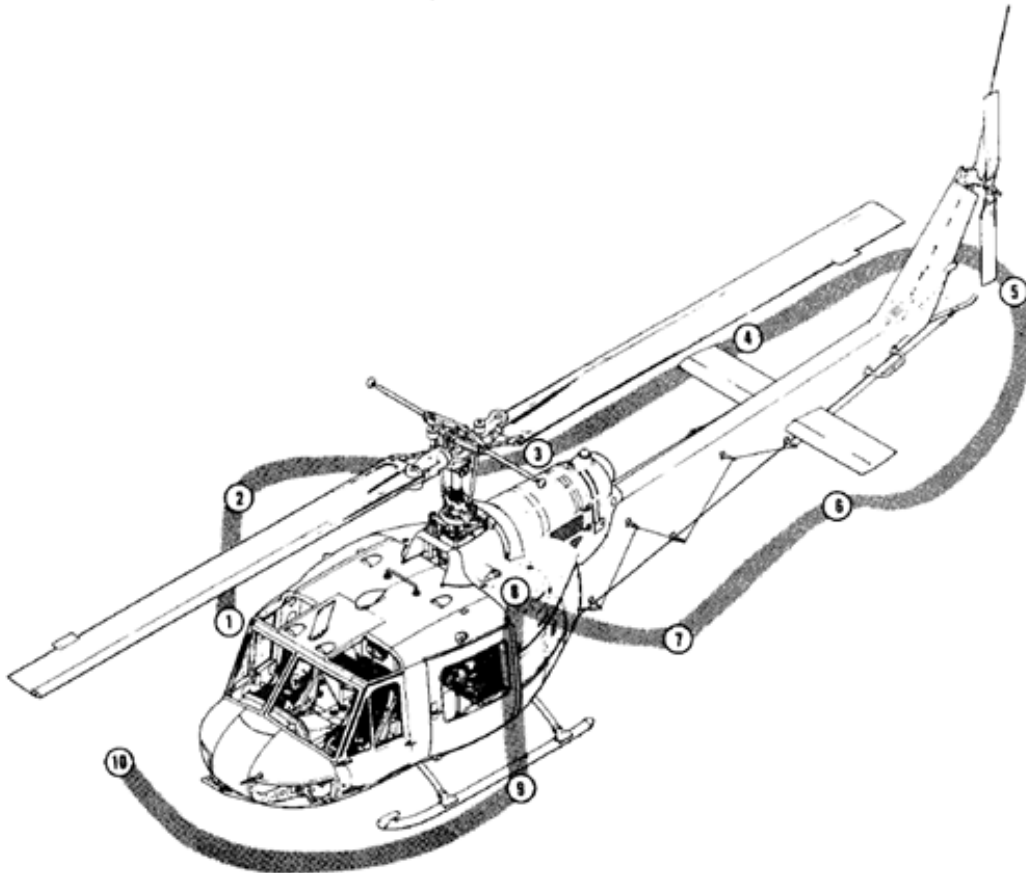
In Chapter 3 titled *"Normal Procedures"*, Section II. titled *"Flight Procedures"*, the preflight inspections area for the engine are defined in Section 3-7 titled *"Pre-Flight Check"*. Paragraph 3-12 contains instructions to inspect Area 3 (**Figure 16**) with a general visual inspection for condition of the engine, evidence of leaks, and no obstructions.

**Figure 16.** Inspection areas as defined in TM 55-1520-219-10.

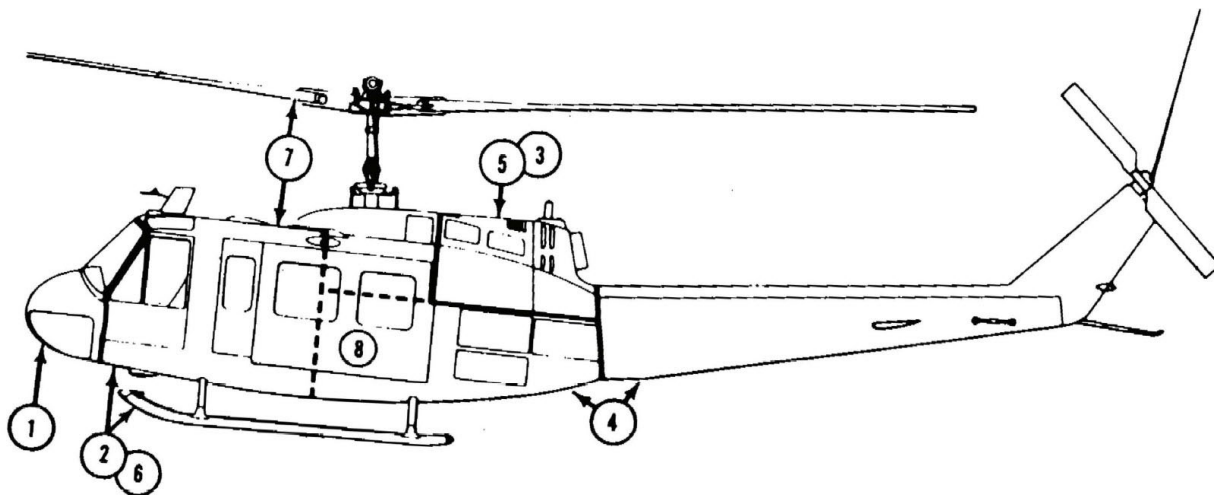
**Figure 17.** Inspection areas as defined in TM 55-1520-210-PMD.

Areas 3 and 5 titled "*Engine Area Left Side*" and "*Engine Right Side*" calls out the same general inspections - All surfaces, components, and equipment associated with the engine installation, located above the engine work deck and within the engine cowling, tailpipe fairing and intake fairing.

In the Preventative Maintenance Daily Checklist, sequence numbers 3.9 and 5.5 call out the inspection of the engine combustion chamber housing, exhaust diffuser, support cone, fireshield, firewall gaskets and seals, and tailpipe for cracks, dents, and burned or buckled areas. In sequence number 3.11, it calls out turbine blades; inspection through tailpipe and through exhaust diffuser for cracks, burns, dents, or missing blades.
