**National Transportation Safety Board
Internal Inspection Factual
Bellingham, Washington
Accident DCA99-MP008**

Appendix 7 Olympic responses to WDOE order

RE: Administrative Order No. DE 96CP-N289

Subject: Failure Analysis of 20 inch Diameter Pipe

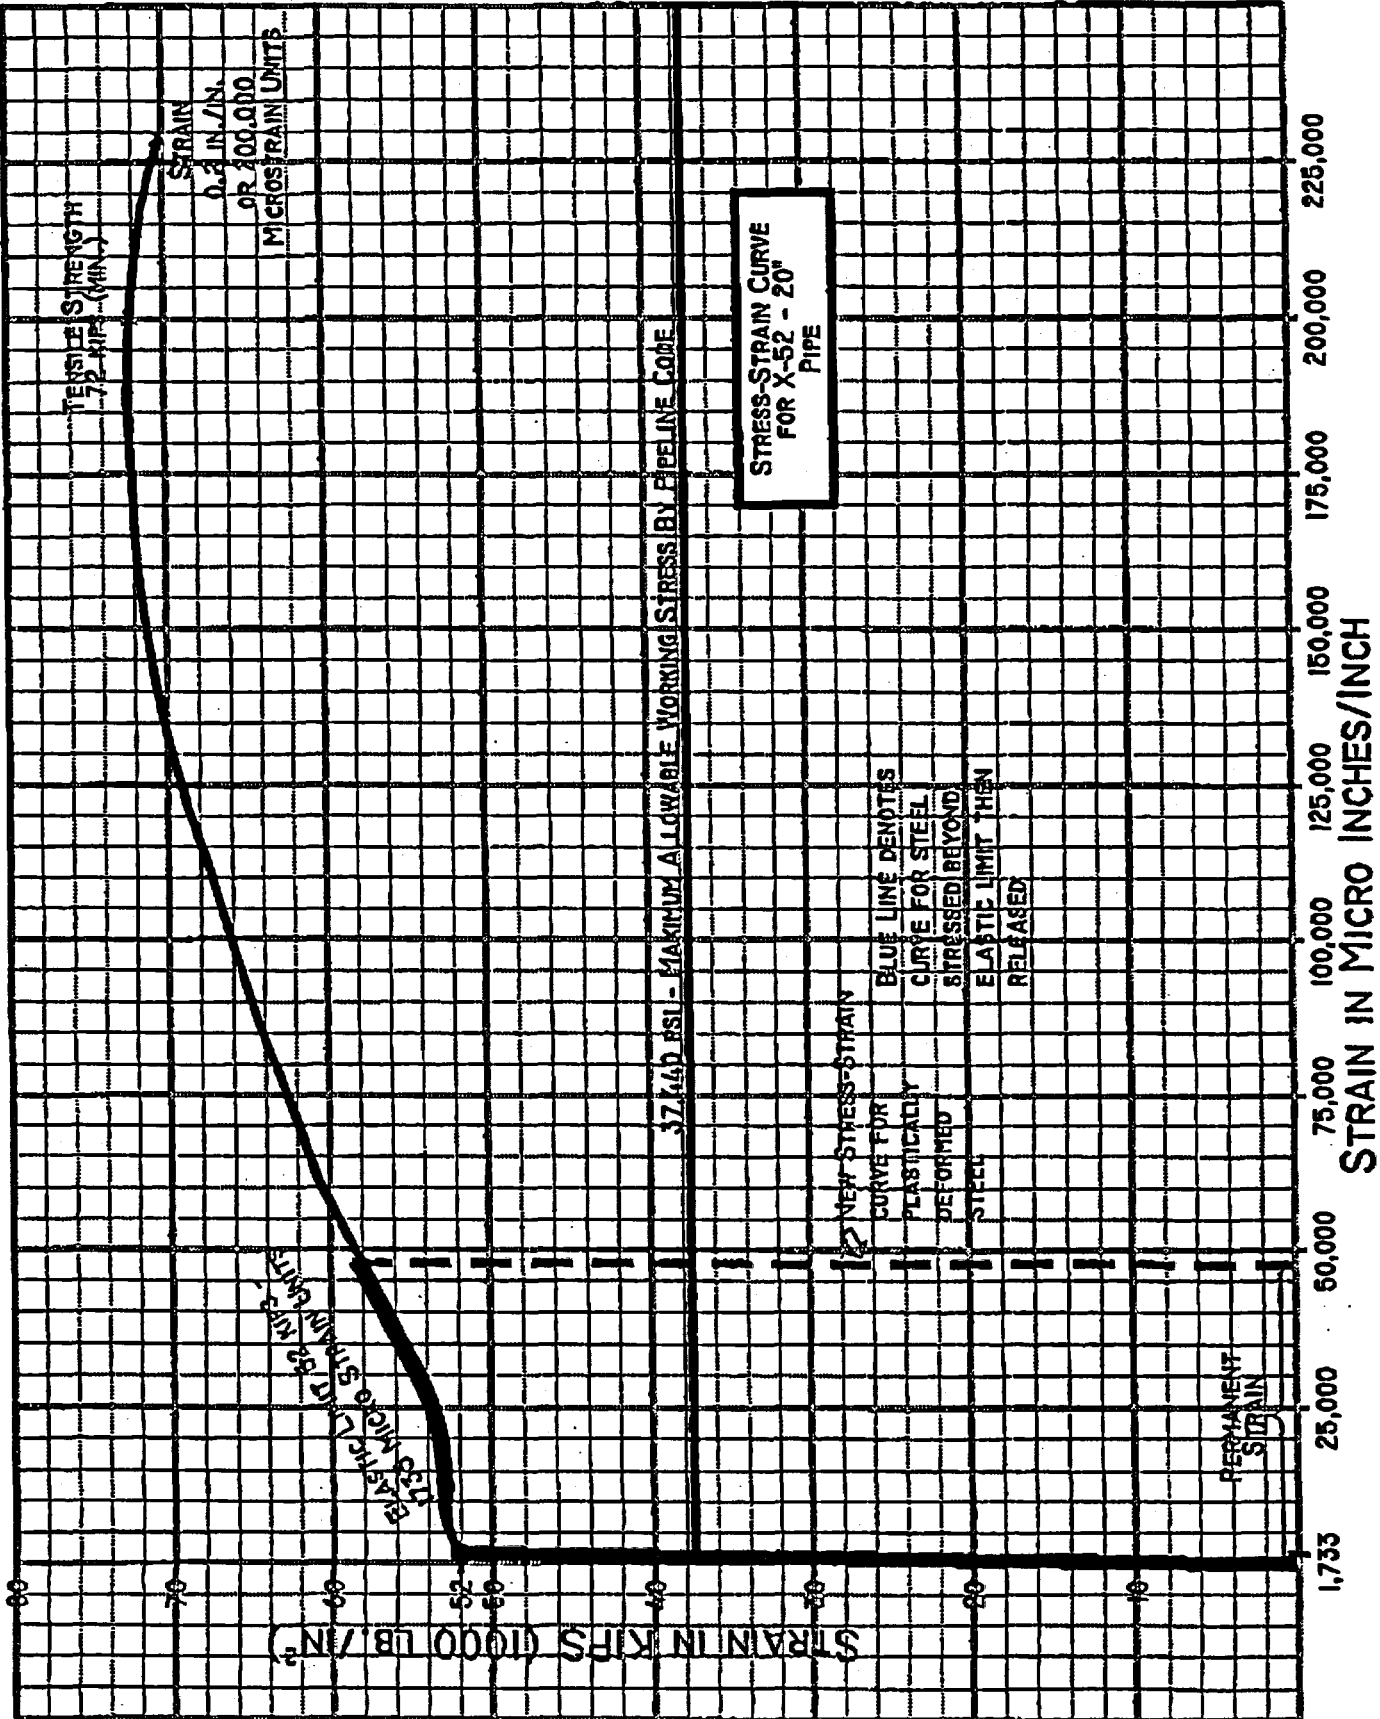
Ebey Slough - Station 1957 + 03
Microstrain Change with Tide Level

As we noted earlier, the measured strains induced on Olympic's 20" line at the Ebey Slough crossing are very low relative to both the elastic or yield strength and ultimate strength of the steel pipe. The strain is also cyclical with the tides and there is no evidence of permanent deformation of the levee that could cause a build up of strain in the entire levee system.

At any rate, the hydraulic forces acting on the levee and pipe cause extremely minor stresses which at the levels measured have no significance to the pipeline. It does produce measurable elastic strains but does not effect the safety of the pipeline in either the short term or long term (50 plus years).
