Title of Investigation:
Fire - Spirit of Boston

ORIGIN AND CAUSE REPORT

Bureau of Alcohol, Tobacco, Firearms and Explosives (ATF) Certified Fire Investigator (CFI) origin and cause determination. ATF case title: Fire - Spirit of Boston, ATF case number [REDACTED]

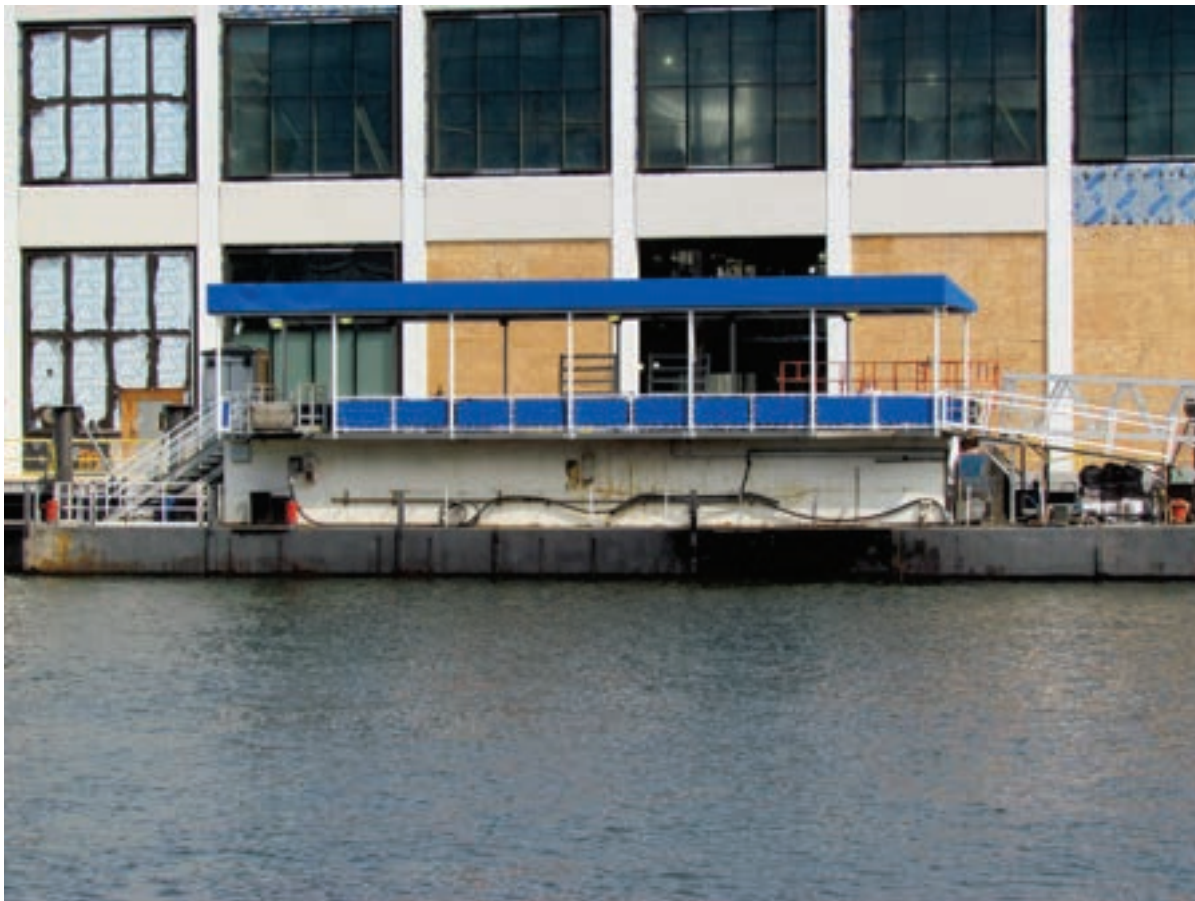
100. The dock was identified by a kiosk with a sign which clearly read “Boston Harbor citycruises SPIRIT OF BOSTON”. The dock contained an elevated pavilion and a lower level along the water. The dock had a large electrical cable stowed along the wall. It was evident where the vessel was docked. A portion of the dock demonstrated blistered paint and soot deposition on the side in contact with the water. There was no fire damage above the water line except to one (1) stanchion which demonstrated soot deposition. The dock was eliminated as the origin of the fire.

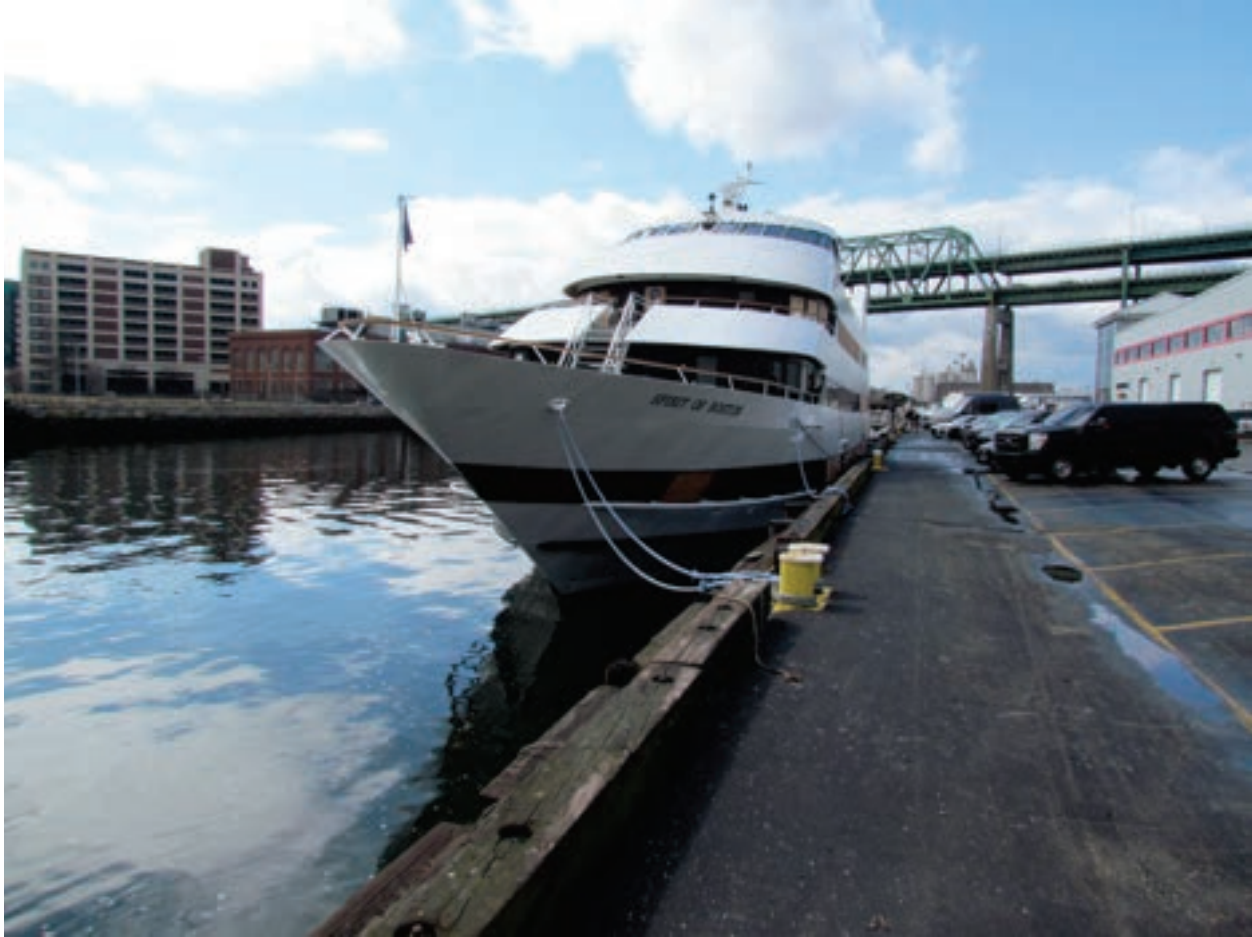
103. The fire scene examination began at the forward end of the bridge deck. The bow of the Bridge Deck consisted of the wheelhouse. The wheelhouse was enclosed with glass windows. No windows were broken or covered over in plywood on the bridge deck. No fire damage was visible on the bow of the bridge deck. It should be noted that all windows and door panel glass was heavily tinted. It was not possible to see through the heavy tint into the vessel from the exterior.

104. The forward end of the balcony deck (labeled Skyline Deck onboard) consisted of an open lounge area. Nine (9) dining room windows, and the starboard side dining room exit door, were covered with plywood. No fire damage was visible on the bow of the balcony deck.

105. The forward end of the upper deck (labeled Esplanade Deck onboard) consisted of an open lounge area. The bow of the main deck was enclosed with windows and glass door panels. No windows were broken or covered with plywood on the bow of the main deck. No fire damage was visible on the bow of the upper deck.

106. The forward end of the main deck (labeled Harborview Deck onboard) was completely enclosed with glass windows. One (1) dining room window on the port side was covered with plywood. No fire damage was visible on the bow of the lower deck.

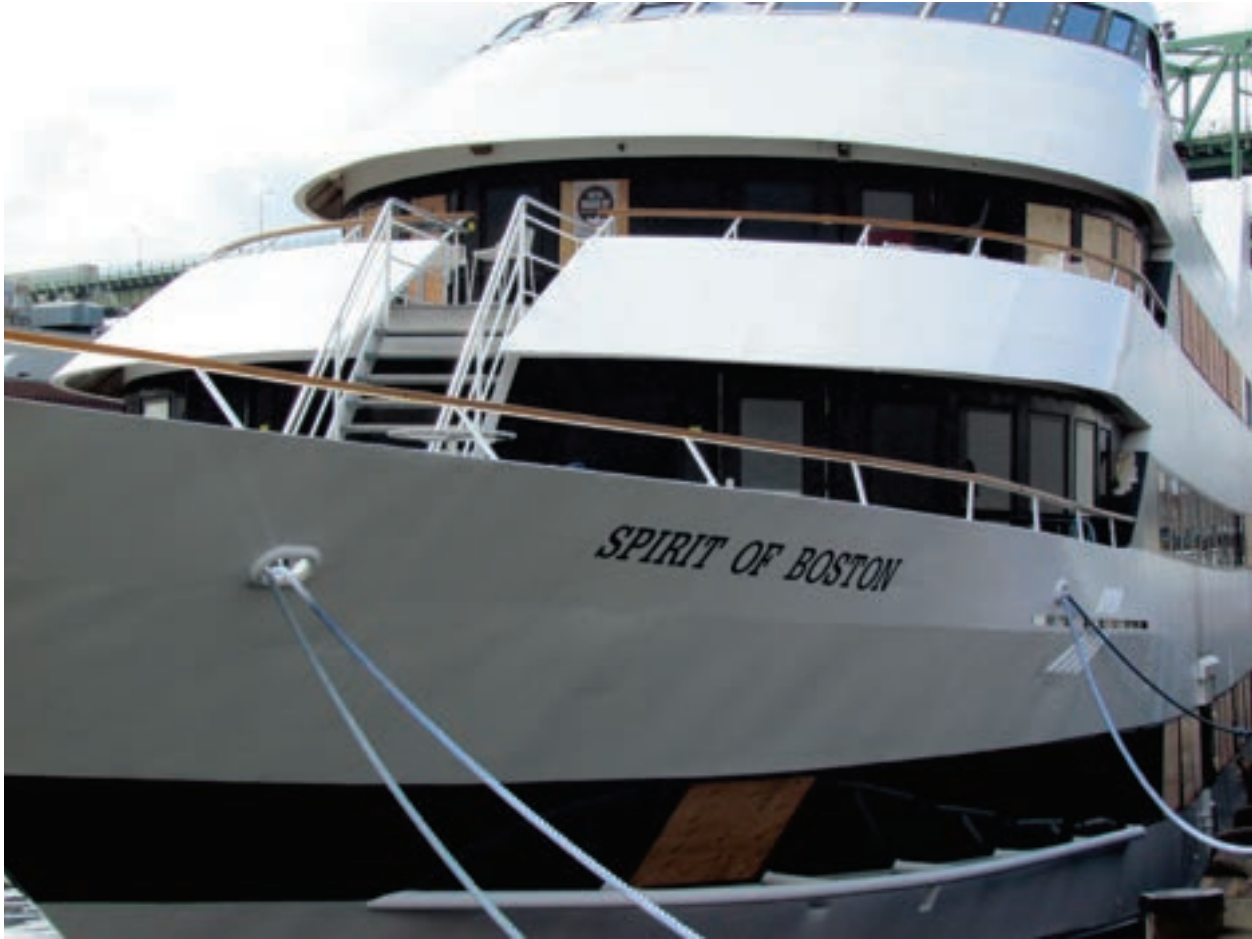
107. The hull area of the bow was intact. No fire damage was visible on the hull of the bow.
108. The starboard side of the bridge deck behind the wheelhouse was an open lounge area. "Boston Harbor citycruises by Hornblower" was clearly painted on the false stack. No fire damage visible on the starboard side of the bridge deck.

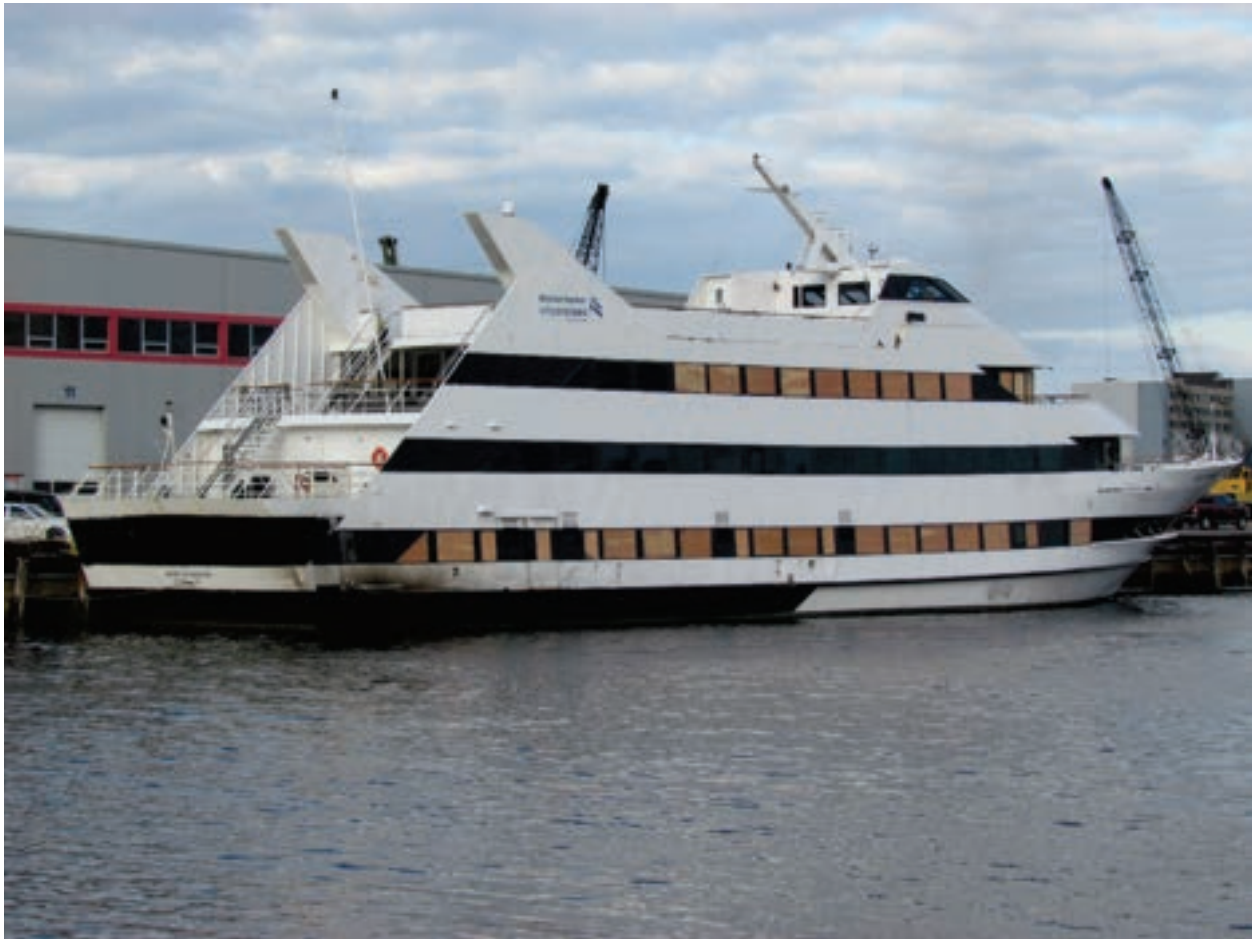
109. The starboard side of the balcony deck was completely enclosed with glass windows. Nine (9) dining room windows were covered with plywood. No fire damage visible on the starboard side of the balcony deck.

110. The starboard side of the upper deck was completely enclosed with glass windows. No windows were broken or covered with plywood on the starboard side of the main deck. No fire damage was visible on the starboard side of the upper deck.

111. The starboard side of the main deck was completely enclosed with glass windows, six (6) vents and a cargo door. All nineteen (19) windows were covered with plywood. The aft of the starboard side of the main deck demonstrated significant soot deposition. Numerous scuff marks were visible in the soot deposition. The soot deposition appeared to be the result of engine exhaust and not soot from a fire event. Two exhaust ports were visible in the freeboard below the soot accumulation. No fire damage was visible on the starboard side of the main deck.

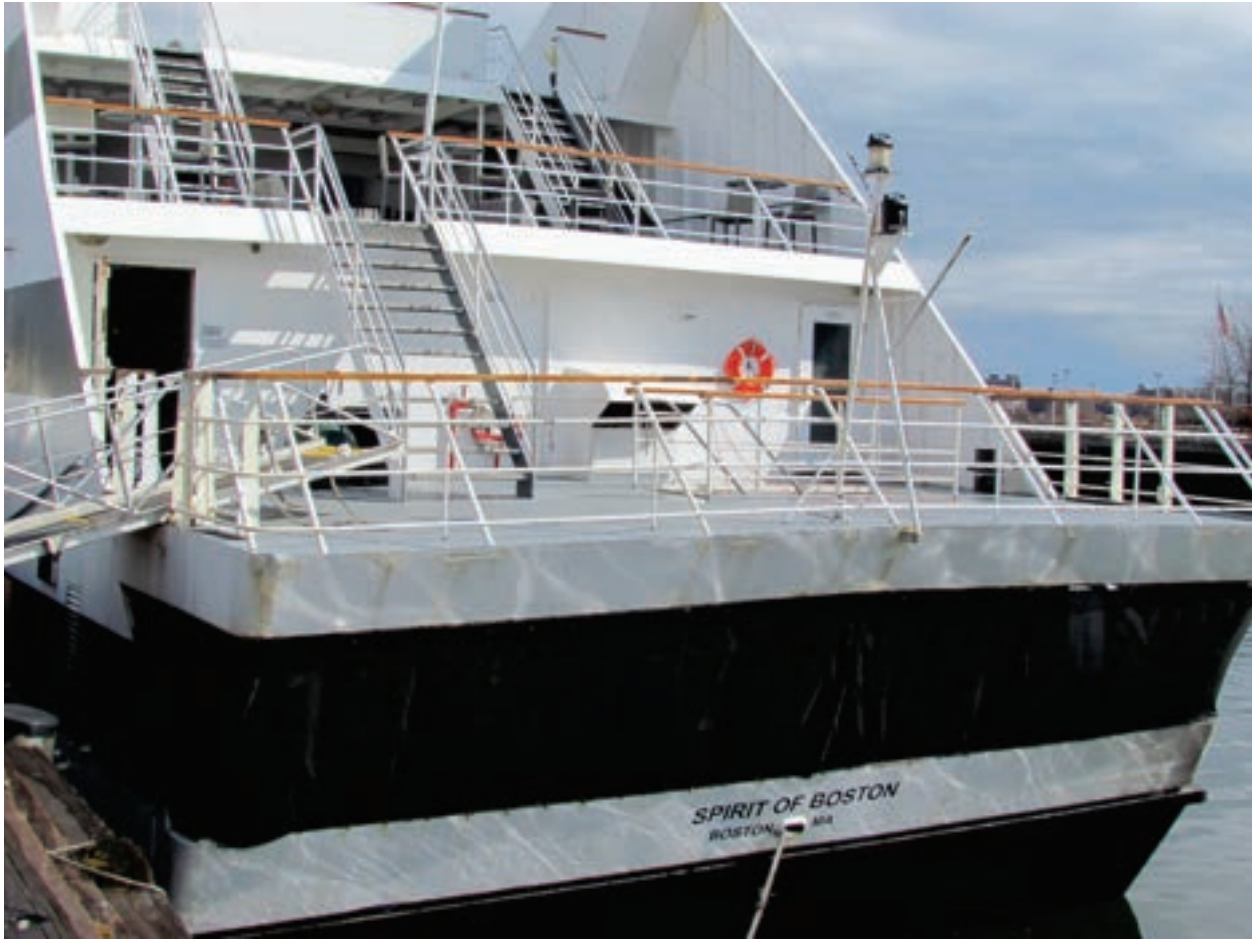
114. The aft balcony deck consisted of an open lounge with a full bar. The two (2) exit doors from the dining room to the aft open lounge were covered with plywood. No fire damage was visible on the aft of the balcony deck.

115. The aft upper deck accessed the main deck dining room via two (2) doors, the balcony deck via stairway, and the main deck via stairway. No fire damage was visible on the aft upper deck.

116. The aft main deck was covered by the aft upper deck and enclosed with a visqueen type curtain. No fire damage was visible on the aft main deck.
117. The aft hull was intact. No fire damage was visible to the aft hull.

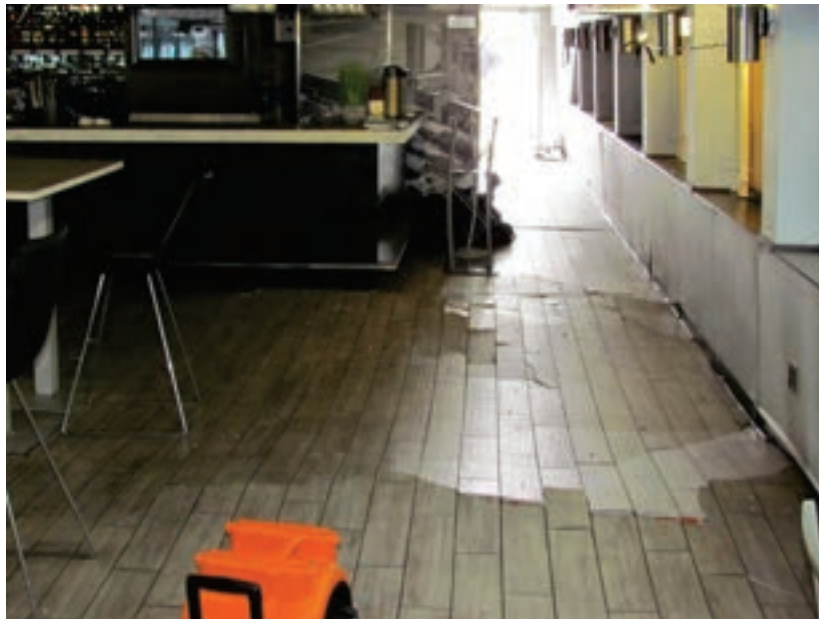
147. Aft of the dining room was a full-service lounge bar. The floor covering on the port side was cracked and the floor was buckled from the port sidewall of the vessel to the center of the full-service lounge bar floor. A plastic milk crate had melted to the floor and adhered to the epoxy/cementitious. When the plastic milk crate was removed the portion adhered to the bottom stuck to it and was separated from the floor. It should be noted the portion of the floor behind the full-service bar did not have a finished floor covering which the dining room and restrooms had.

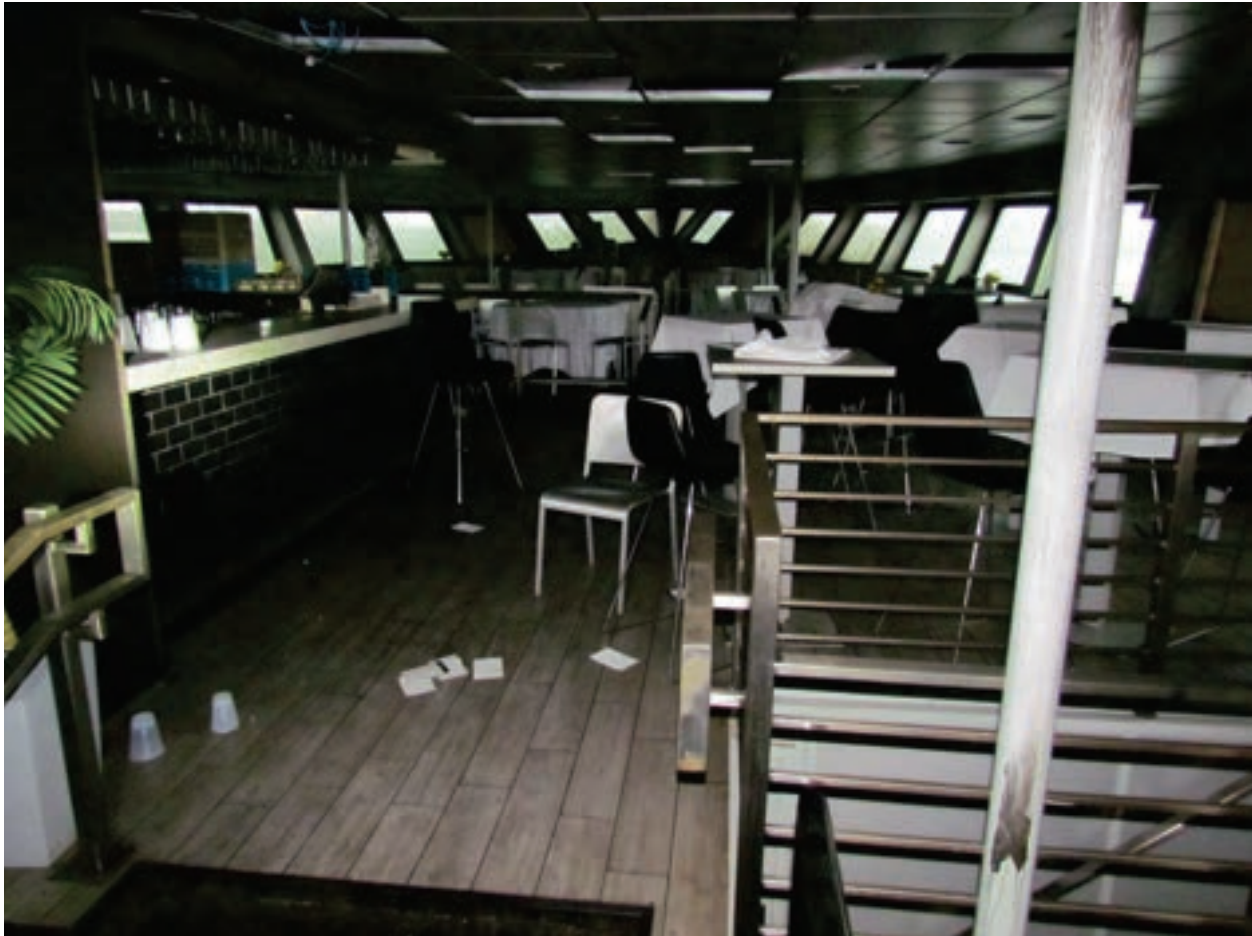
152. The interior of the main (Harborview) deck was examined. The forward portion of the main deck was a dining room furnished with tables and chairs. On the port side was a full-service lounge bar. The forward dining room demonstrated moderate soot deposition. Multiple ceiling tiles were dislodged.

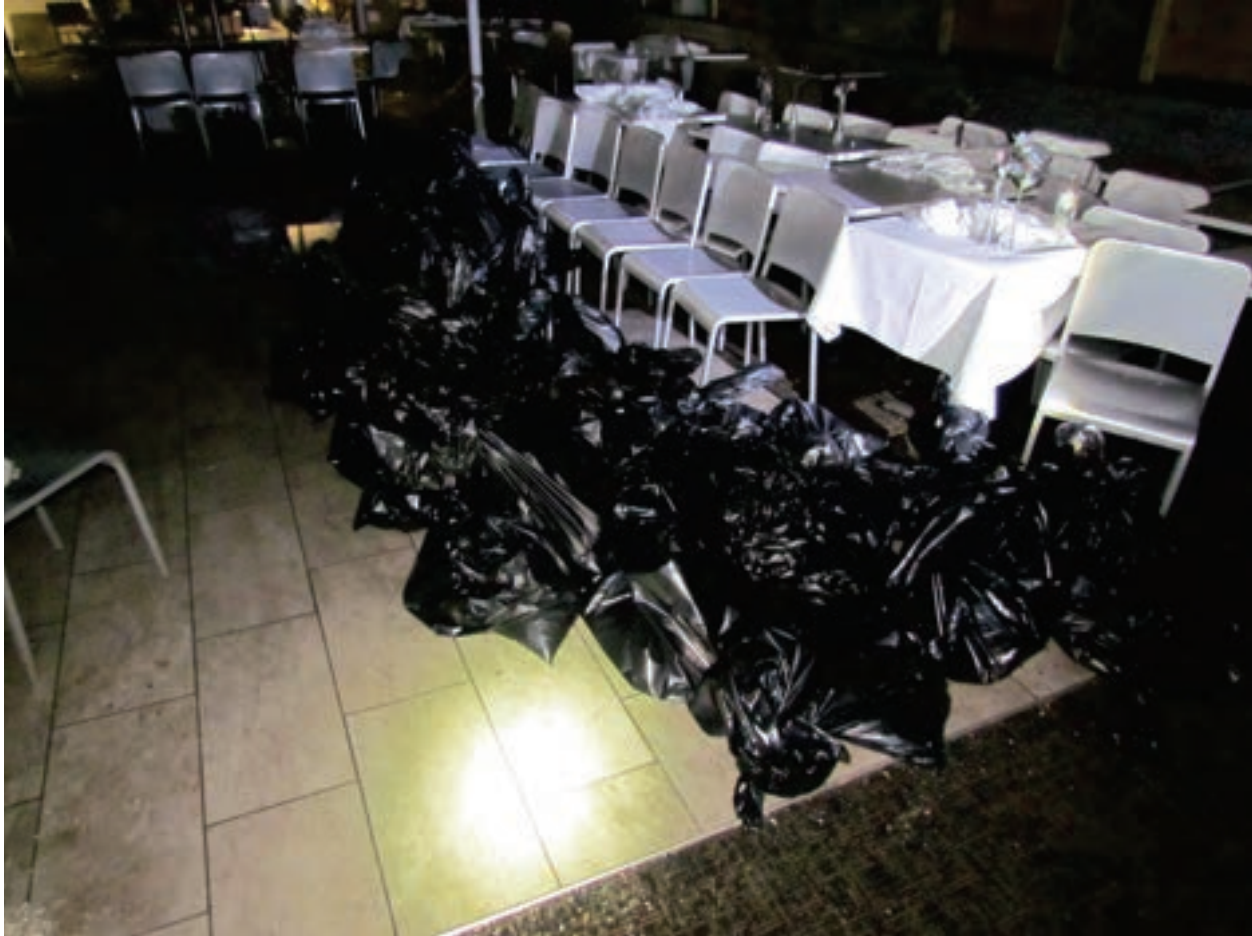
154. Aft of the two (2) stairways was a dining room furnished with tables and chairs. The forward portion of the aft dining room demonstrated significant soot deposition. Tables and chairs were in disarray. The tables were in various stages of being cleaned and bussed. The dining room contained a buffet station with roll top chafing trays and tureens. The aft dining room was carpeted with a tiled dance floor area in the middle. Numerous black trash bags were piled on the floor indicative of clean up efforts that had commenced prior to the fire scene investigation. Temporary portable lighting was also located through out the deck.

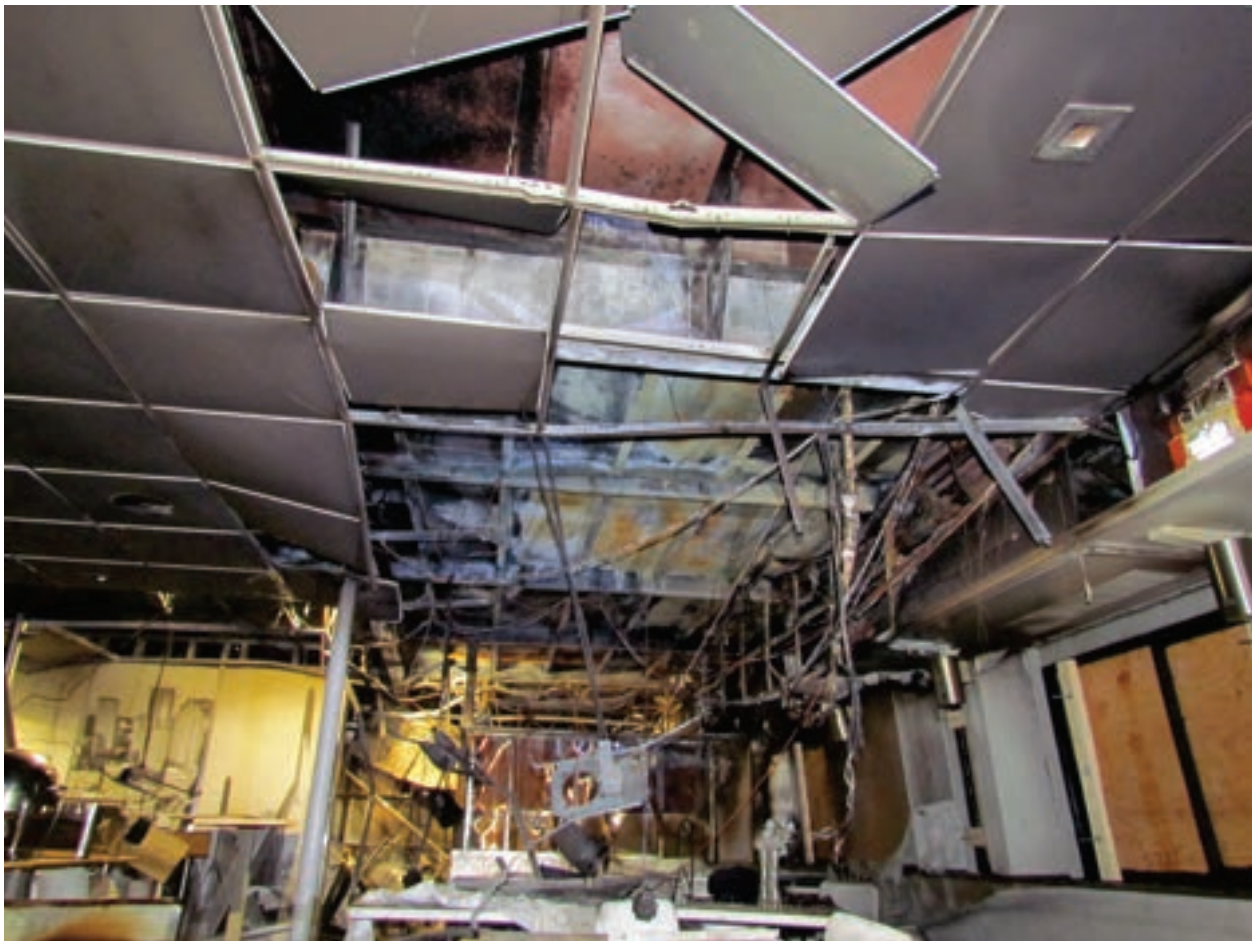
157. The heating, ventilation, and air conditioning (HVAC) units were also along the exterior hull above the windows in line with the shelves storing the life preservers. The units were intermittently spaced throughout the main deck.
158. The heat, fire, and smoke damage increased in severity in the dining room on the port side aft. The port side aft was cordoned off with yellow barrier tape. Metal ceiling tiles and a significant portion of the suspended track were dislodged or removed along the port side of the dining room. The amount of fire heat and smoke damage increased along the port side of the aft dining room. The exposed metal portion of the underside of the upper deck demonstrated significant oxidation and deformation.

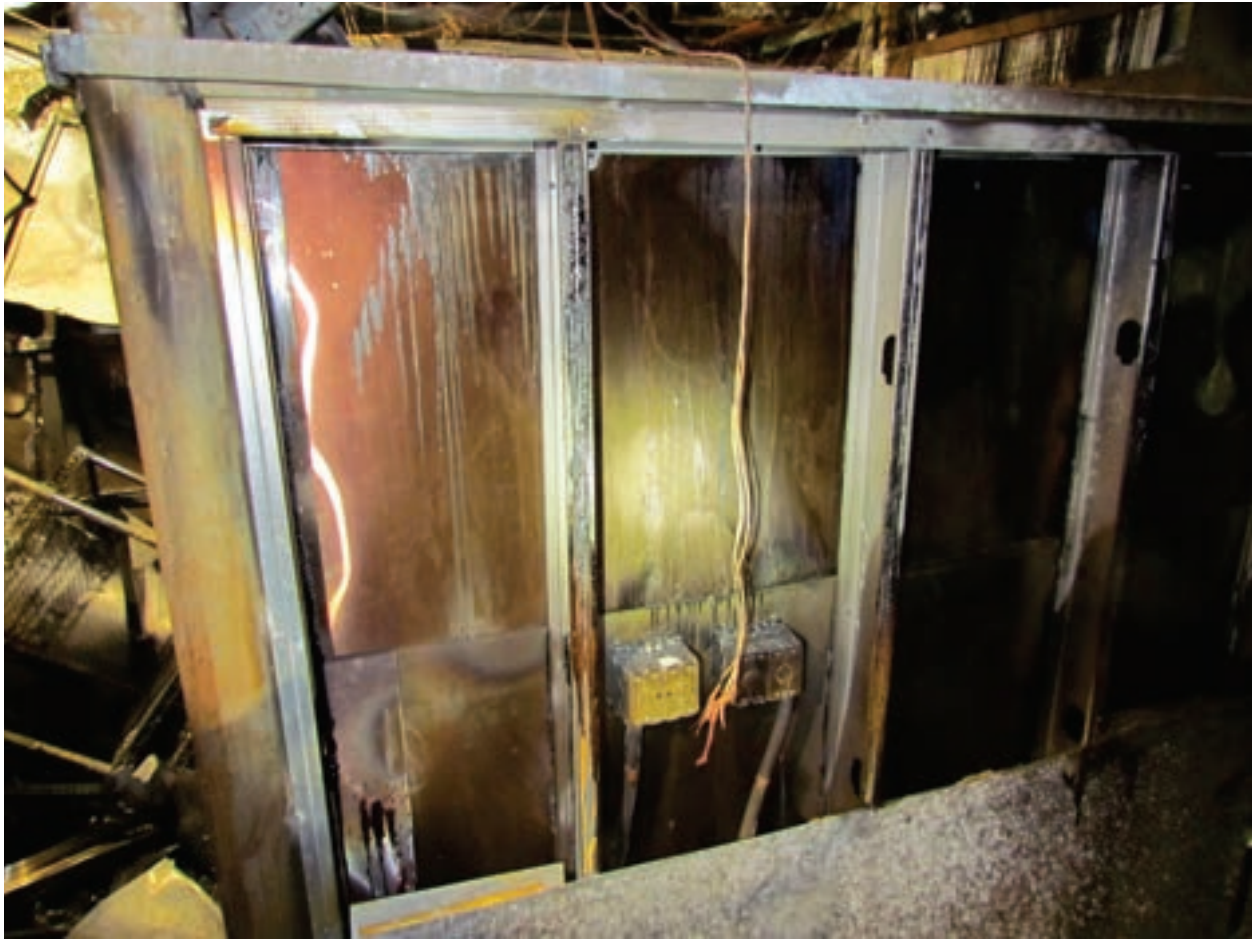
159. The dining room port aft side partition wall separated the port aft side wait staff station along the port side vessel hull. The upper portion of the wall covering on the aft dining room port side partition wall was absent. The wall was constructed of standard metal vertical framing studs with metal paneling as the wall covering on both sides. The exposed back side of the metal paneling on the port aft side wait staff station demonstrated significant oxidation which increased in severity towards the port side of the hull of the vessel. Electrical conductors and the back side of outlet boxes were exposed. They were examined and did not demonstrate any anomalous electrical activity. It was evident the fire exposed the aft dining room from the port aft wait staff station.

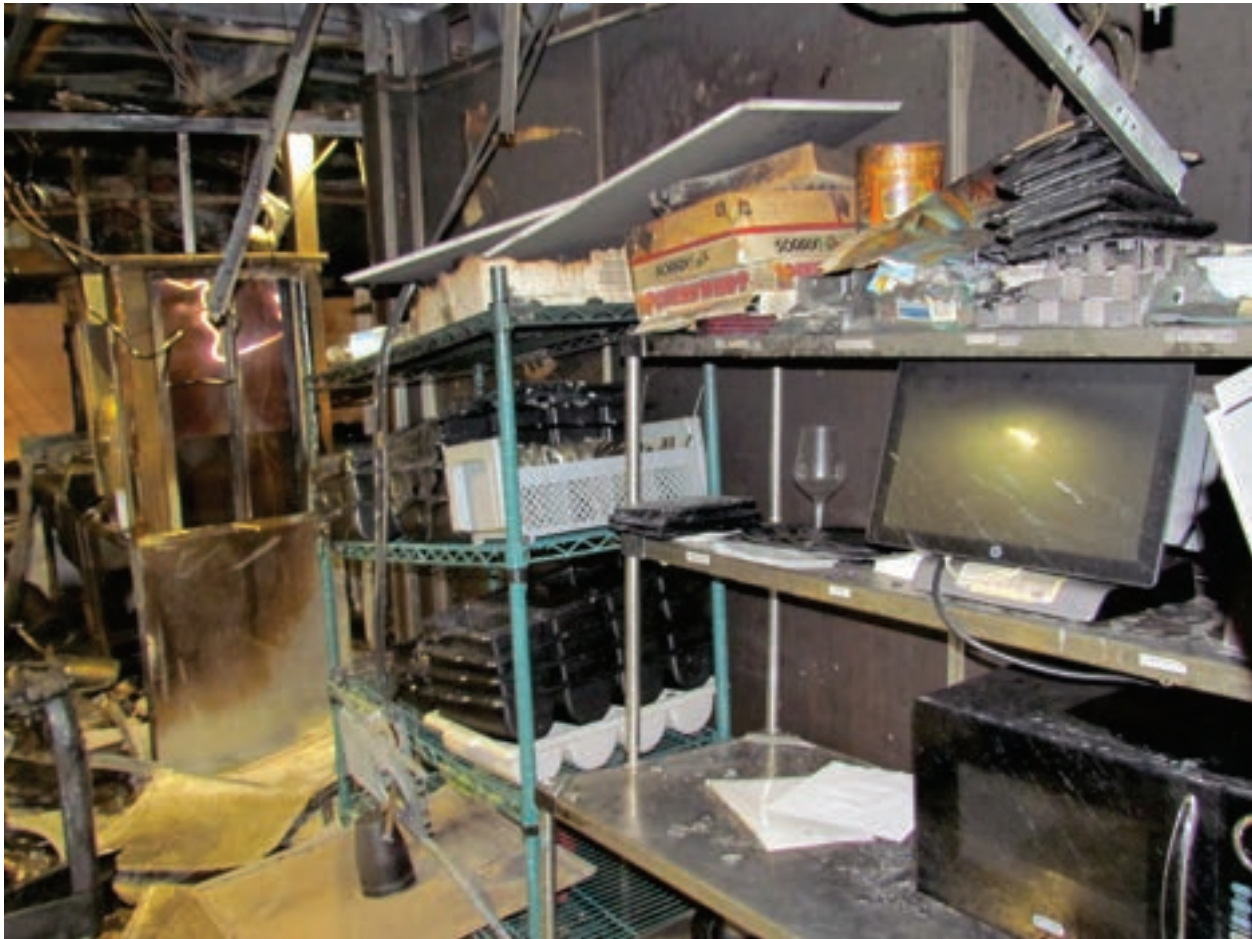
162. The starboard side of the midship aft wait staff station consisted of permanent metal shelving with computer equipment, a microwave, various stored items, and hospitality table setting items. Heat, fire, and smoke damage increased toward the port side of the vessel.

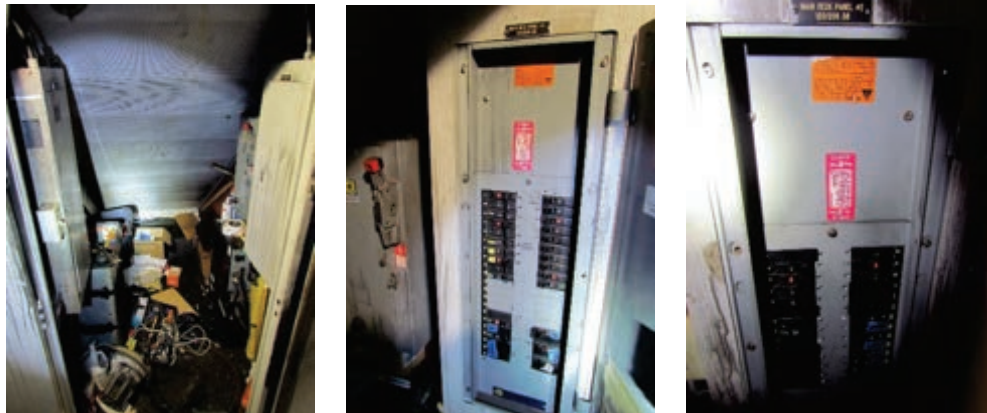
170. A Powervar electrical power conditioner and various other electrical components were in the closet. An examination of all electrical components in the closet and electrical distribution panels did not reveal any anomalous electrical activity. The electrical components in the closet were eliminated as a cause for a fire.

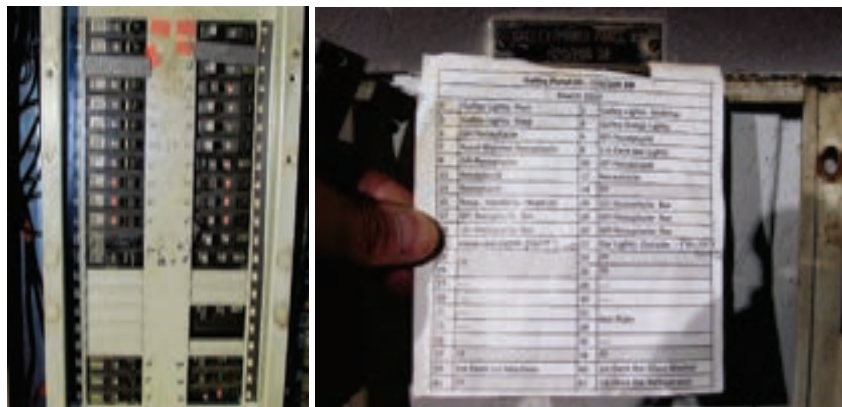
All other breakers were in the on position. An examination of all electrical components did not reveal any anomalous electrical activity. The electrical components in the galley electrical distribution panels were eliminated as a cause for a fire.

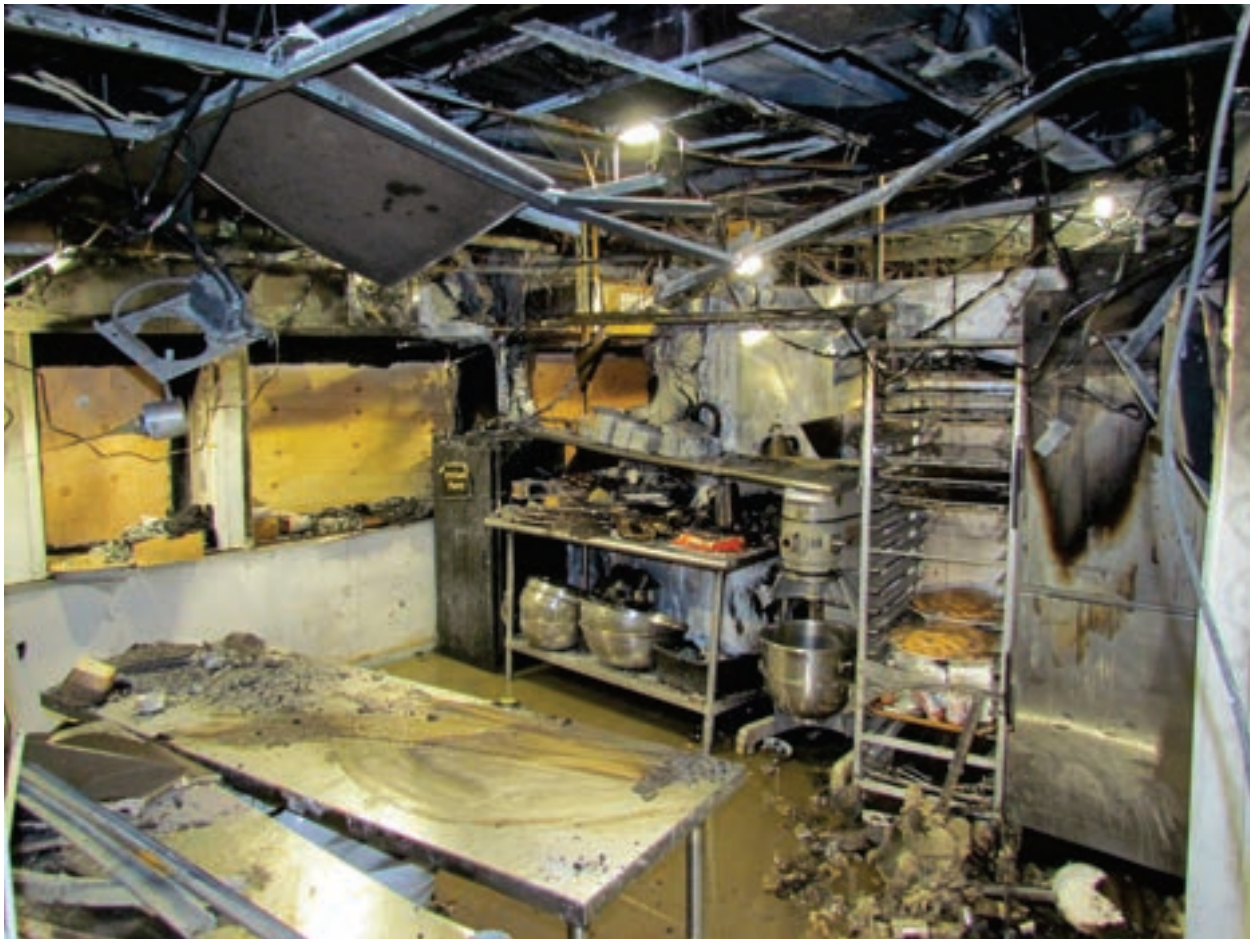
178. Forward of the galley was the pantry. The pantry demonstrated significant heat, fire, and smoke damage. The ceiling consisted of a suspended track with gypsum drywall tiles. Most of the gypsum drywall tiles were dislodged or absent and the suspended track was significantly damaged. Recessed lighting fixtures were in the ceiling as well as various wires and cables.

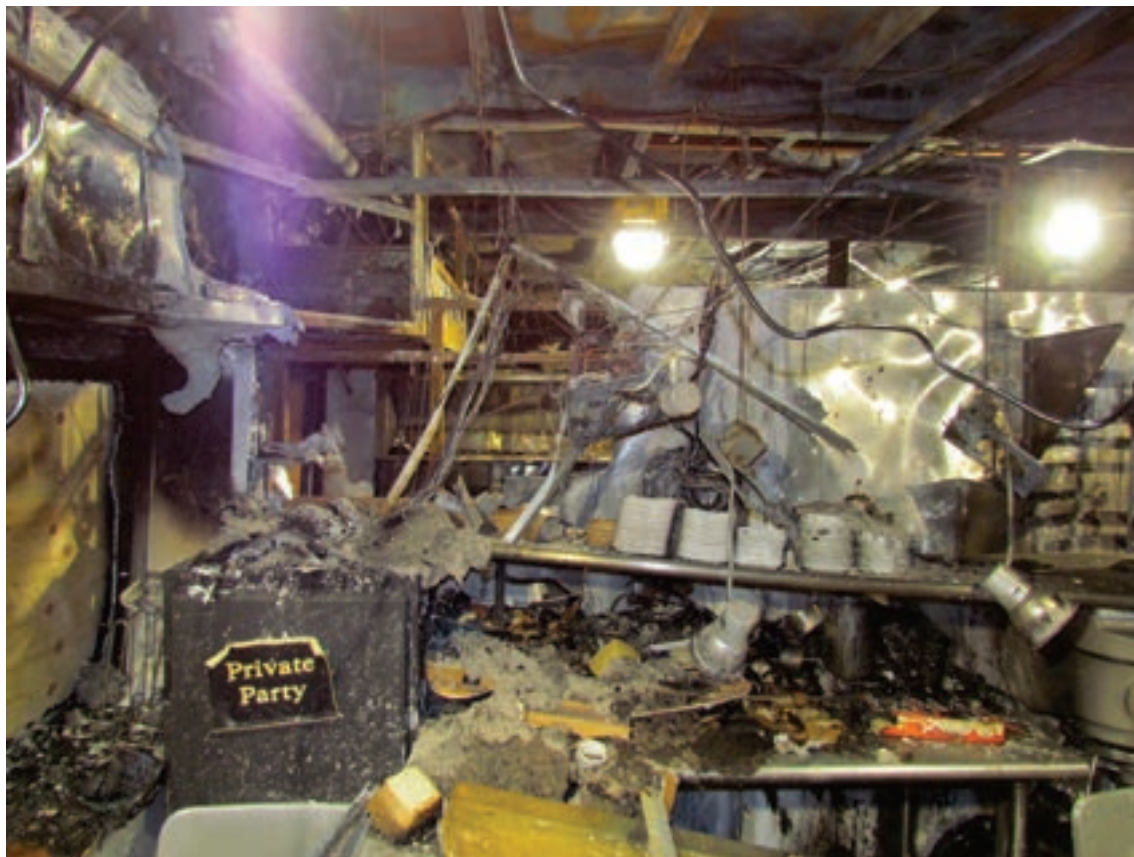
182. The permanently mounted shelves on the forward wall, which adjoined the port aft side wait staff station had both collapsed. The upper shelf demonstrated a significant oxidation pattern on the port side which diminished laterally starboard. The damage to soffit along the port wall decreased in severity from the forward port corner of the galley stores. The metal soffit covering had been consumed in the forward port side corner. The metal wall covering of the forward partition wall, which adjoined the port aft side wait staff station, had been consumed. This was indicative of a long duration fire event with significant fire impingement.

183. The underside of the upper deck demonstrated significant oxidation with the most severity in the forward port side corner.

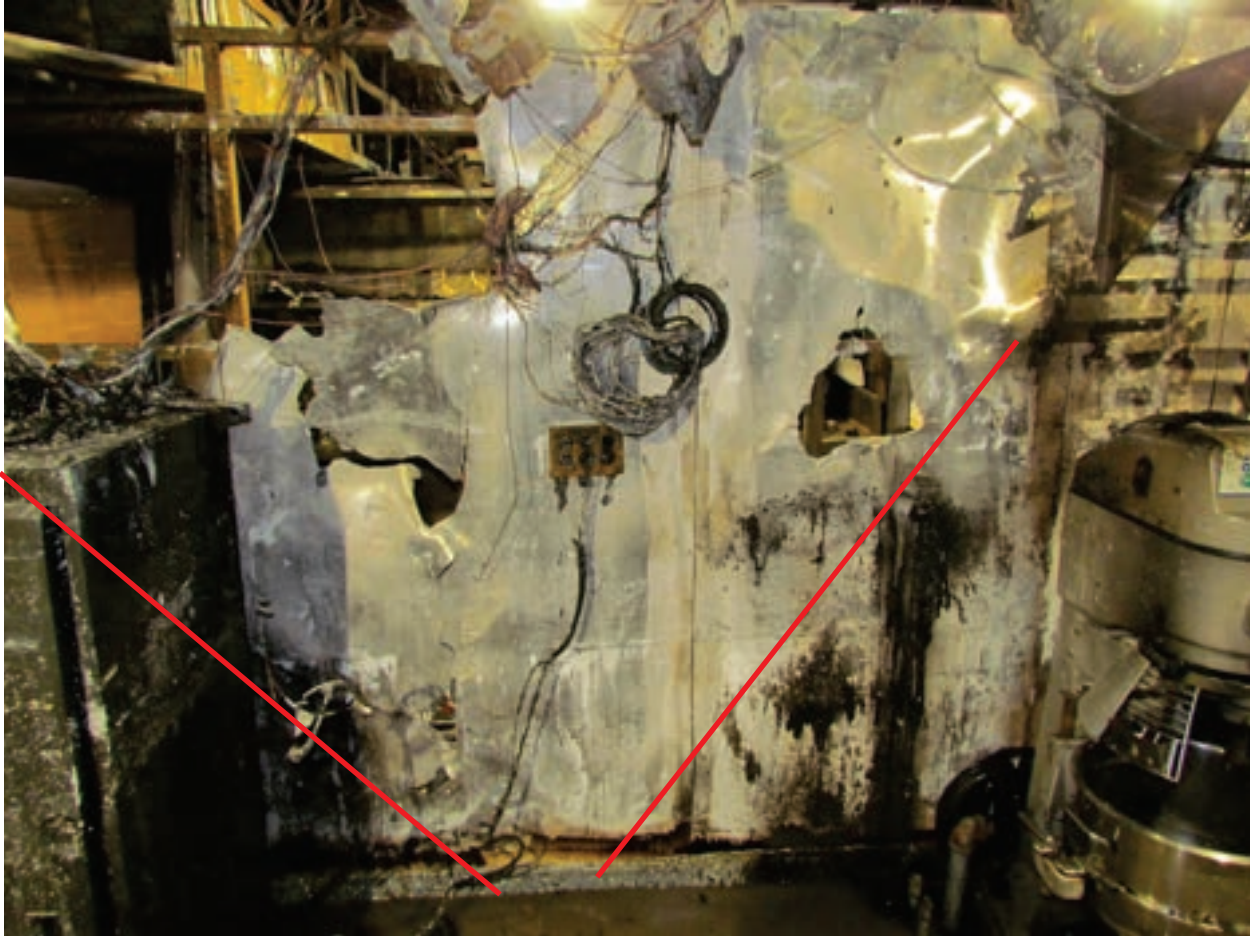
184. The stored contents and shelving on the forward galley stores wall, which adjoined the port aft side wait staff station were removed to examine the wall covering. The partition wall demonstrated a fire “V” pattern which originated at floor level and extended upwards and outwards. There were several penetrations in the metal wall covering near floor level. The penetrations increased in number and size in the upper portion of wall. The metal panel wall covering was consumed along the port side. Stored combustibles in contact with the metal wall covering had melted and adhered to the metal wall covering due to radiant heat transfer through the metal wall.
185. The appliances, electrical wiring, and fixtures were examined. The pantry was eliminated as an origin for a fire. It was evident the fire exposed the pantry from the port aft wait staff station.

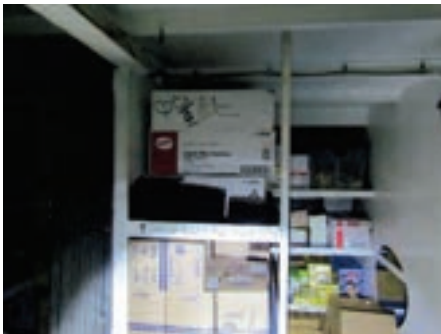
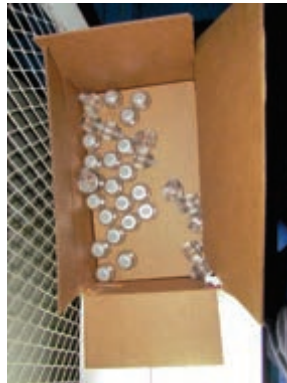
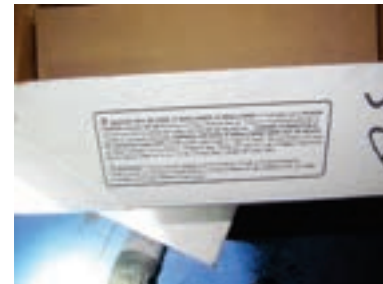
189. The warning label on the box read, in part: DANGER: Store locked up. Dispose of contents/container in accordance with local/regional/national/international regulations. DANGER: COMBUSTIBLE: Contains petroleum distillates. Combustible if absorbed on paper or fabric. Do not store or use near ignitable materials. Do not store near heat or open flame. Use only in well-ventilated area. Keep tightly capped when not in use.

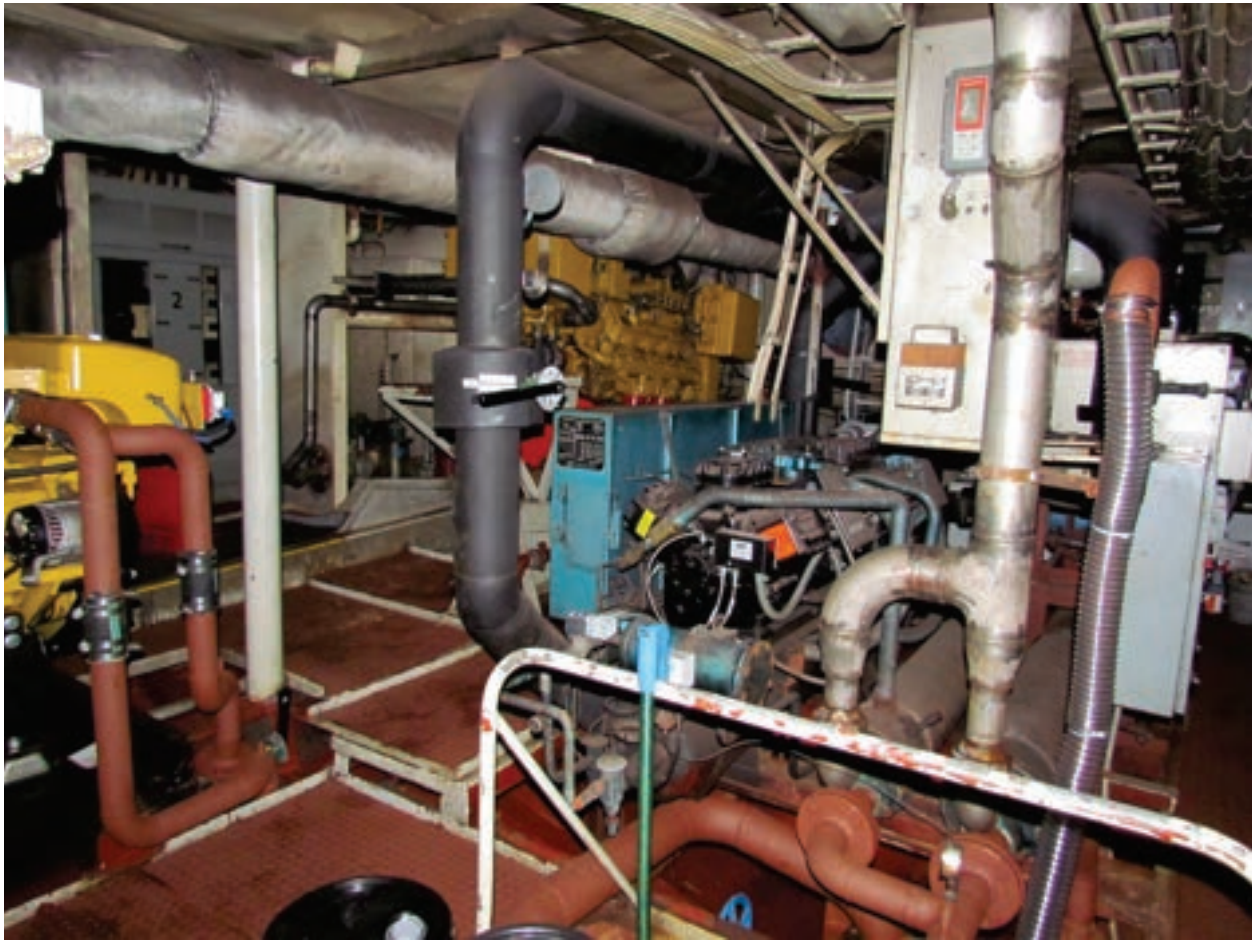
192. The four (4) engines were intact and did not demonstrate and abnormalities. The port side of the engine room demonstrated moderate to significant heat and smoke damage.

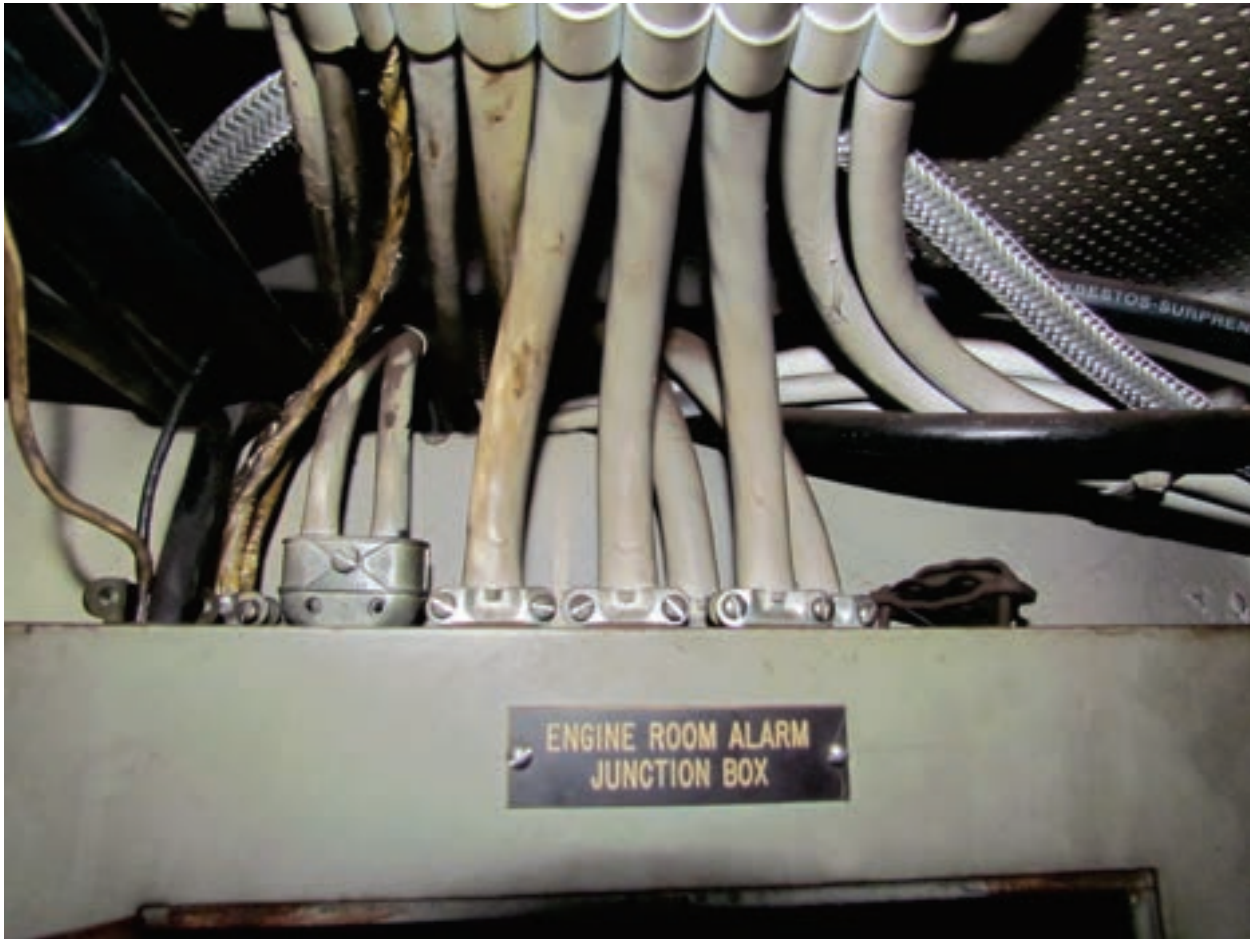
195. The insulation on the three (3) specified conductors was melted, charred, discolored and deformed. The area adjacent to and above the described conductors demonstrated soot deposition to the exposed conductors and ridged conduit. There was no evidence of an external heat source which exposed the damaged conductors. The thermal damage to the conductors was due to internal heating.
