Title of Investigation:
Fire - Spirit of Boston

ORIGIN AND CAUSE REPORT

Bureau of Alcohol, Tobacco, Firearms and Explosives (ATF) Certified Fire Investigator (CFI) origin and cause determination. ATF case title: Fire - Spirit of Boston, ATF case number [REDACTED]

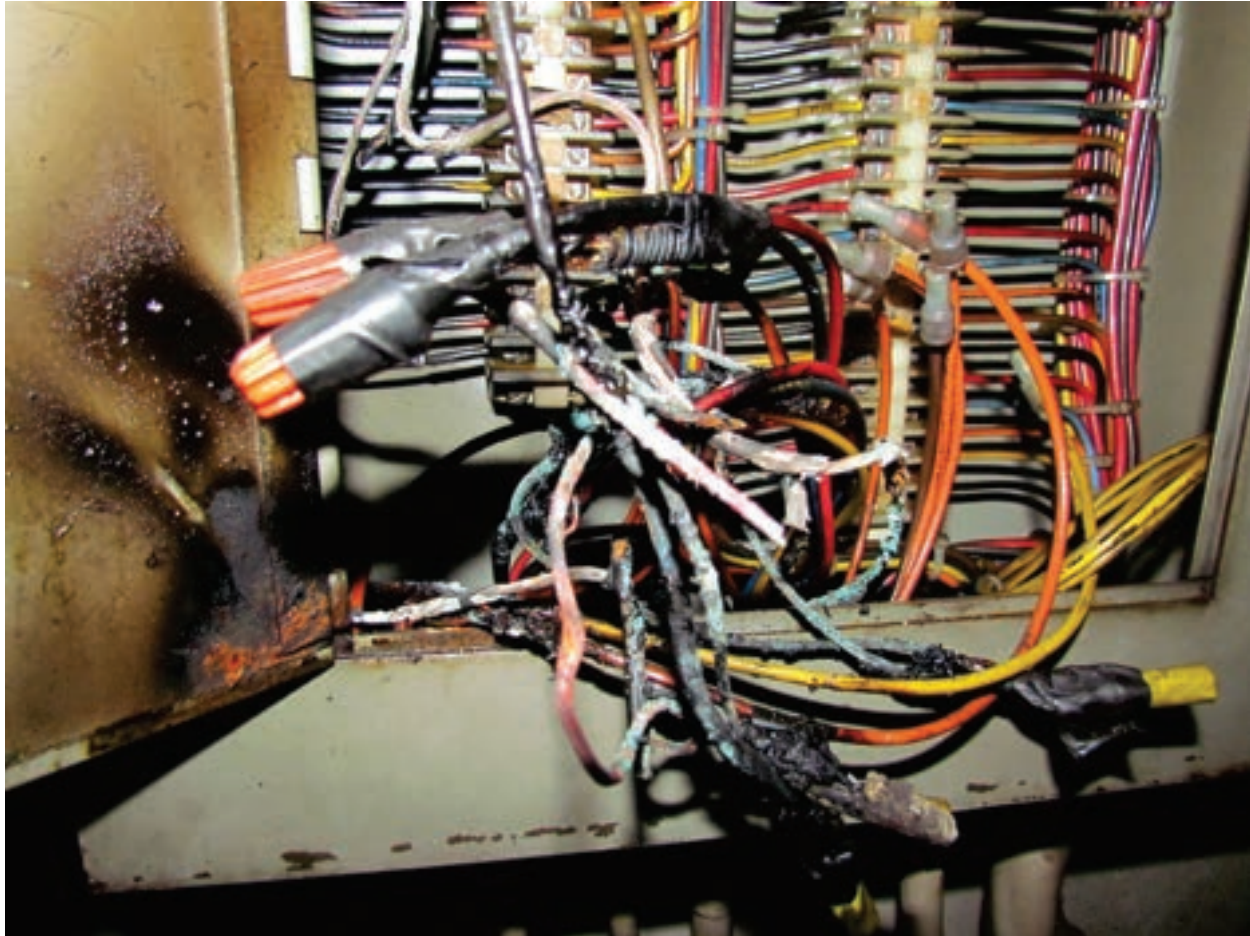
200. The three (3) conductors which demonstrated anomalous electrical activity were not connected to the bus bars. The six (6) wires inside the ERAJ Box appeared to terminate in five (5) splices. The

splices appeared to be connected in wire nuts and covered with common black polyvinylchloride (PVC) electrical tape.

202. It was evident by the presentation of the conductors, conductor insulation, PVC tape, and distribution panel box damage, the specified conductors were exposed to conductive heating, through the hull from the port aft wait station, were overheated and produced and overload on the specified conductors. The PVC tape melted which caused the conductors to contact the distribution panel box. The overcurrent resulted in sleeving of the conductor insulation and the exposed conductors demonstrated associated oxidation.

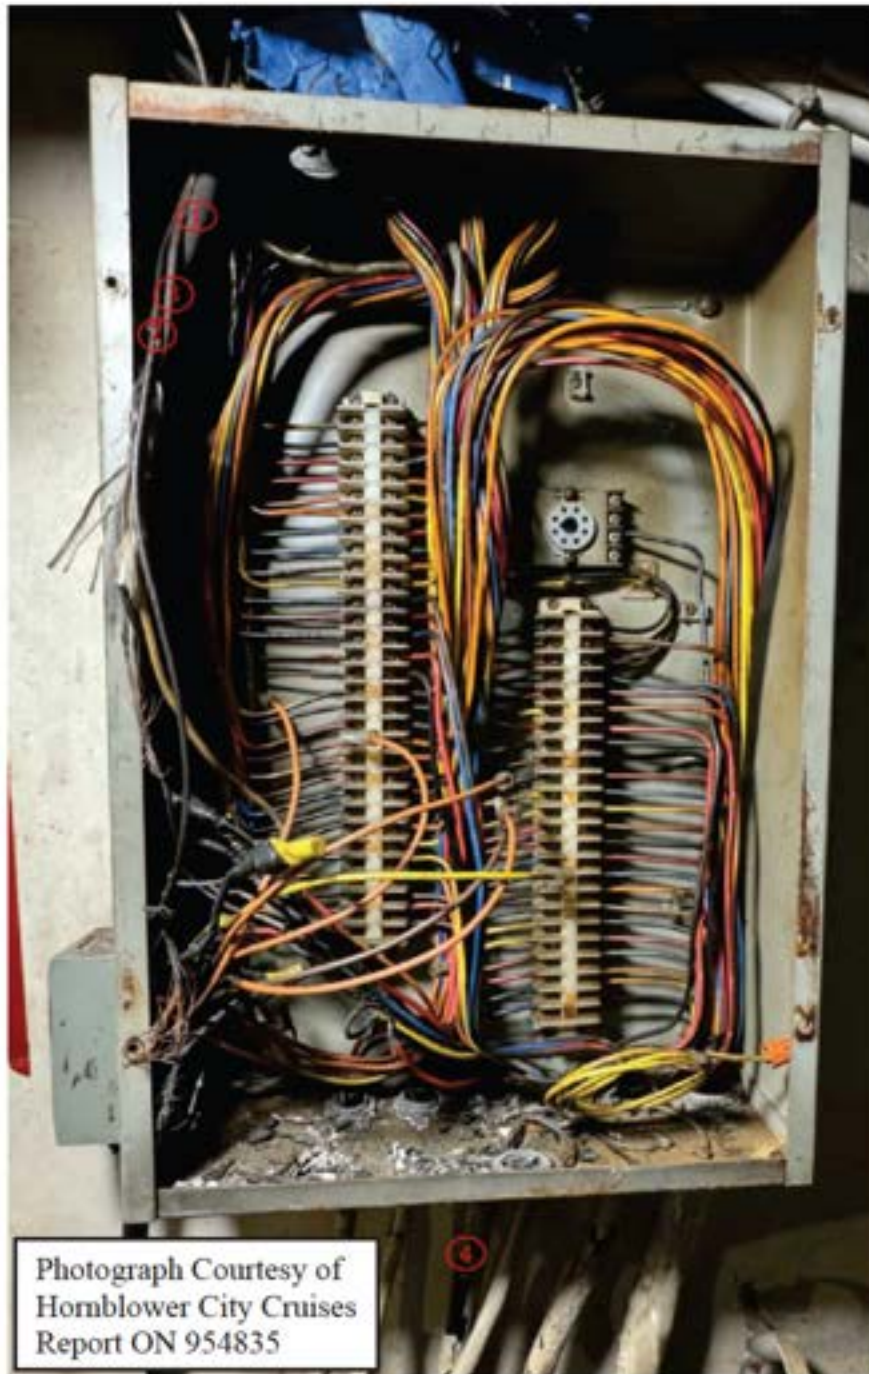
Photograph Courtesy of
Hornblower City Cruises
Report ON 954835

201. Hornblower City Cruises conducted an examination and analysis of the damaged conductors. In summary the conclusion by Hornblower City Cruises determined the wires labeled 1,2,4 and 5, by Hornblower City Cruises in the diagram below, supplied power to the windshield wiper system located in the pilot house from the port main engine starting batteries in the engine room. The connection to the battery did not have overcurrent circuit protection to protect the wires from short circuits. The wire was not routed through the vicinity of the fire origin area as it made its way to the pilot house. Hornblower City Cruises concluded that Wire 4, located in the main deck exterior superstructure bulkhead, was damaged when the fire spread which caused the short which burnt the wires in the engine room. Therefore, the burnt wires in the engine room were a result of the fire not the cause. Please refer to Hornblower Cruises and Events Spirit of Boston Report ON 954835 (Attachment 2).

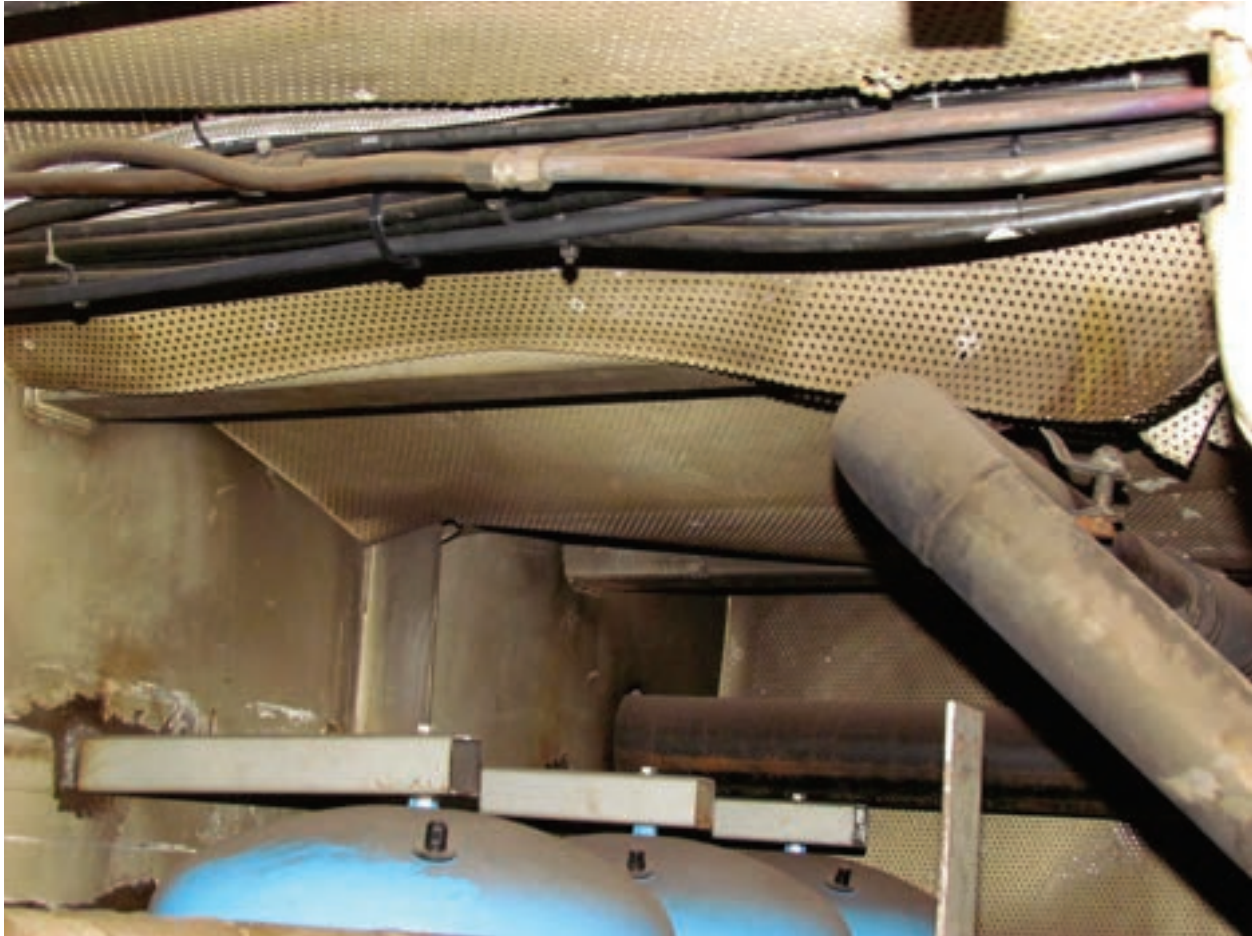
203. The port side engine room ceiling finish was perforated metal panels. The perforated metal panels on the port side demonstrated significant soot deposition and demonstrated deformation. Above the perforated metal ceiling panels the metal underside of the main deck exhibited significant oxidation. Above the perforated metal ceiling panels plastic material had melted and dripped to the engine room deck below before solidifying. It was evident from the configuration of the vessel the oxidation was below the area of the port aft side wait staff station. No fuel lines, electrical conductors, or heating appliances were in the area below the port aft side wait staff station. The damage was attributed to conductive heat transfer through the metal deck.

204. There was no evidence of penetration through the deck. The engine room was eliminated as an origin for a fire.

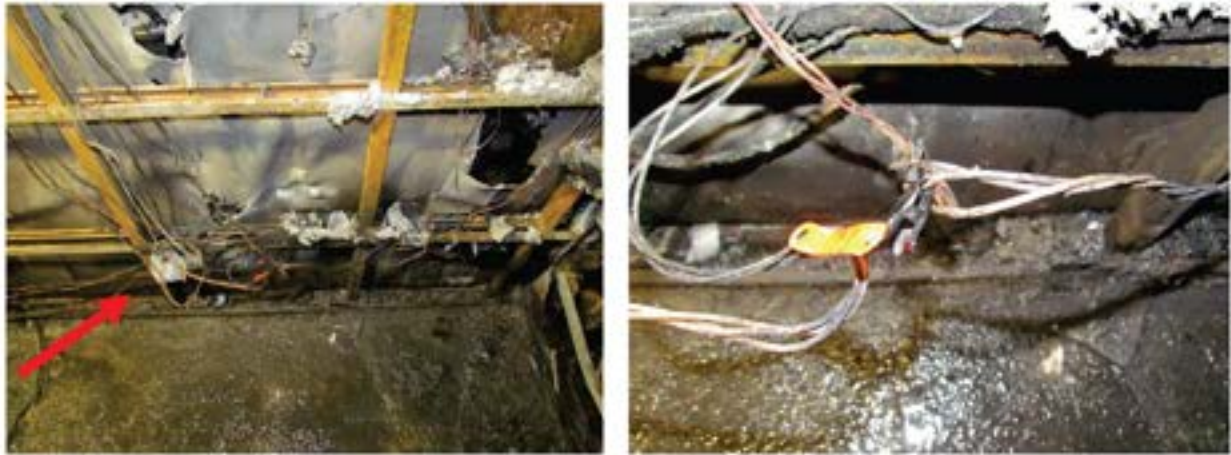
216. An examination of the interstitial space of the port side aft wait staff station wall revealed electrical conductors and three (3) receptacles. Two (2) of the receptacles, a duplex and triplex, faced the galley stores aft, and a duplex faced port aft side wait staff station. The electrical conductors, related connections, work boxes, receptacles, and attachment locations were examined. Arc melting was observed on a branch circuit stranded conductor that ran along the interior of the aft partition wall which separated the galley food preparation area. The presence of the arc melting on

the branch circuit conductor is consistent with the circuit being energized at the time the artifact was created. No other anomalous electrical activity was present.

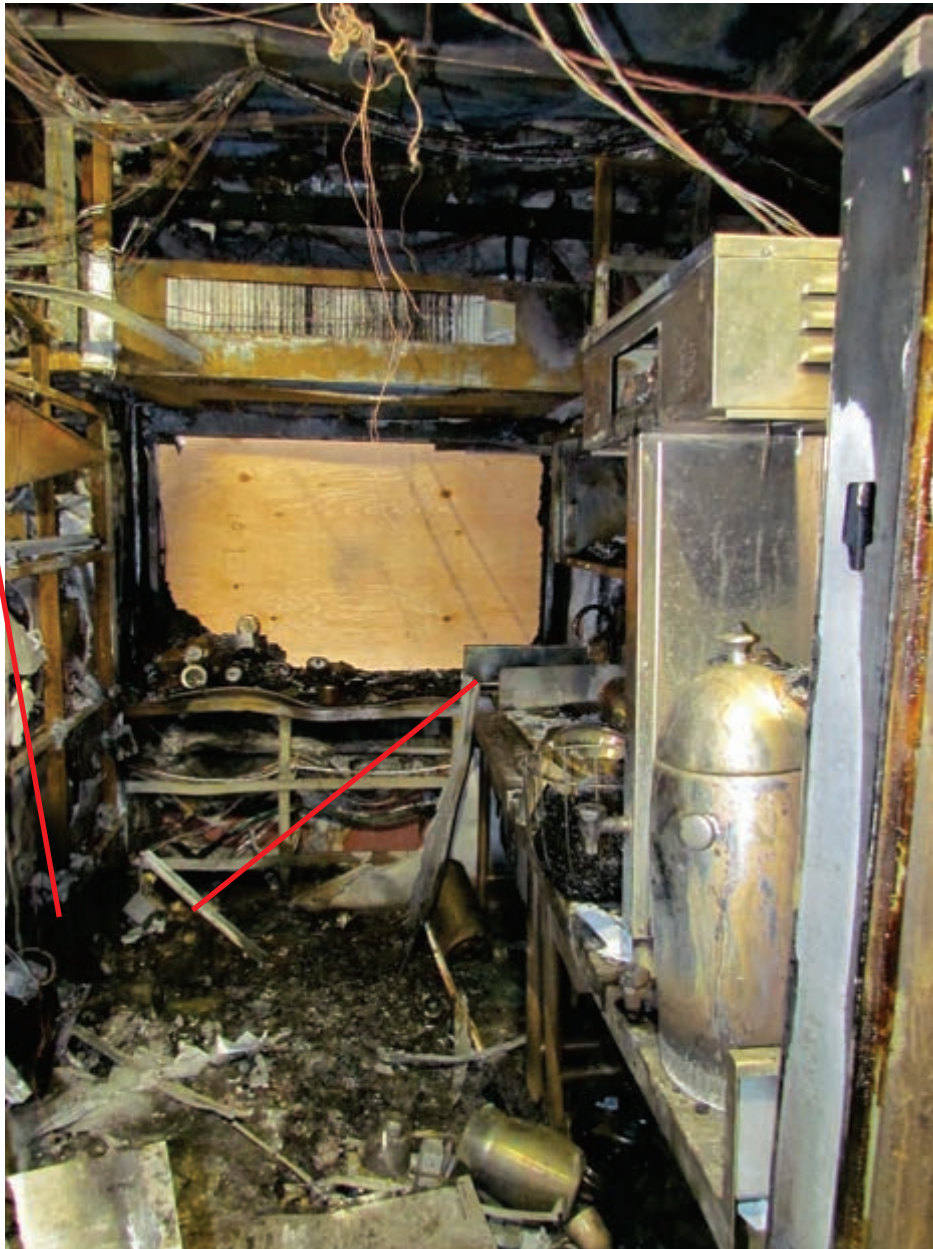
217. The port side interior wall contained one (1) window, which was ventilated by the fire. The remaining interior and exterior windowpane glass demonstrated significant soot deposition. A metal storage shelf was below the window. The metal shelf was significantly deformed. An examination of the metal storage shelf revealed a corrugated cardboard box which contained chafing fuel containers, windowpane glass, and fire debris. The chafing fuel containers were consistent with Sterno brand, stem wick, six (6) hour chafing fuel containers. An examination of the Sterno brand chafing fuel containers and corrugated cardboard storage box revealed the upper portion of the corrugated cardboard storage box was consumed. The Sterno brand chafing fuel containers did not demonstrate any evidence of failure. It was evident the corrugated cardboard storage box of Sterno brand chafing fuel containers was exposed from the fire event.

218. Below the shelf was an interstitial space the sidewall was constructed of metal columns and slats with metal paneling as the wall covering. The columns and slats were significantly deformed. The sidewall was insulated with fiberglass batts. The metal panel wall covering demonstrated a fire "V" pattern due to consumption of the metal panel wall covering. The fire "V" pattern originated at the deck and extended upward and outward from the aft forward.

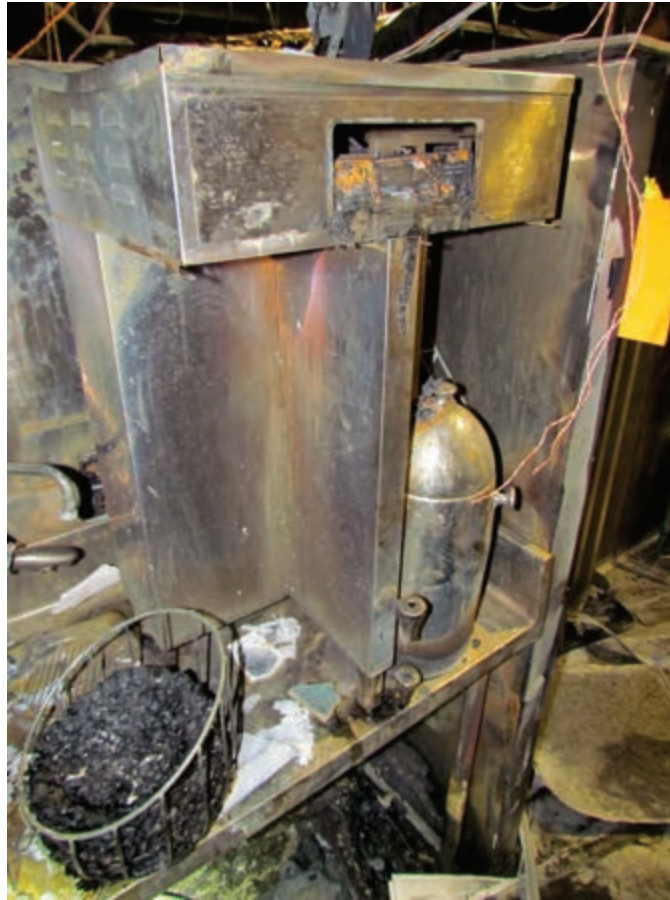
221. Along the forward partition wall of the port aft side wait staff station were three (3) sinks, a counter, coffee station, a metal paper towel dispenser, and an upper cabinet. A metal wire coffee filter holder, coffee urn(s), warmer, pitchers, and fire debris were on the countertop. The metal

paper towel dispenser was affixed to the wall above the port sink. It demonstrated significant oxidation from exposure to the fire event. The exposed paper towels at the bottom of the dispenser were partially consumed. The paper towels inside the metal dispenser were unaffected. The coffee station was examined and did not demonstrate any failure and was exposed to the fire event.

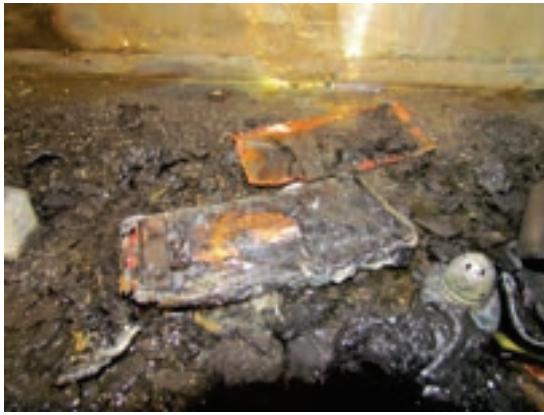
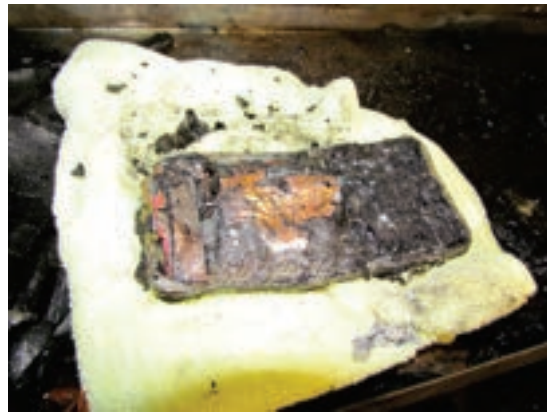
223. A cellular telephone was on an upper shelf. The cellular telephone was in the location as described by H [REDACTED]. The cellular telephone was not connected to a portable charging source, and was not connected to a vessel electrical receptacle, as described by H [REDACTED]. No thermally thin materials were located on the upper shelf. The cellular telephone demonstrated significant thermal damage. The cellular telephone demonstrated minimal mechanical damage to the thermally damaged components.

224. The battery housing demonstrated expected thermal damage from exposure from a fire. The battery did not demonstrate damage expected from an internal failure which may have resulted in the ejection of flaming electrolyte. The battery did not present visually apparent mass loss that would accompany ejection of flaming materials.

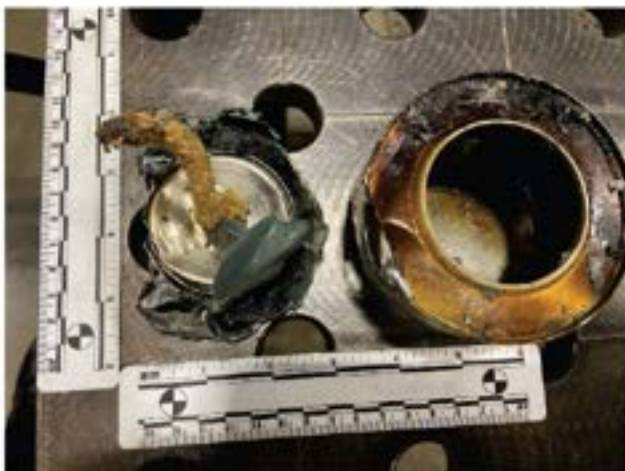
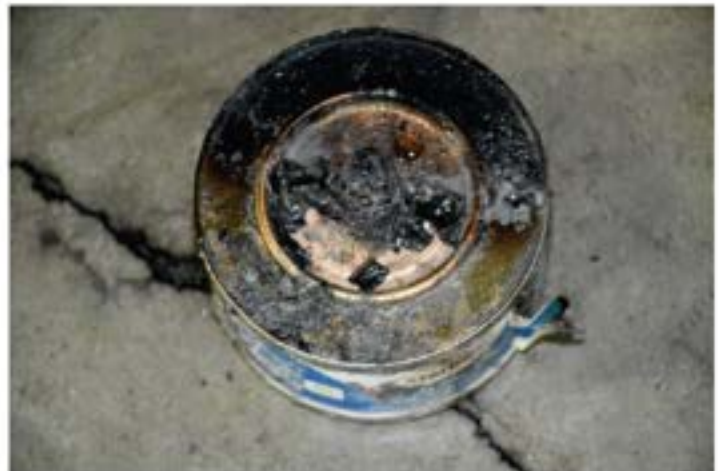
240. The Sterno brand chafing fuel container was mechanically removed from the solidified plastic debris for examination (left photograph). The Sterno brand chafing fuel container demonstrated a distinct pattern to one (1) half of the container. One (1) half of the container was significantly more discolored than the other half. Right hand photo is exemplar Sterno brand chafing fuel container, placed on its side, after FRL test fire.

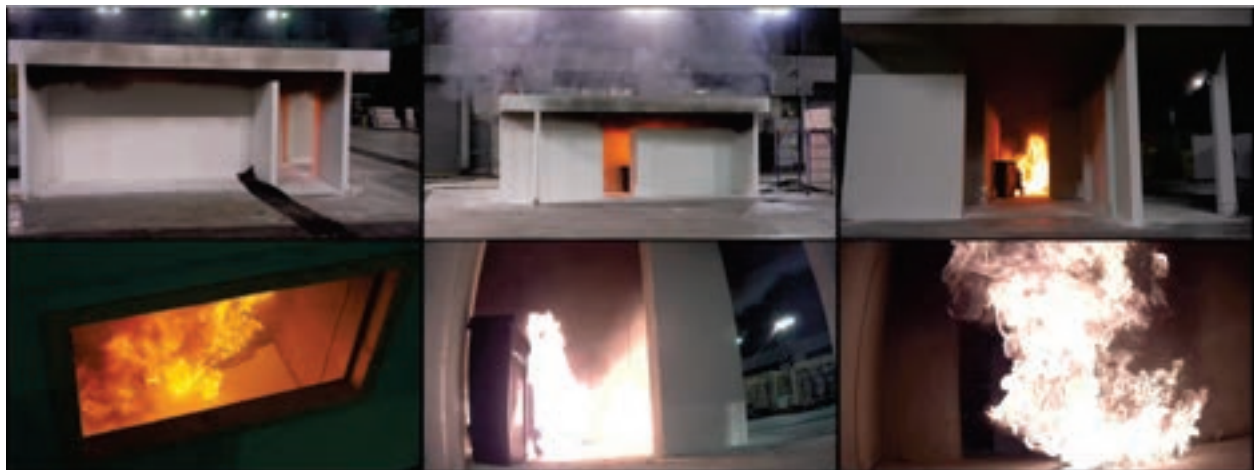
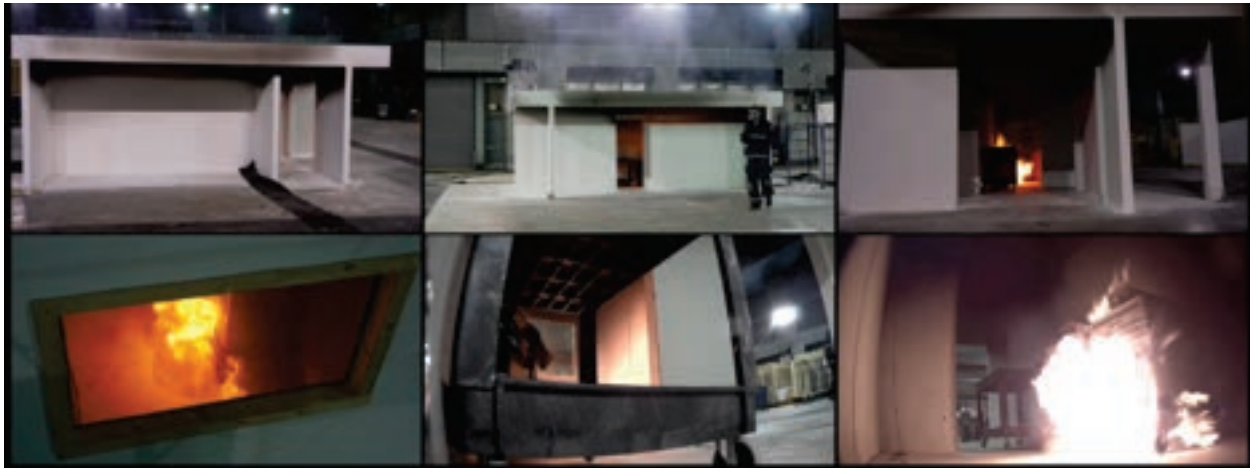
249. Screen captures of “Master” video of full scale FRL fire testing. It should be noted shortly after dripping plastic was observed, sounds could be heard that were described by observers as “crackling” and “hissing”. Subsequent to crackling and hissing, the fire continued to grow in size until light smoke was observed coming out of the test structure. Video of one series of testing was conducted with audio recording which captured the as described noise(s).
