National Transportation Safety Board
Washington, D.C. 20594

Group Chairman's Factual Report of the Investigation

Operations and Integrity Management Report

Natural Gas Pipeline Release

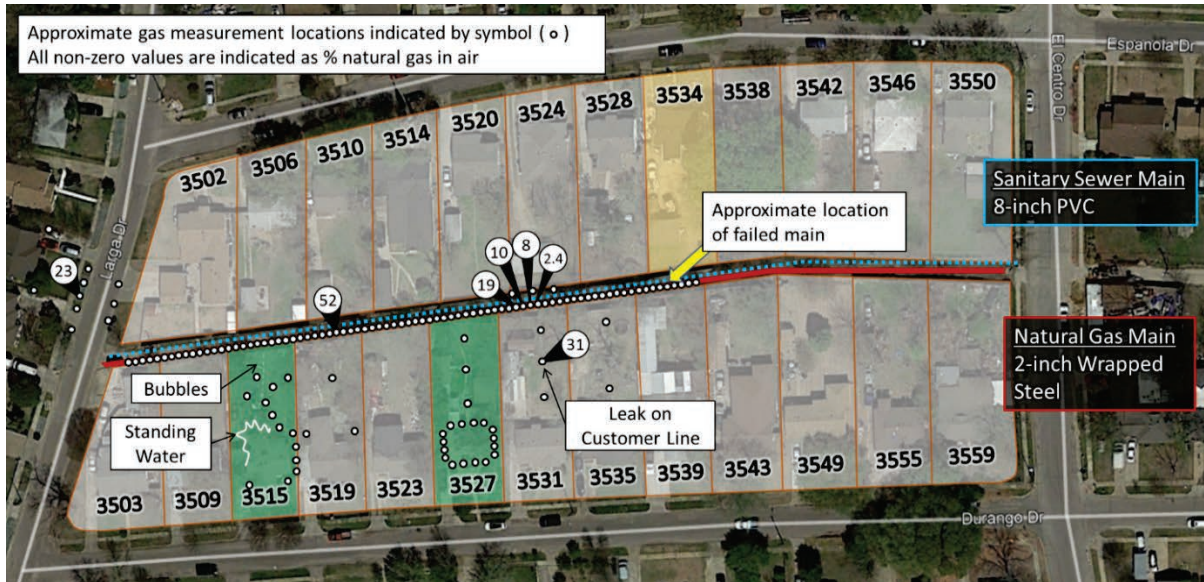
Figure 19. Bar hole testing results around the 3500 block of Durango Drive and Espanola Drive on Thursday, February 22, 2018.

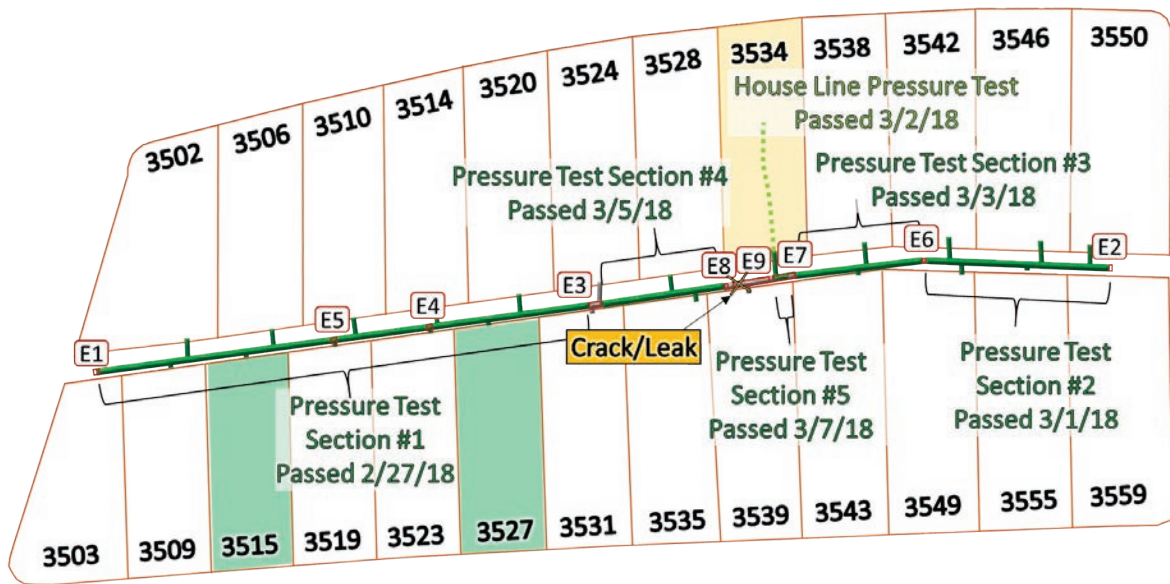
Figure 23. Overview of Main Integrity Tests Performed Following the Accident. Approximate excavation locations are indicated by a red rectangle with identification above the symbol (e.g., “E1” is Excavation #1).⁶²

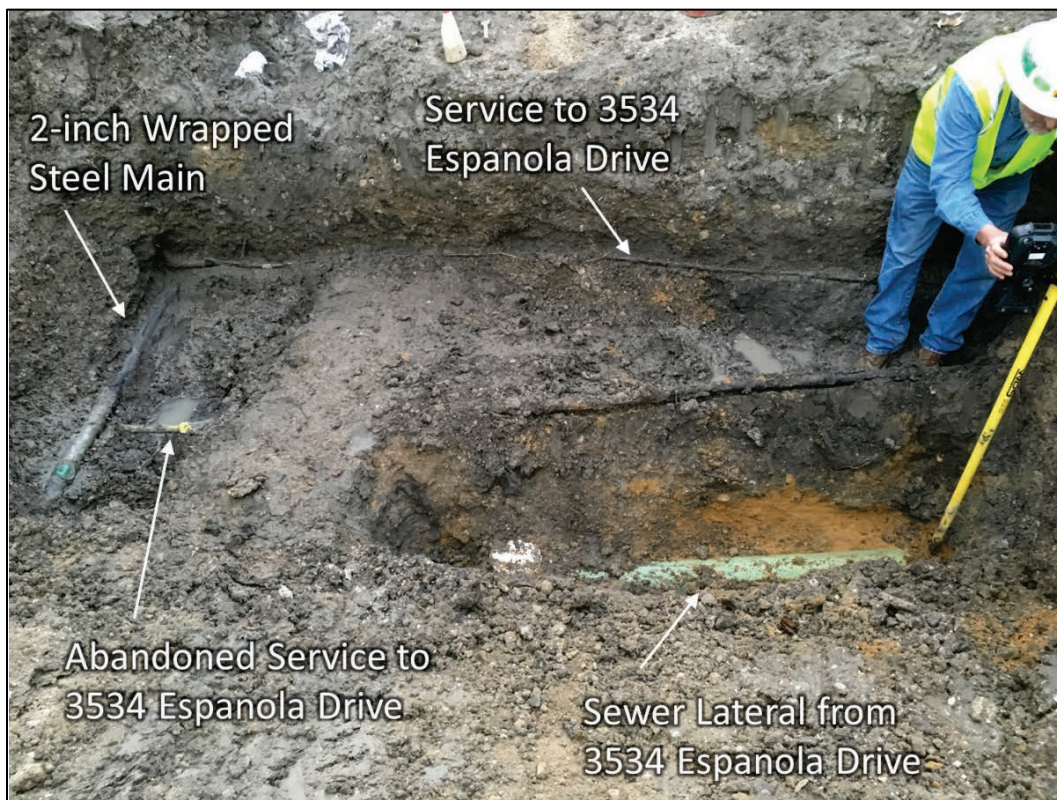
Figure 26. Sewer Lateral from 3534 Espanola Drive at Excavation #7 facing west (Photograph by PHMSA, 3/1/18)

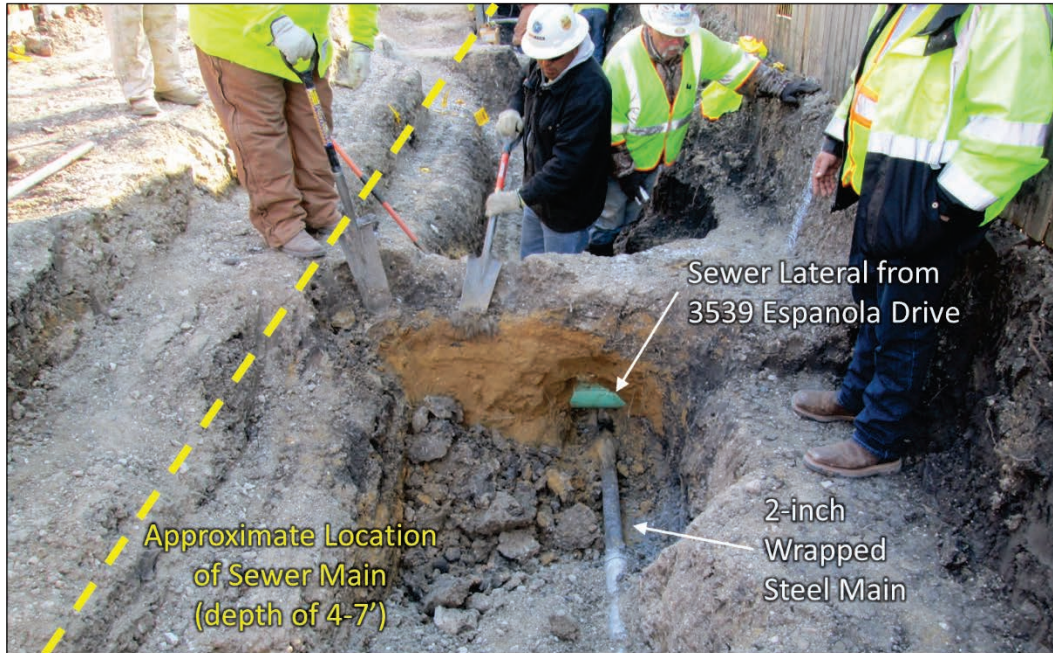
Figure 27. Sewer Lateral from 3539 Espanola Drive at Excavation #8 Facing East (Photograph by TX-RRC, 3/6/18)

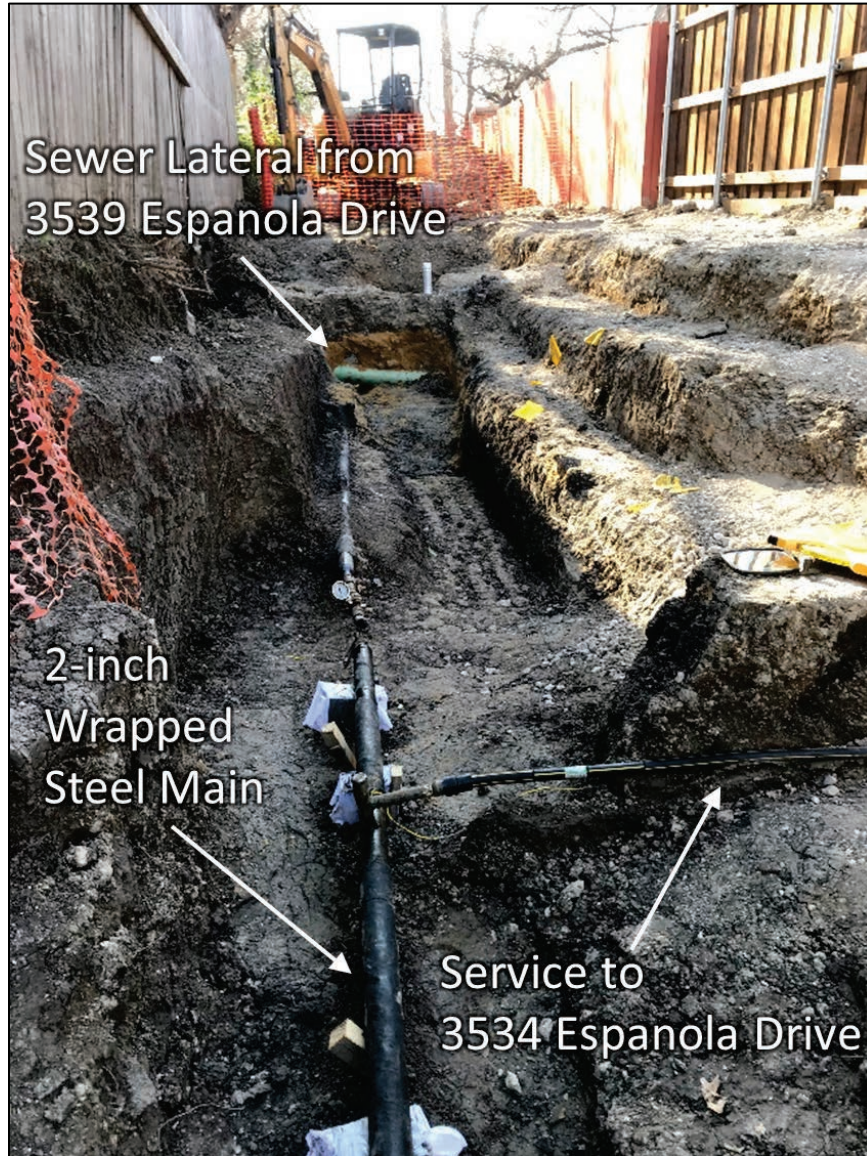
Figure 28. View from Excavation #7 Facing West Towards 3539 Espanola Drive Sewer Lateral (Photograph by Atmos Energy, 3/6/18)

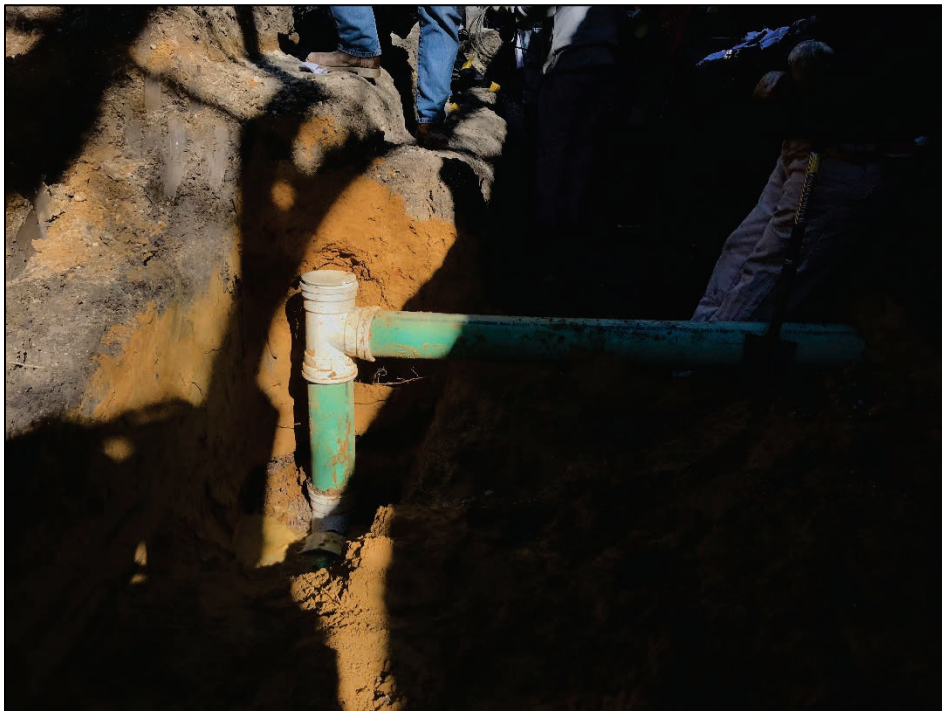
Figure 31. Sewer lateral from 3539 Durango Drive Connection to Sanitary Sewer Main, Facing East (Photograph by Atmos Energy, 3/7/18)

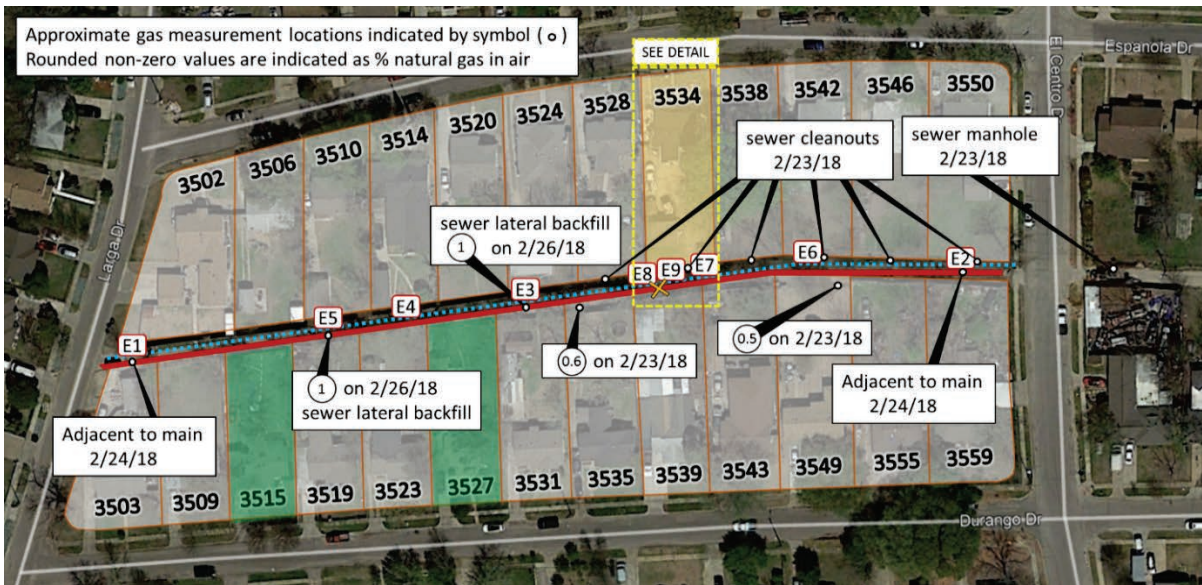
Several gas measurements were taken following the accident using a SENSIT[®] GOLD CGI. Figure 33 and Figure 34 depict a compilation of the results of the gas measurements that were taken following the accident. The numbers within the white circles identify the gas concentration readings in percent natural gas in air as indicated in Atmos Energy records⁶⁴ or measured during the NTSB investigation. Locations where the gas measurement indicated that no natural gas was present are shown, but there is no accompanying measurement value. The graphic also identifies (by an orange “X”) the location of the crack that was discovered in the 2-inch main.

Figure 32. Post-Accident Gas Measurements (Detail Near 3534 Espanola Drive Provided in Subsequent Figure)⁶⁵

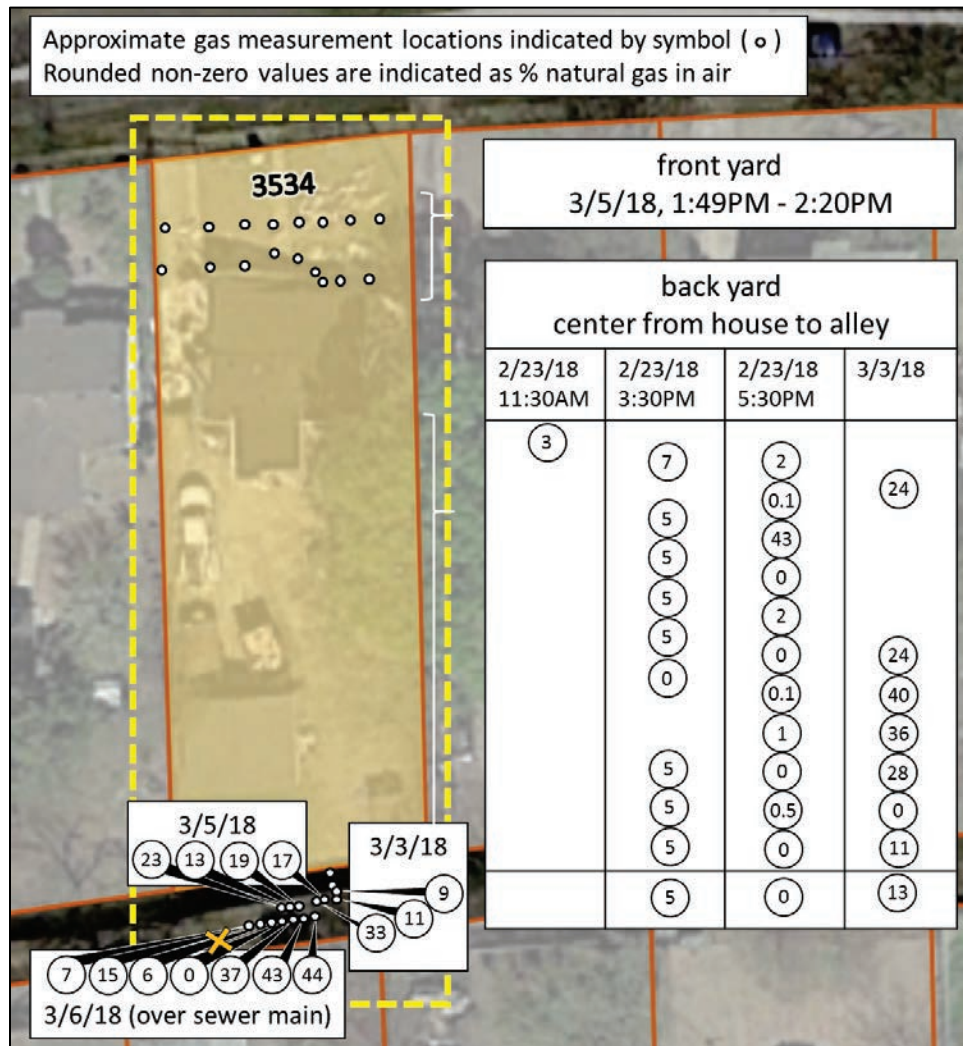
Figure 33. Post-Accident Measurements (Detail Near 3534 Espanola Drive).⁶⁶ Measurement locations in the back yard are not shown; they were taken between the house and alley near the centerline of the property.

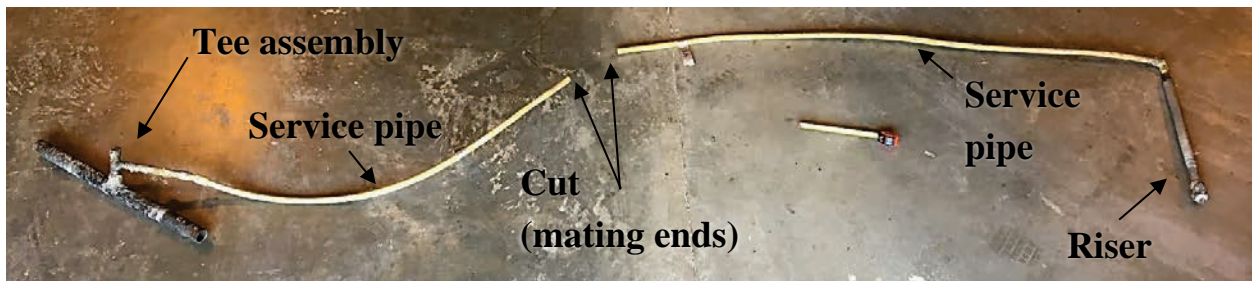
Figure 37 -- As received riser and service pipe for dwelling 3524 Espanola Drive that connects to the tee assembly and main
