POWERPLANT GROUP CHAIRMAN'S FACTUAL REPORT

ENG22LA002

IAE Metallurgical Report Titled "Metallurgical Investigation of (certain parts) from PW1100G Engine 771708", dated December 16, 2021

Subject: Metallurgical Investigation of (certain parts) from PW1100G Engine 771708

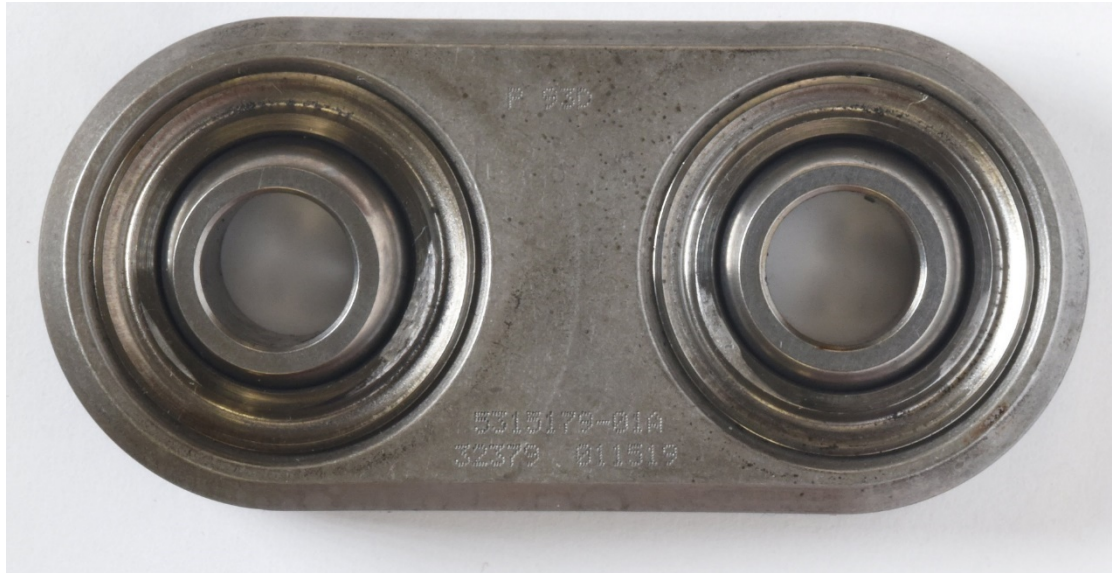
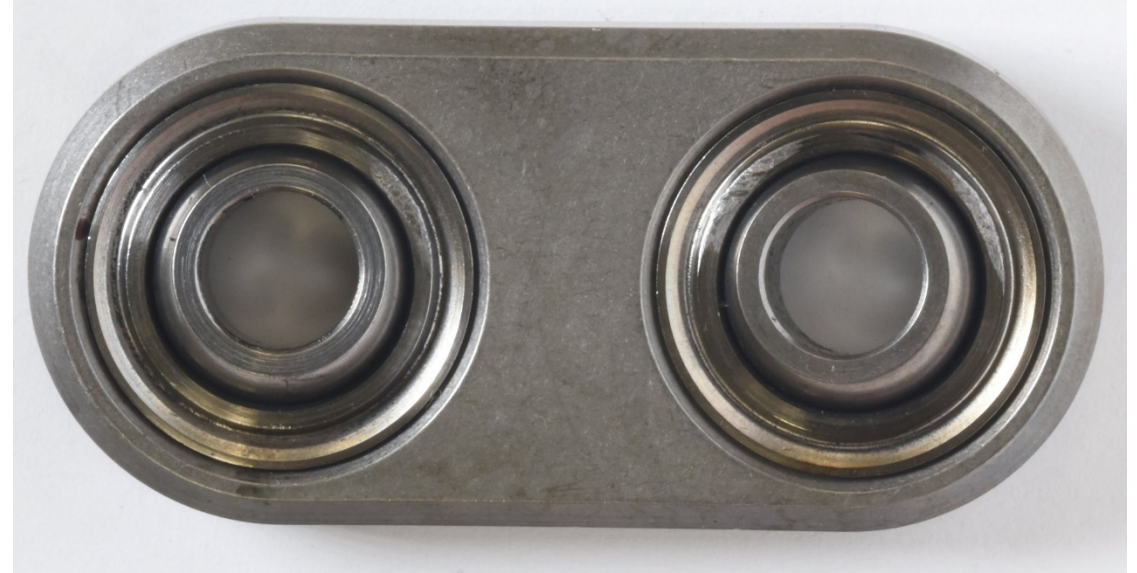
FIGURE 4: PN 5315179-01A TMS UPPER AFT LINK

Schematics of engine externals showing the relative location of the CP09 tube and TMS mounting hardware are shown in **Figure 1** and **Figure 2** for reference. Hardware submitted for investigation included one cracked PN 5318103-01 CP09 tube (**Figure 3**), one PN 5315179-01A TMS upper aft link (**Figure 4**), one PN 5318008-01E TMS Upper Aft Case Mount and three mounting bolts (**Figure 5**), one PN 5318316-01 TMS Lower Aft Case Mount with one intact mounting bolt and two fractured mounting bolts (PN ST1503-12) (**Figure 6**), and one PN 5327400-01 TMS Forward Case Mount (**Figure 7**). Visual and binocular microscope review of the TMS upper aft link, the TMS upper aft case mount, and the TMS forward case mount did not reveal any cracks or distress.

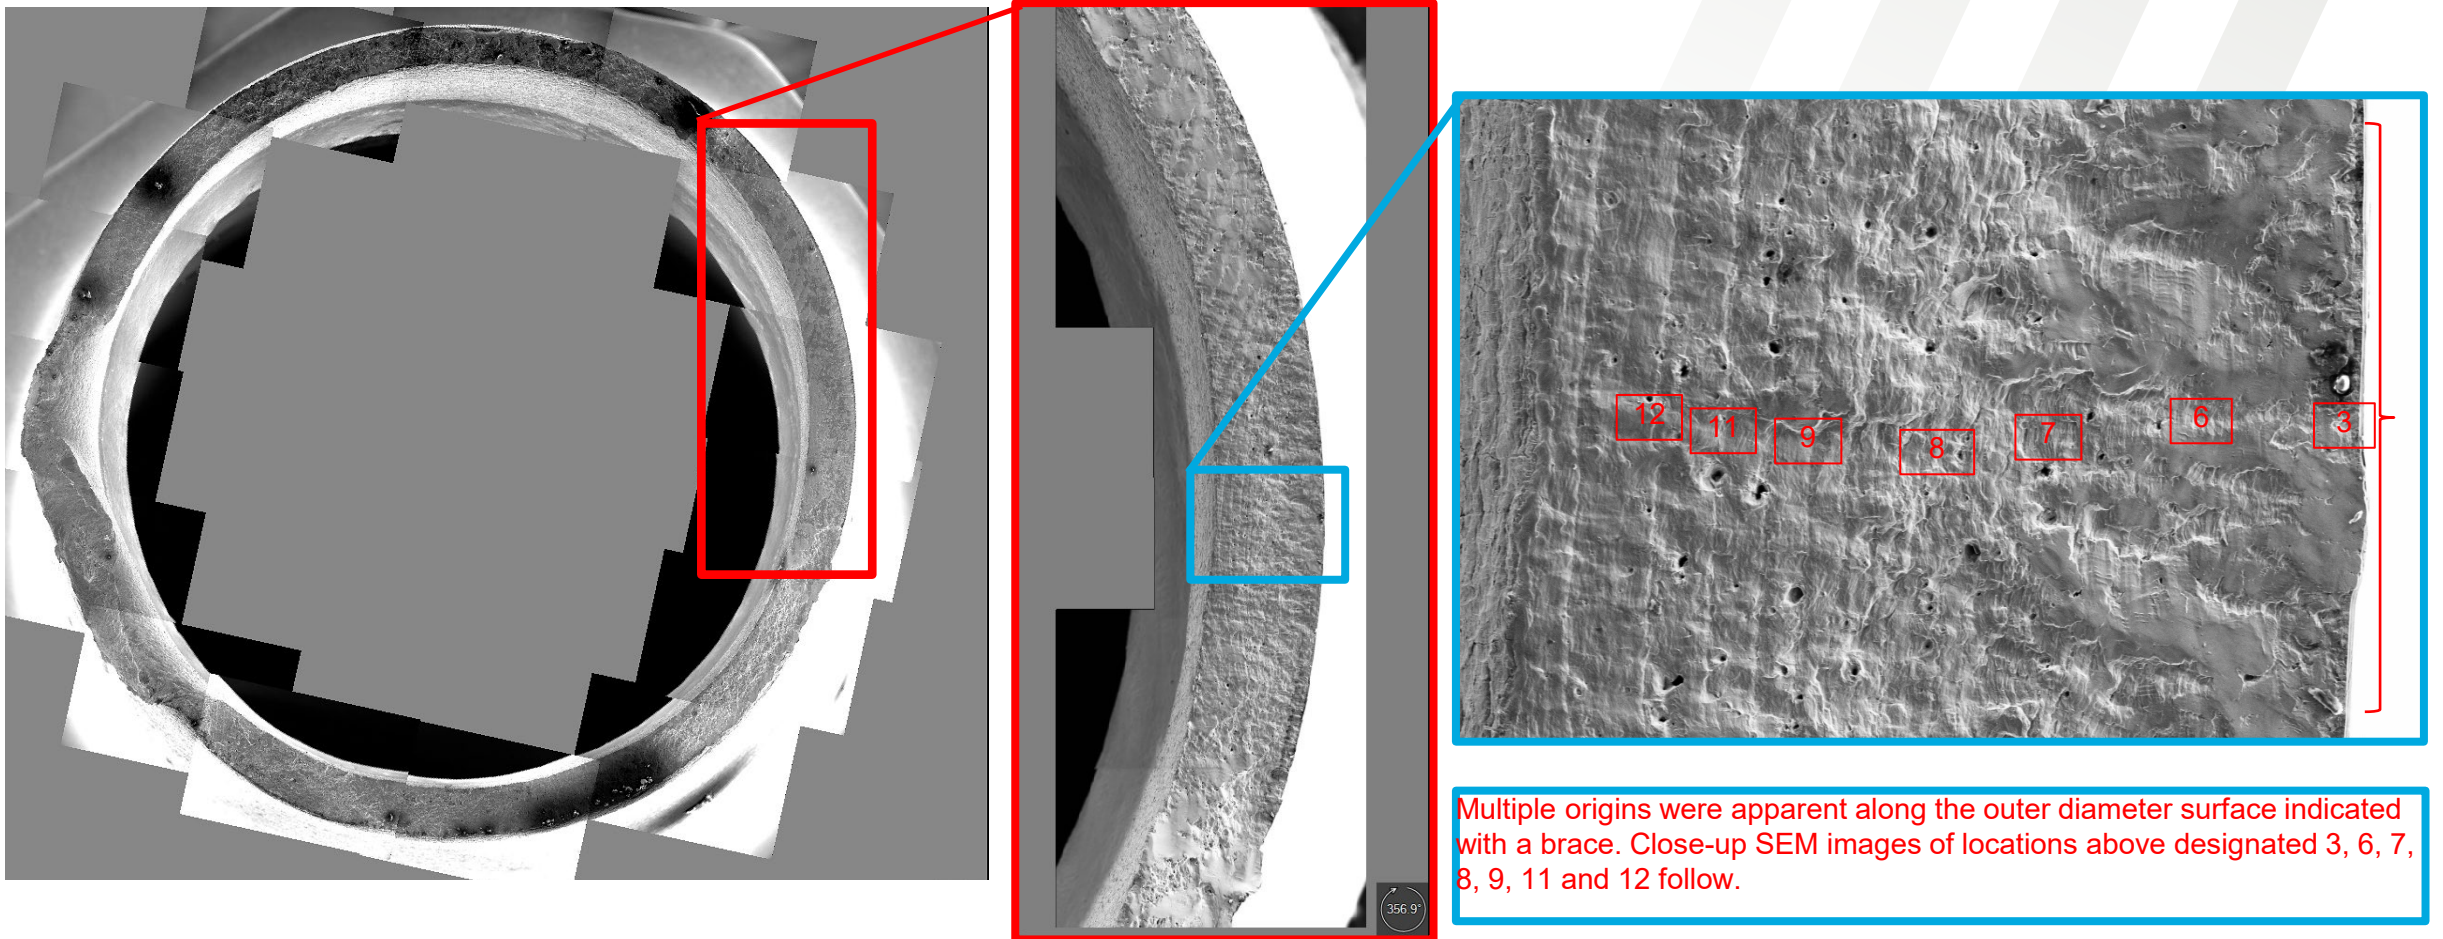
FIGURE 9: SEM EXAMINATION OF CP09 CRACK SURFACE

The sample was then reviewed using a scanning electron microscope (SEM). The entire crack surface was mapped at 65 times magnification, and the resulting montage was stitched using Thermofisher's MAPS software². The sample was then removed from the SEM for additional cleaning. The crack surface was lightly brushed with a new toothbrush and soapy water, followed by five minutes of ultrasonic cleaning in Blue Gold solution followed by another five minutes of ultrasonic cleaning in isopropyl alcohol. The sample was then further reviewed using a SEM, which revealed that this second round of cleaning was largely successful. Increasingly higher magnification montages were captured and stitched of the fatigue region as well and the origin region. The fatigue region appeared to be transgranular and was striated through thickness. Multiple origins were present along the outer diameter surface of the tube, and some regions were rubbed out. Clamshell shaped arrest lines were clearly evident across the latter half of the fatigue progression, and the apex of these arrests used to trace back the likely location of the primary origin as shown in **Figure 9**. A series of SEM images along the path from this origin to the apex of the arrest line that was closest to the inner diameter (ID) surface is presented in **Figures 10 – 14**. While striated progression was evident in most fields of view, the extent of secondary rubbing damage to the crack surface made it difficult to find regions with enough well-formed striations to confidently calculate striation spacing. The best location found is shown in **Figure 12**. This location, approximately 5/8 through thickness, exhibited an average striation spacing that suggested a local growth rate of 1.68E-5 inch per cycle. Tube composition was verified at two locations along this path using energy dispersive spectroscopy (EDS), and a representative spectrum of this analysis is shown in **Figure 13**. The analysis revealed a composition that was similar to the composition specified for tube, AMS 5557 (321 SS).

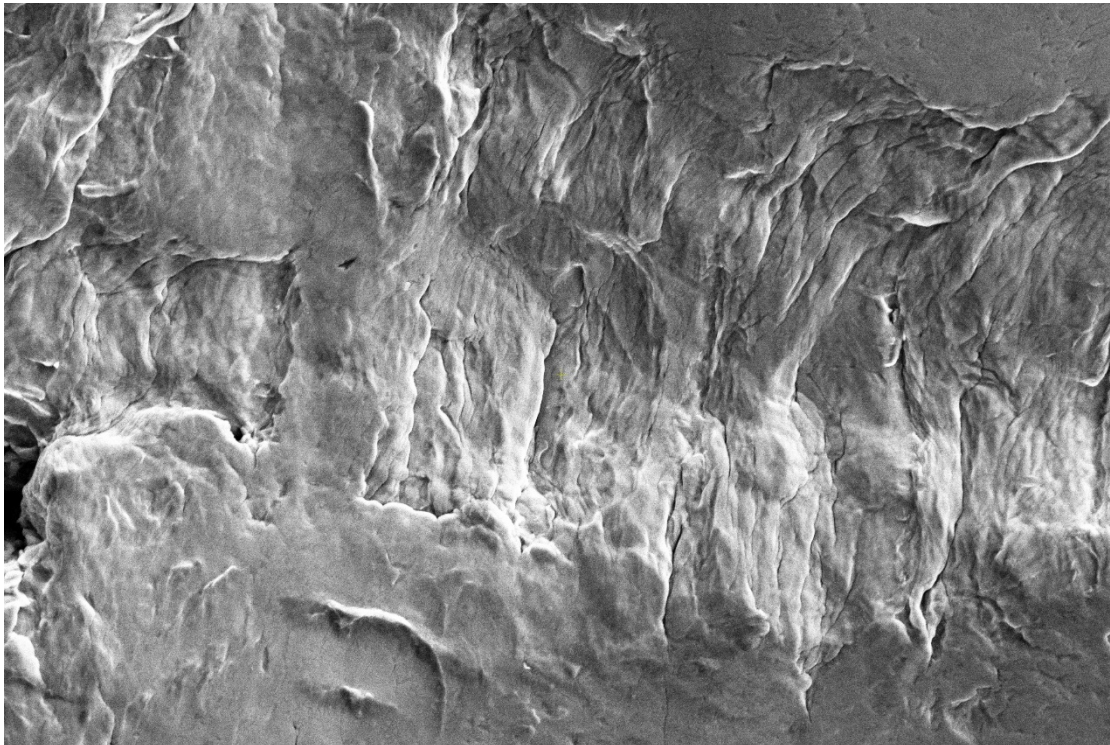
Location 6

FIGURE 10: SEM EXAMINATION OF CP09 CRACK SURFACE LOCATIONS 3 AND 6

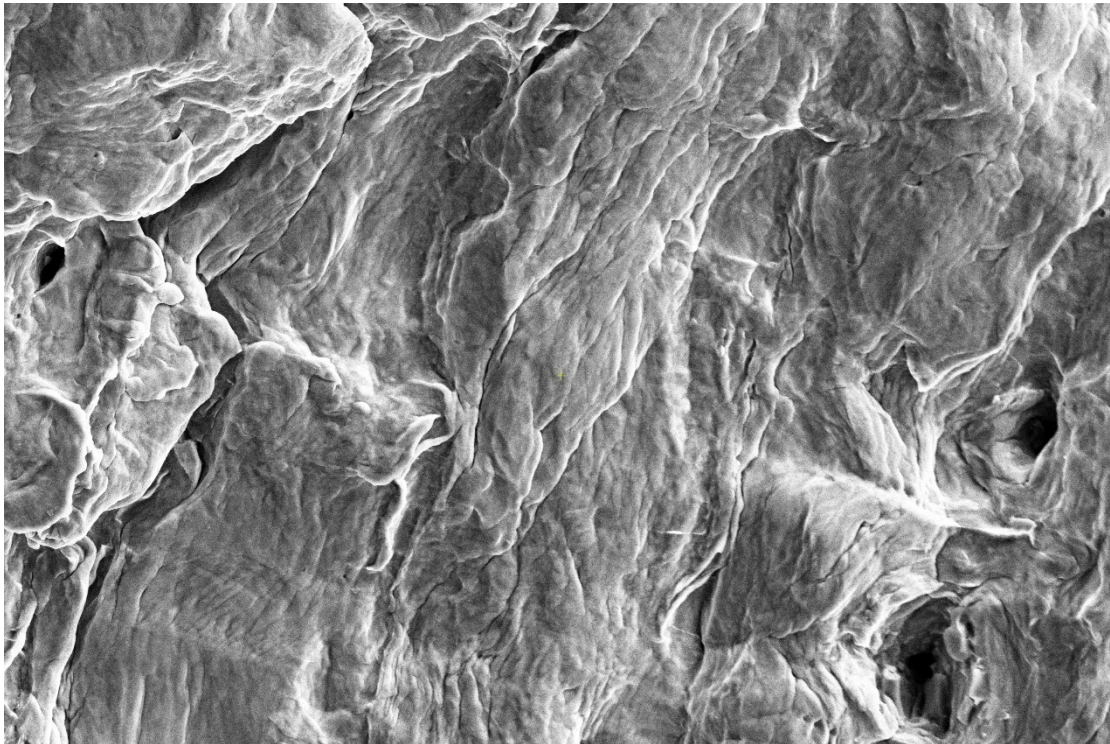
Location 8

FIGURE 11: SEM EXAMINATION OF CP09 CRACK SURFACE LOCATIONS 7 AND 8

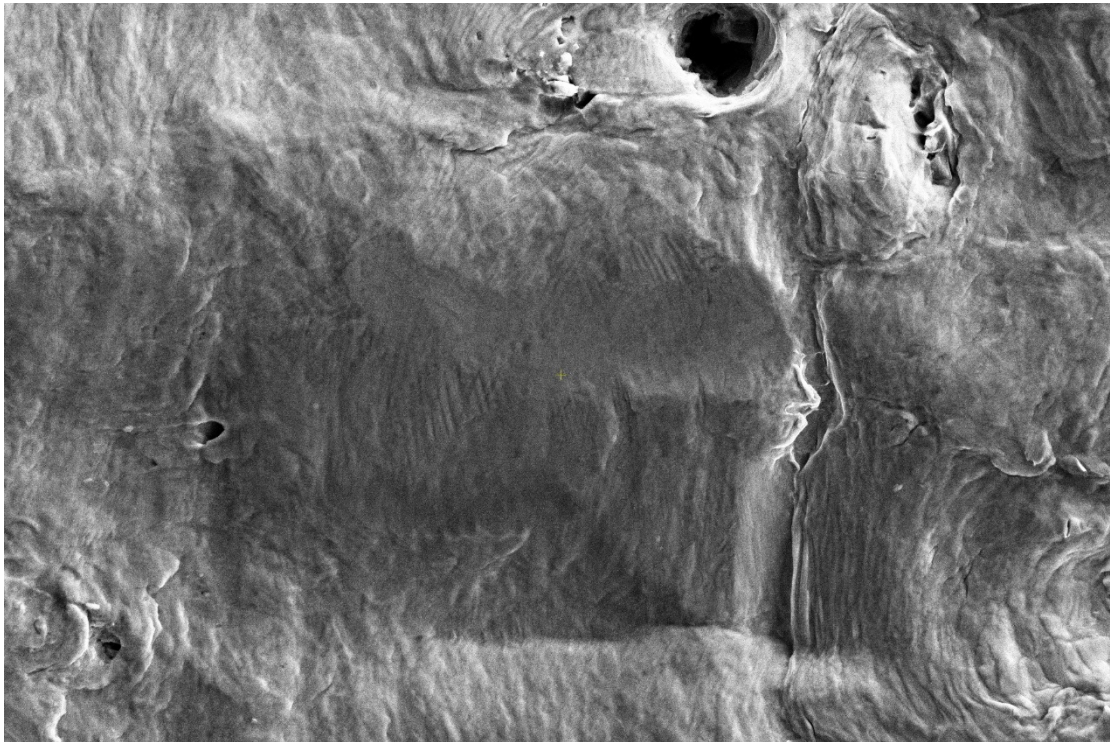
Location 12

FIGURE 14: SEM EXAMINATION OF CP09 CRACK SURFACE LOCATIONS 11 AND 12

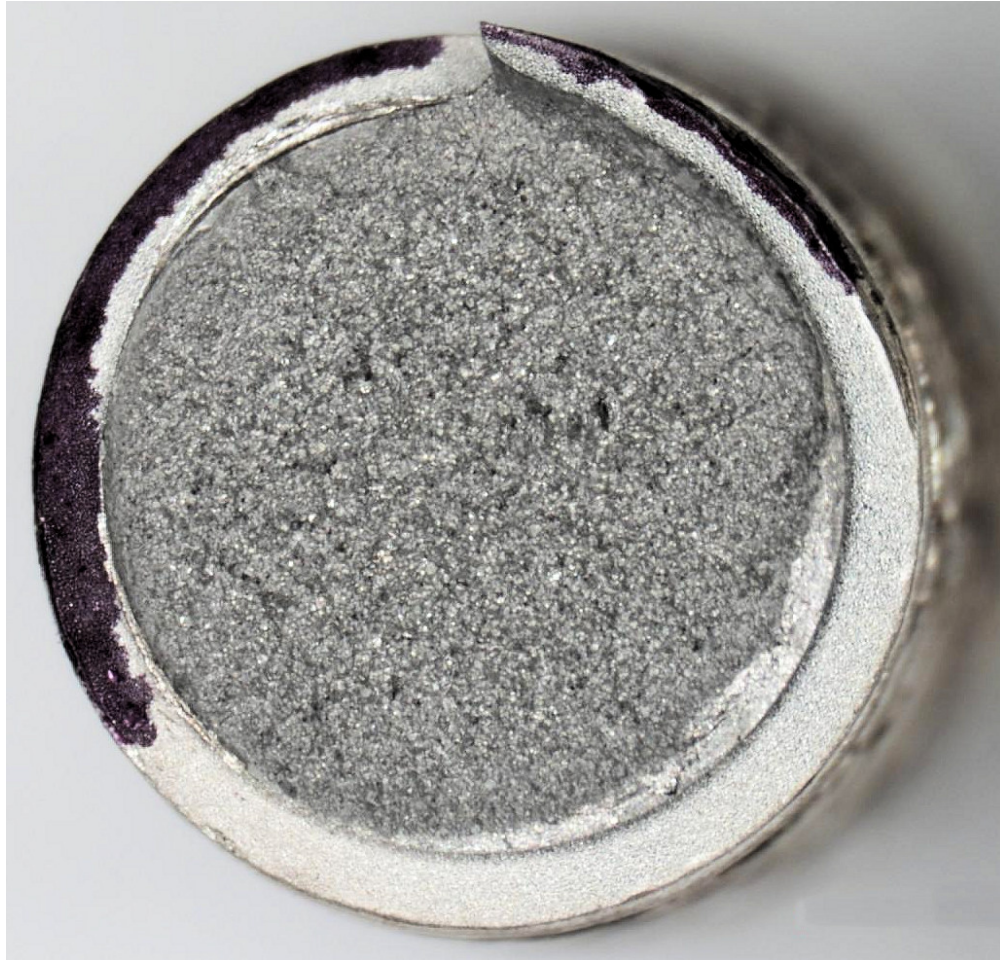
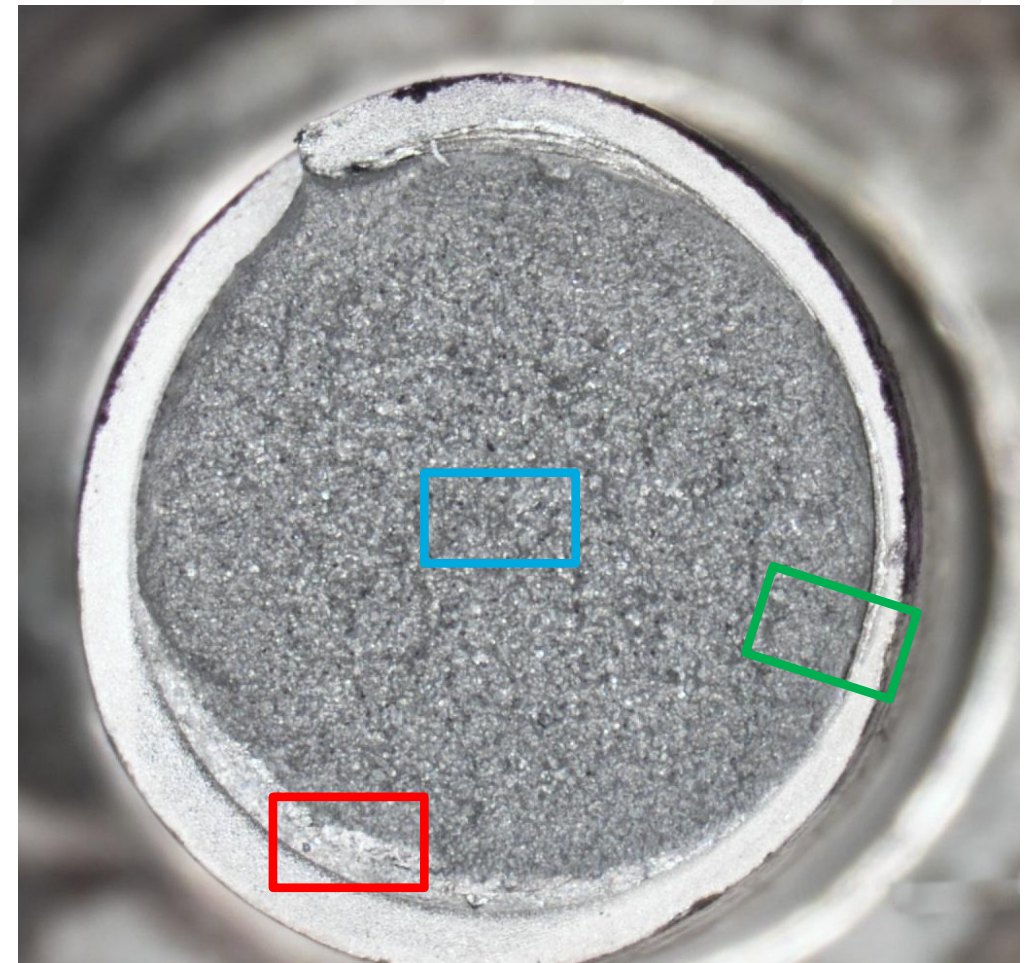
FIGURE 21: PN 5318316-01 TMS LOWER AFT CASE MOUNT; CLOSE-UP VIEWS OF OPENED CRACK SURFACE

Close up views of the indicated region follow.

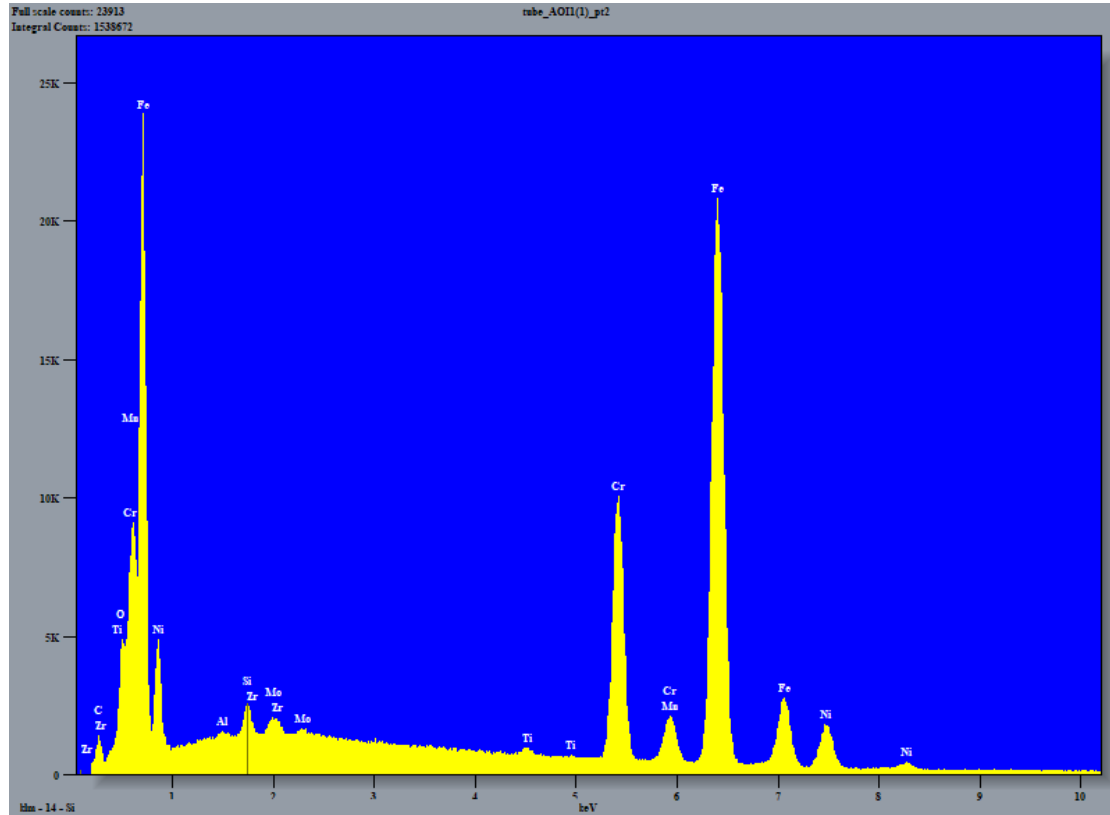
SEM EDS analysis of the tube revealed a chemistry similar to AMS 5557 (321 SS). EDS of the bolt revealed a chemistry similar to AMS 5508 (Waspaloy) (**Figure 30**).

EDS Spectrum from Tube revealed a similar composition to AMS 5557.

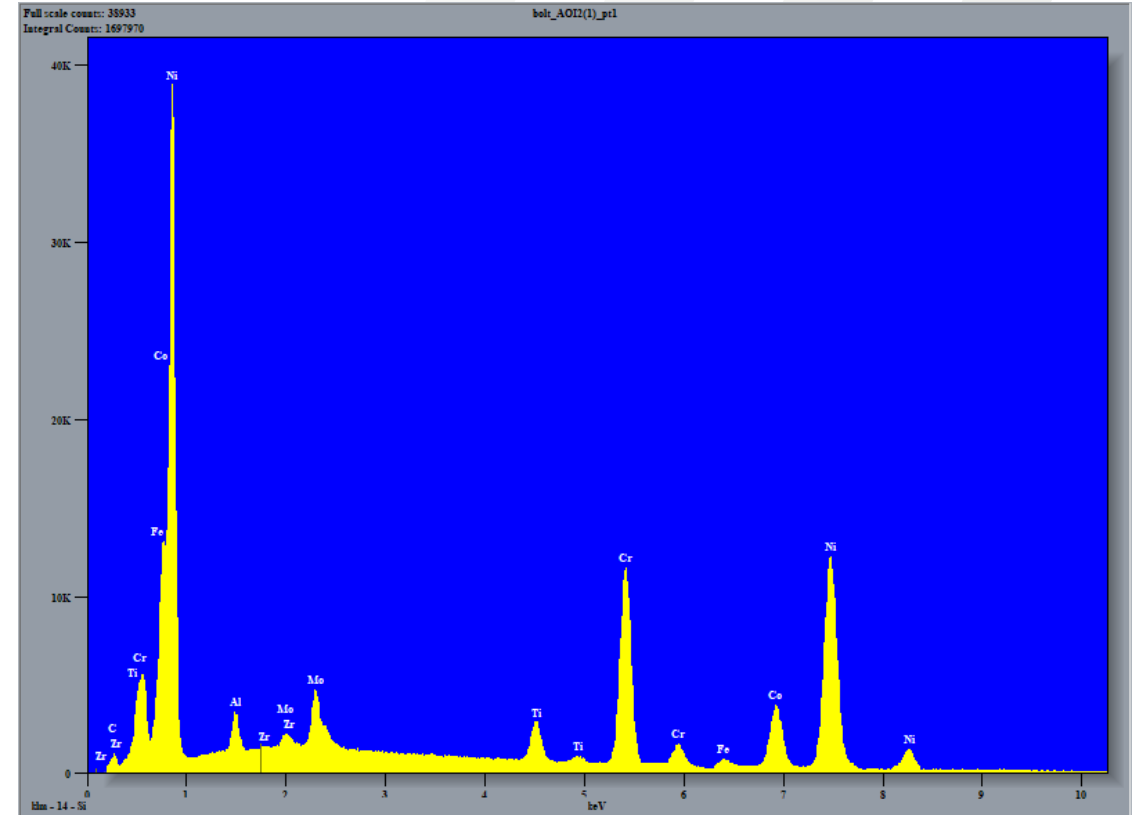
EDS Spectrum from a bolt revealed a similar composition to AMS 5508.
