Subject: Boeing Component Examination Report - Red Air MD-82 HI1064 Landing  
Gear Collapse and Runway Excursion Miami, Florida - 21 June, 2022

## FRACTURE ANALYSIS REPORT

Engineering Report No: MS 80040

A/P Customer:	RedAir	A/P Model:	MD-82
Registry No:	HI1064	Line Position No:	1805
Flight Hours:	68,229	Number of Landings:	35,873

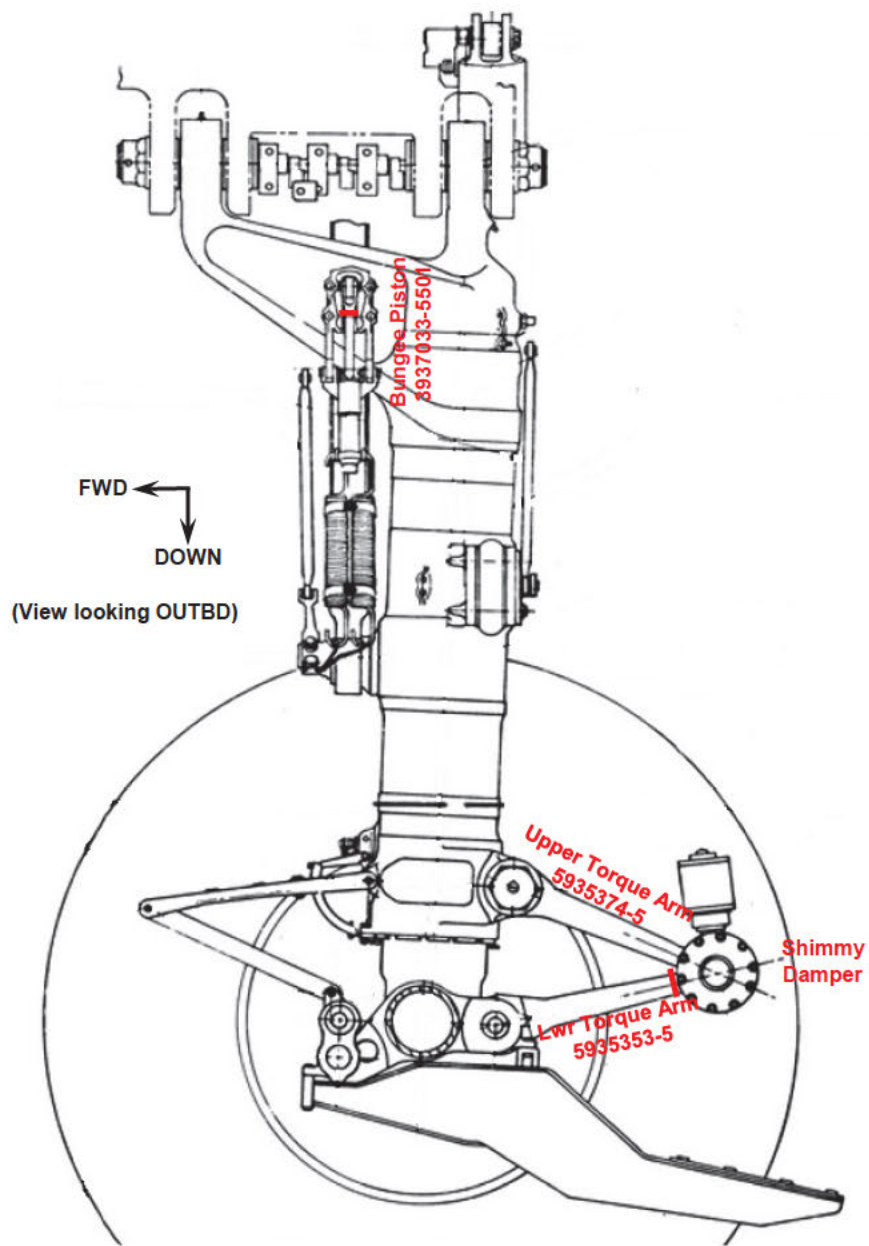
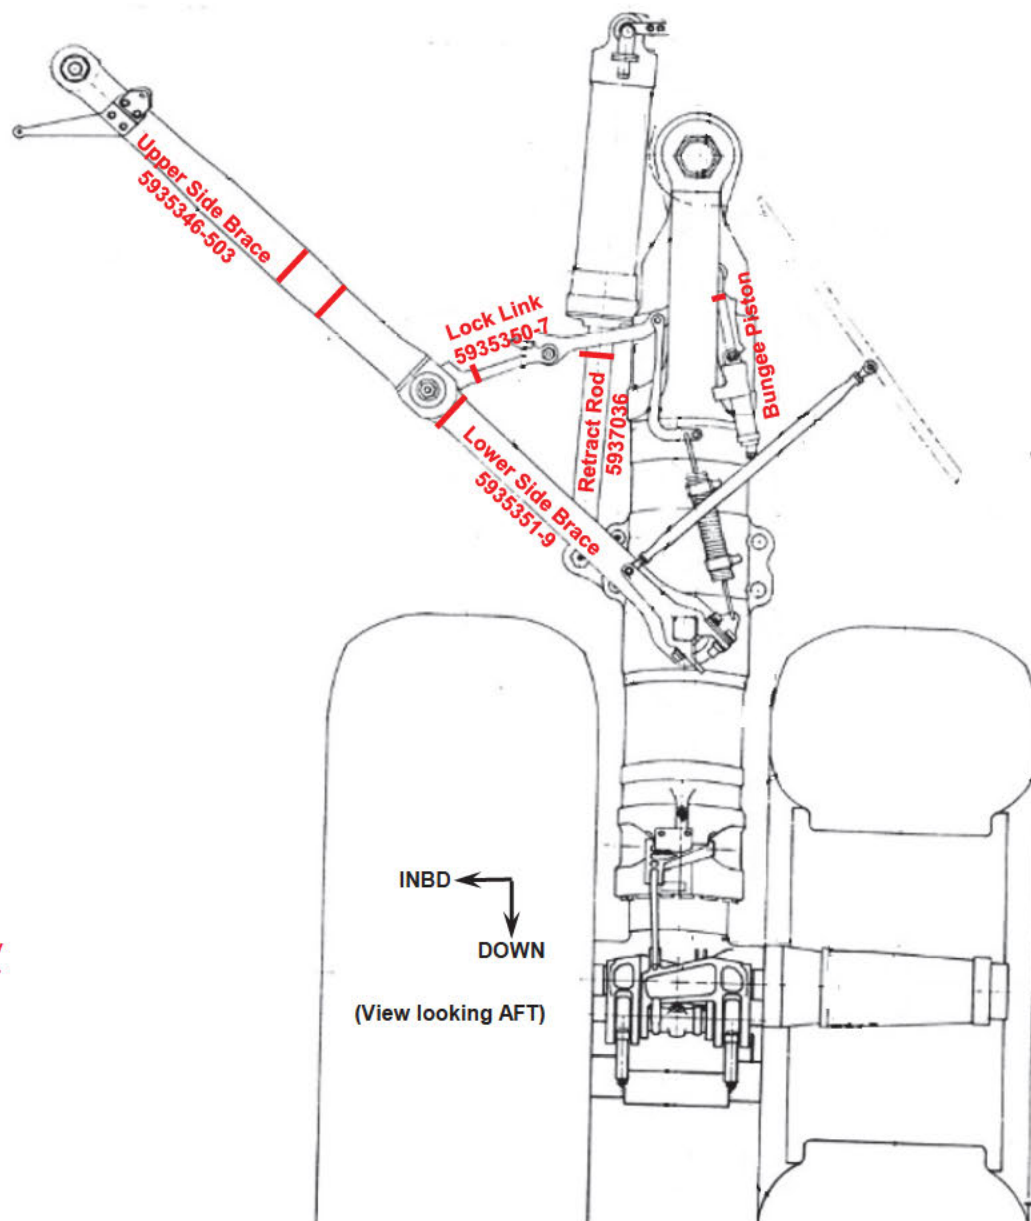
Figures 1 and 2. Illustrations showing typical MLG assembly. (Red lines indicate fracture locations.)

The left MLG shock strut assembly was subsequently sent to Boeing BR&T Laboratories in Huntington Beach, CA for evaluation in coordination with the NTSB and FAA (Figures 1 to 4).

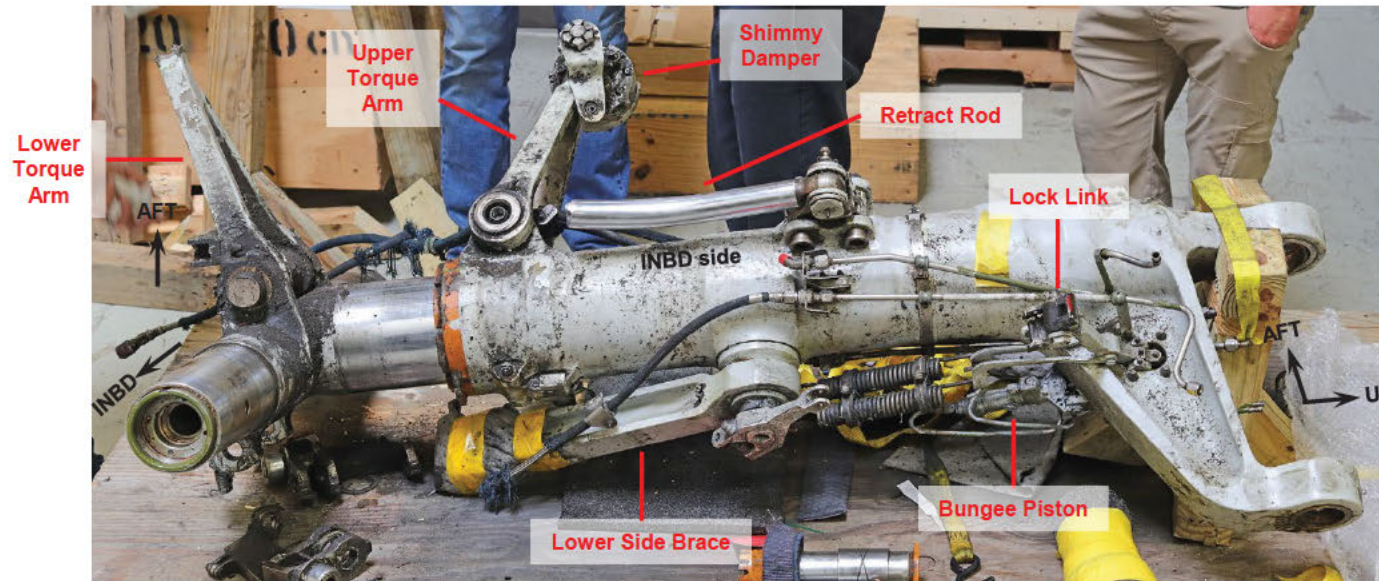
Figure 3. Overall of MLG assembly in as-received condition [axle rotated 45° clockwise relative to cylinder]

The lower torque arm was still attached to the axle, and the upper torque arm was still attached to the cylinder in the as-received condition (Figure 3). The lower torque arm exhibited two complete, transverse fractures which intersected the upper lug hole, approximately 1.6 inches from the end of the part (Figures 5 to 7). Both of the fracture halves closest to the upper end were relatively smooth and smeared in an inboard/outboard direction (Figure 6). The fracture surfaces occurred along an oval/elliptical path, indicating that the fracture may have occurred due to a combination of compression and bending/shearing. The mating fracture halves were heavily damaged due to post-fracture smearing (Figure 7). The fractured lug end appeared to be bent slightly in an inboard direction.

The lower side brace link was still attached to the shock strut cylinder in the as-received condition (Figure 3). The upper side brace link had been separated from the assembly. Once reassembled, witness marks on the cylinder and links indicated that the side brace assembly had become hyper-extended and crossed over the cylinder (transitioned from inboard to outboard side of cylinder) during the incident (Figures 28 to 31).

The retract cylinder rod was still attached to the cylinder in the as-received condition (Figure 3). The rod exhibited a complete, circumferential fracture approximately 16 inches from the attached end (Figure 64). The rod was bent in an outboard direction. The fracture surface occurred along oblique planes and the fracture end portion, along the concave side, was locally buckled, typical of ductile separation due to bending (Figure 65).

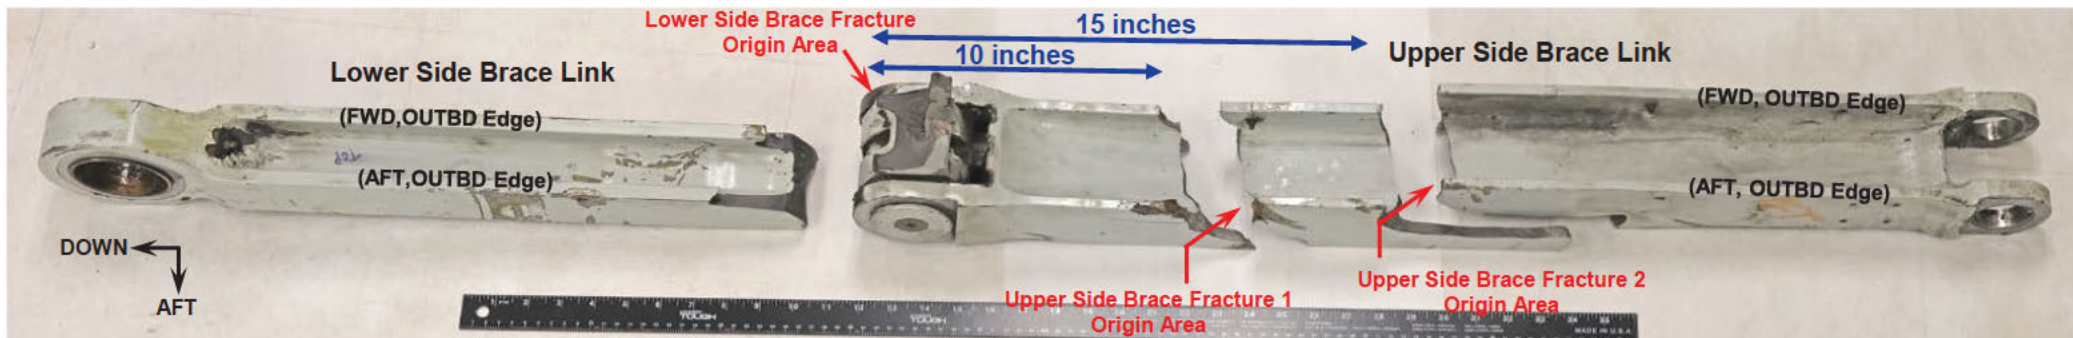
Figure 32. Overall of Side Brace Links in extended position

The upper side brace link exhibited two complete, transverse fractures which were located approximately 10 inches and 15 inches from the lower end (Figures 32 and 33). Both fractures initiated from areas of mechanical damage along the aft, outboard flange. The fractures were arbitrarily identified as #1 and #2 in the lab for discussion purposes. The origin area of fracture #1 was heavily smeared (Figure 34). The flange was heavily damaged and deformed inward in this area. The origin area of fracture #2 exhibited an elliptical shape, and the fracture surface exhibited a dull texture, typical of ductile separation (Figure

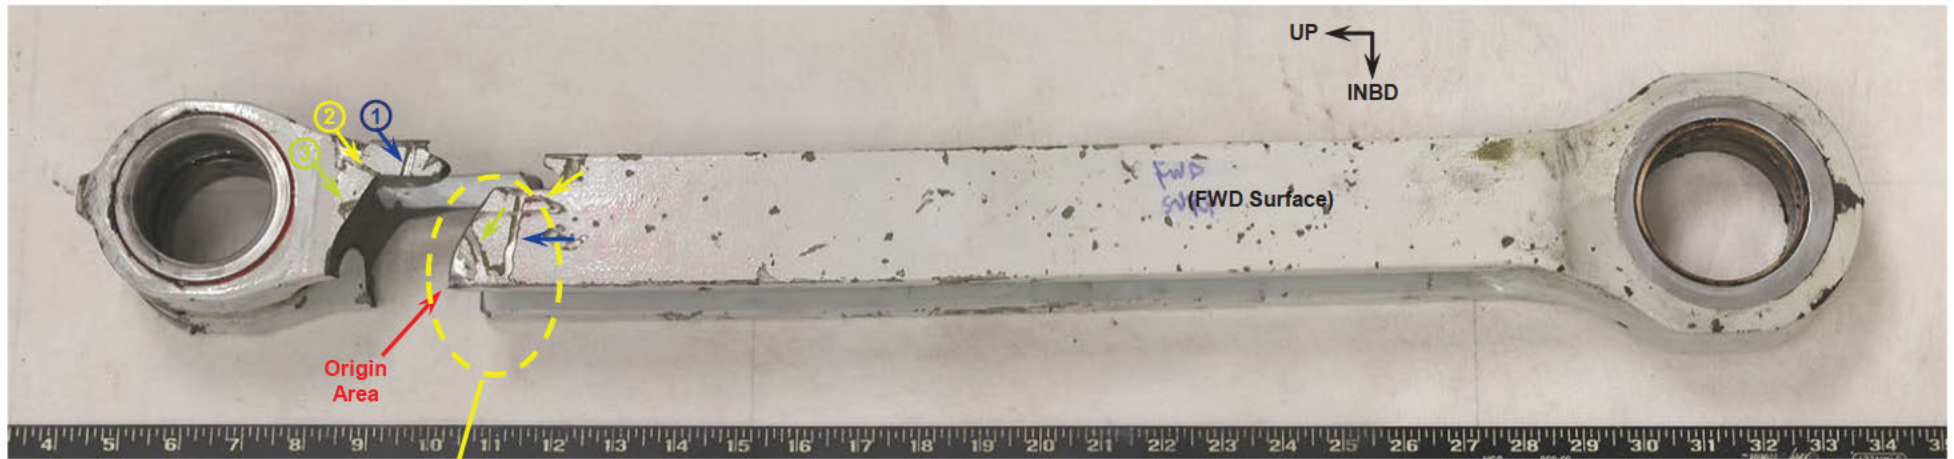
Figure 38. Overall of Lower Side Brace [Blue, yellow, and green arrows indicate areas of matching witness marks].

The lower side brace link exhibited a complete, transverse fracture approximately 4.1 inches from the upper end (Figure 38). The fracture initiated at the forward, inboard flange (Figure 39). The origin area appeared elliptically-shaped and rusted to a crack depth of 0.05 inch (Figure 40). The remainder of the fracture surface appeared less oxidized and exhibited a dull texture, typical of ductile separation. Witness/damage marks along both sides of the fracture indicated that the pieces were still together during hyper-extension of the side brace links (Figure 38).

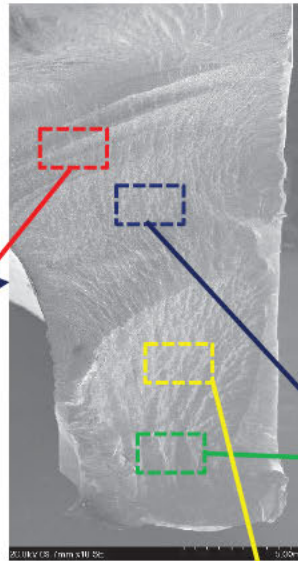
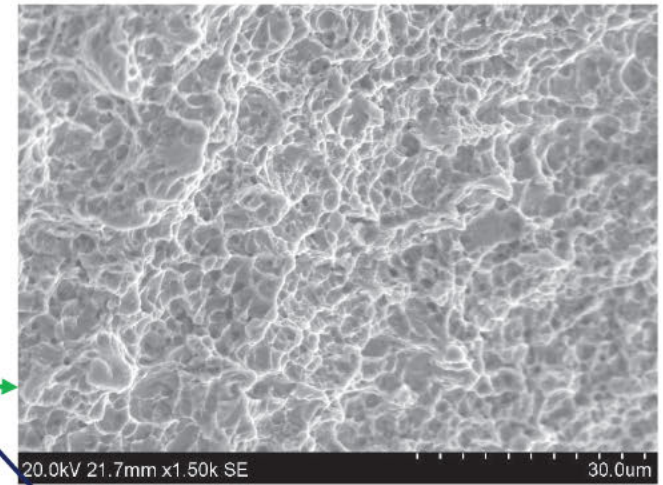
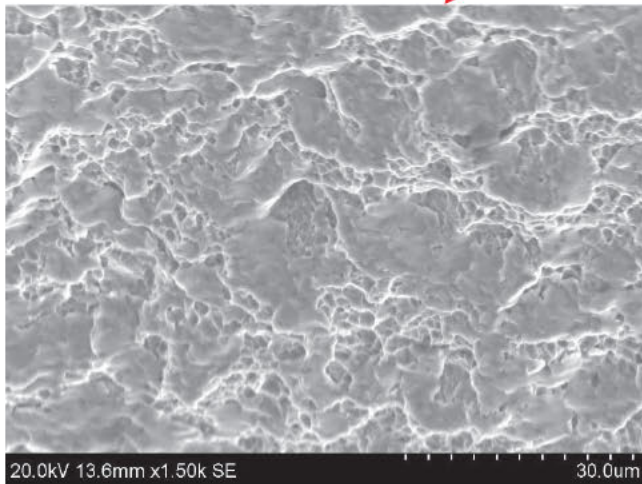
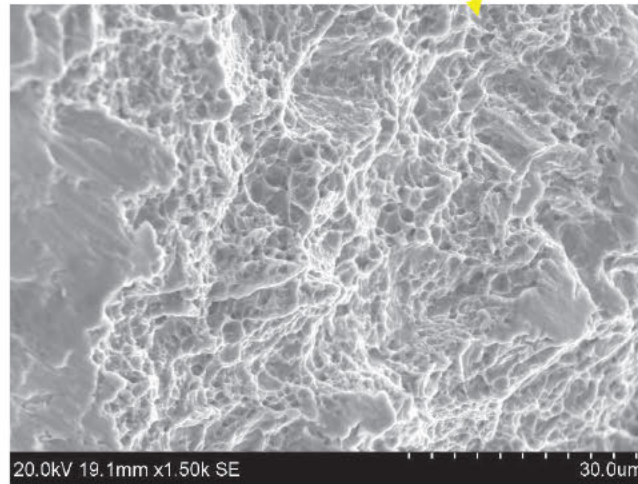
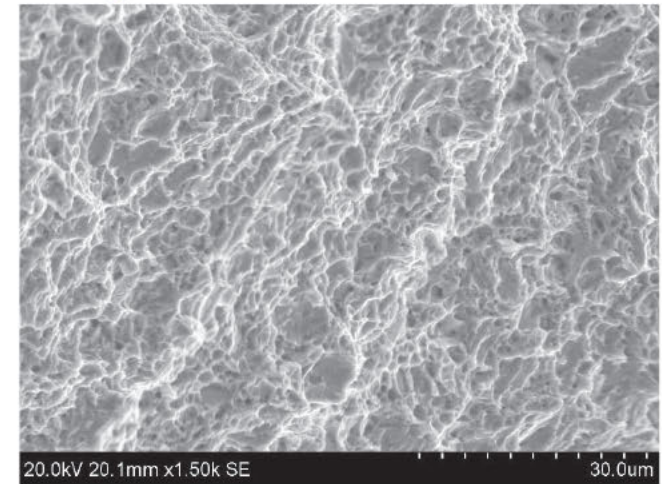
A majority of the origin area of fracture #1 in the upper side brace link was smeared from post fracture damage. All undamaged, observable regions exhibited evidence of ductile separation (Figures 41 to 46).

Figure 42. SEM close-up of origin area

Figure 43. SEM close-up of origin area

Figures 44 to 46. SEM close-ups from origin area [Upper Side Brace]

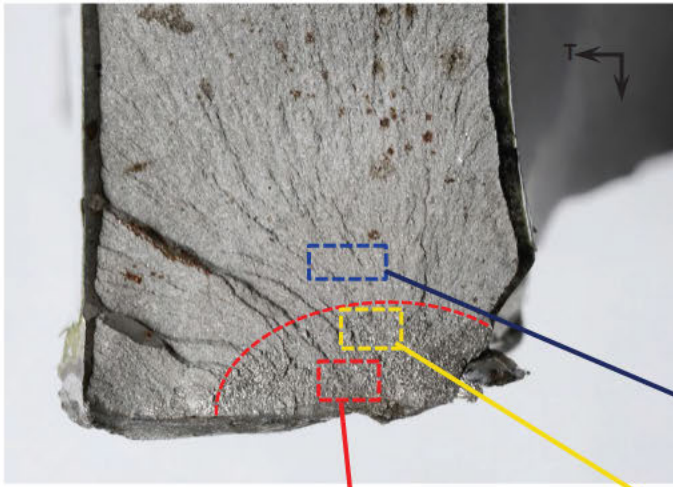
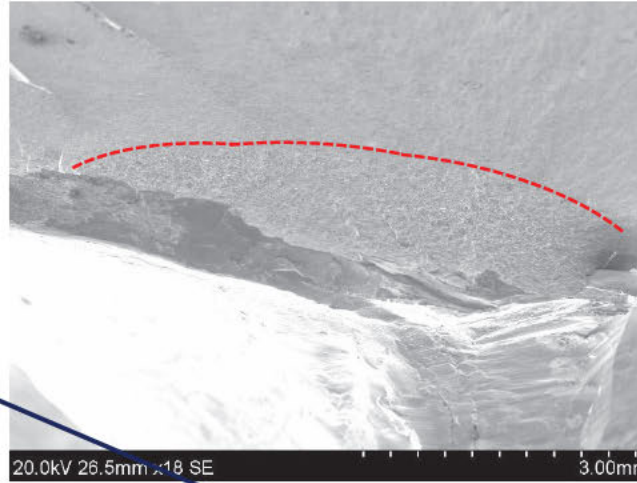
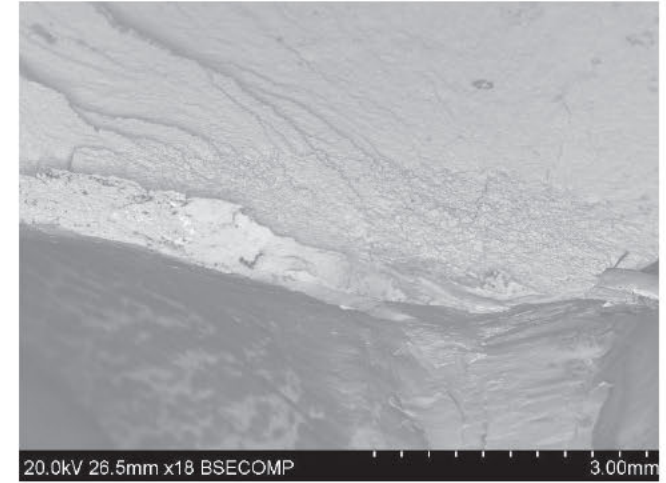
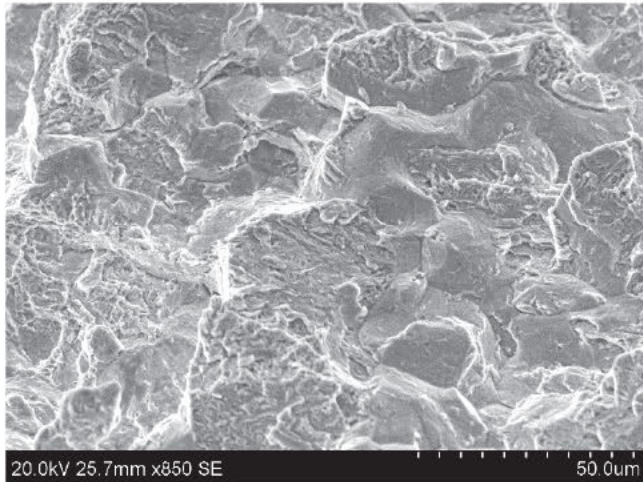
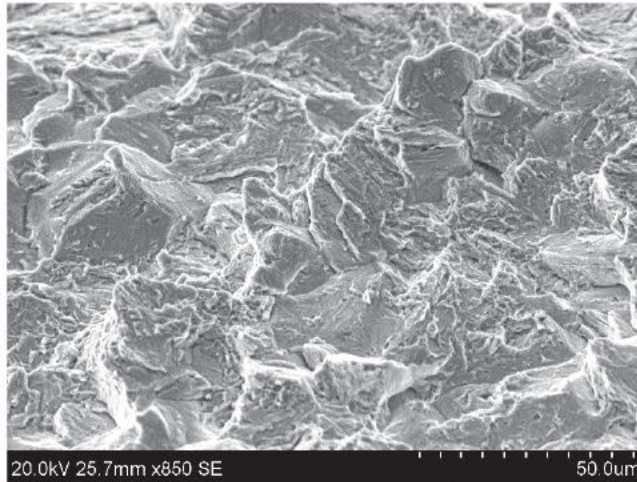
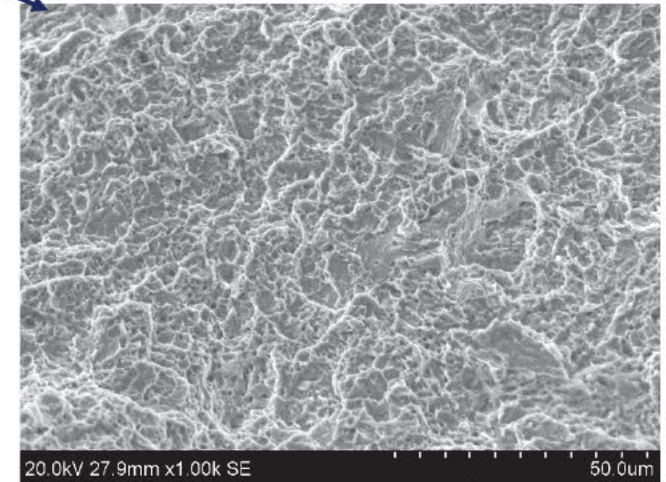
SEM analysis of the secondary crack which intersected fracture 1 revealed a mixture of intergranular, quasi-cleavage, and dimpled morphology to a crack depth of 0.09 inch (Figures 47 to 51). Beyond this depth, the remainder of the crack exhibited evidence of ductile separation (Figure 52).

Figure 47. Close-up of origin area [Upper Side Brace]

Figures 48 and 49. SEM close-ups of origin area [Upper Side Brace]

Figures 50 to 52. SEM close-ups of origin area [Upper Side Brace]

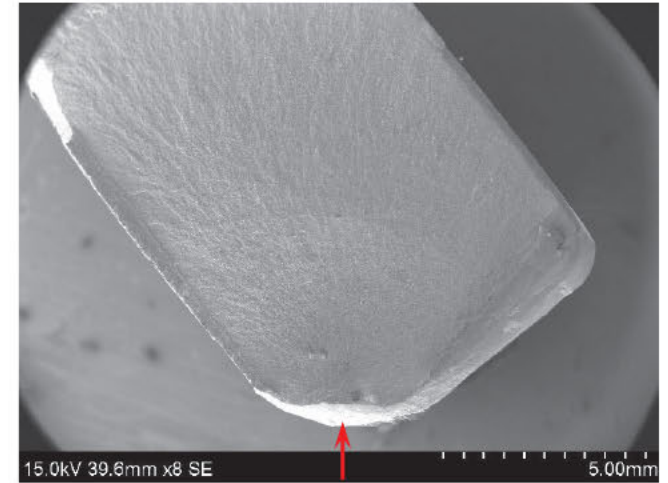
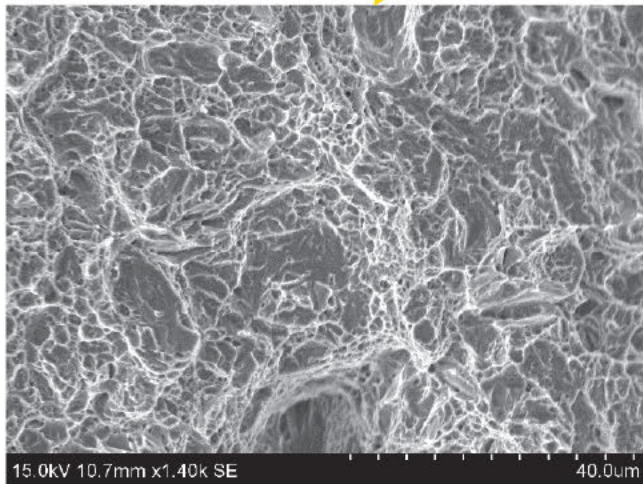
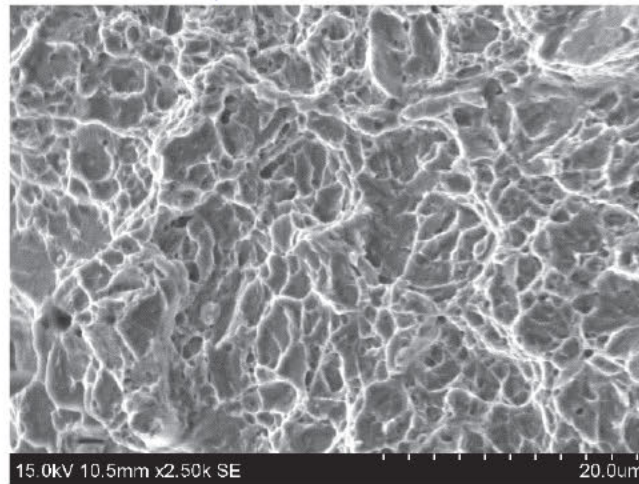
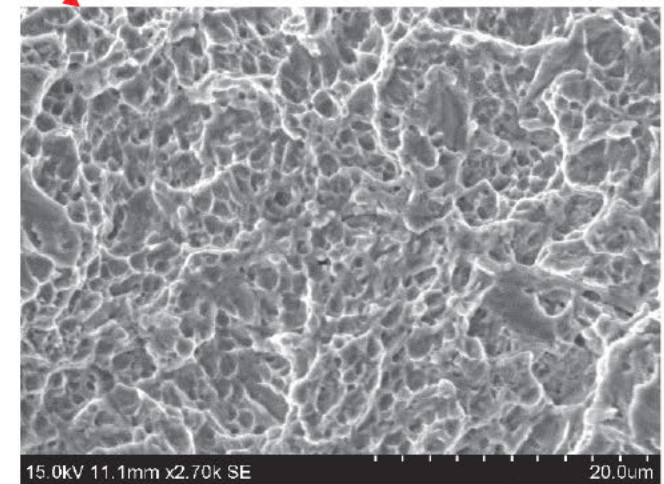
SEM analysis of fracture #2 revealed evidence of ductile separation (Figures 53 to 57).

Figure 54. SEM close-up of origin area

Figures 55 to 57. SEM close-ups of origin area [Upper Side Brace]

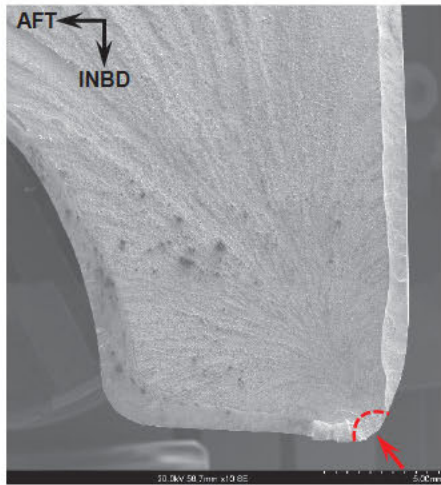
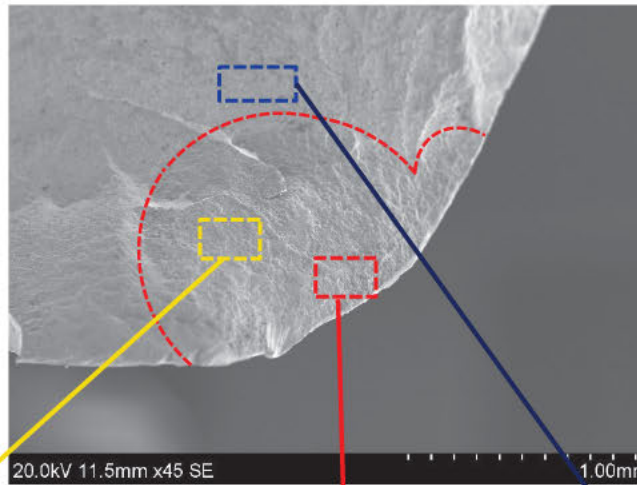
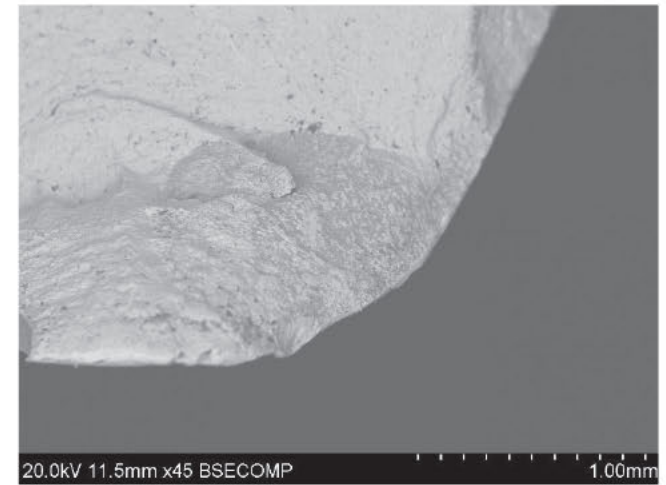
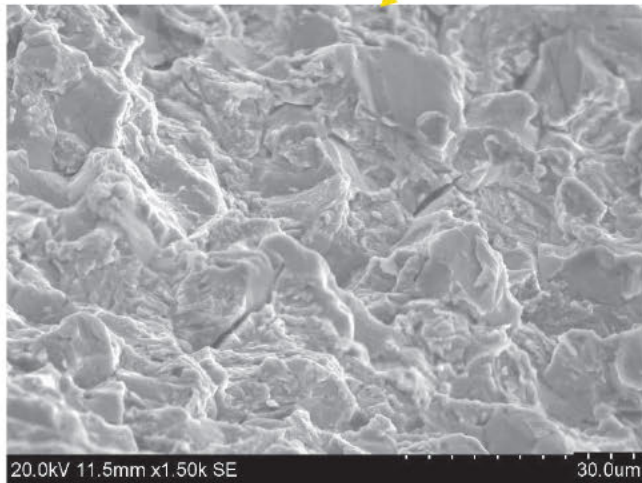
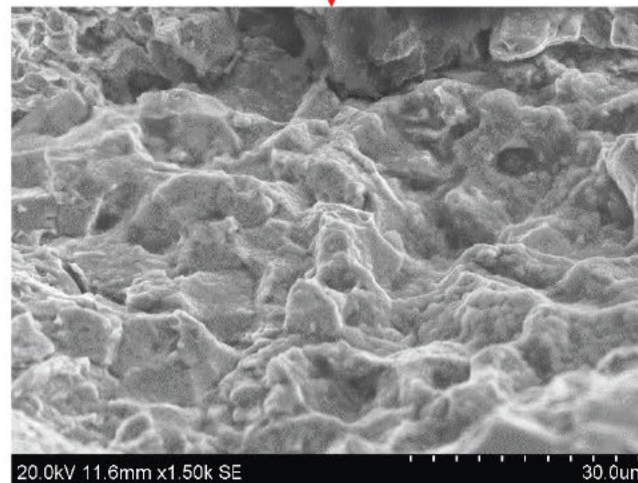
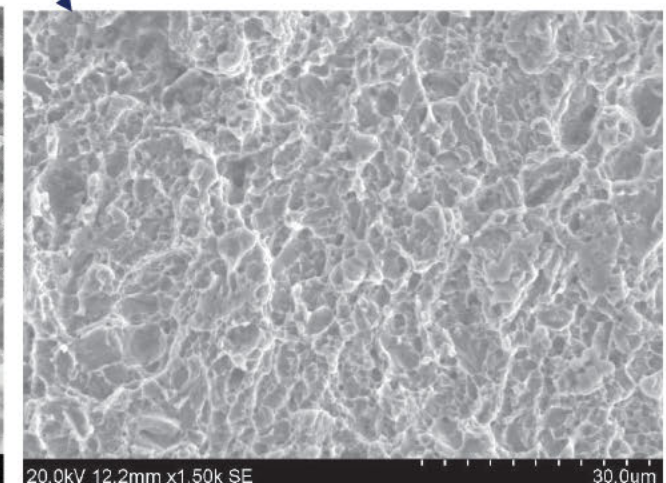
SEM analysis of the lower side brace link revealed evidence of intergranular separation to a crack depth of 0.05 inch (Figures 58 to 62). This region appeared oxidized. The remainder of the fracture exhibited evidence of ductile separation (Figure 63).

Figure 58. Close-up of origin area [Lower Side Brace]

Figure 59. Close-up of origin area [Upper Side Brace Fracture 2]

Figure 60. SEM backscatter image of origin area

Figures 61 to 63. SEM close-ups of origin area [Low Side Brace]

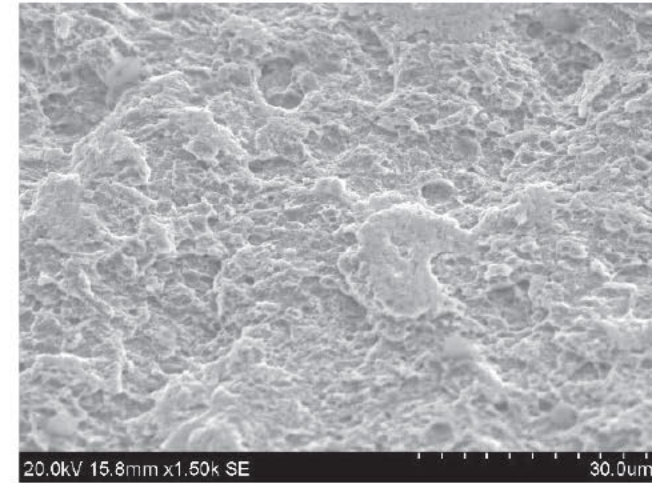
Figure 70. SEM close-up of fracture surface [Retract Rod]

SEM analysis of the fracture surface revealed evidence of ductile separation (Figures 66 to 73).

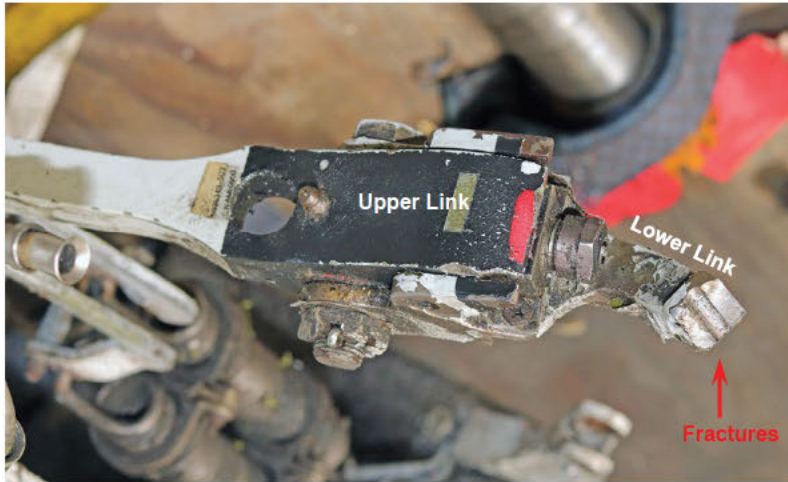
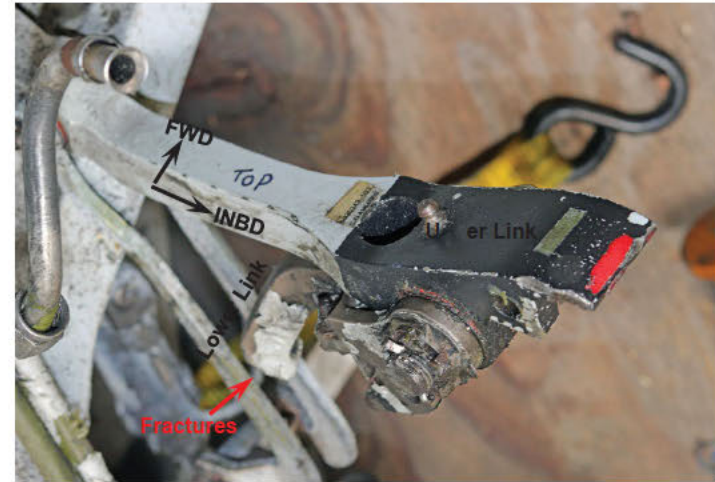
The lower lock link exhibited complete transverse fractures through the arm approximately four inches from the inboard end (Figures 74 to 78). The upper end of the lower link was still attached to the upper link (Figures 74 and 75), and the lower end (the lug portion of lower lock link) was still attached to the side braces in the as-received condition (Figure 76). The lower lock link was bent in an upward and aft direction (Figures 77 and 78). The upper link was bent in a forward direction (Figure 77). One fracture intersected a hole in the arm (Figures 79 and 80). This fracture consisted of two segments which intersected diametrically opposite sides of the hole. The fracture surfaces were smeared in a forward/aft direction (Figure 80). The other fracture appeared to have occurred outside the hole (Figure 81). This fracture appeared smeared in a longitudinal (up/down) direction.

Figure 74. Close-up of Lock Links

Figure 75. Close-up of Lock Links

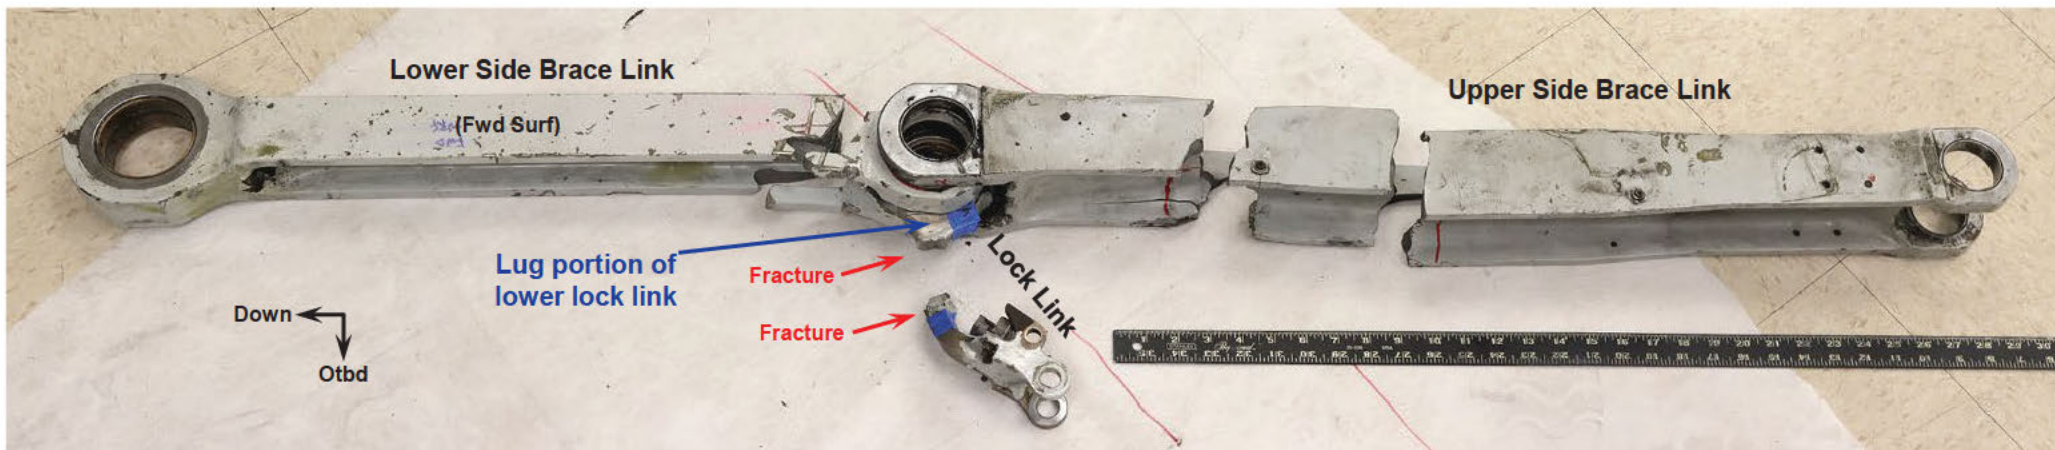
Figure 76. Close-up of Side Braces with Lock Link intact

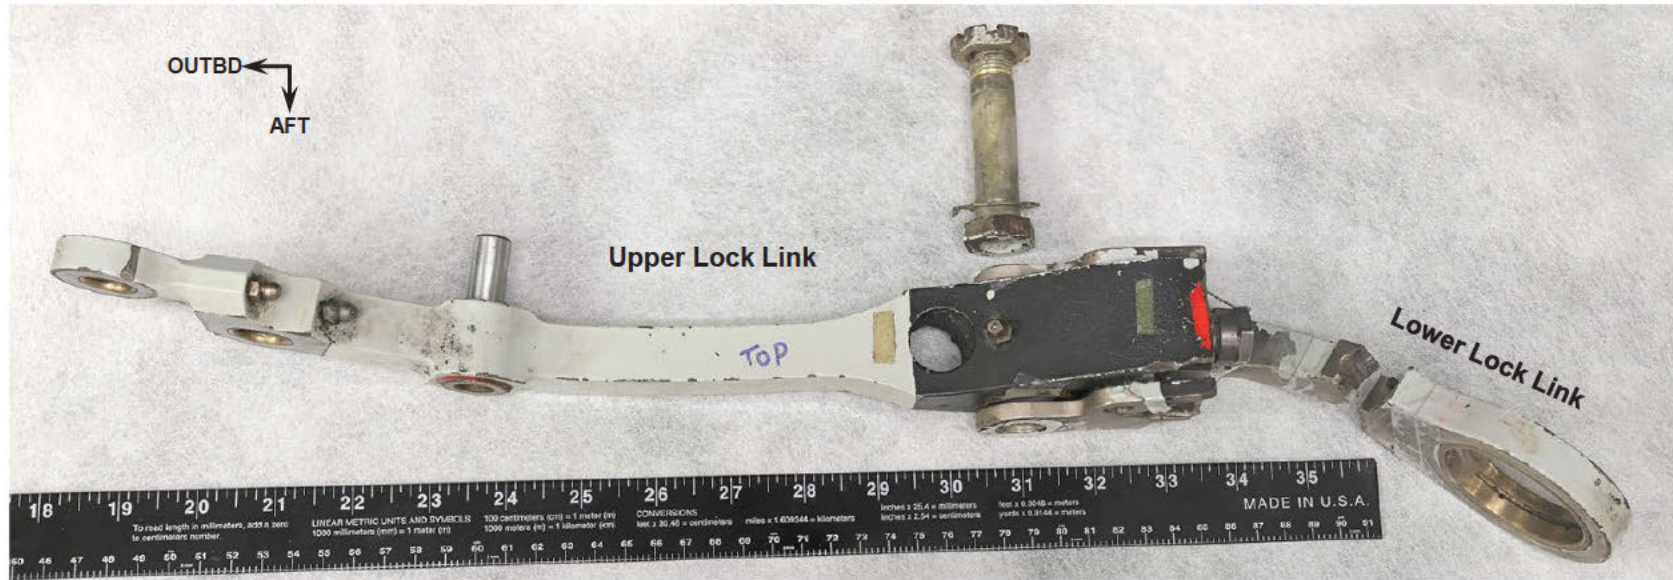
Figures 77 and 78. Close-ups of Lock Links after removal

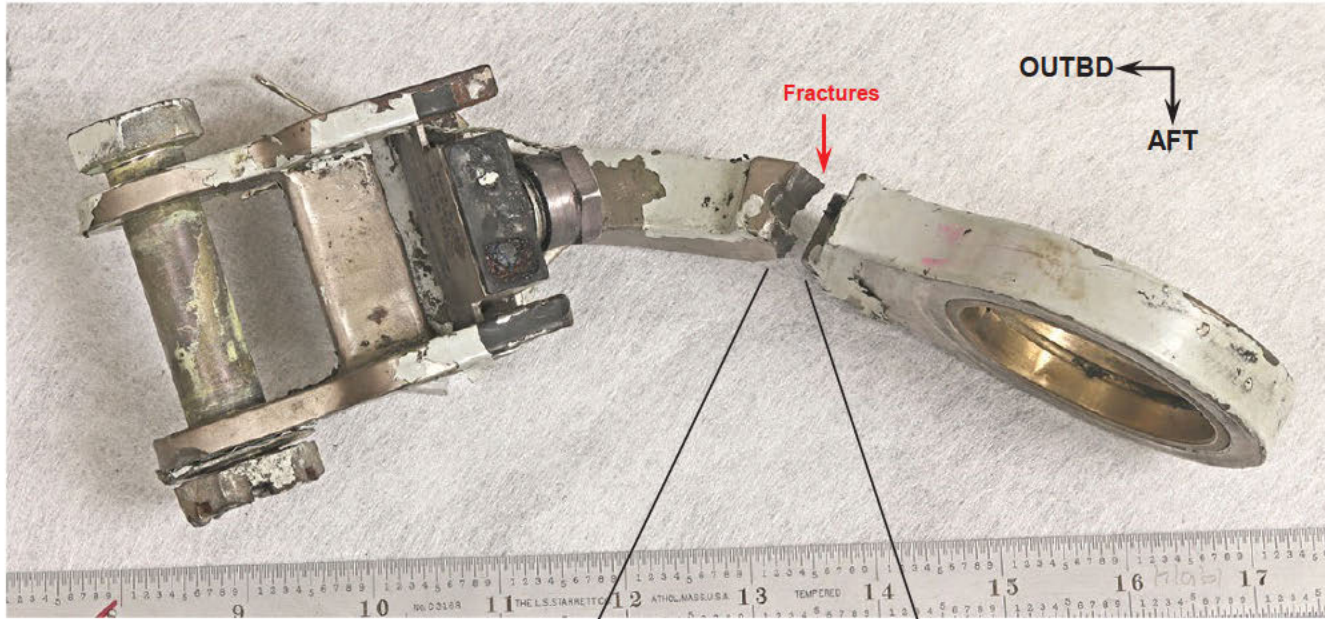
Figure 79. Close-up of lower Lock Link after removal

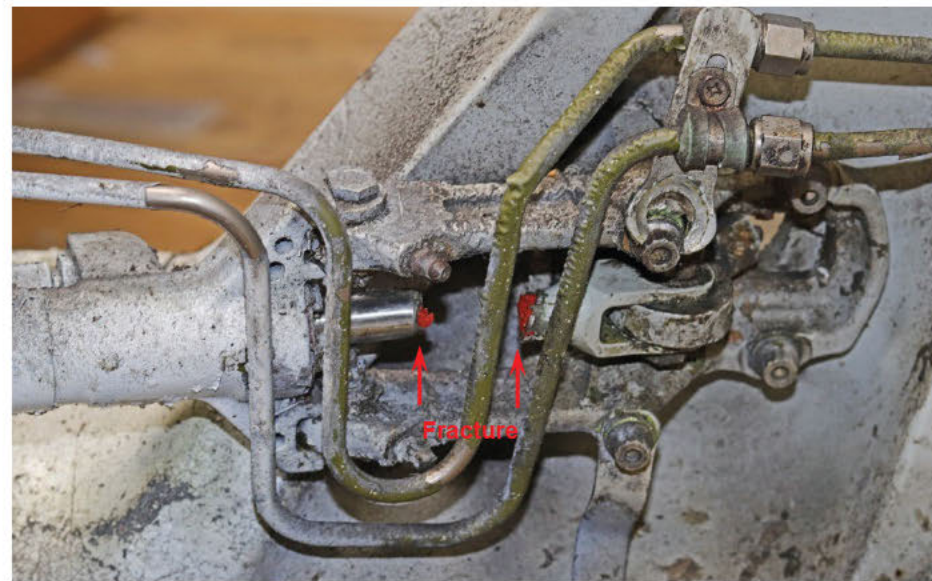
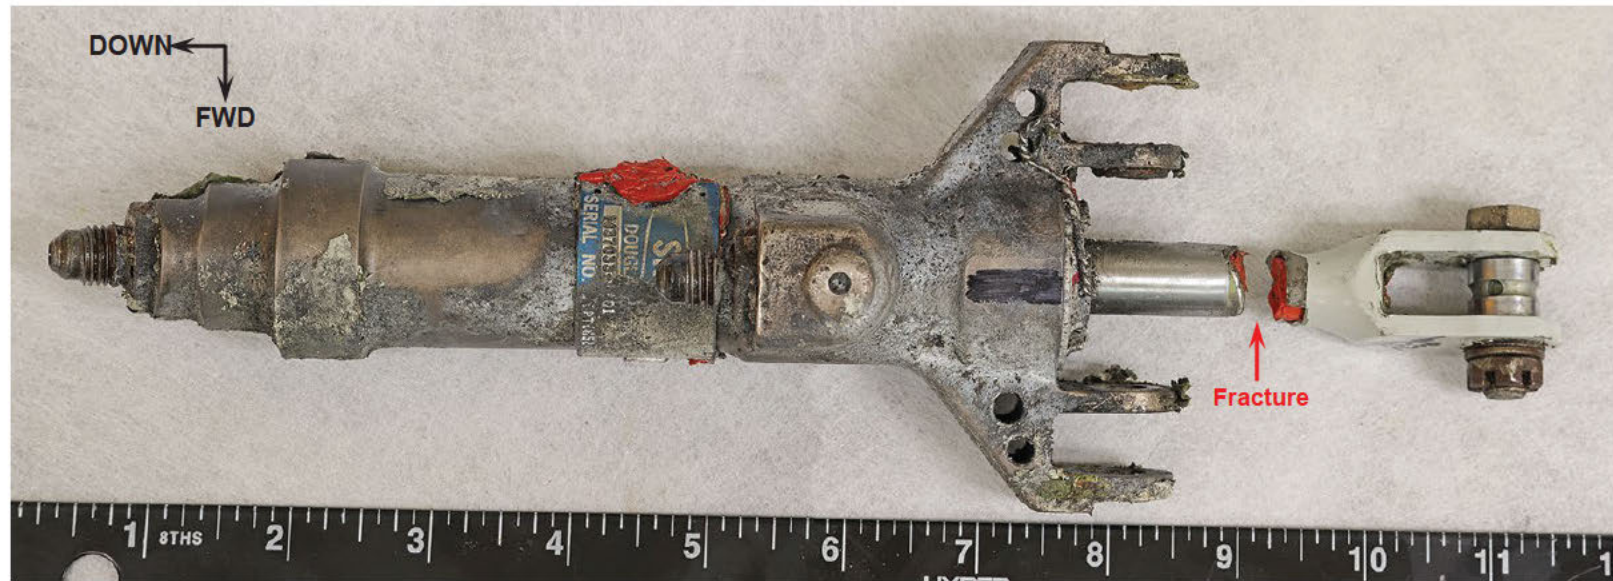
The bungee piston rod exhibited a complete fracture approximately two inches from the end of the clevis lug (Figures 92 to 94). The fracture surface occurred along an oblique plane, typical of ductile separation (Figures 95 and 96). The rod appeared to be bent slightly in an aft direction in the area of fracture.

Figure 93. Close-up of fractured Bungee Piston

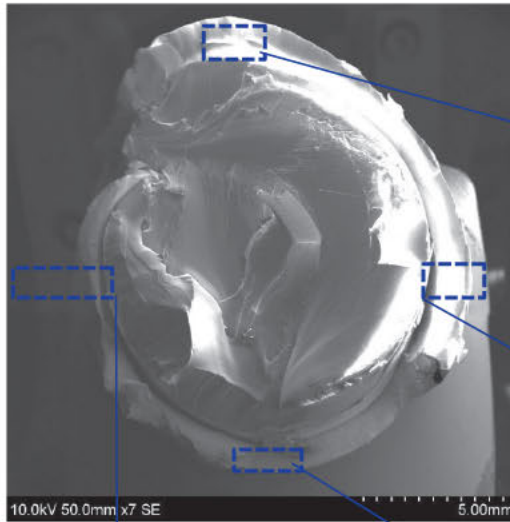
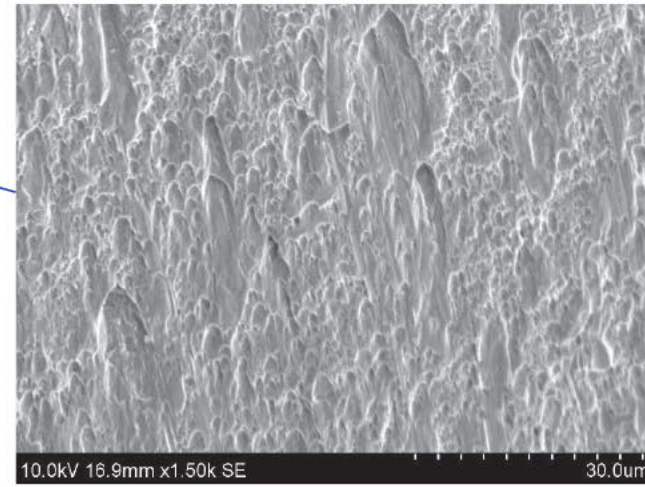
SEM analysis of the fracture surface revealed evidence of ductile separation (Figures 97 to 101).

Figure 97. SEM close-up of fracture surface [Bungee Piston]

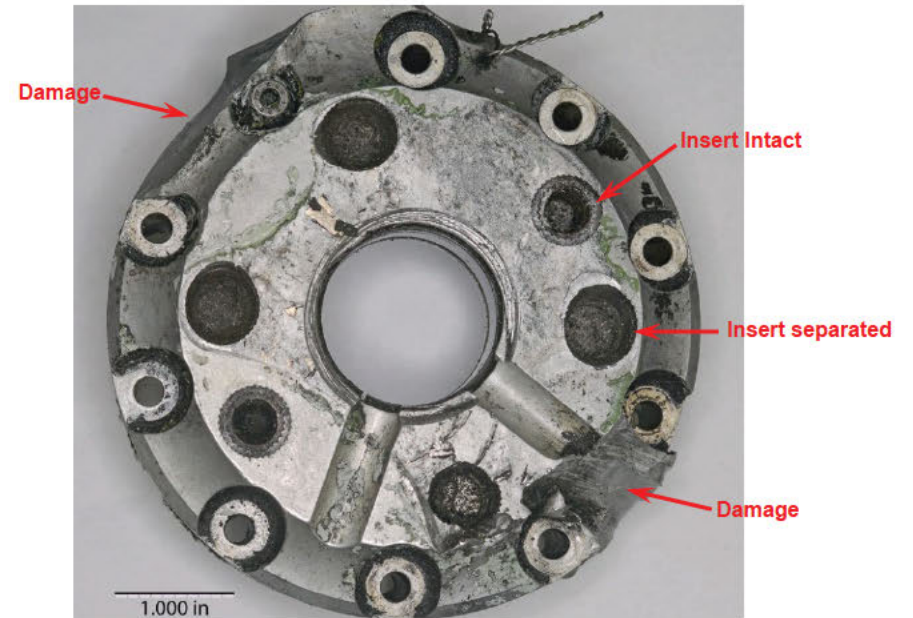
Figure 103. Close-up of Shimmy Damper

The shimmy damper housing exhibited evidence of impact damage, and a number of the threaded inserts had partially pulled out of the housing (Figure 102). Some of the insert threads contained remnants of the mating shimmy damper housing threads which had been sheared away. The ends of the holes were elongated in a mostly circumferential direction (Figure 103). The hole surfaces exhibited circumferential scrape/shear marks (Figure 104).

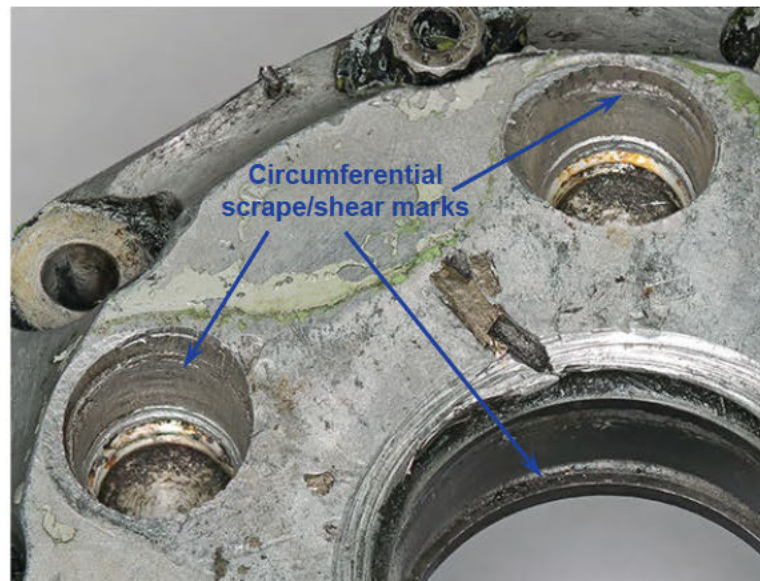
Figure 104. Close-up of holes with no inserts

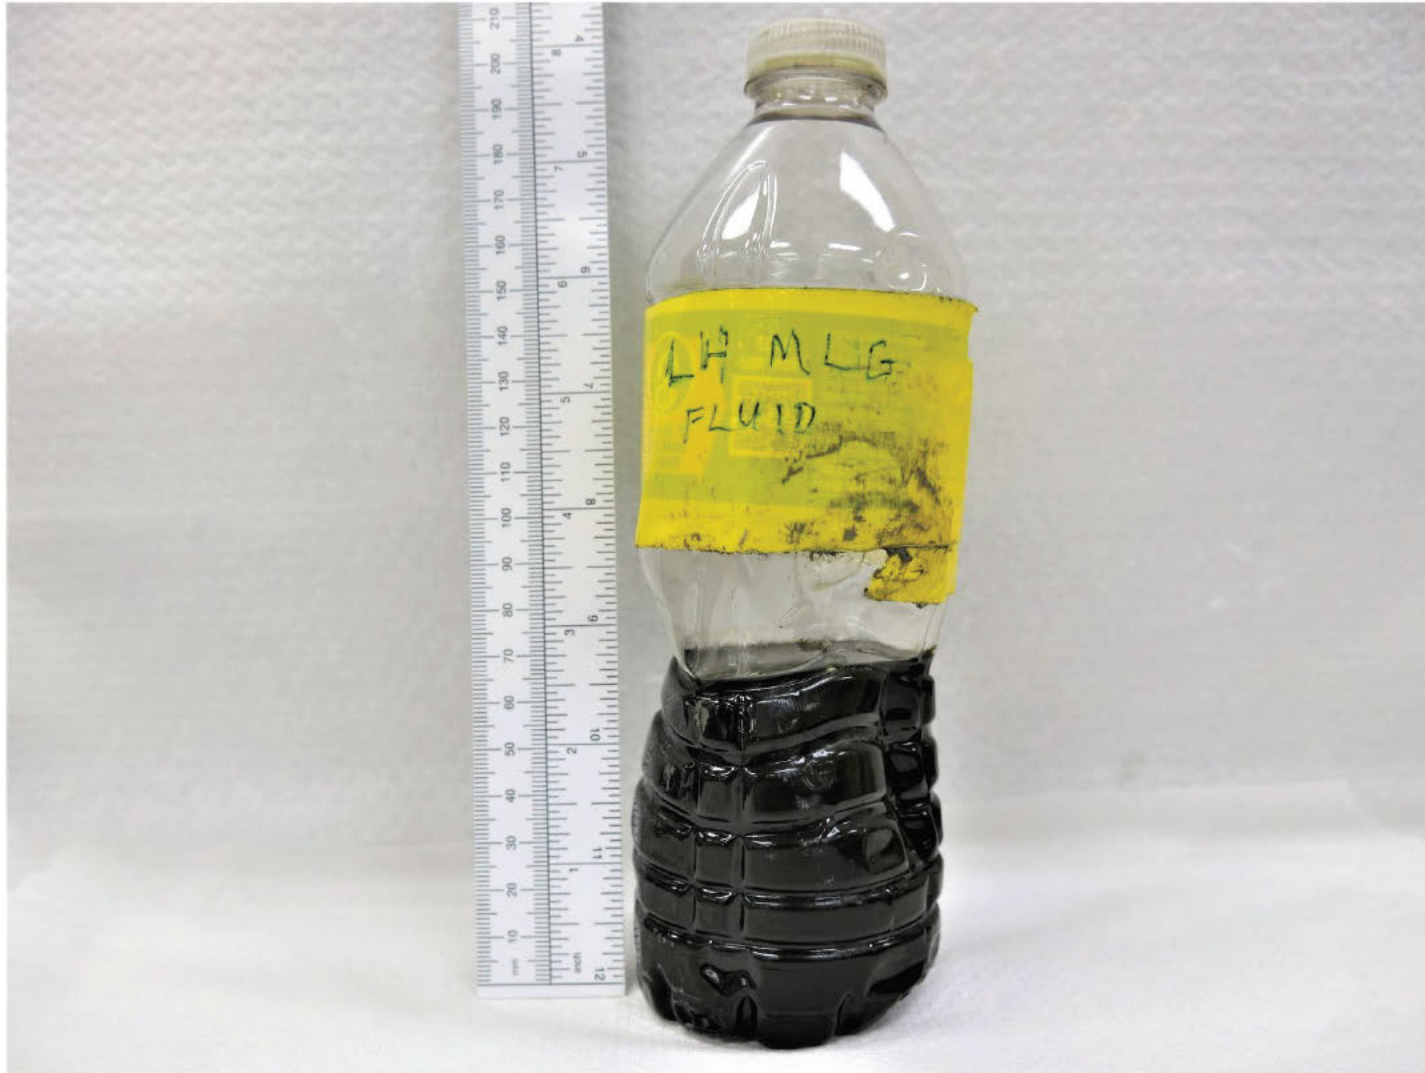
Approximately 8 fl. oz. of yellow-black MLG hydraulic fluid (S/B DPM 6176) was submitted in an emptied 16 fl. oz. water bottle (Figs. 1-2) for evaluation of the condition (moisture, contamination, etc.) of the fluid.

Figure 1. Hydraulic oil, in water bottle after approximately 75 mL was removed.
