Subject: Boeing Component Examination Report - Red Air MD-82 HI1064 Landing  
Gear Collapse and Runway Excursion Miami, Florida - 21 June, 2022

## FRACTURE ANALYSIS REPORT

Engineering Report No: MS 80040

A/P Customer:	RedAir	A/P Model:	MD-82
Registry No:	HI1064	Line Position No:	1805
Flight Hours:	68,229	Number of Landings:	35,873

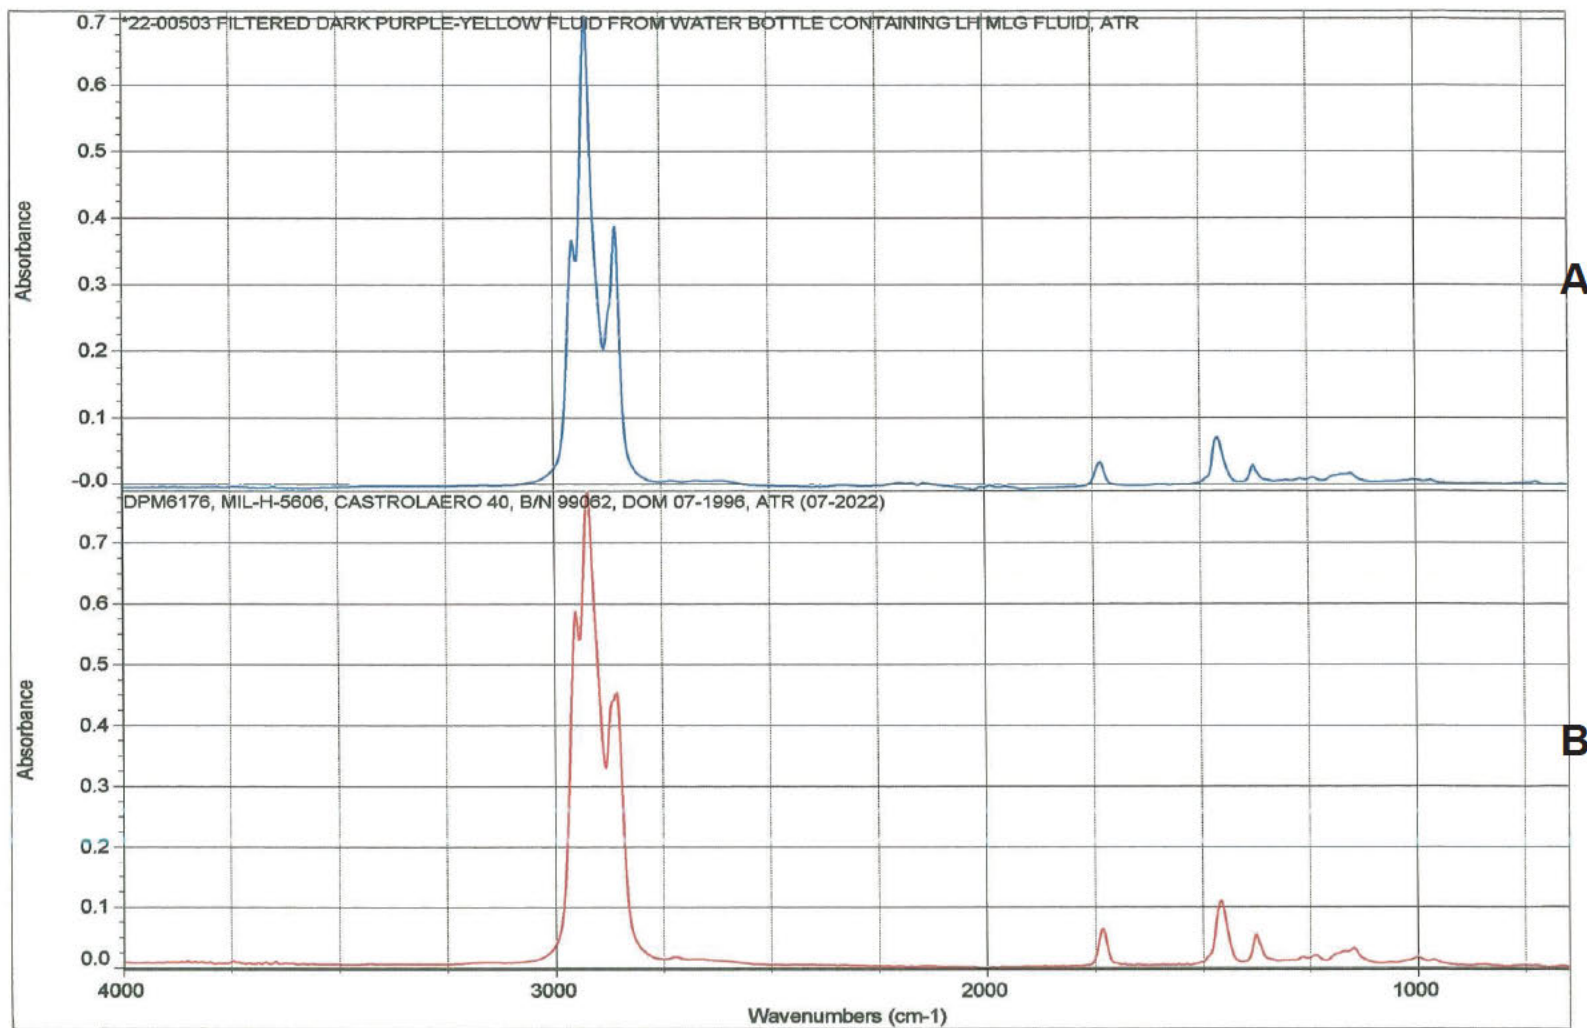
1. Hydraulic Fluid was identified by FTIR analysis as DPM6176, MIL-PRF-5606 (Fig. 4) (meets requirements).
2. Acidity = 3.59 mg KOH/g (meets requirement of 2.3-5.0 mg KOH/g)
3. Moisture Content = 772 ppm (fails requirement of  $\leq 150$  ppm)

Figure 4. FTIR spectrum of hydraulic oil in blue (A), reference spectrum in red (B).

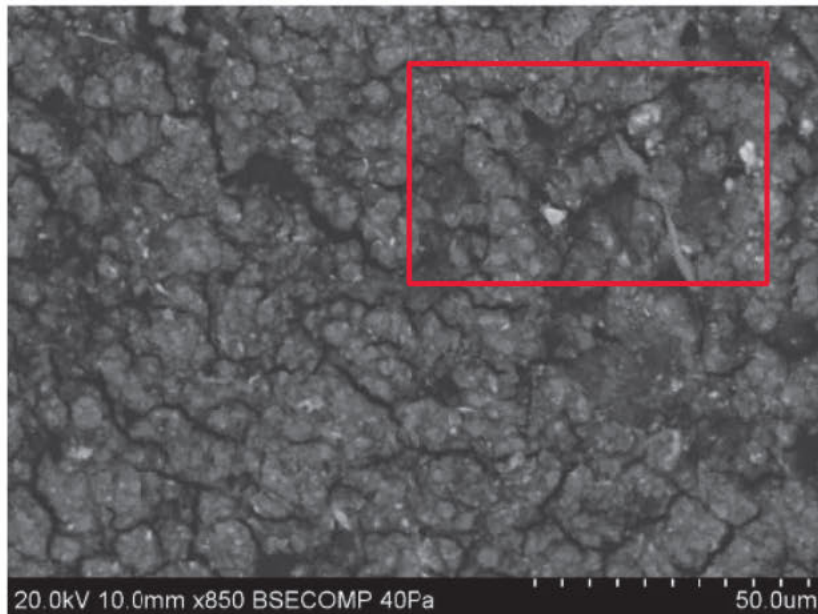
SEM Figure 6. SEM image showing material distribution after transferring to carbon tape.

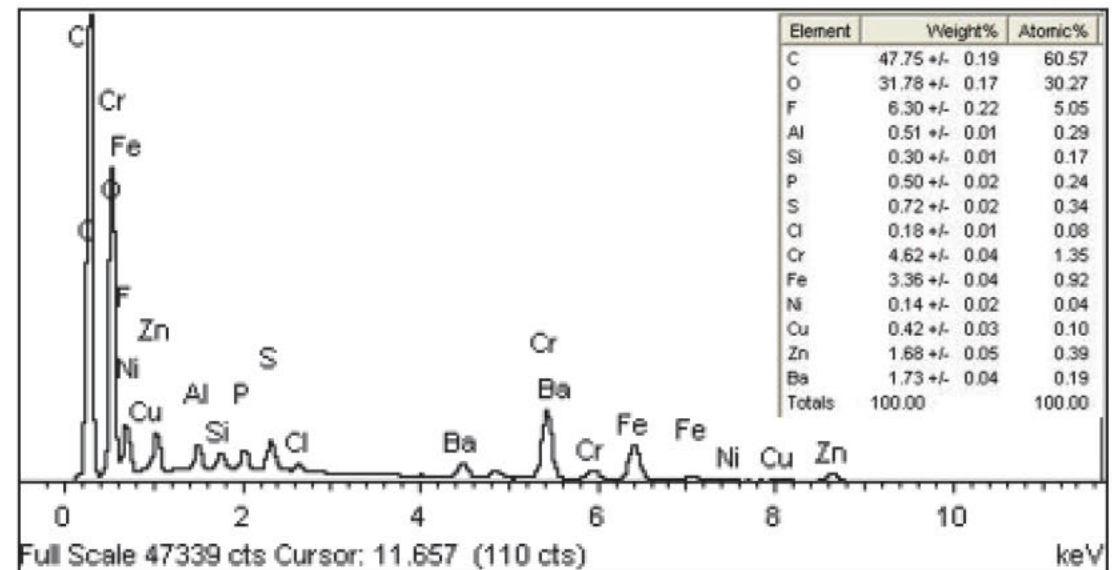
SEM Figure 7. Corresponding EDS spectrum and approximate chemical composition of sample on carbon tape.

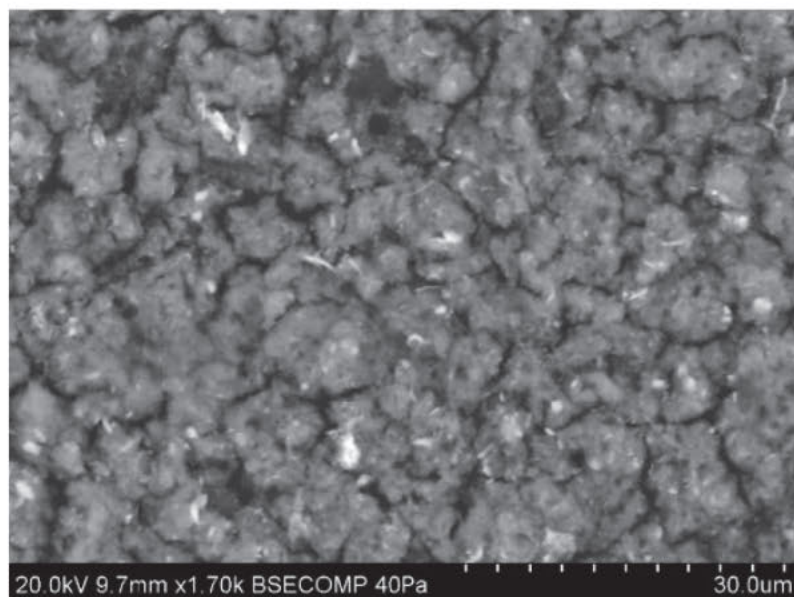
SEM Figure 8. SEM image showing material distribution after transferring to carbon tape.

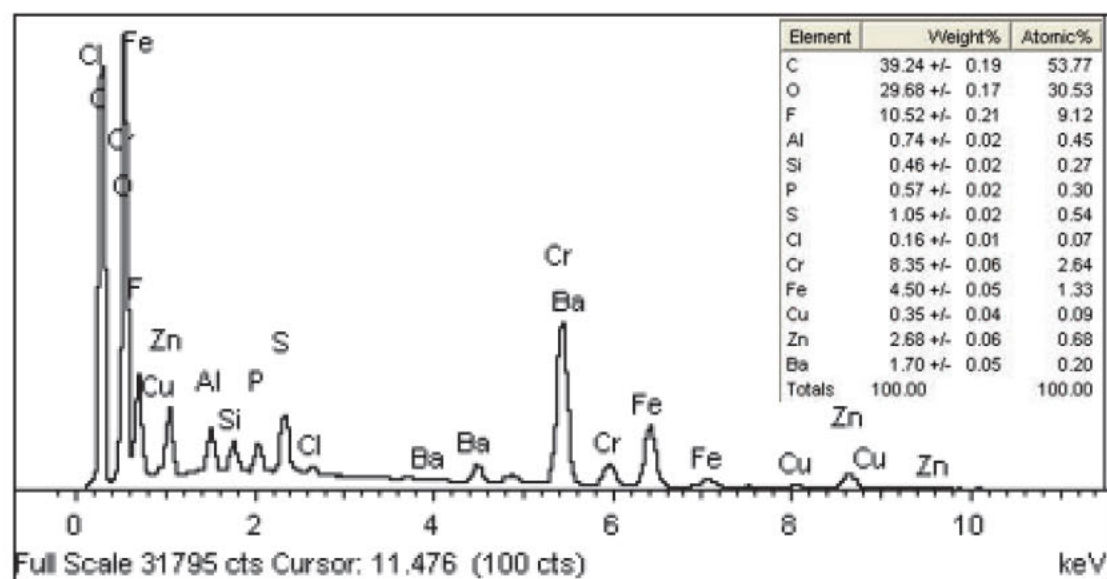
SEM Figure 9. Corresponding EDS spectrum and approximate chemical composition of sample on carbon tape.
