Federal Railroad Administration
Tank Car Damage Assessment Form

Reporting Marks	PPRX 171143		Car Location City/State	Custer, WA	
Date inspected	12/28/2020	Railroad	BNSF	DOT Specification	DOT 117 R 100 W
Last Contained	PETROLEUM CRUDE OIL		Was product released?	NO	
(Jacket thickness)	Jacket <u>1/8</u> _____	Non-jacketed	Does car contain product	Yes	
Car builder	TRIN	Stub Sill Design	TRN 024	Built Date	1/31/2013
Capacity (GAL)	31760		LD Limit (LB)	200200

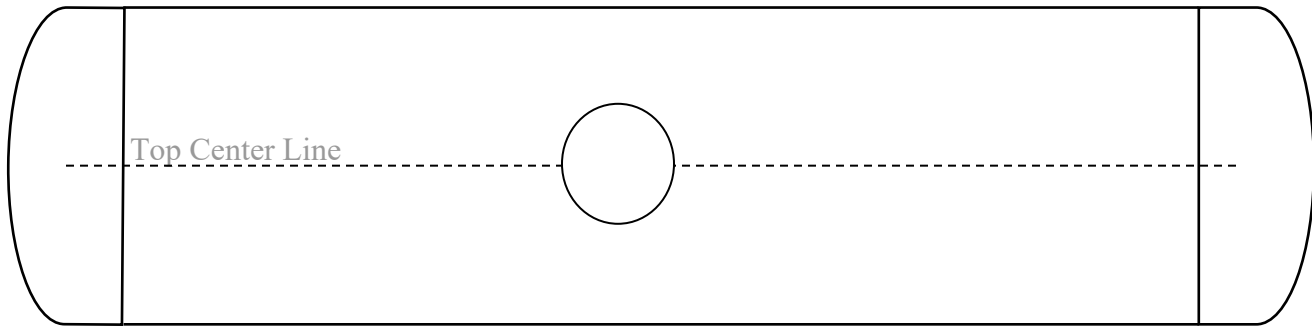
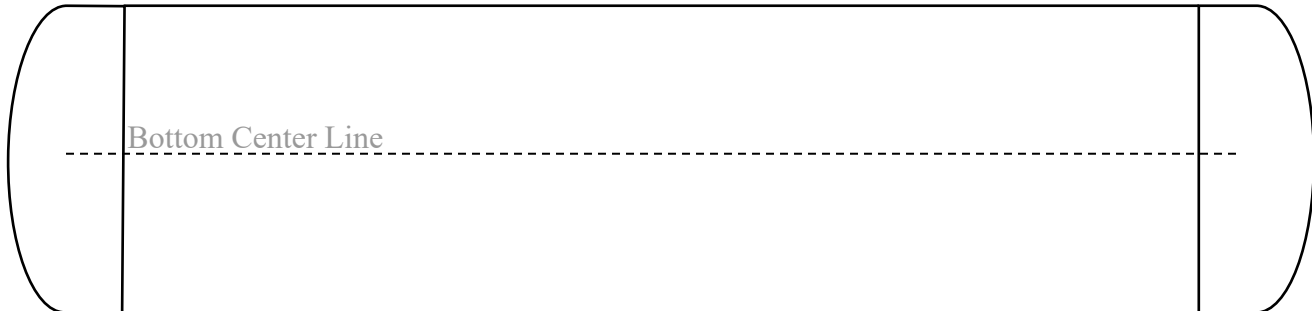
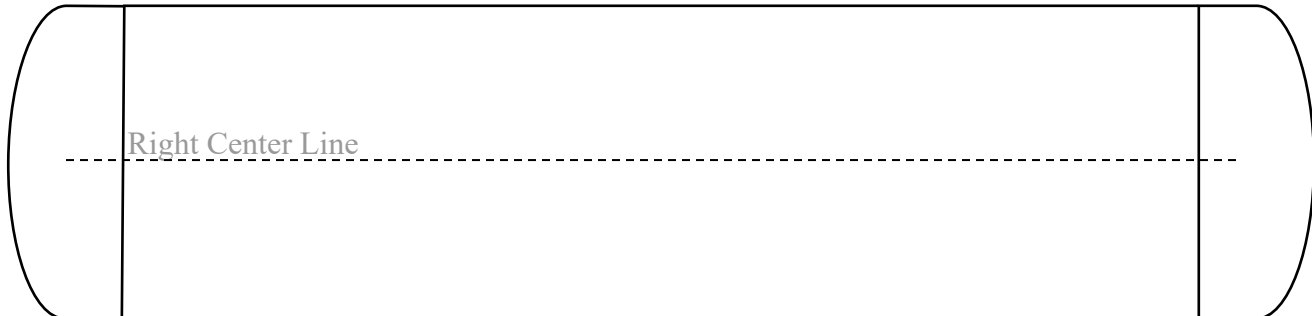
1.	Affected?	Head	Location?	"A" end	Dimensions:	Length	85" high	Width	80"	Depth	Est 6"
-	Defect type?	Dent	Shape?	Oblong	Possible Cause?	Coupler strike					
2.	Affected?		Location?		Dimensions:	Length		Width		Depth	
-	Defect type?		Shape?		Possible Cause?						
3.	Affected?		Location?		Dimensions:	Length		Width		Depth	
-	Defect type?		Shape?		Possible Cause?						
4.	Affected?		Location?		Dimensions:	Length		Width		Depth	
-	Defect type?		Shape?		Possible Cause?						
5.	Affected?		Location?		Dimensions:	Length		Width		Depth	
-	Defect type?		Shape?		Possible Cause?						
6.	Affected?		Location?		Dimensions:	Length		Width		Depth	
-	Defect type?		Shape?		Possible Cause?						
7.	Affected?		Location?		Dimensions:	Length		Width		Depth	
-	Defect type?		Shape?		Possible Cause?						
8.	Affected?		Location?		Dimensions:	Length		Width		Depth	
-	Defect type?		Shape?		Possible Cause?

2. Was this tank car exposed to fire? (Indicate one) **Yes** No
3. How long was the car exposed to fire? Unknown
4. What percentage/locations of the tank were exposed to fire? **"A" end, 15%** Indicate location in figures on page 1.
5. What material burned to create the fire that the car was exposed to? **Petroleum crude**
6. To what degree did the car roll? Initially **90 degrees** and stopped at **Upside down**
7. Distance traveled from track center? B-end? **8 feet west** A-end? **16 feet** Center?
8. Brief description of details of surfaces tank was exposed to in transit to present location? E.g. mud, track, rocks, etc...

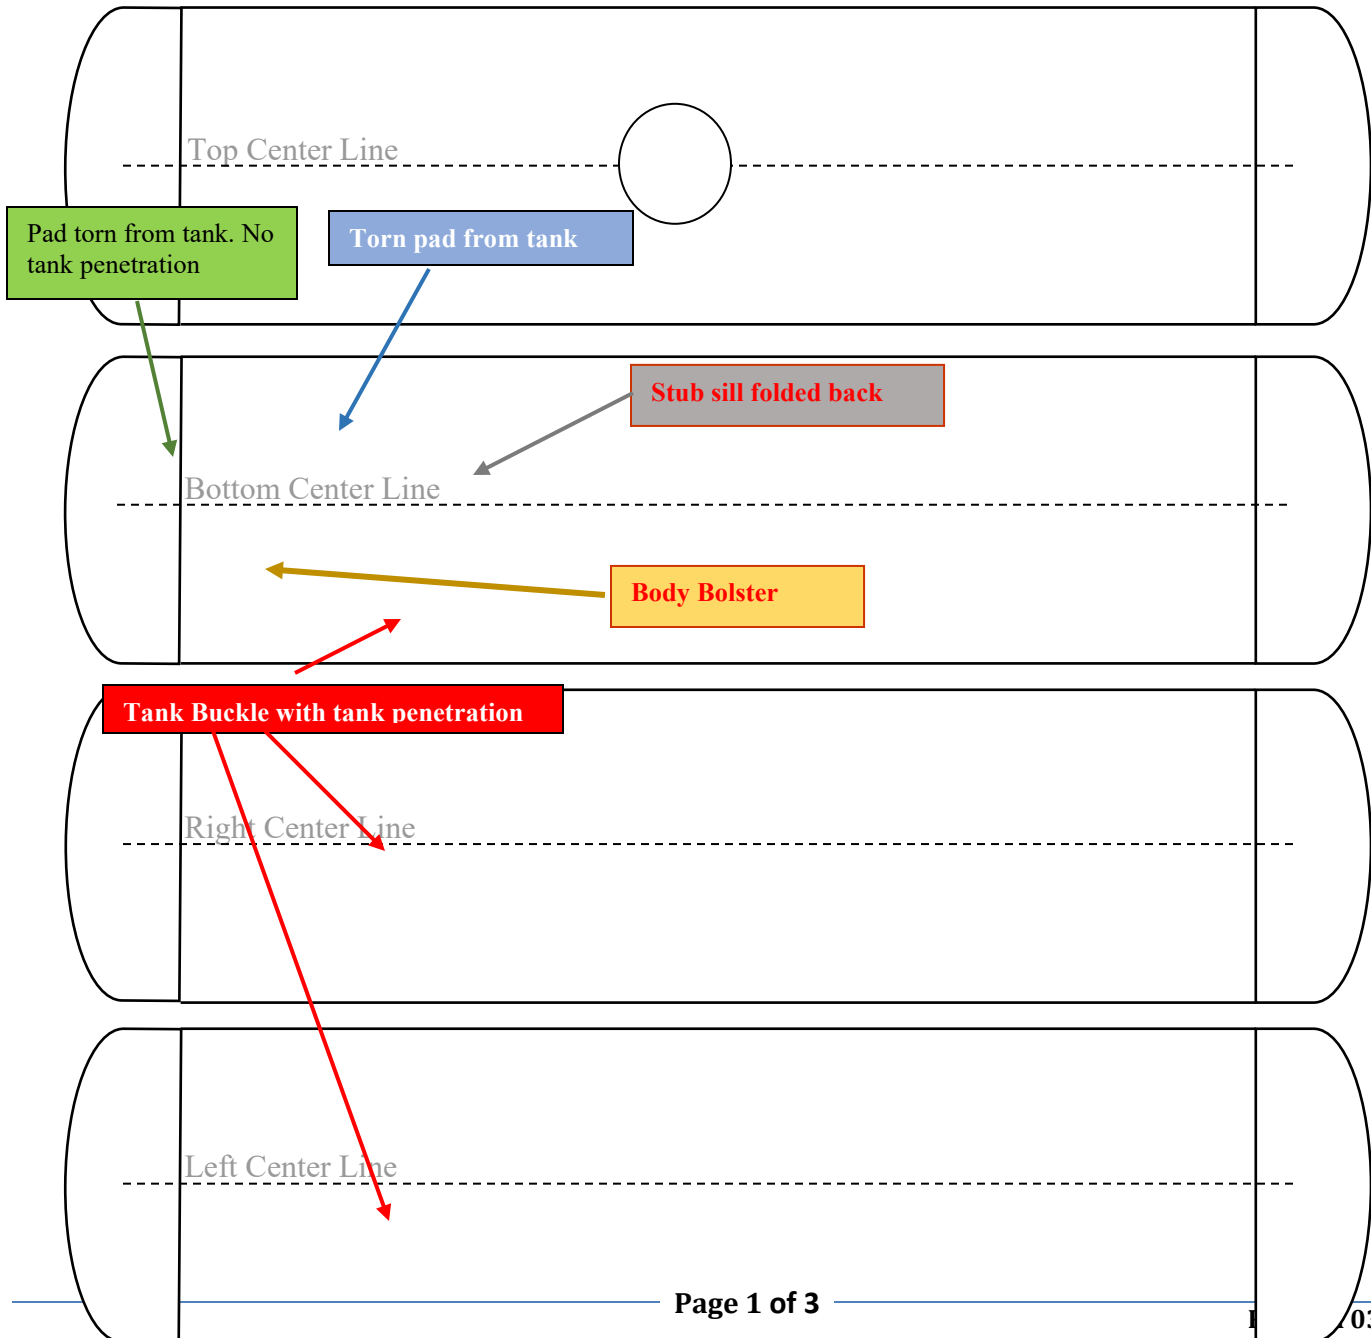
1.	Affected?	"B" end	Location?	bottom right	Dimensions:	Length	12	Width	12	Depth	
-	Defect type?	Punch hole	Shape?	12x12	Possible Cause?	Coupler strike					
2	Affected?	"B" end	Location?	Bottom center to right	Dimensions:	Length	40	Width	60	Depth	10 inches

-	Defect type?	Dent	Shape?	Crescent moon	Possible Cause?	Coupler strike					
3	Affected?	"B" end	Location?	Left side	Dimensions:	Length	34	Width	32	Depth	2 inches

-	Defect type?	Dent	Shape?	Oblong	Possible Cause?	Unknown					
4	Affected?		Location?		Dimensions:	Length		Width		Depth	
-	Defect type?		Shape?		Possible Cause?						
5	Affected?		Location?		Dimensions:	Length		Width		Depth
