# Car Damage Report

Date of Derailment 4-24-19

Location Et Worth TX

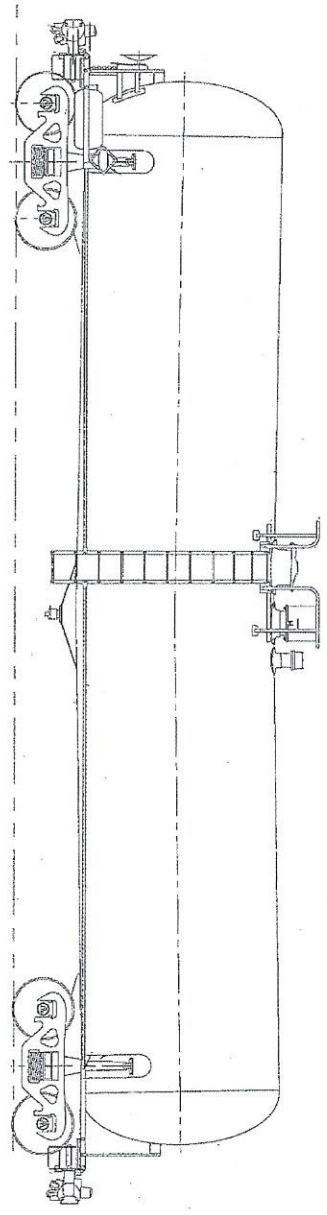
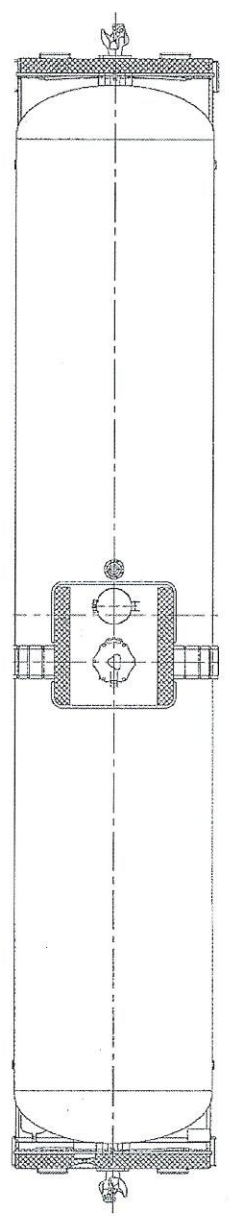
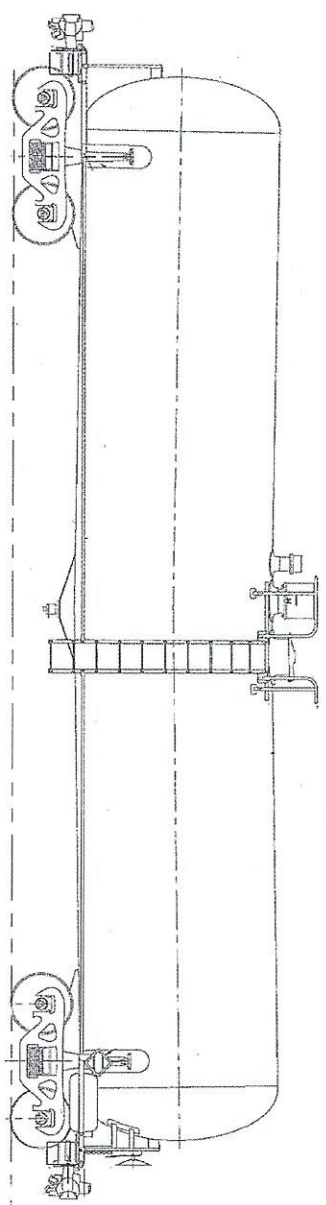
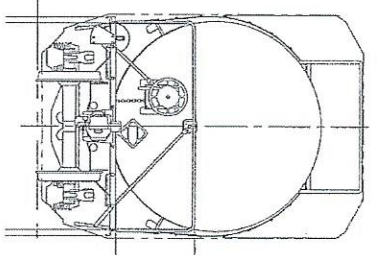
Car Number TILX 199335

Loss of Commodity Yes / (No)

Top fittings MW

Bottom Outlet Leg Sok

Shell Tear Thermal

Draft Sill A B

Head Shield A B

Trucks off of Rail  
Did not inspect

No Photos

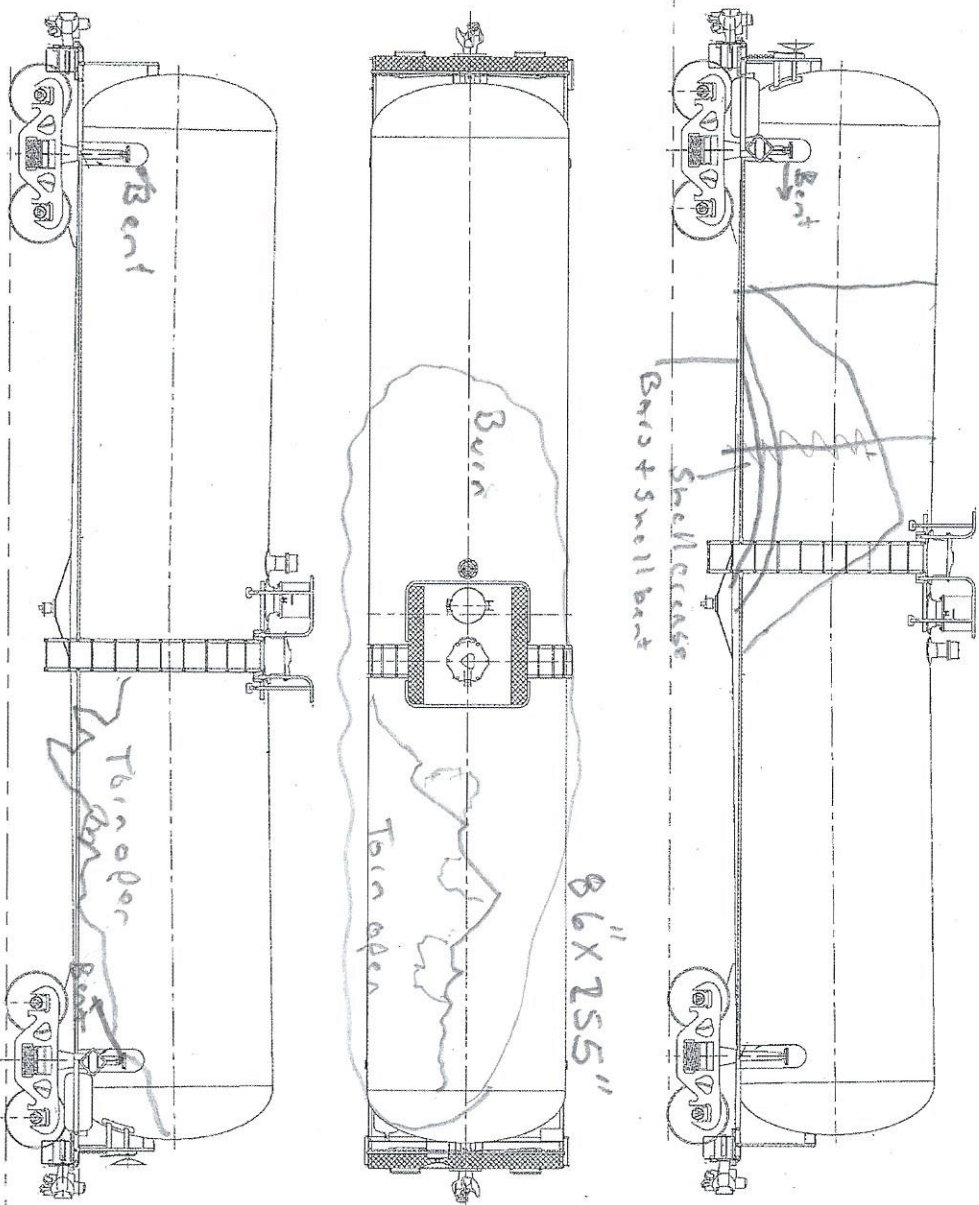
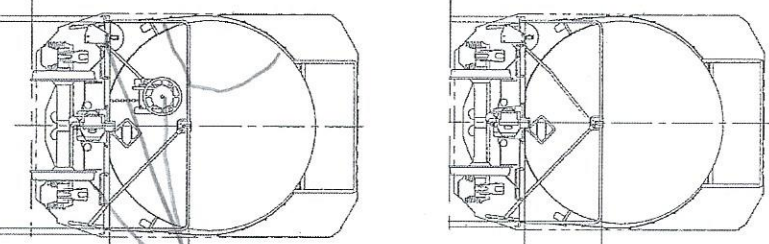
Builder TRN  
 Built Date \_\_\_\_\_  
 DOT 111A10001  
 File# \_\_\_\_\_  
 Loss of Commodity Yes / No

Major / Full loss

Top fittings MW OK MH OK PRD - Did not function  
 \*Bottom Outlet Leg OK open Handle DH - No long Trn handle  
 Shell Tear Thermal No Mech Yes MAJOR  
 Draft Sill A Bent Left side B Bent C OK Torn out right side  
 Head Shield A None B None  
 Skid Condition Torn from bolts dented on center side

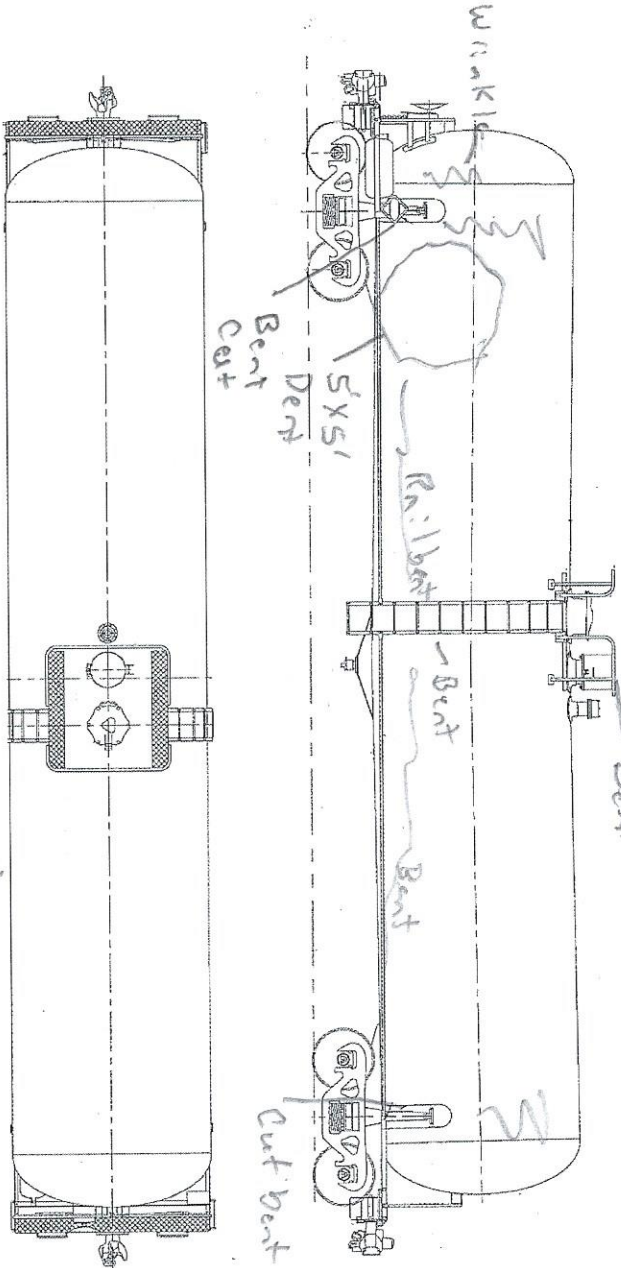
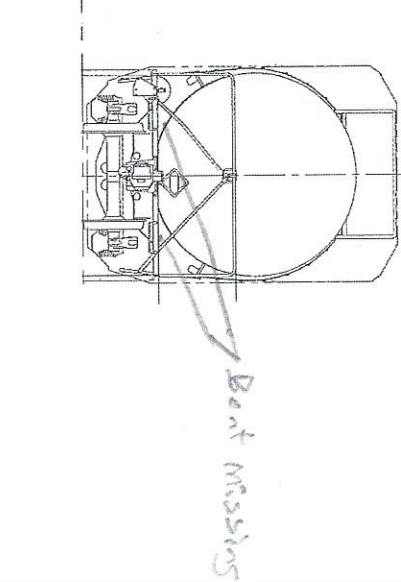
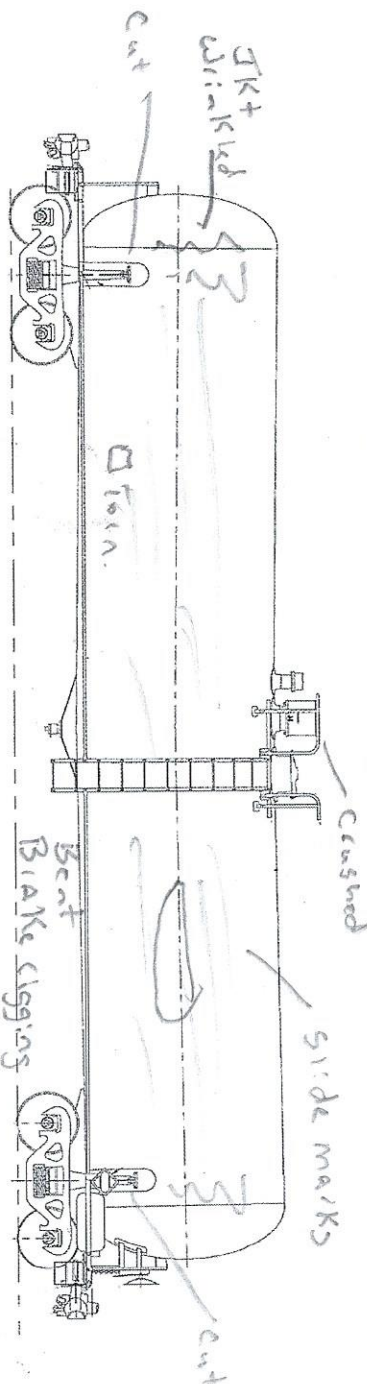
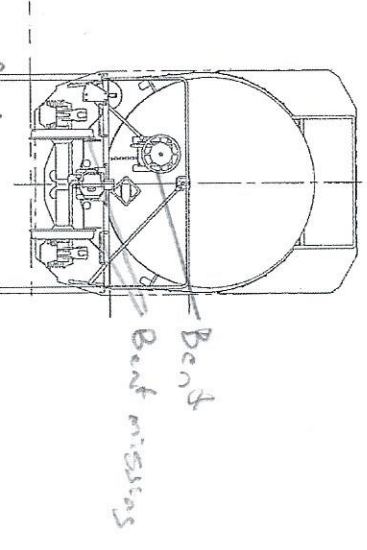
Builder Gunderson  
 Built Date 2-16  
 DOT 1175100W  
 File# \_\_\_\_\_  
 Loss of Commodity Yes/No

Boo Drop  
Check

Top fittings MW OK      MH Leg muddn  
 Bottom Outlet Leg S OK      Handle DH torn ok GDX  
 Shell Tear Thermal No      Mech No  
 Draft Sill A DK7      B OK  
 Head Shield A OK      B OK  
 Skid Condition OK

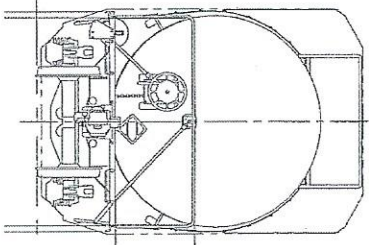
Builder Gunderson  
 Built Date 2-16  
 DOT 1175100W  
 File# \_\_\_\_\_  
 Loss of Commodity Yes/No

Top fittings MW OK MH OK  
 Bottom Outlet Leg S OK Handle DH Bent CBX  
 Shell Tear Thermal No Mech No \_\_\_\_\_  
 Draft Sill A Bent Pass B Bent  
 Head Shield A Dent B OK  
 Skid Condition OK Leg Skewed
