Investigation Report	Doc. No.: IR-E4-19-2021 Rev. No.: 0
	Engine Type: E4	Subject: Accident 40.NC055

Aircraft Registration: **N853L**
 Aircraft S/N: **40.NC055**
 Engine s/n: **E4-A-00588** having **~1337fh**
 Date: **06.06.2021**
 Time: **~10.20**

Aircraft Type: Diamond Aircraft DA 40 NG
 Serial No.: 40.NC055
 Flight hours: >1337 hours (acc. to information provided by operator)

Engine Serial Number: E4-A-00588
 EECU Serial Number: 2786
 EECU HW Revision: AD
 Design data: EECU Software VC33_1_06_24

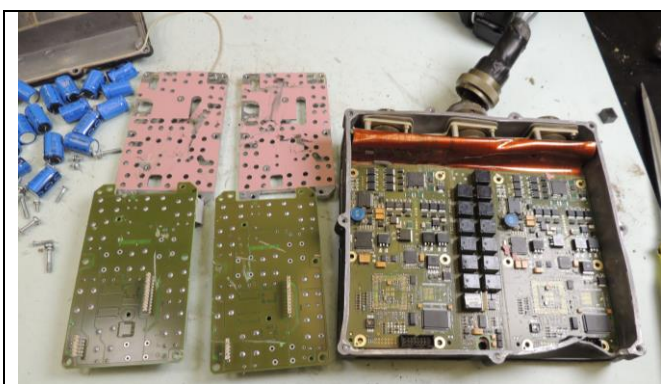
Figure 3 - EECU opened

The memory chips of ECU A and ECU B were found in good condition, except for some superficial scratches (refer to Figure 6, yellow highlighted area). These chips will be transferred together to a substitute EECU for readout.

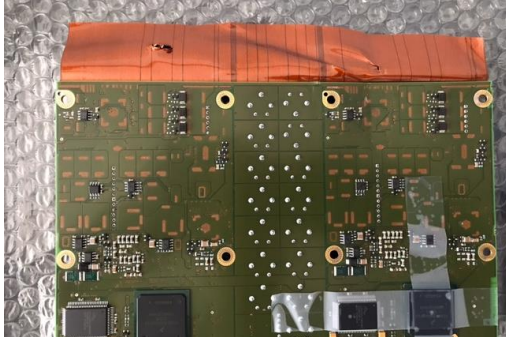
<p>Figure 8 – EECU MB upper side</p>

<p>Figure 13 - EECU MB upper Side</p>	<p>Based on the visual inspection, Austro Engine confirms that there is the possibility to recover the data. Mechanical damage had been detected on two sides of the mainboard so that the board is bent, but the location of flash memory and EEPROM do not seem to be affected.</p>

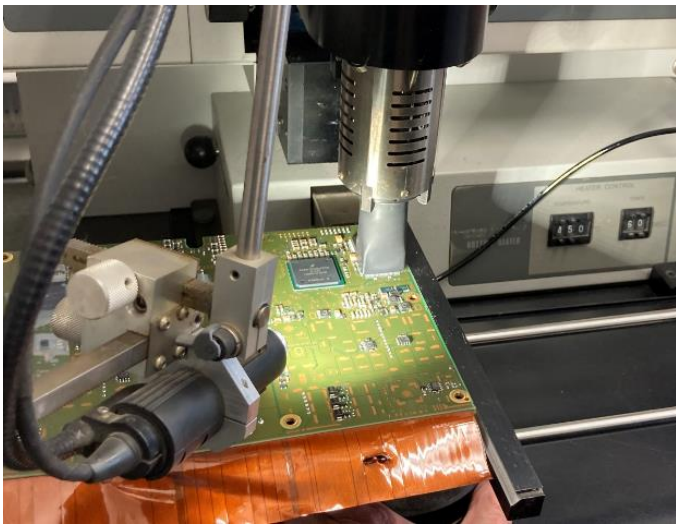
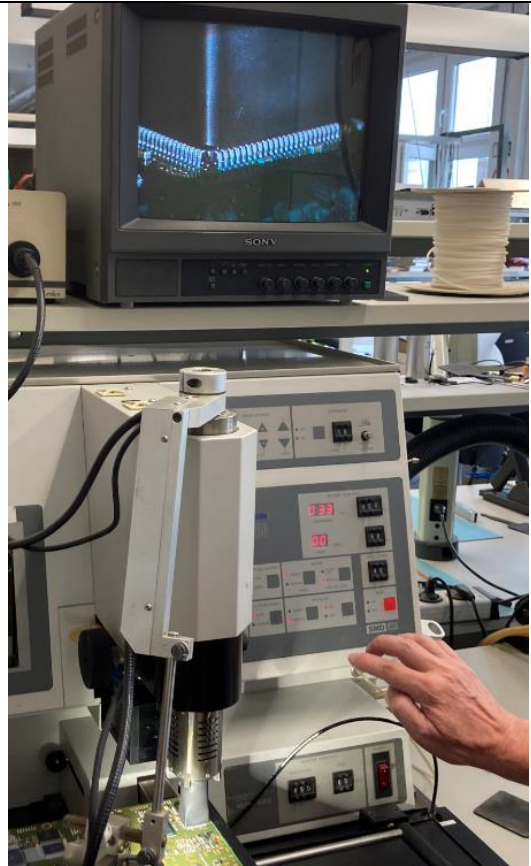
Figure 18 - EECU s/n 2786 MB memory removal

Figure 19 - EECU s/n 2786 MB memory removal

The damaged mainboard with s/n 2786 and the new mainboard with s/n 1657 will be transferred to ELPRO Elektronische Geräte Produktions GesmbH laboratory. In presence of the Austro Engine HW and SW CVE, the memory chips from the EECU mainboard with s/n 2786 will be unsoldered, then soldered on the EECU mainboard s/n 1657. The process will be documented with pictures.

The following pictures provide evidence of flash memories uninstallation/installation from s/n 2786 to s/n 1657

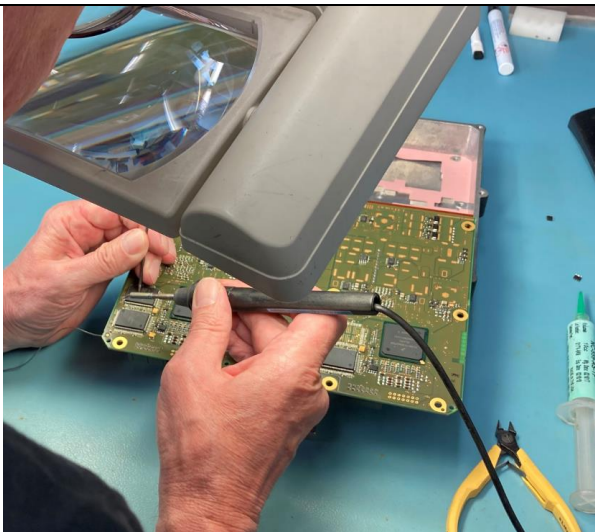
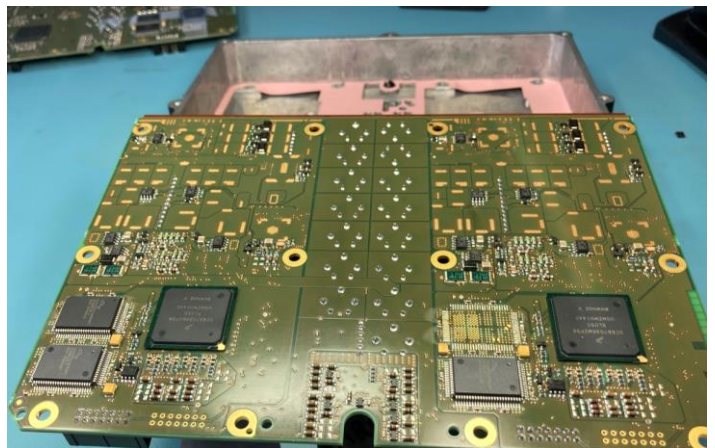
Figure 20 - EECU s/n 1657 MB memory installation

Figure 21 - EECU s/n 1657 MB memory installation

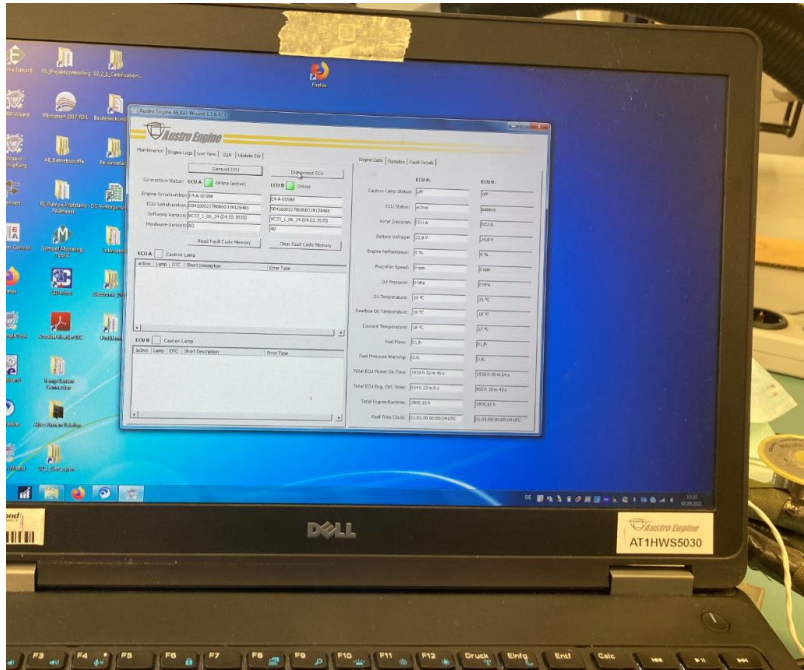
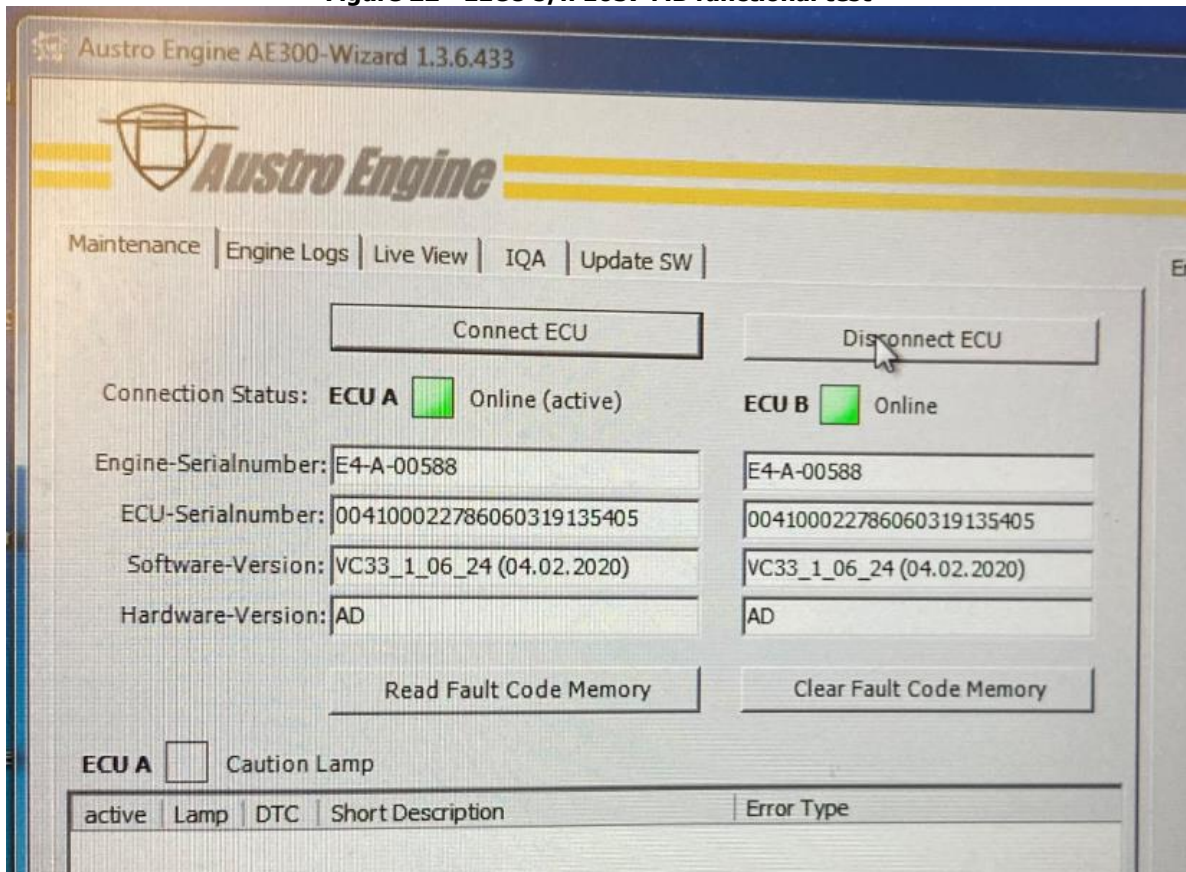
The following pictures provide the functional test after memory installation, no data was read or downloaded. The test aimed to check the EECU s/n 1657 correct operation after the memory swap.

Figure 22 - EECU s/n 1657 MB functional test

Figure 23 - EECU s/n 1657 MB functional test

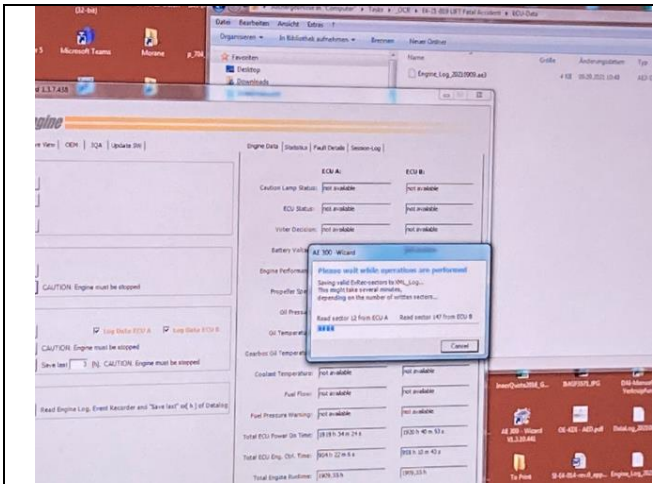
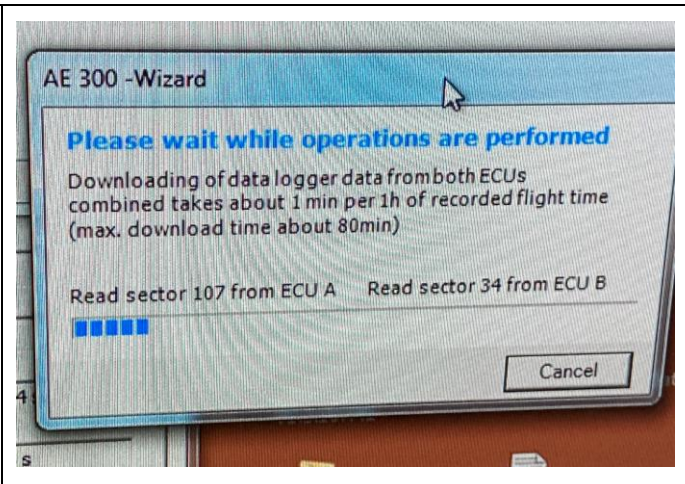
Figure 28 - EECU s/n 1657 data download

Figure 29 - EECU s/n 1657 data download

It was determined that during the last flight, ECU B was the active EECU channel while ECU A was in hot stand-by mode. It was confirmed that data related to the occurrence was recorded on ECU B, thus engine operation data prior to the occurrence is available. ECU A had a recording error (ref. to the following table), thus data recording related to last event is available only from channel B. The following errors with the relevant explanation are verified after the download:
