**Bridge Factors Factual Report Attachment 21 – BPA Cracks Report No. 1 - Email from
Mr. Jose Morales of BPA to Mr. Rodrigo Isaza of MCM dated February 13, 2018**

HWY18MH009

**FIU Pedestrian Bridge / BT-904
Crack Inspection Report**

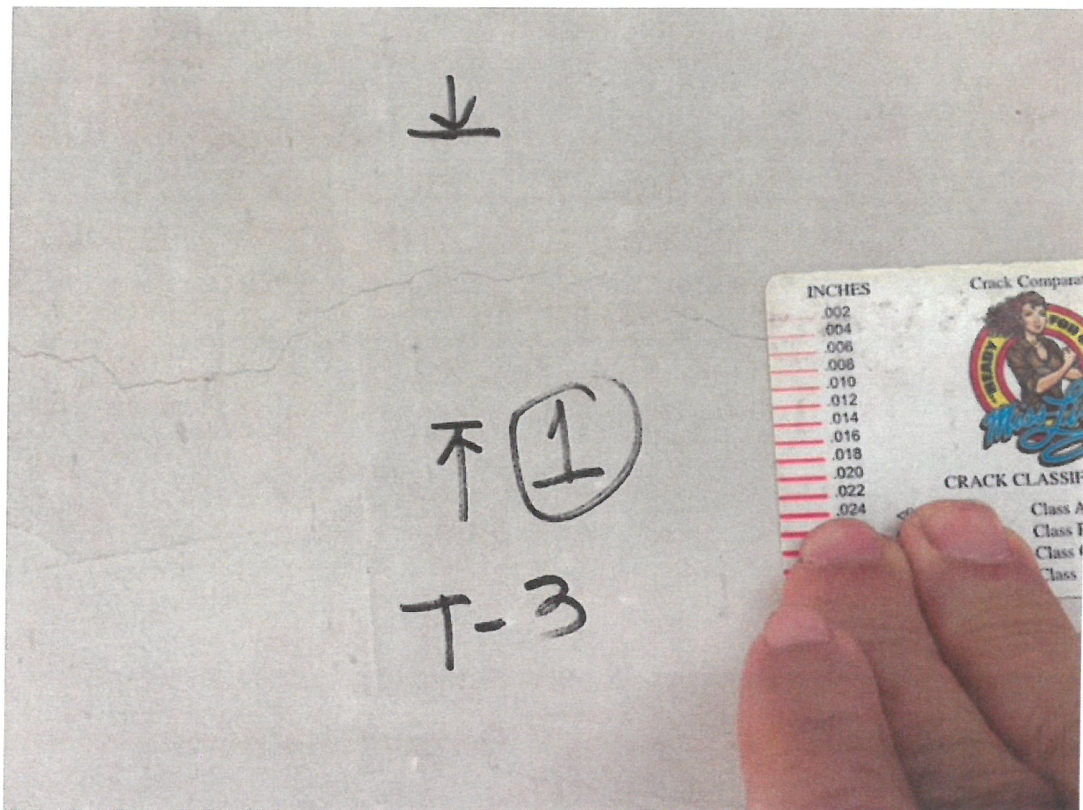
Bolton Perez & Associates, serving as the CEI for the project performed a visual inspection of main span truss members on 02-06-18 after PT bars tendons No 2 and No 11 were stressed. Cracks were found at moment of the inspection. These have been identified per truss member and a consecutive number within the member. The intent is to monitor these cracks after the bridge is fully tensioned and the main span is at the final location.

The members showing these small cracks are truss members that share the same blister at the canopy of the already stressed members No 2 (stressed 1/30/18) & No 11 (stressed 1/29/18) . We believe, this first stressing operation has temporarily created tension on members No 3 & No 10; thus, creating cross sectional cracks transferring the tension loads to the steel on these members. No other truss members within span 1 show any cracks similar to these shown on members No 3 & No 10.

- CEI's observations of the conditions of members 3 and 10 after stressing members 2 and 11 are temporary in nature. The current condition will change as soon as the stressing of the PT bars in members 3 and 10 is performed.
- The release of the canopy falsework will improve the state of stress in members 3 and 10.
- As mentioned in CEI's Report, the observations regarding the current condition of members 3 and 10 are the results of an intermediate step in the stressing operation.
- It is recommended that the truss members not be marked with a marker/sharpie as this will lead to discoloration of the concrete.
