TANK CORROSION INSPECTION REPORT

Car Reporting Mark and Number UTLX 209301 Location Forth Worth, TX (FRA & NTSB)

UNION TANK CAR COMPANY
TANK CAR UTT REPORT

STANDARD ULTRASONIC THICKNESS PATTERN

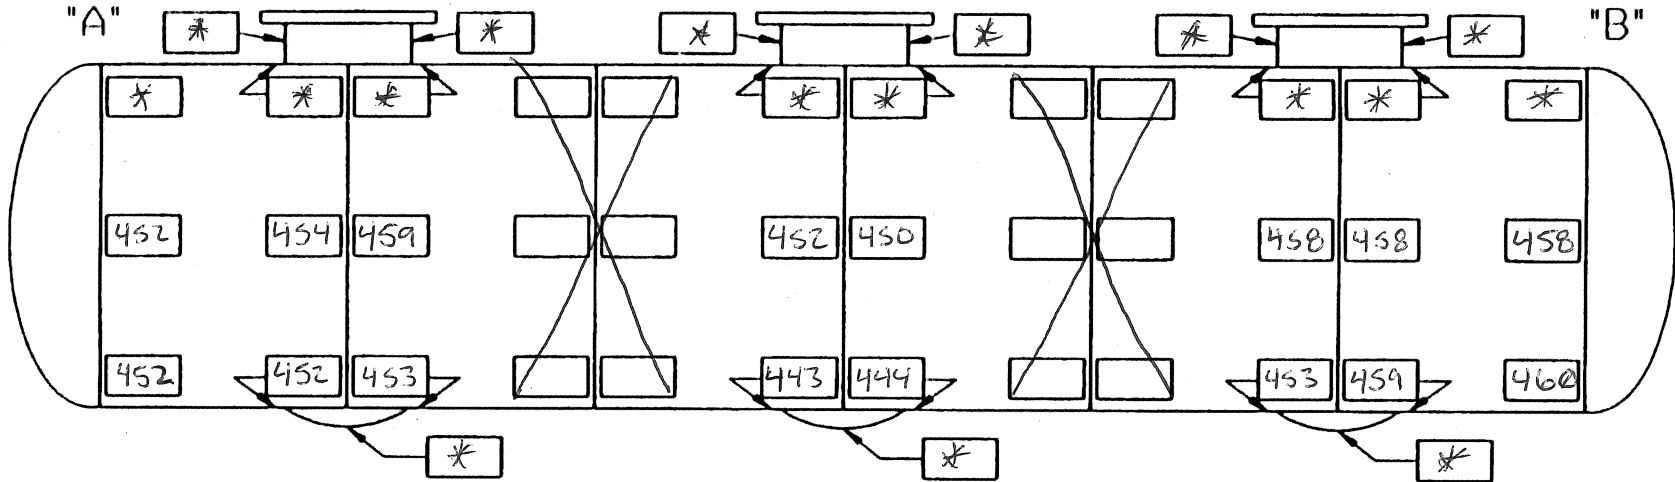
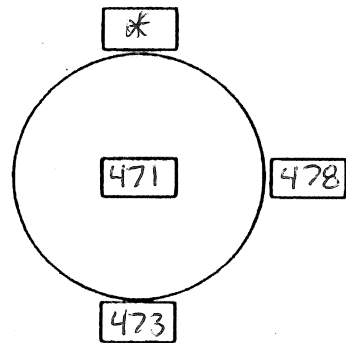
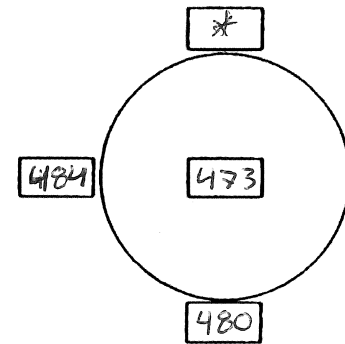
Car reporting Mark And Number UTLX 209301
Received At Shop 6/18/19 (Derailed Tank car)
Mo Day Yr.

General Corrosion from 4-5 & 7-8 o'clock positions
from head to head. Spot checks made with
UTT after grinding

4 Ring Tank
* No readings taken
on all nozzles,
Sump or 12 o'clock
positions.

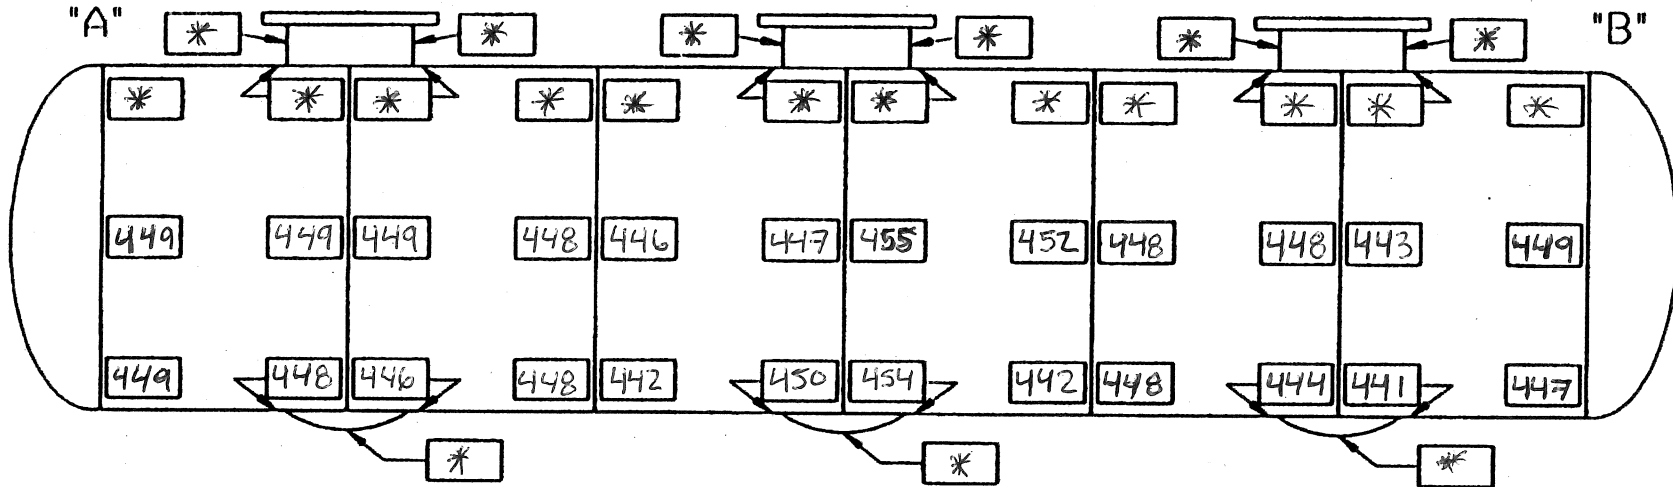
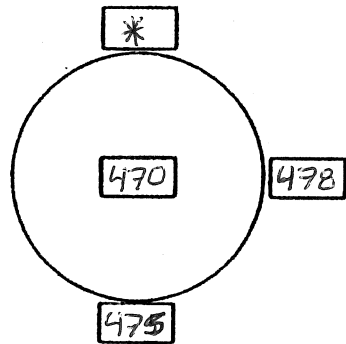
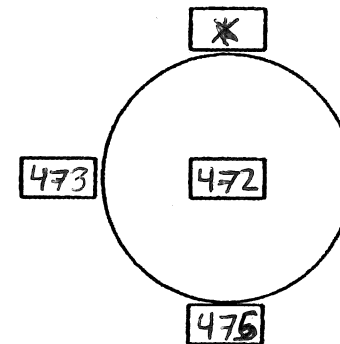
Car reporting Mark And Number UTLX 209403
Received At Shop 6/18/19 (Derailed tankcar)
Mo Day Yr.

General corrosion from 4-5 & 7-8 o'clock positions
from head to head. Spot checks made with
UTT after grinding.

6 Ring Tank

* No Readings taken on all nozzles, sump, or 12 o'clock position.
