Federal Railroad Administration
Tank Car Damage Assessment Form

| Reporting Marks | UTLX 643949 | | Car Location City/State | HYNDMAN, PA | |

Car Damage Report

Car Number UTLX 643949

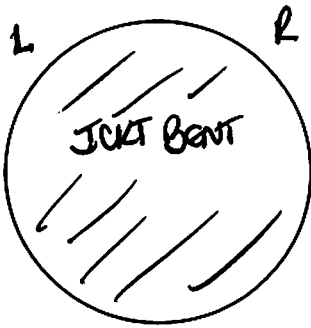
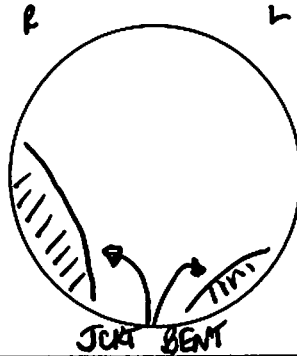
A END DRAFT SILL TWISTED & BROKEN COUPLER MISSING.
 B END DRAFT SILL IN PLACE COUPLER BROKEN
