Federal Railroad Administration
Tank Car Damage Assessment Form

Reporting Marks	SUJX 299124		Car Location City/State	HYNDMAN, PA	
Date inspected	8/5/17	Railroad	CSX	DOT Specification	DOT-111A100W-1
Last Contained	SULFUR 2448		Was product released?		
(Jacket thickness)	Jacket YES	Non-jacketed	Does car contain product		
Car builder	TRINITY	Stub Sill Design		Built Date	
Capacity (GAL)	13902		LD Limit (LB)

Car Damage Report

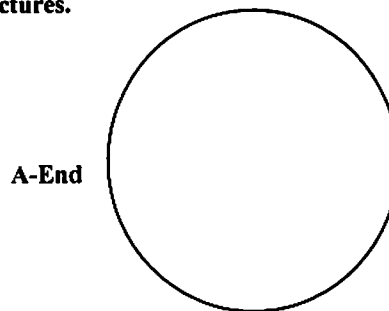
BOTTOM

Top fittings manway bolt (U) damaged - VENT DAMAGED
Bottom Outlet OPEN - HANDLE BENT
Punctures NO
Draft sill A & B OK
