DCA21FA174

Specialist's Factual Report - Attachment 7
Pratt & Whitney DCA21FA174 Metallurgical Investigation Report, July 29, 2022

Final Report for DCA21FA174

Subject: Metallurgical Investigation of High Pressure Turbine (HPT) Blades from an accident on July 2, 2021 in Honolulu, Hawaii involving a Boeing 737-200 aircraft, N810TA, operated by Rhodes Aviation Inc., dba Transair Flight 810.

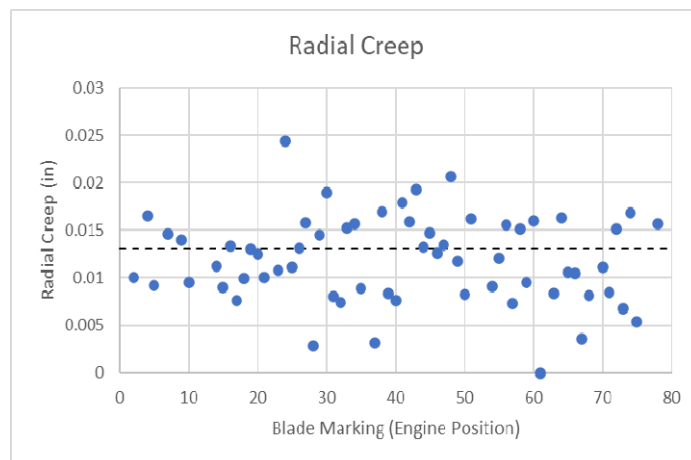
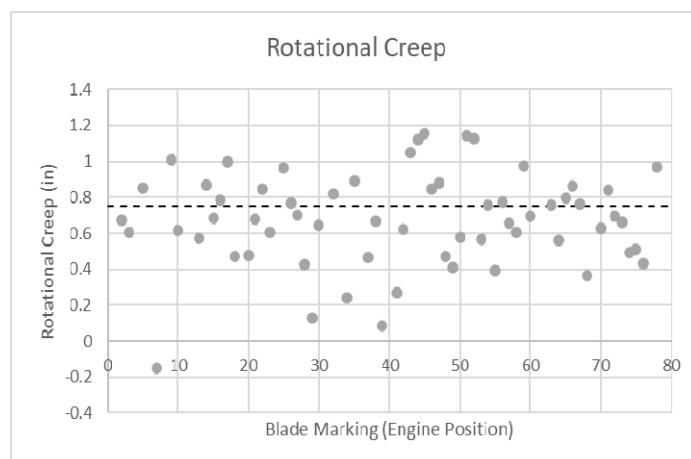
Appendix 1: Results of Non-Destructive Dimensional Inspections. Red text dimensions are rejectable to the engine manual. Orange text dimensions must be repaired per the engine manual. Blank cells could not be measured due to the interference of barnacles.
