Bridge Factors Factual Report Attachment 73 – FHWA Assessment of Bridge Design and Performance

**Florida International University Pedestrian Bridge Collapse Investigation:
Assessment of Bridge Design and Performance**

National Transportation Safety Board
NTSB Accident ID: HWY18MH009

September 12, 2019

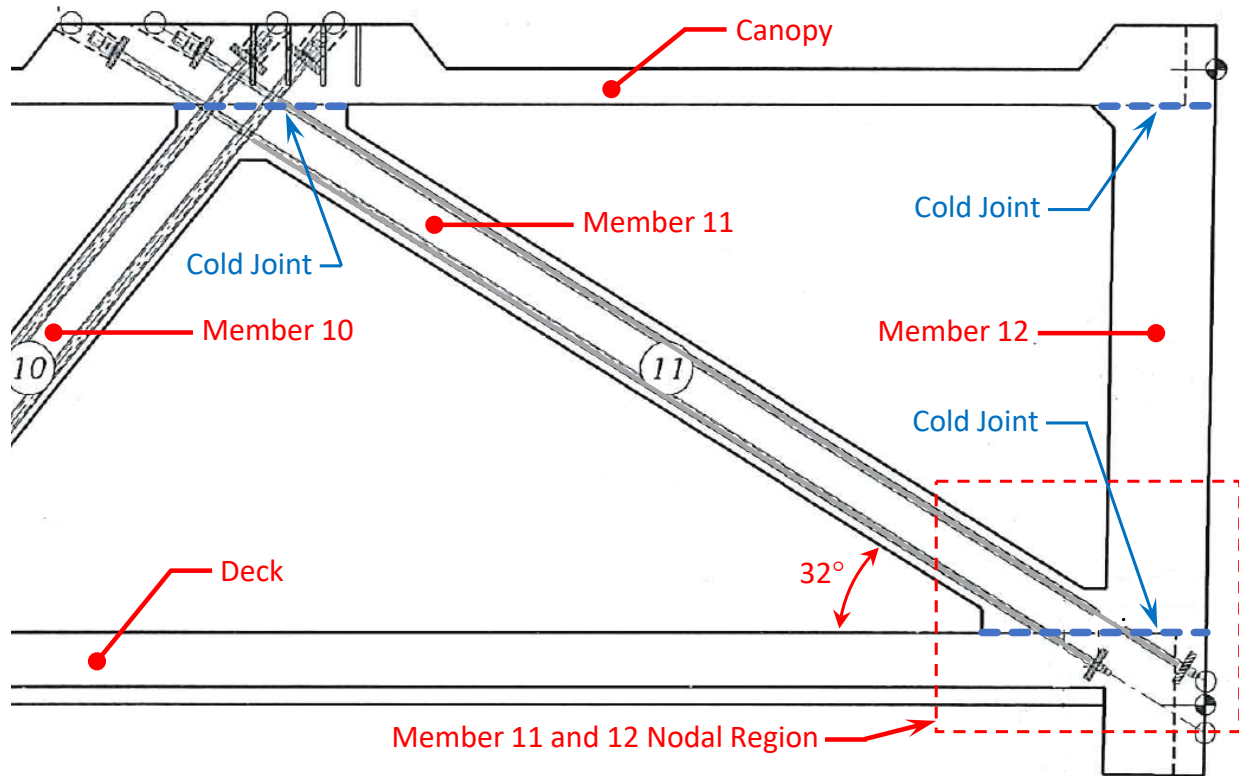
Figure 8. Elevation view of a vertical cross section through the longitudinal centerline of the member 11 and 12 nodal region.

As this was a simple span structure and a single plane truss, there were no alternate load paths that bypassed this nodal region. The cold joint at the base of truss members 11 and 12 is in a location that would be subjected to significant shear and axial stresses.

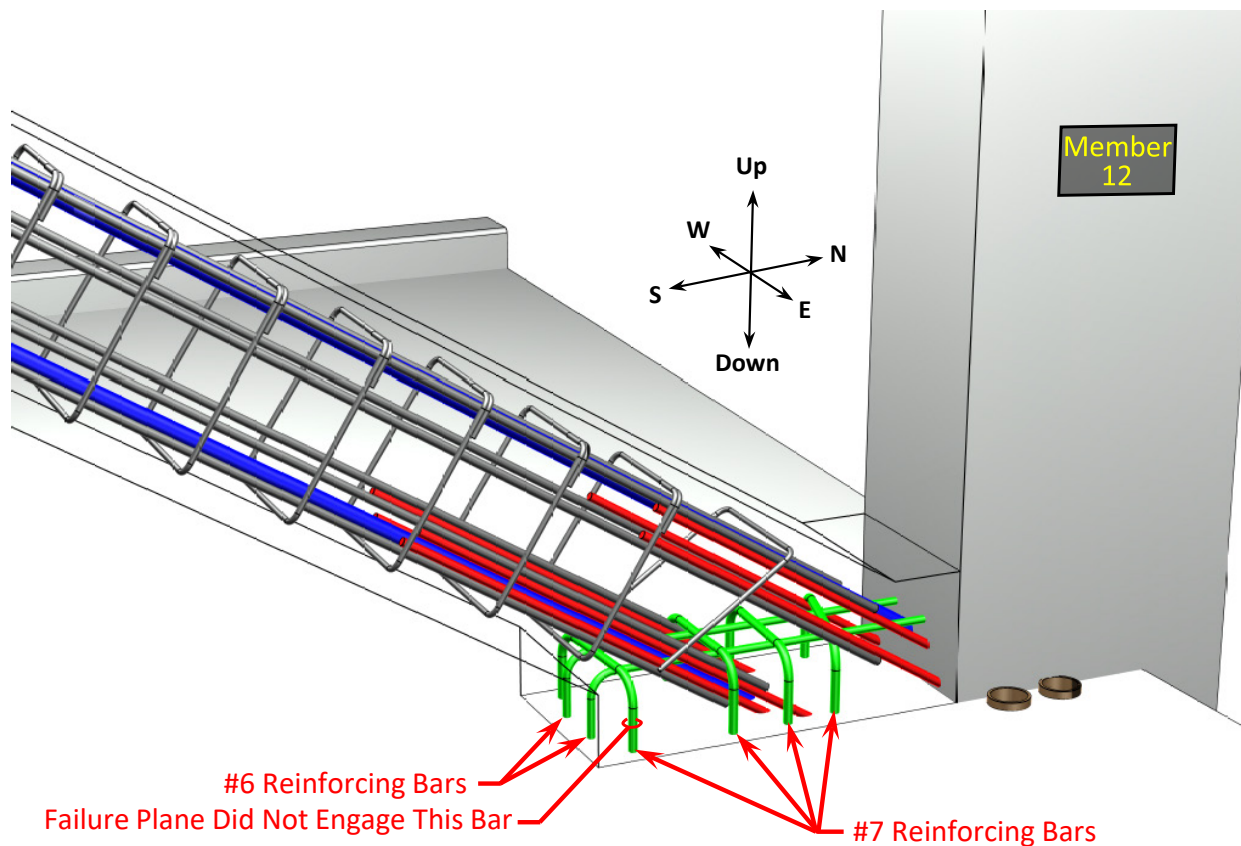
Figure 14. Illustration showing the steel reinforcing bars passing from the deck into the base of truss member 11.

It is important to note that the longitudinal post-tensioning anchorages in the deck were not in a location that could resist a significant portion of the northward thrust applied to the nodal region by truss member 11. As will be discussed in Section 6.3.2 of this report, only horizontal loads applied within the footprint of truss member 11 had an opportunity to flow outward to the longitudinal post-tensioning anchorages. Since the horizontal interface under truss member 11 was cracked and the node was translating northward, it appears that only the northward shear force transferred into the deck via the reinforcing bars traversing the member 11 footprint shear plane would have been reacted by these anchorages. Recall that there were only six #7 bars engaged on this shear plane (see Figure 14).

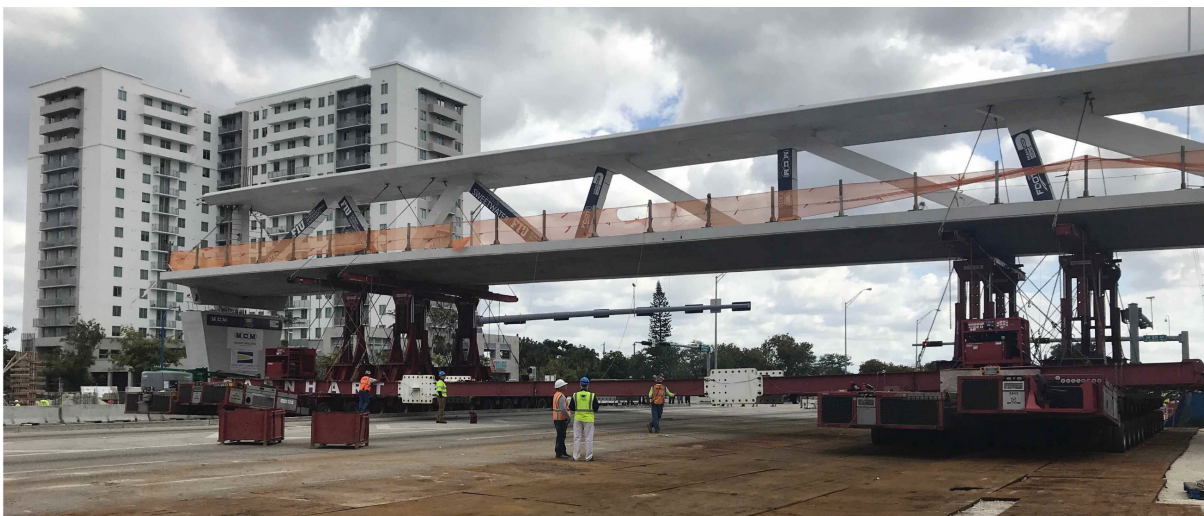
Although apparently not intentionally roughened, the upper and lower concrete surfaces at this plane would have offered some interlocking resistance due to their matched profiles. The SPMT transport process imposed one cycle of reverse shear demand on a critical plane at the cold joint. Given the crack that had already formed on this horizontal shear plane during formwork release, the single reversal cycle on the previously cracked plane would have likely decreased the interlock. Thus, once the bridge had been placed on the permanent support piers, the centroid of the shear resisting mechanisms under truss members 11 and 12 would likely have shifted farther to the north.

Figure 15. Photograph showing SPMT transport of the bridge.

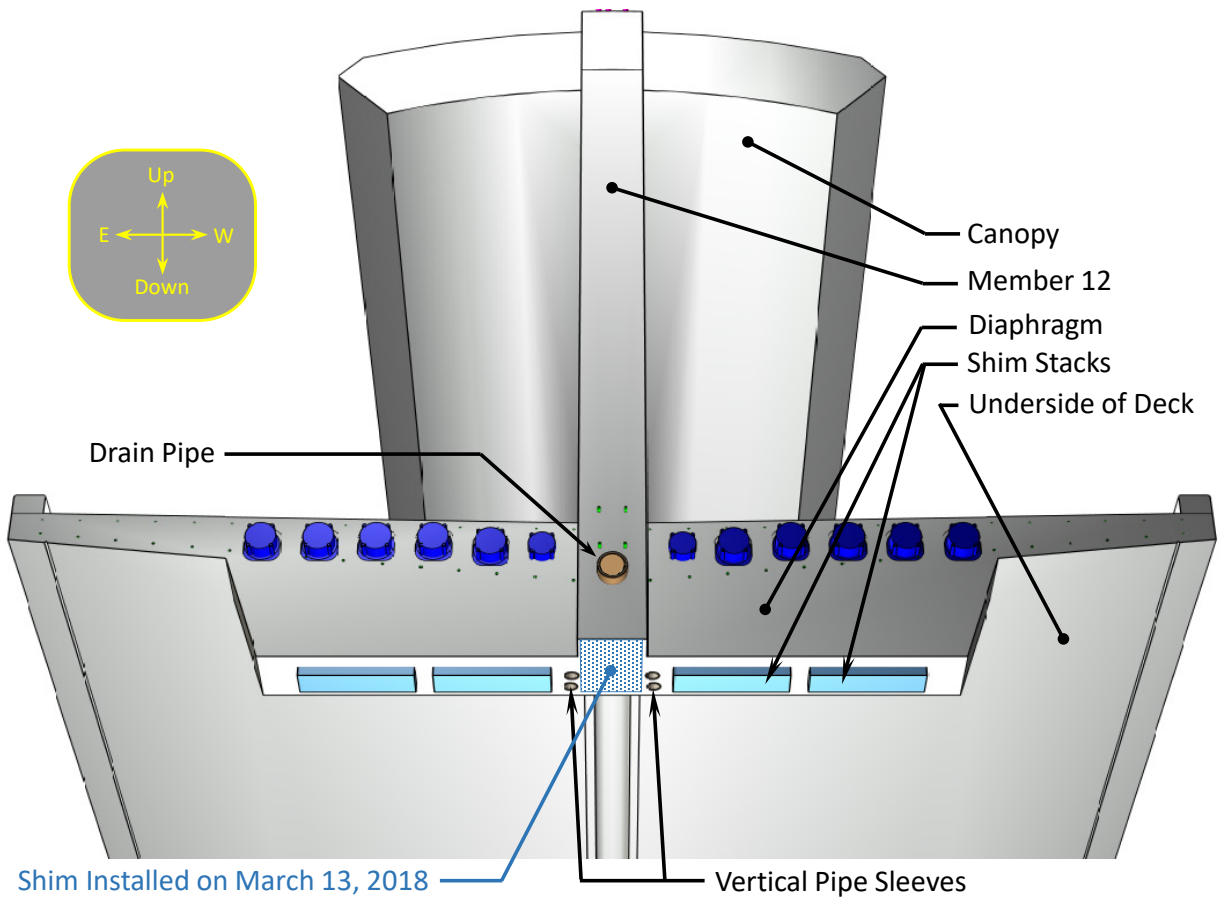
1. Placement of additional shim between the underside of the deck diaphragm and the top of Pier 2 within the truss member 12 footprint, with shim installation occurring on March 13, 2018. This is further discussed in Section 3.7 and shown in Figure 16.
2. Retensioning the post-tensioning rods in truss member 11, with re-tensioning occurring on March 15, 2018. This is further discussed in Section 3.8.

Figure 16. Illustration showing the post-SPMT transport support locations on the underside of the north diaphragm.

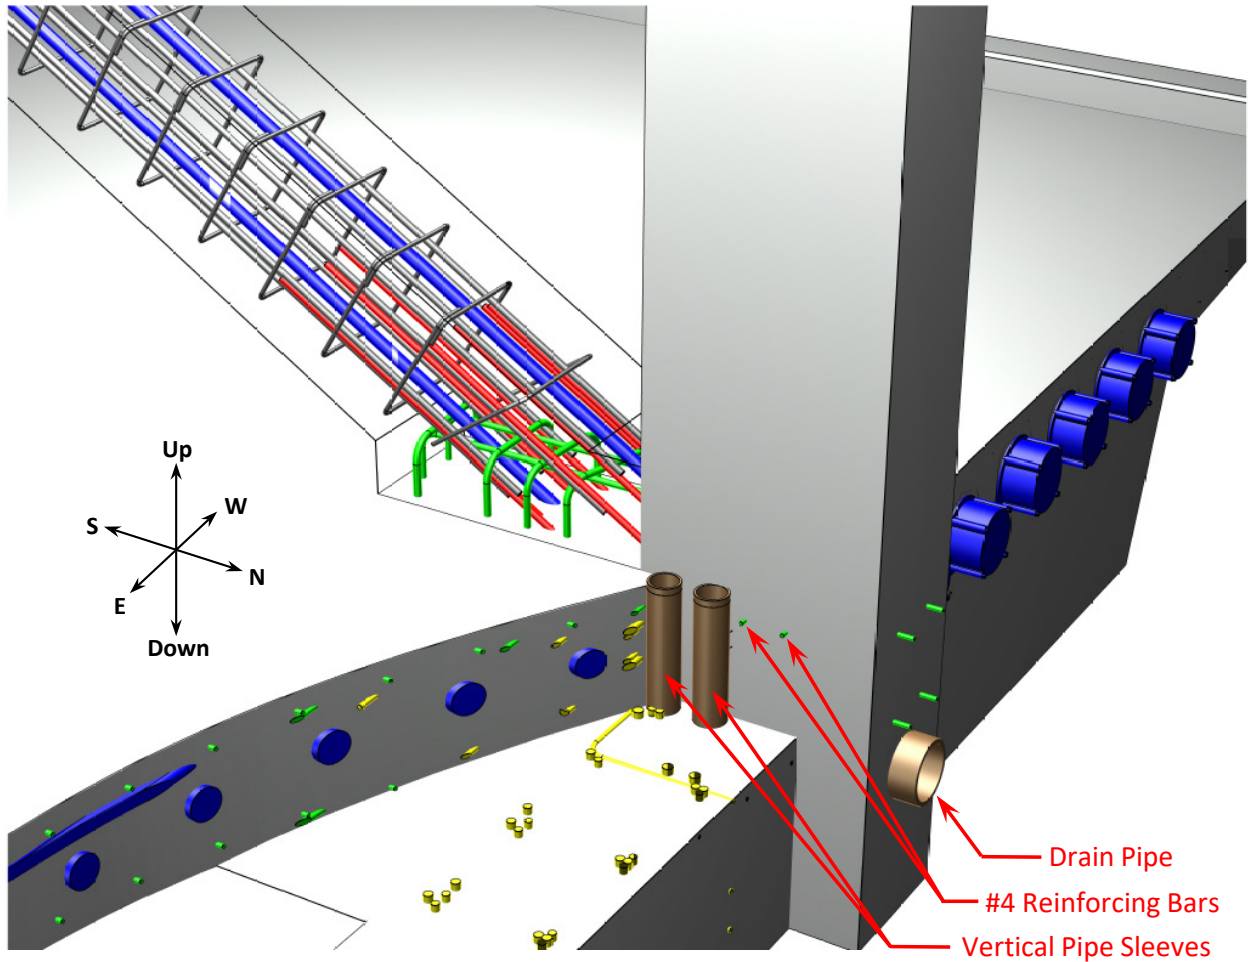
Figure 20. Cutaway illustration showing the reinforcing bars crossing and the conduit paralleling the shear plane below the east face of truss member 12.

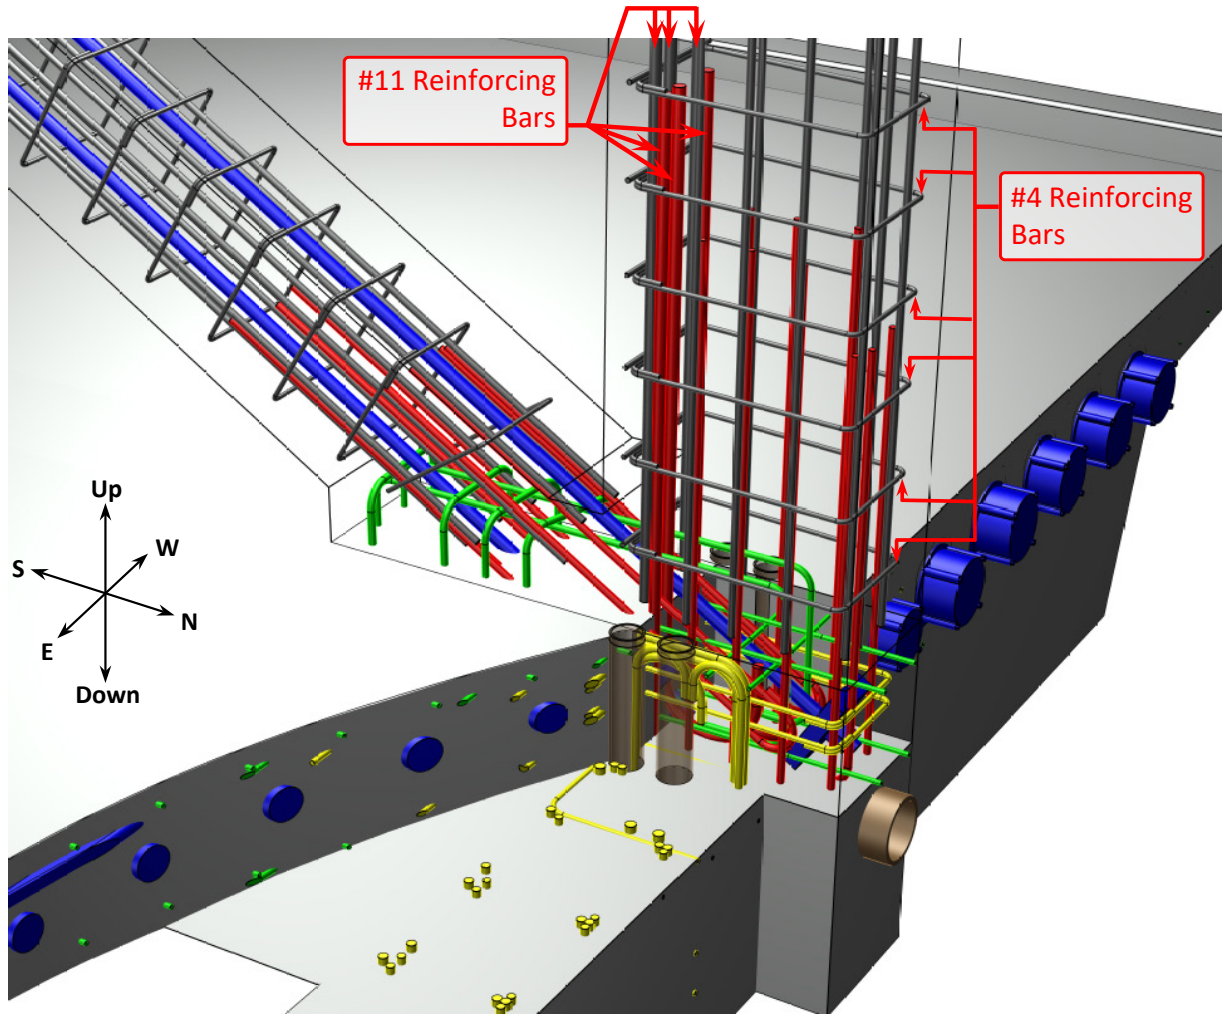
Figure 21. Cutaway illustration showing the reinforcing bars and conduits within and near the base of truss member 12.

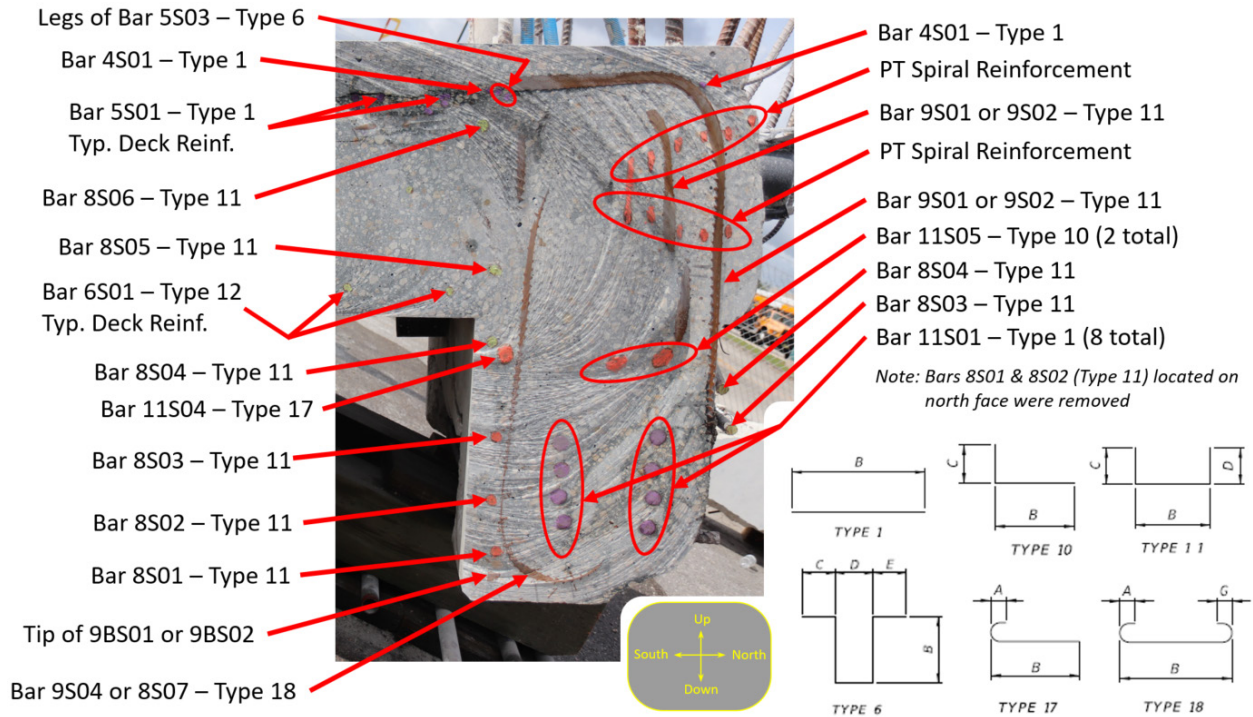
No significant deviations from the construction plans were identified through the assessment of in-place steel reinforcement sizes and locations.

Figure 54. Illustration of reinforcing bar assessment and reconciliation, shown here for a portion of the deck after being cut from the retained nodal region deck element. The vertical cut is approximately 20-inches east of the east face of member 12.

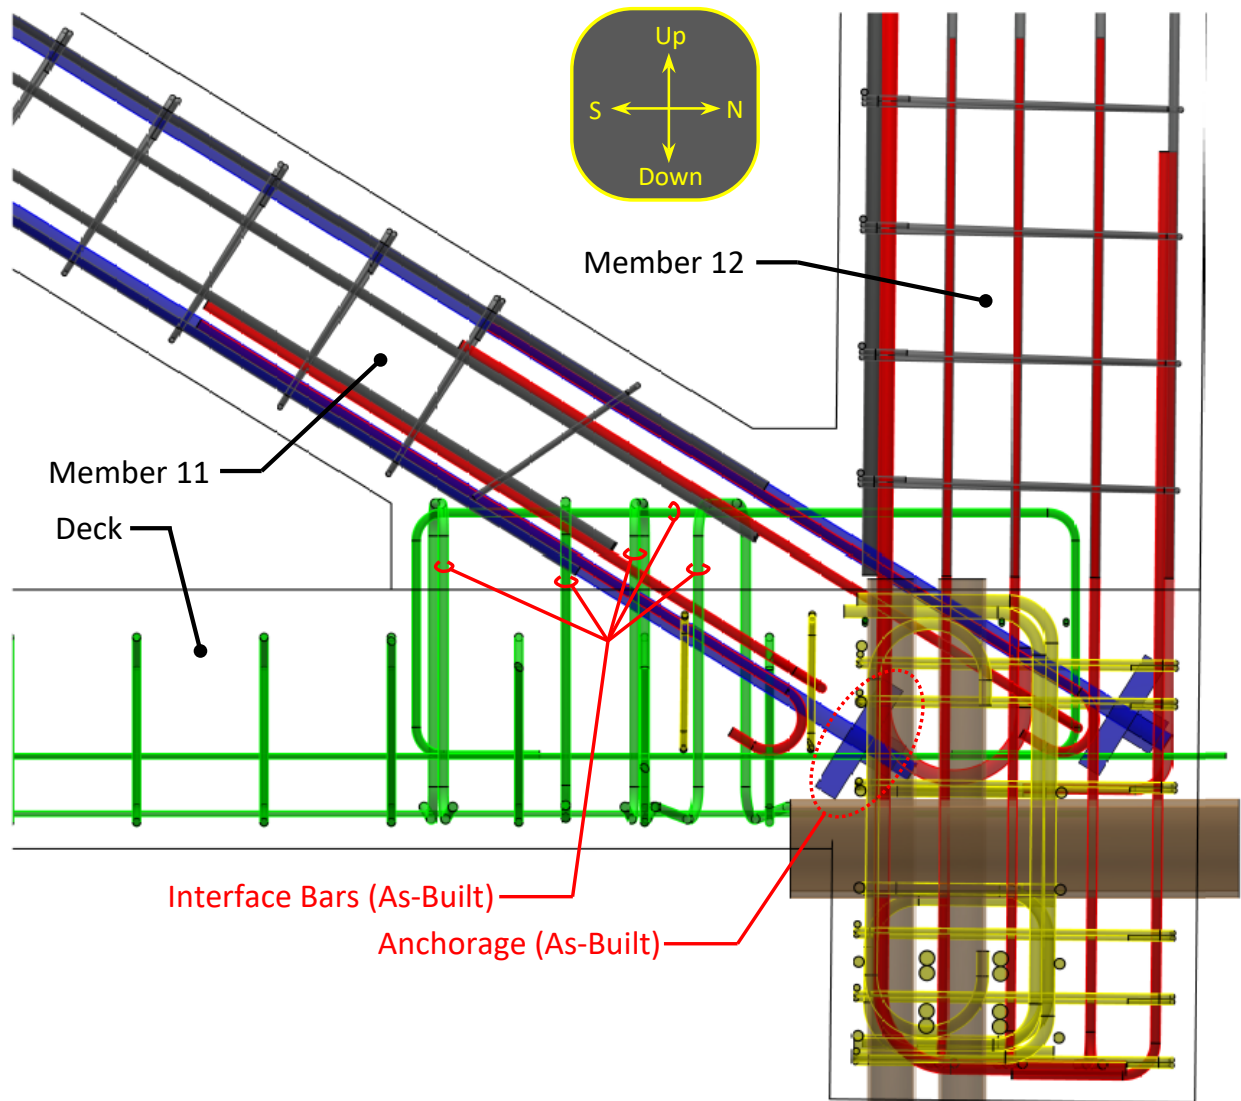
The crack in the truss member 11 and 12 nodal region began at the reentrant corner between the south face of truss member 11 and the deck. It largely followed the location of the cold joint between truss member 11 and the deck. The southernmost portion of the crack deviated from the cold joint, instead following the projection of the south face of truss member 11 through the chamfer that closed the reentrant corner between the south face of truss member 11 and the deck. This specific path of the southernmost portion of this crack is of significance in that this path allowed the crack to bypass 21 percent of the reinforcing steel area that was, per the FIGG Design and FIGG Plans, intended to offer interface shear resistance at the base of truss member 11. Per the construction plans, eight #7 reinforcing bars and two #6 reinforcing bars were to cross the cold joint under truss member 11. Although all ten bars were present in the structure, because of the detailing specified on the FIGG Plans, the southernmost two #7 bars were not anchored above the crack. Thus, those two bars were not engaged by the crack and could not offer resistance to the northward thrusting shear demand of the upper portion of the node. Figure 14 provides an illustration showing the size and location of the ten legs of these reinforcing bars. These bars are also shown later in the report in Figure 57.

Figure 57. Illustration showing a rendering of the as-built reinforcement geometry the member 11 and 12 nodal region along the truss line of the bridge.

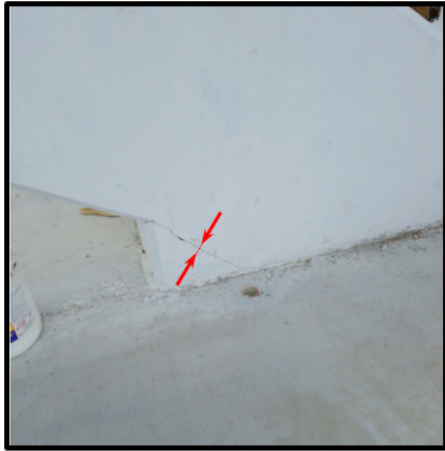
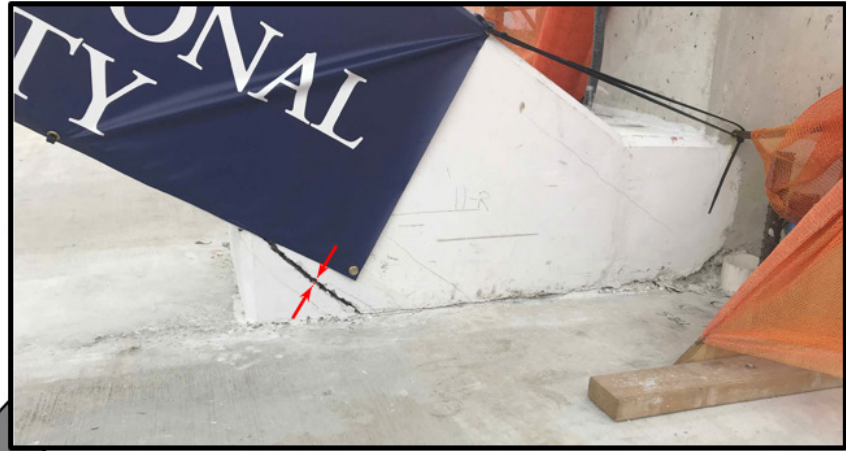
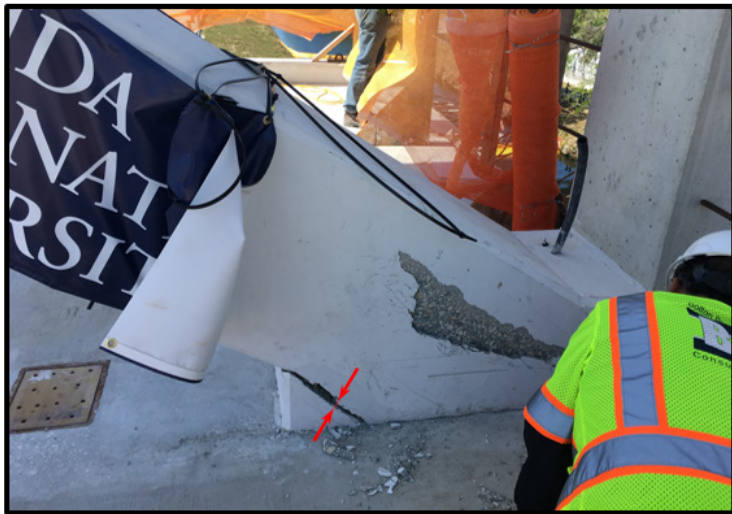
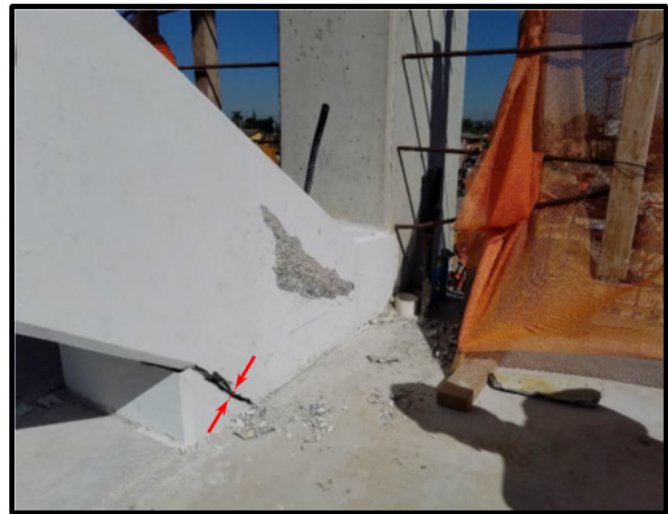
The structural cracking and northward dislocation of the upper part of the member 11 and 12 nodal region as documented in the days leading up to the collapse is strong evidence that the structure was progressing toward failure.

Figure 58. Photographs showing the progression of cracking on the east side of member 11 at the deck.

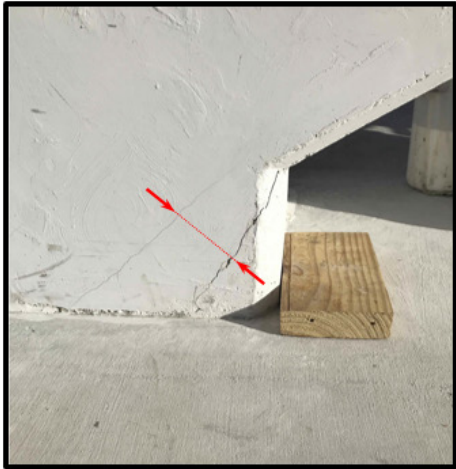
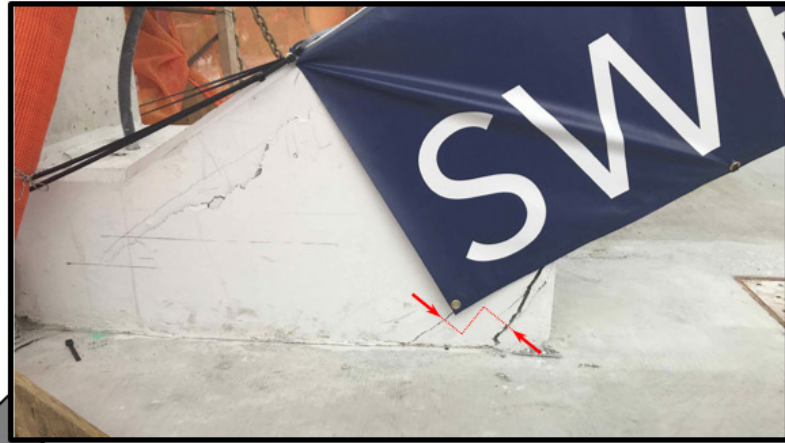
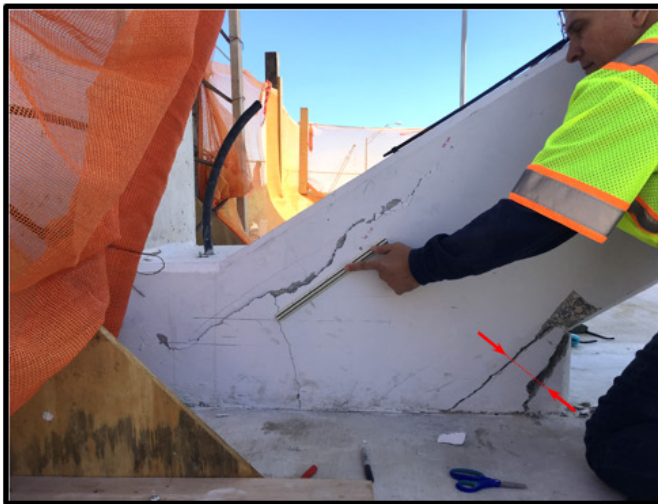
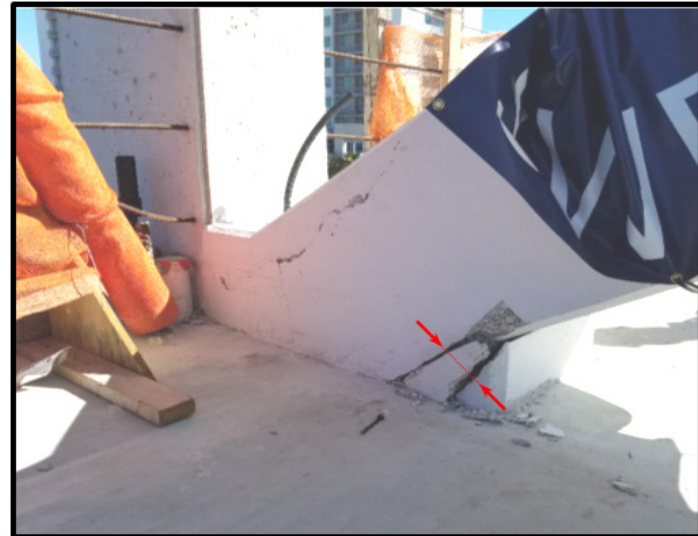
Figure 59. Photographs showing the progression of cracking on the west side of member 11 at the deck.

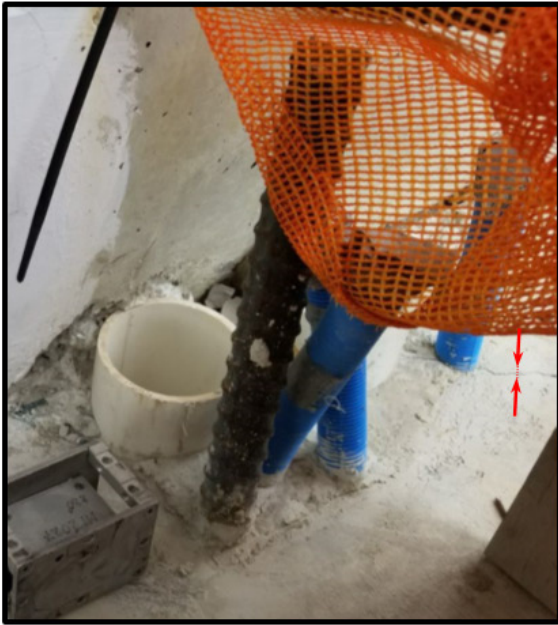
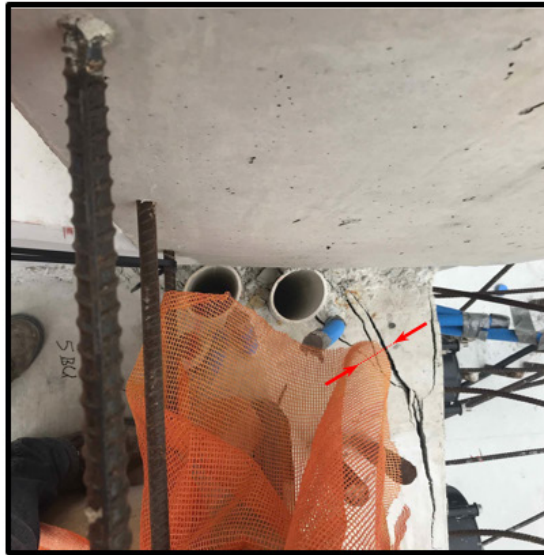
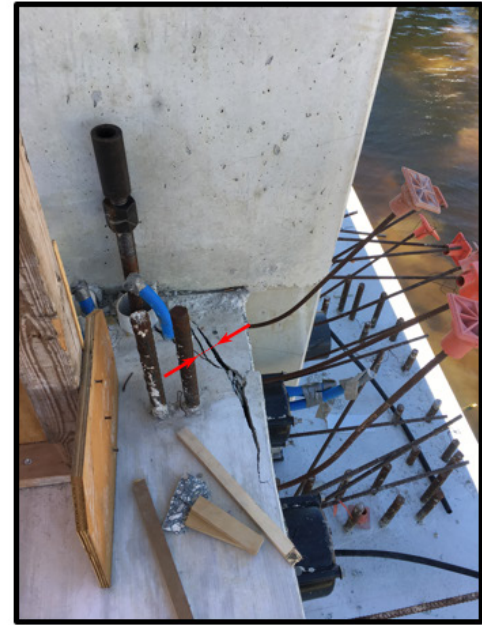
The northward movement, or dislocation, of the upper part of the truss member 11 and 12 nodal region relative to the deck is apparent in two specific structural behaviors that were observed. First, cracking was observed on the north face of truss member 12. The northward movement of the base of this member, while the top of the member was restrained from translation and rotation by the canopy, caused the member to bend in double curvature and exhibit flexural cracking. These north face cracks, annotated in Figure 35 and Figure 41, were perpendicular to the flexural tensile extreme fiber of the member and were observed within the lower half of the member. Second, cracking consistent with interface shear along much of the node and punching shear at the northern extent of the node was observed in the deck around the bases of truss members 11 and 12.

Figure 60. Photographs showing the progression of cracking on the north end of the deck on the east side of member 12.

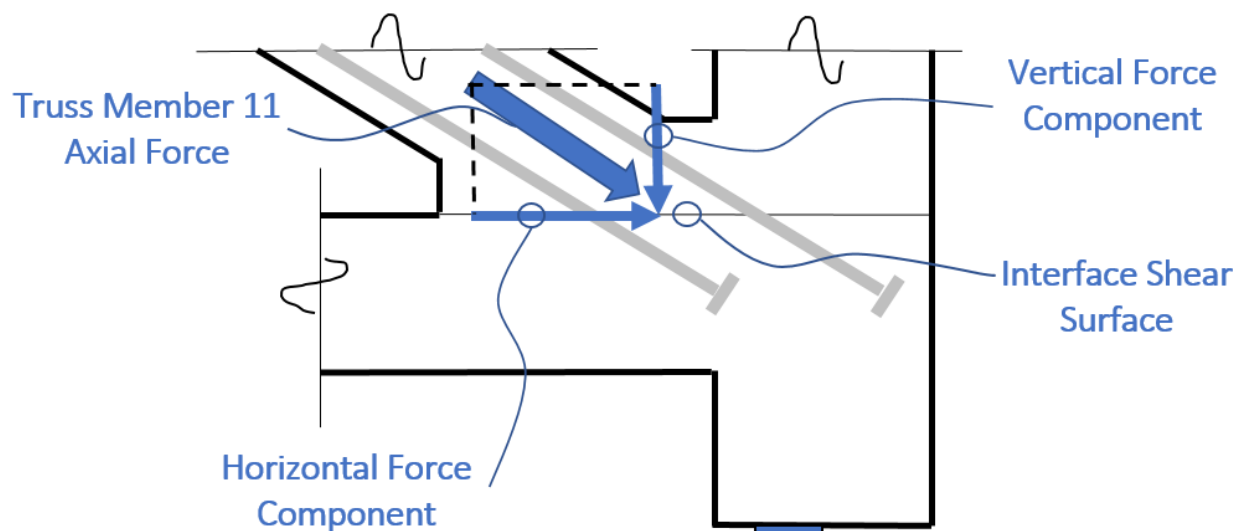
Each analytical model generated multiple force effects for every structural component included. For the design of the truss member connections, the truss member axial forces were extracted from these analyses and used in the design of each truss member connection. The axial force in the truss member was subsequently resolved into vertical and horizontal components. This resolution of forces is illustrated in figure 62 for the 11-12 nodal region, where the large arrow represents the axial force in Member 11 from the analytical model, and the two smaller arrows represent this axial force resolved into two orthogonal components acting on the interface shear surface. The vertical component is the compressive or clamping force that contributes to interface shear resistance. The horizontal component is the shearing force on the interface shear surface or the interface shear demand. Axial forces in the truss members due to dead load (self-weight) of the structural components and non-structural attachments (DC), pedestrian live loading (PL), forces induced in the structure from post-tensioning (PT), and forces induced in the structure due to temperature (TU) were extracted from the analytical models and used in the FIGG Design of the force transfer across the shear interface surface in the nodal regions.

Figure 62. Force from truss member 11 on the nodal region shear interface surface.

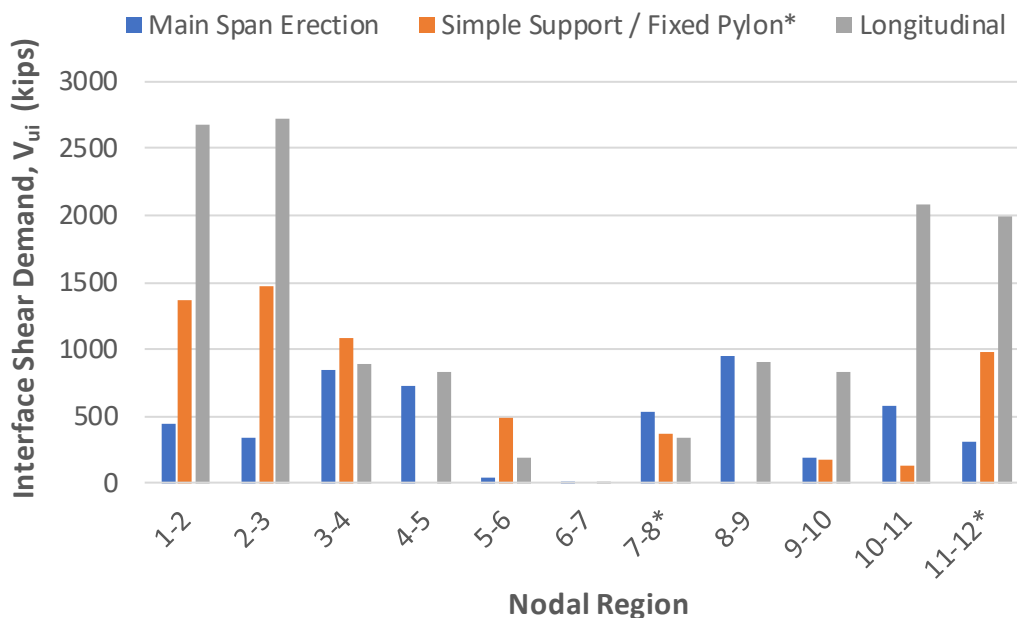
Figure 63. Nodal zone interface shear demand results generated for the FIGG Design.

The chart in figure 63 shows that the interface shear demand generated for each construction stage can vary significantly. Both the magnitude of the interface shear demand and concurrent permanent net compression force, P_c , need to be considered for each construction stage in determining the governing load case for each nodal region. Therefore, the largest interface

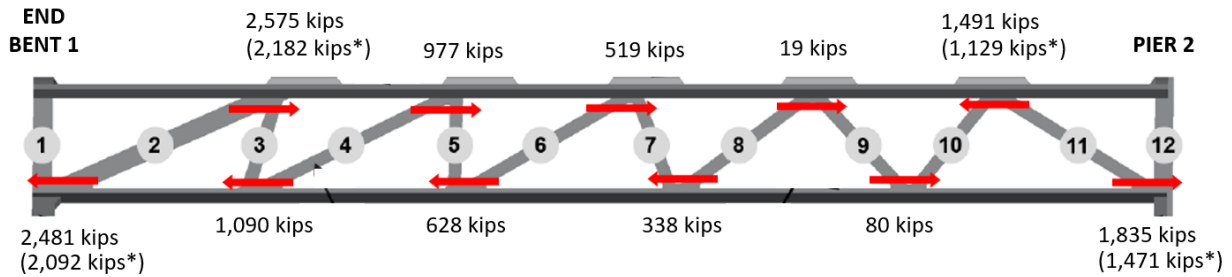
Figure 64. Interface shear demands from FHWA independent analysis.

The FHWA Check generated significantly higher interface shear demand for the nodal regions at the ends of truss member 2 (nodal regions 1-2 & 2-3) and truss member 11 (nodal regions 10-11 & 11-12) when compared to the results used for the FIGG Design. The Simple Support and Fixed Pylon Model results which were used exclusively in the FIGG Design resulted in the underestimation of interface shear demand compared to the FHWA Check as highlighted here:

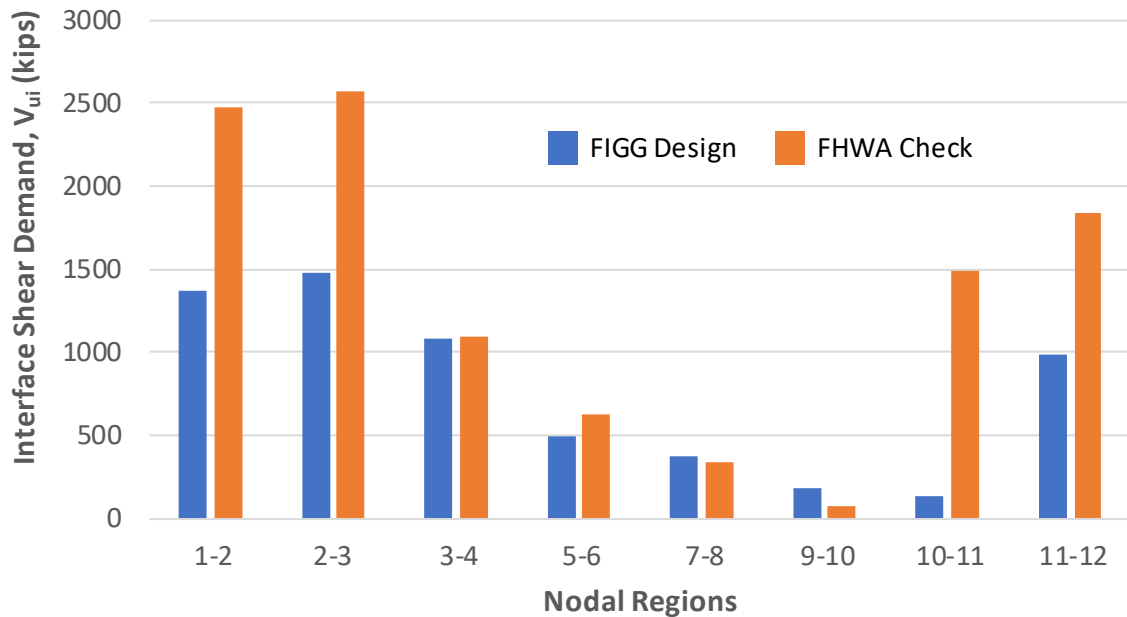
- Nodal Region 1-2 – The force effect selected by the FIGG Design of this nodal region underestimated the maximum force effect by approximately 1,100 kips (49%)
- Nodal Region 2-3 – The force effect selected by the FIGG Design of this nodal region underestimated the maximum force effect by approximately 1,100 kips (43%).
- Nodal Region 10-11 – The force effect selected by the FIGG Design of this nodal region underestimated the maximum force effect by approximately 1,360 kips (91%).
- Nodal Region 11-12 – The force effect selected by the FIGG Design of this nodal region underestimated the maximum force effect by approximately 850 kips (46%).

Figure 65. Nodal zone horizontal shear modeling results comparison between FIGG Design and FHWA Check.

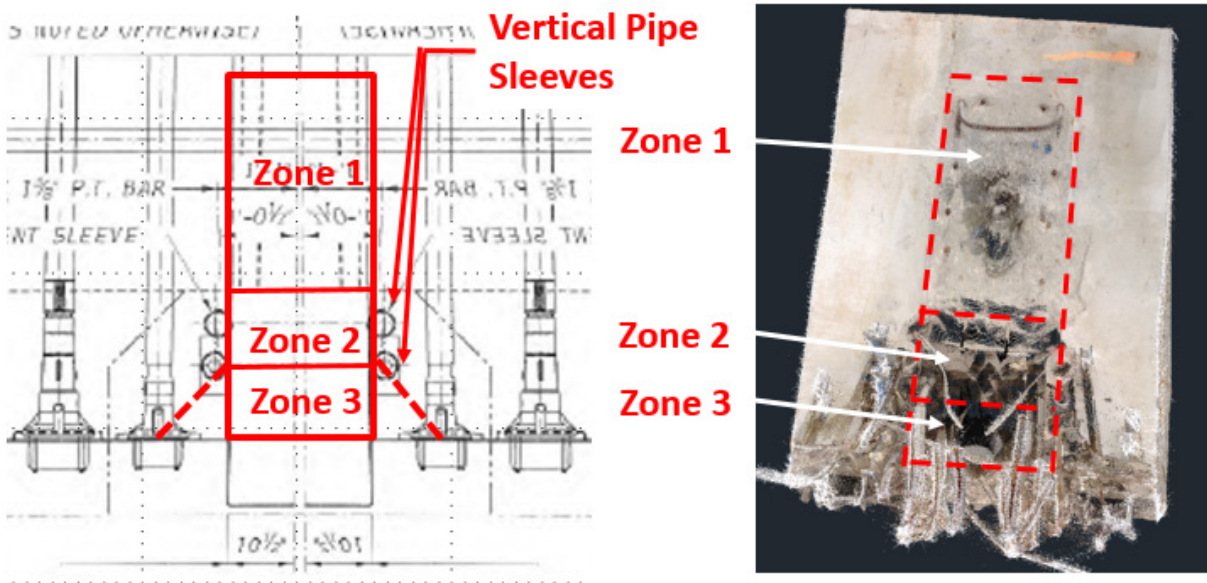
A unique detail that occurs at nodal region 11-12 is the presence of two vertical pipe sleeves that flank both faces of the 11-12 nodal region (4 pipes total). These vertical pipes penetrate the full depth of the bridge deck and essentially isolate or “wall-off” the area bounded by these pipes. Consequently, the area identified as Zone 2 in Figure 66 is also isolated from the deck and therefore should not be used in the interface shear capacity calculation for the 11-12 nodal region.

The interface shear designs included in the FIGG Design only used the interface shear transfer areas under truss member 2 for the 1-2 nodal region design and interface shear transfer area under truss member 11 in the 11-12 nodal zone for the nodal region designs. Although the designer’s intent cannot be deduced, the FHWA Check determined that the FIGG Design correctly chose to exclude Zone 2 and Zone 3 in determining the area engaged in interface shear transfer.

Figure 66. Interface surface zones 1, 2, and 3.

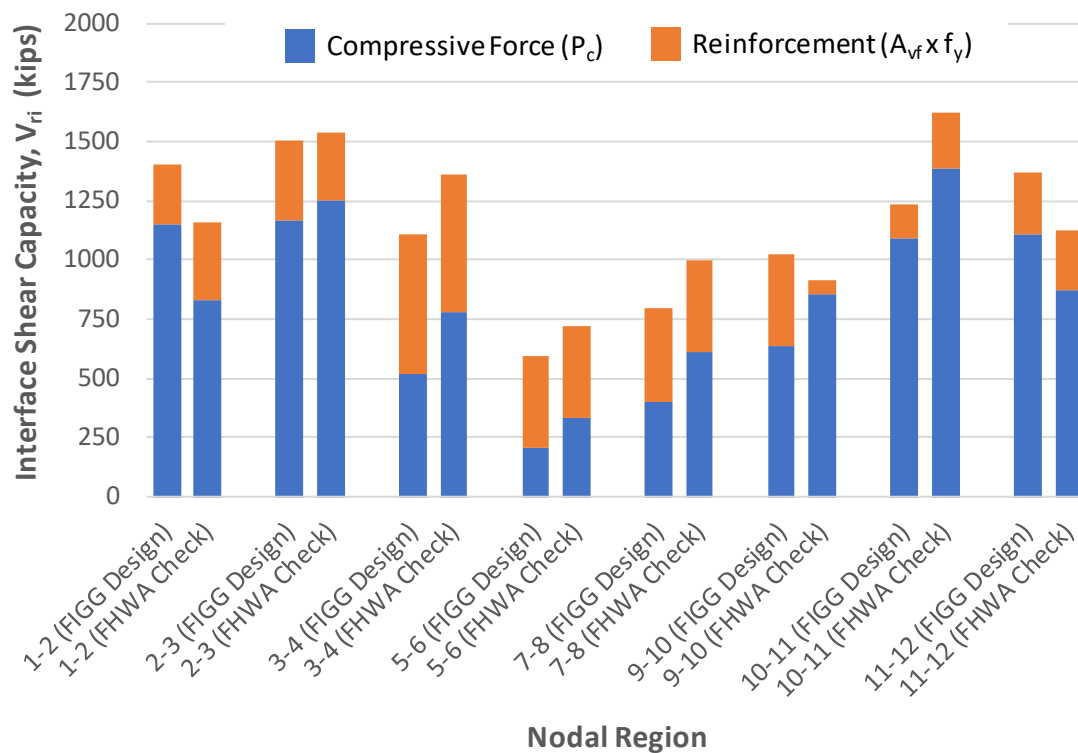
Figure 67. Interface shear capacity breakdown.

The capacities shown in the bar graph in Figure 67 are broken down into the two capacity-supplying mechanisms. These are identified as capacity from compressive force (P_c) and capacity from reinforcing steel ($A_{vf} \times f_y$). The interface shear capacity values calculated in the FIGG Design are shown. The FHWA calculated capacity values based on the FIGG Plans with appropriate interpretation of the AASHTO LRFD are also shown.

This figure shows that, for the highly loaded nodal regions of 1-2 and 11-12, the interface shear capacity is highly dependent on the compressive force (P_c) that was assumed to act on the interface. The high dependence on a capacity from a compressive force that was significantly and inappropriately overestimated resulted in a significantly under-reinforced connection. Had

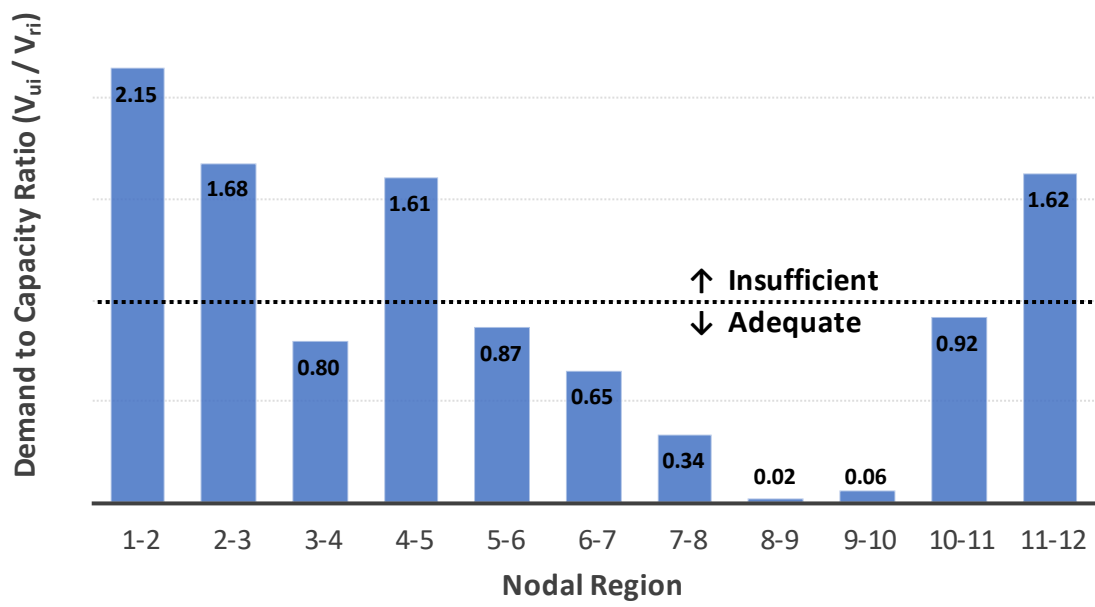
Figure 68. Demand to capacity ratios for main span nodal regions.

Figure 68 below displays ratios in which the maximum interface shear demands (forces) acting upon a nodal region is divided by the capacity provided by the nodal region. This produces a ratio commonly referred to as the demand to capacity ratio (D/C). A demand to capacity ratio less than or equal to 1.0 represents an assessment that the capacity provided by the nodal region can adequately carry the applied loading (as prescribed by the design requirements). The lower the value the more conservative the design. A demand to capacity value above 1.0 represents an assessment that the capacity provided by the nodal region is not sufficient to carry the applied loading (as prescribed by the design requirements). The higher the value, the more under-designed the connection. Figure 68 includes D/C ratios for every nodal region in the main span at the time of collapse.

The maximum demands used to compute the D/C ratios in figure 68 were based on the FHWA Check load case for Stage 2 (from Table 2). The capacity was calculated using the interface shear transfer area, A_{cv} , and the reinforcing steel area crossing the interface plane, A_{vf} , as shown on the FIGG Plans (from Table 3). Cohesion was not included in these capacity calculations. In addition, the compressive force, P_c , acting on each interface surface is the concurrent load generated by the FHWA Check for Stage 2. The compressive force used for nodal regions 1-2 and 11-12 includes the temporary post-tensioning in truss members 2 and 11.

Four of the main span nodal regions have D/C ratios above 1.0. The graph below shows that nodal region 1-2 had the highest demand to capacity ratio indicating that this nodal region was the least sufficient to carry the applied load. However, the bridge failed at nodal region 11-12. Comparing these two nodal regions reveals that truss member 2 was 36-inches deep as opposed to the thinner truss member 11 which was 24-inches deep. In addition, nodal zone 1-2 framed into a 42-inch wide deck diaphragm while nodal zone 11-12 framed into a thinner 24-inch diaphragm that was also penetrated by four vertical pipe sleeves that isolated a portion of the nodal region. Therefore, a likely reason for the favorable performance of nodal region 1-2 as opposed to nodal region 11-12 was the unintended capacity from the more substantial elements available at the 1-2 nodal region.

The distress observed in nodal regions 1-2 and 11-12 is consistent with the underestimation of demand and the overestimation of capacity identified in these nodal regions.
