Federal Railroad Administration
Tank Car Damage Assessment Form

(# 45)

Reporting Marks	UTLX 953969		Car Location City/State	Manuelito, NM	
Date inspected	4/29/24	Railroad	BNSF	DOT Specification	112J 340W
Last Contained	LPG (Non-odorized)		Was product released?	No	
(Jacket thickness)	Jacket <input checked="" type="checkbox"/>	Non-jacketed	Does car contain product	No	
Car builder	UTC	Stub Sill Design	UTL-2BG	Built Date	2006
Capacity (GAL)	30,147		LD Limit (LB)

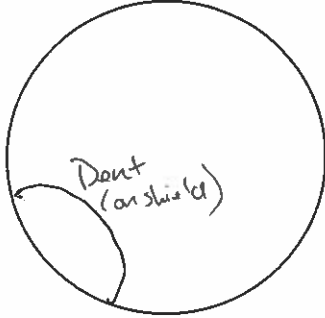
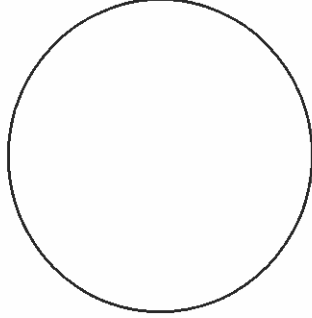
- Head shield Removed only showing a dent on the shell, no tear
 - Product was transferred to another car ; Car #47 was in front of it in the original orientation
 - No breach on this car

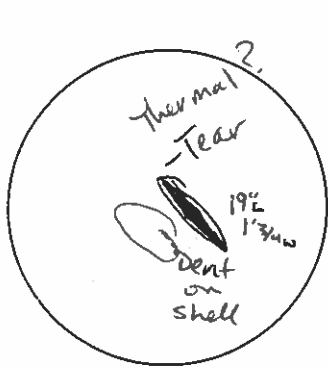
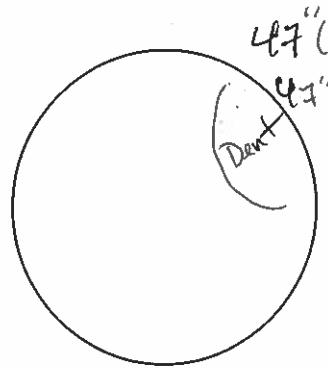
NHIA 100000

- No tear on the B-end headshield; No tear found on A-end head shield removed, just dent
- coupon of the tear taken (3ft x 3ft); Bent bolster (A-end)

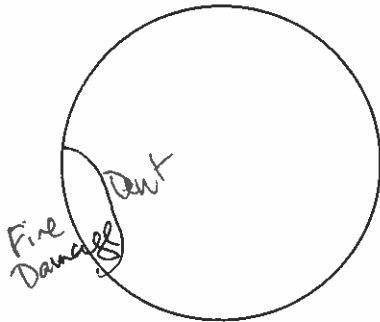
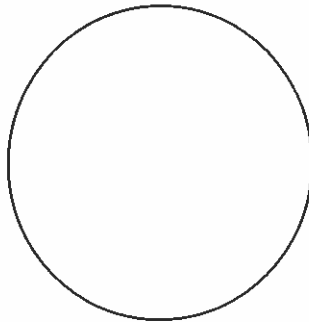
- Drone footage shows the ^{flair}car next to car # 50, which was on-fire
 - No Breach found after removing B-end headshield, large dent only
 - car was turned upside to flare off product from the housing

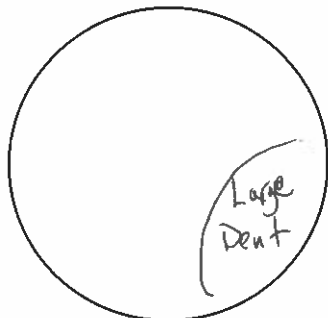
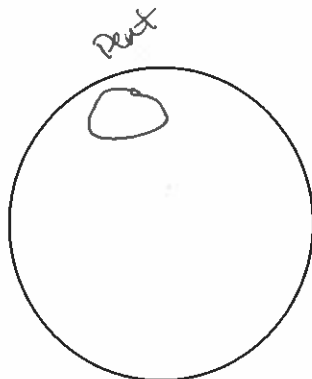
- Jacket removed, car was bulging/swollen, observed possible thermal tear
 - car was laying between #46 and #50, that was on fire
 - coupon taken of the tear; B-end head shield removed, no tear found on the shell
