**AUTOMATION AND DATA SUMMARY
FACTUAL REPORT**

Mountain View, CA

HWY18FH011

Location: Southbound US Highway 101 (US-101) south of North Shoreline Boulevard at the exit ramp transition to State Route 85 (SR-85), milepost 48.38, Santa Clara County, Mountain View, California.

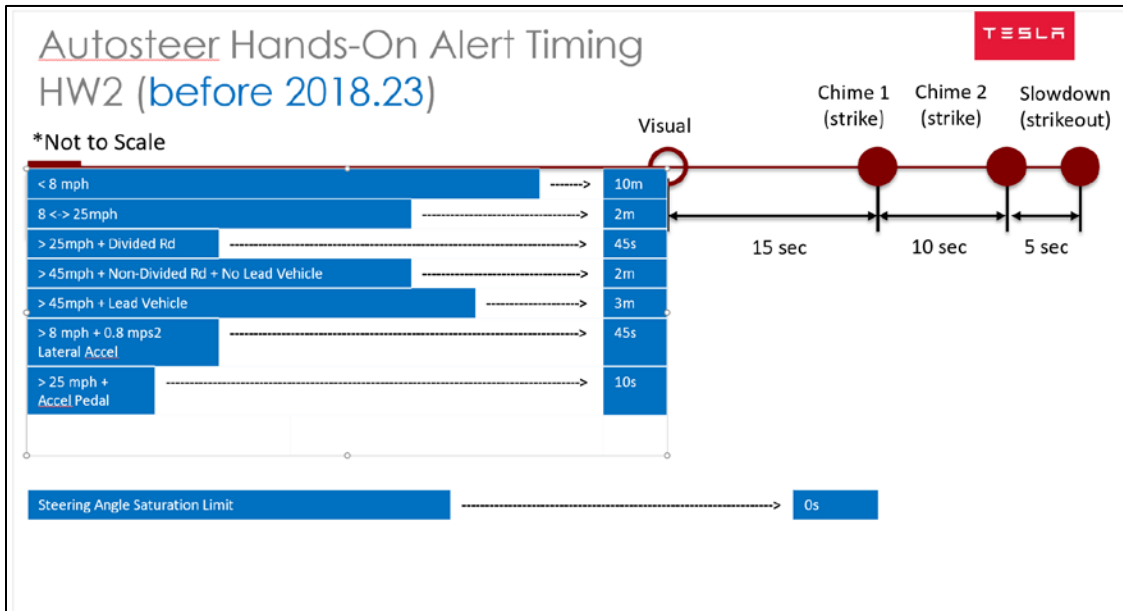
The timing of Autosteer hands on wheel alerts is based upon whether the roadway is a divided roadway, vehicle speed, and other factors. Figure 1 depicts the Autosteer hands-off-wheel triggers for the Tesla Model X at the time of the crash. Figure 2 depicts firmware updates

Figure 1. Autosteer hands-on alert timing for the Tesla Model X with firmware develop/2018.10.4-4460-998269610au present at the time of the crash.⁵

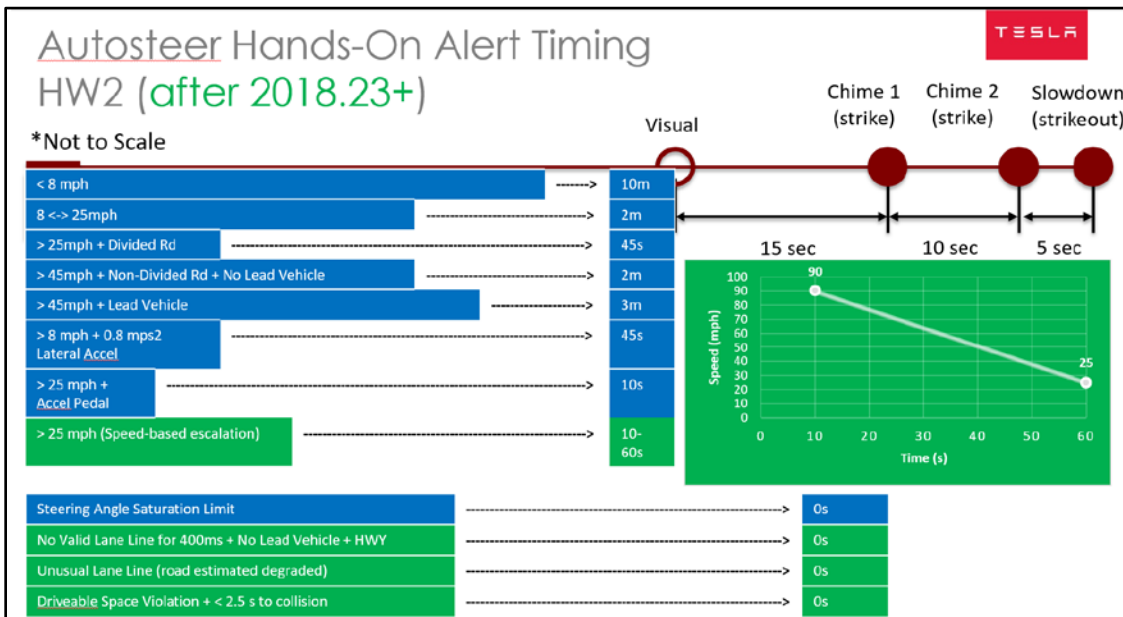
introduced in version 2018.23 (June 2018). There are other conditions, such as hardware errors, not represented here in these figures.

Figure 2. Autosteer hands-on alert timing (shown in green) for the Tesla Model X after firmware version 2018.23 was introduced in June 2018.

Following the Mountain View crash, Tesla made design changes to Autopilot firmware. The changes included an improved vision system, more immediate Autosteer hands-off wheel alert timing warnings (as shown in figure 2), and an Autopilot “Driveable Space” forward collision warning and avoidance system. These changes are summarized below:

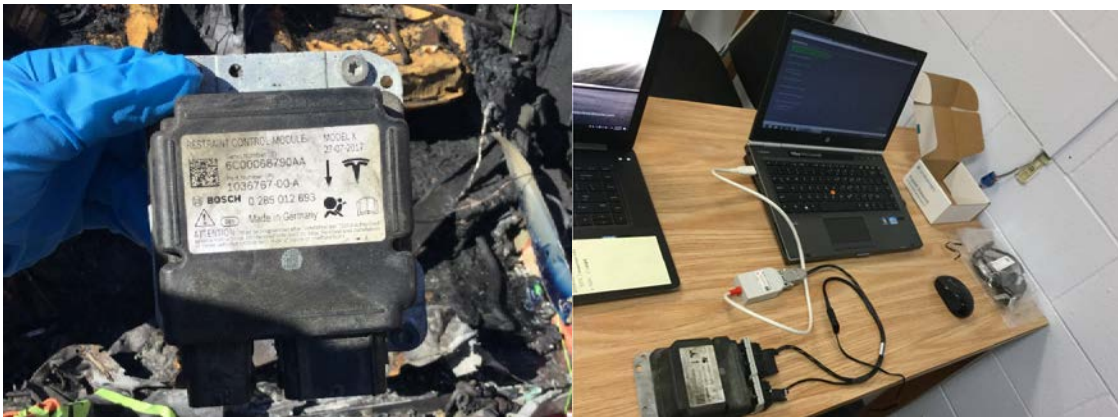
On March 28, 2018, NTSB investigator Karol and CHP investigators responded to Atlas Towing facility in San Mateo, California to inspect the Tesla Model X. The RCM was located among the burned remains of the Tesla, under a melted plastic panel between the front seats. The RCM was photographed and then removed by the CHP for further analysis.⁸ Later in the day, on March 28th, the RCM was imaged at the CHP Redwood City Area office. Tesla personnel assisted with the imaging of the RCM. Upon retrieving data from the RCM, the data was uploaded to the Tesla EDR report service at <https://edr.tesla.com> to produce an EDR report.⁹ Figure 2 depicts photographs of the module and the imaging process. An excerpt from the EDR report, depicting 5 seconds of data prior to the crash, is shown in Figure 3.

Figure 2. Photograph of RCM following removal from Tesla and imaging process at CHP Redwood City area office.

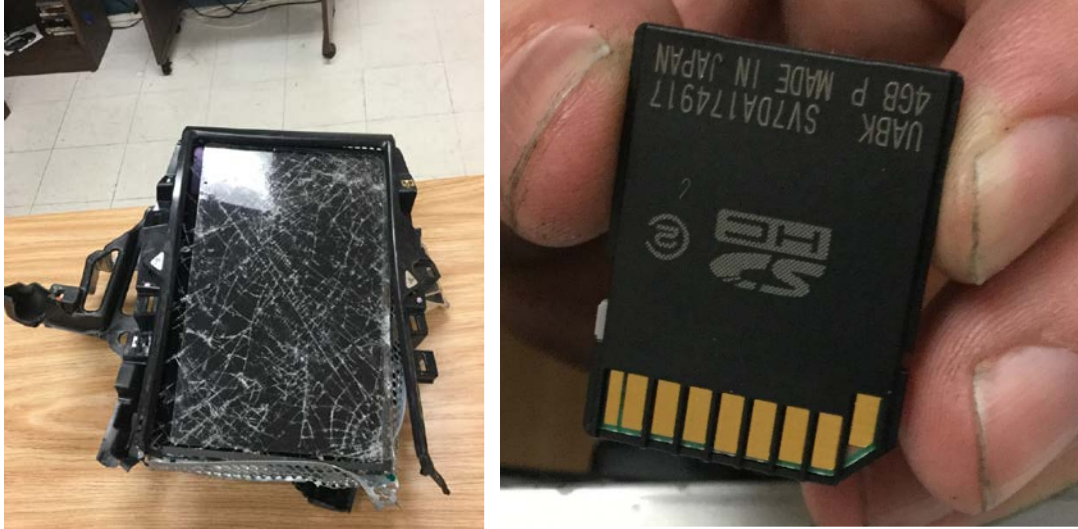
On March 28, 2018, the SD card was removed from the MCU at the CHP Redwood City area office (see figure 4). Tesla personnel copied the data from the SD card so that it could be decrypted and translated at Tesla headquarters. Following the copy of the data, the SD card was returned to CHP evidence storage at the Redwood City area office. Additionally, NTSB retained a copy of the raw data on the SD card which consisted of approximately 1.16 GB of data composed of 156 files organized in 11 folders. Most data, including the vehicle log files containing parametric data was stored in a proprietary binary format that required the use of Tesla in-house software tools for conversion into engineering units.

Figure 4. Removal of the SD card from the MCU on March 28, 2018 at the CHP Redwood City area office.
