NATIONAL TRANSPORTATION SAFETY BOARD
OFFICE OF AVIATION SAFETY
WASHINGTON, D.C. 20594

POWERPLANTS GROUP CHAIRMAN'S FACTUAL REPORT

NTSB ID No.: ERA20MA001

Location: Bradley International Airport, Windsor Locks, Connecticut
Date: October 2, 2019
Time: 0953 eastern daylight time
Aircraft: Boeing B-17G, N93012, Collings Foundation

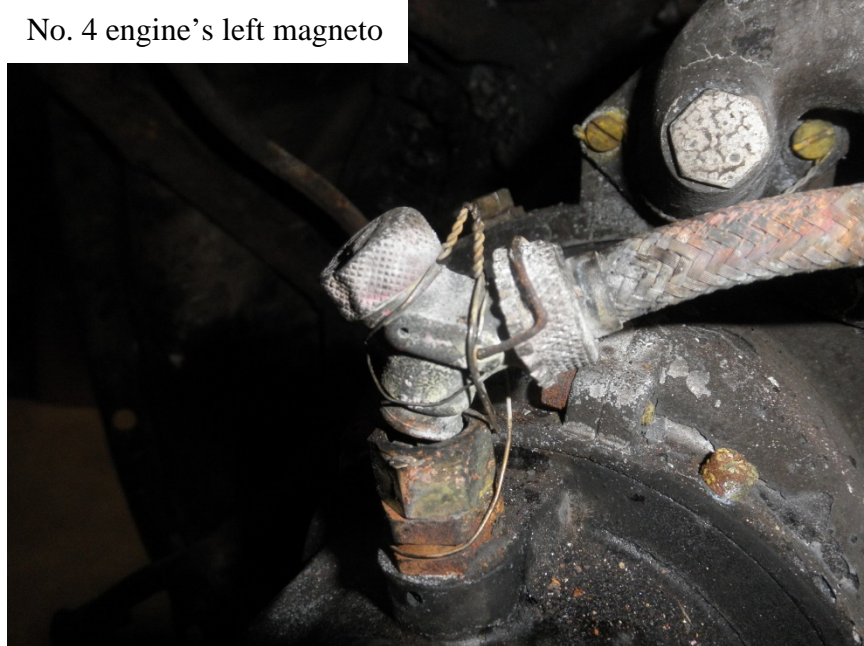
The left and right magnetos were still in place on the rear of the engine. (Photo No. 1) The left and right magnetos' serial numbers were D7384 and CC-44131, respectively. The left magneto's P-lead was pulled out of its fitting. The left and right magnetos' P-leads were both safety wired to their respective housings with a single strand of safety wire that was loose. The right magneto's P-lead was still in place, although it was partially pulled out of its fitting. (Photos Nos. 2 and 3) According to the maintenance instructions, the magnetos' P-leads should be secured with a clip rather than safety wire. The left magneto's lead had pulled out of the swaged fitting causing the magneto to internally ground when the grounding tab contacted the housing. (Photo No. 4) The right magneto's grounding tab had a gap between the tab and the magneto's housing. (Photo No. 5) It appeared that the safety wire was being used to hold the P-leads in position to the fittings.

Photo No. 2: Close up of No. 4 engine's left magneto showing P-lead pulled out of the fitting and single strand of safety wire wrapped around the lead.

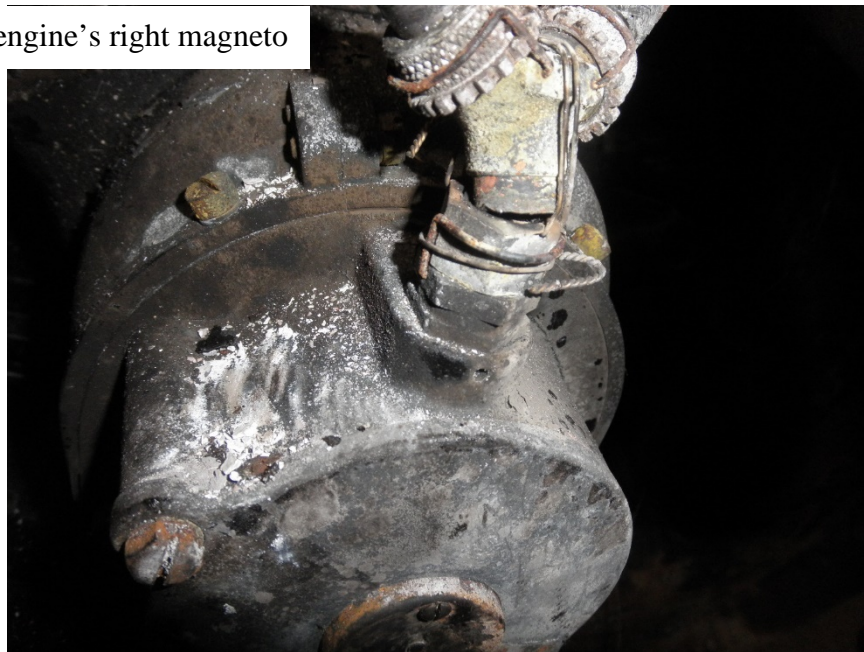
Photo No. 3: Close up of No. 4 engine's right magneto showing P-lead partially pulled out of the fitting and the single strand of safety wire wrapped around the lead.

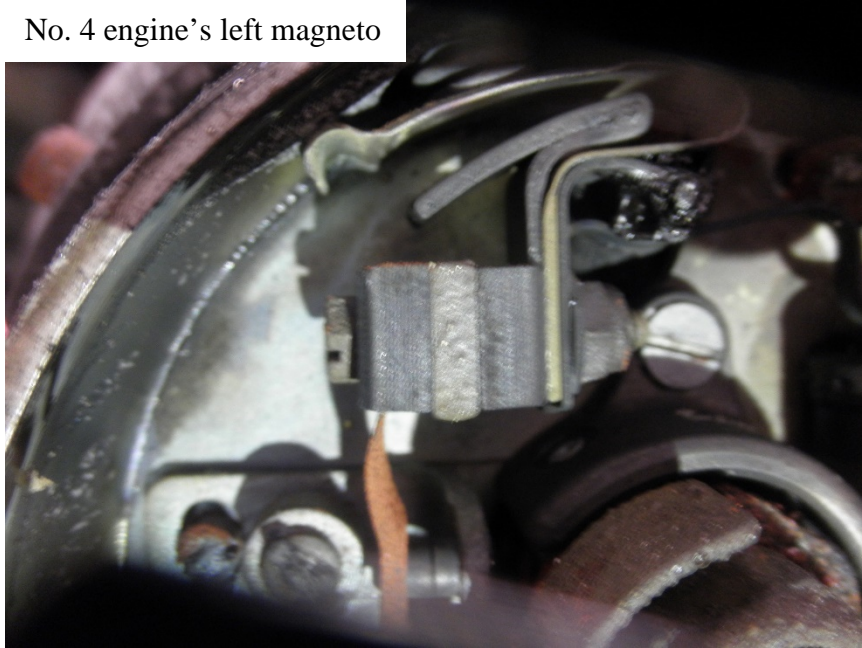
Photo No. 4: Close up view of No. 4 engine's left magneto showing grounding tab contacting the housing wall.

The left and right magnetos were tested on a magneto test bench. (Photos Nos. 8 and 9) When the left magneto was initially tested, there were no sparks because the grounding tab was shorting out on the housing. When a piece of cardboard was inserted between the housing and the grounding tab and the magneto was tested again, there were sparks from all nine of the

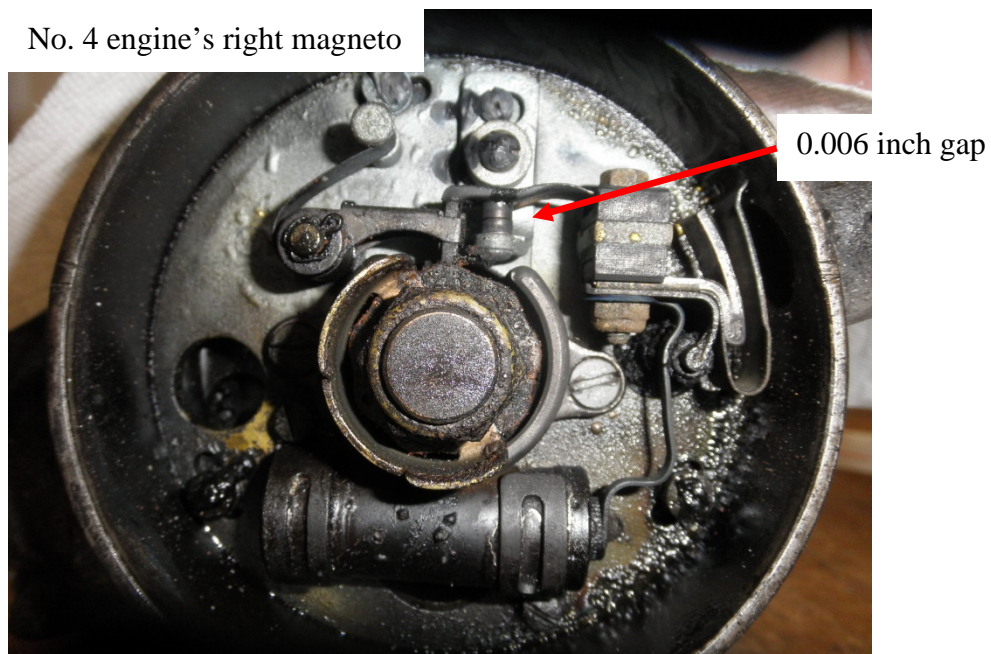
gap when the points were open was measured and found to be 0.006 inches. (Photo No. 7) The gap should be 0.008 to 0.010 inches.

Photo No. 7: Close up of the No. 4 engine's right magneto points showing a gap of 0.006 inches.

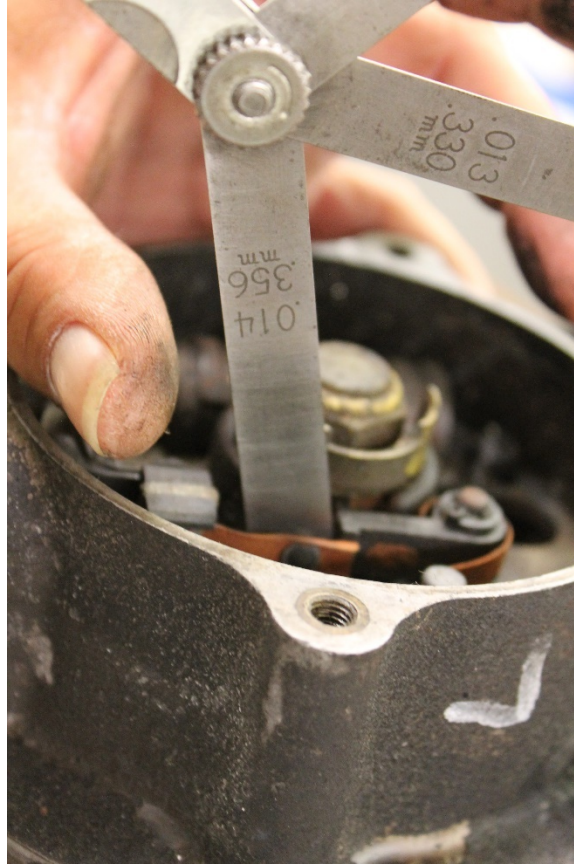
When the spline drive was rotated, the compensating cam rotated concurrently. The points gap was measured with a feeler gage and found to be 0.014 inches. (Photo No. 15) The compensating cam was corroded. When the surface of the compensating cam was cleaned, it was noted that it was marked 'R 1820 MR-1.' (Photo No. 16) The R 1820 MR-1 indicates the cam is usable on a R-1820 radial engine and that the master rod is cylinder No. 1.

Photo No. 15: Close up view of left magneto's measured point gap of 0.014 inches. (S&T)

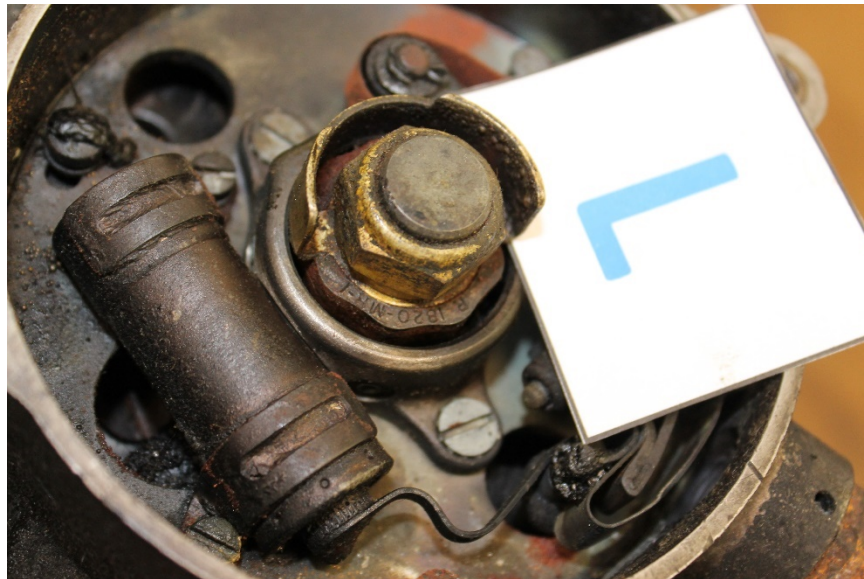
Photo No. 16: Close up view of left magneto's compensating cam showing it is marked R-1820 MR-1. (S&T)

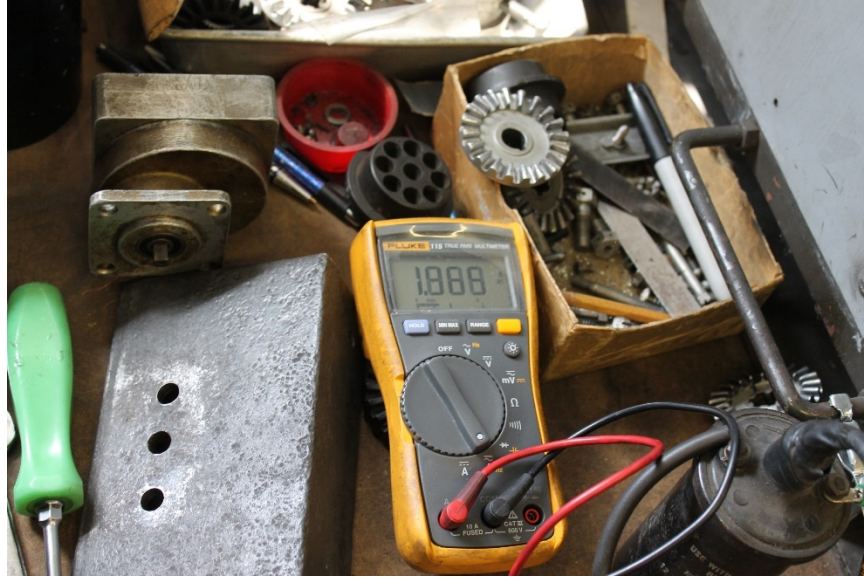
condenser to clean the grease from the inside of the magneto. The points gap was noted to be dirty and were cleaned with acetone. When the magneto was tested again, it produced sparks on all nine leads. The magneto would produce sparks at 51 rpm and higher. The strength of the magnet is checked by measuring the primary current output. The primary current was checked at 400 rpm and found to be vary between 1.8 to 1.9 amps. (Photo No. 18) The primary current output should be at least 1.65 amps.

Photo No. 18: View of left magneto's multimeter reading of magnet's primary output of 1.888 amperes. (S&T)

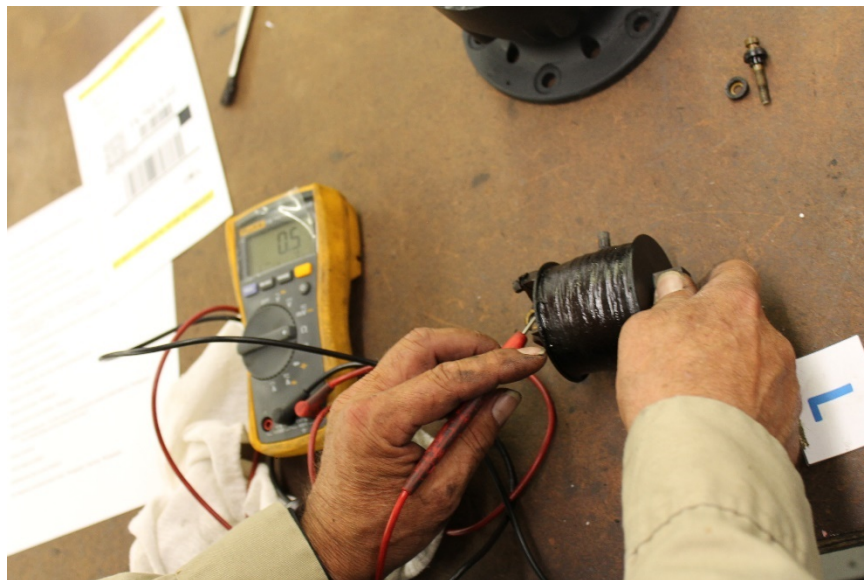
After the left magneto was removed from the test bench, the coil assembly was removed from the magneto. The coil assembly primary coil resistance was 0.5 ohms and the secondary coil resistance was 3,919 ohms. (Photos No. 19 and 20, respectively) The coil assembly primary and secondary resistance requirements are 1.0 ohms minimum and 3,900 ohms minimum, respectively.

Photo No. 19: Left magneto coil assembly's primary coil resistance was 0.5 ohms. (S&T)

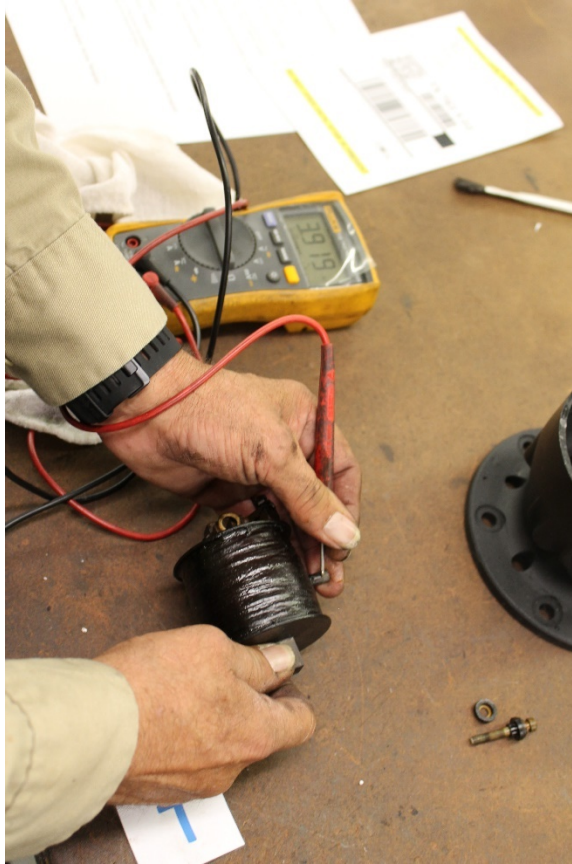
Photo No. 20: Left magneto coil assembly's secondary coil resistance was 3,919 ohms. (S&T)

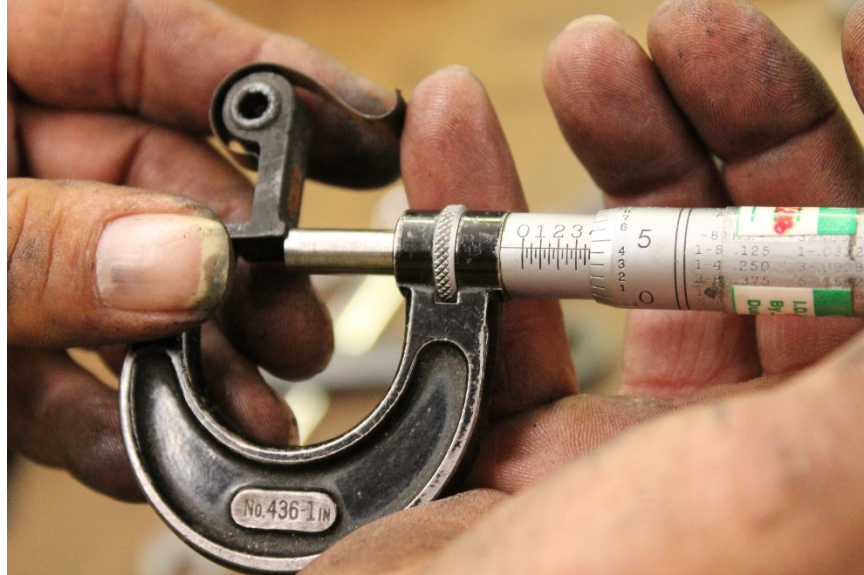
The cam follower was removed from the magneto and the contact surface thickness was measured with a micrometer. The thickness was 0.379 inches. (Photo No. 24) According to S & T, the left magneto's cam follower was the new configuration that has an integral spring. An exemplar cam follower was measured, and the thickness was 0.393 inches.

Photo No. 24: View showing the measurement of the left magneto's cam follower at 0.379 inches. (S&T)

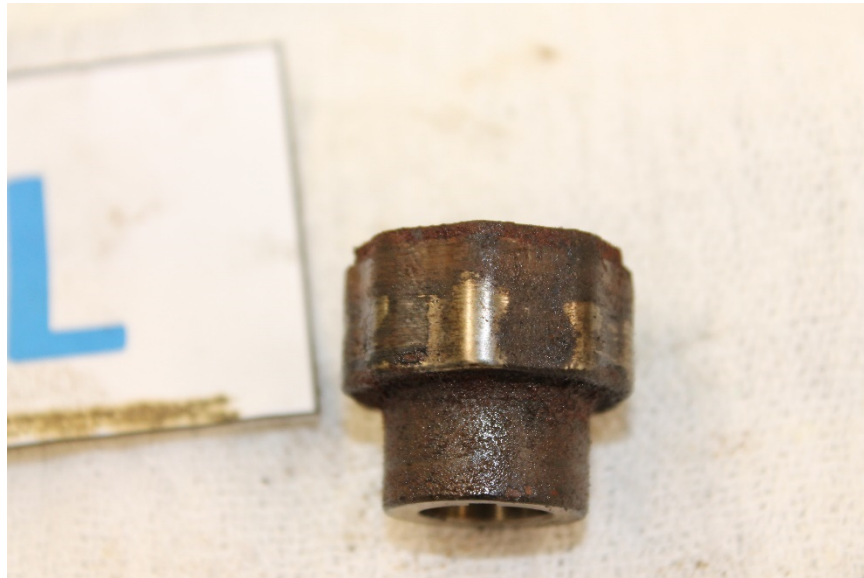
The visual examination of the cam compensator showed that the wear surface was smooth. (Photo No. 25)

Photo No. 25: Close-up view of left magneto's cam compensator showing smooth wear surface. (S&T)

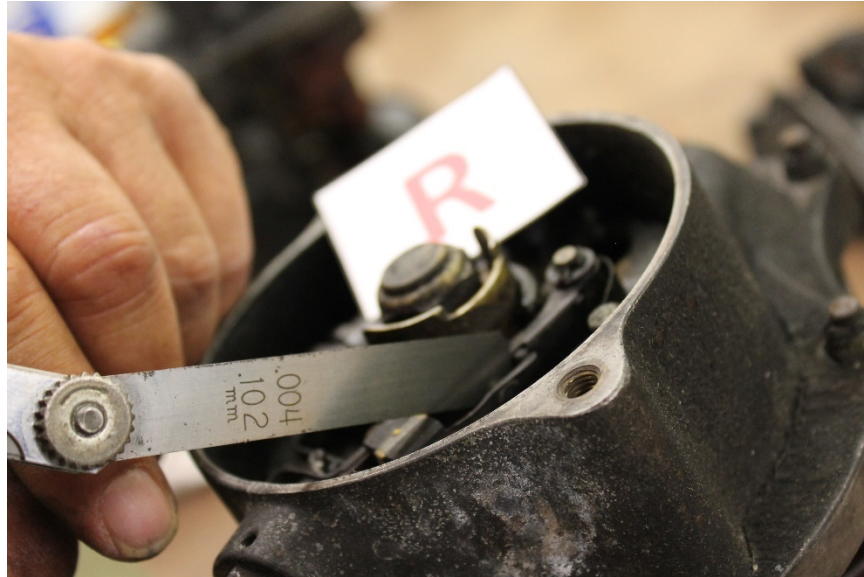
When the spline drive was rotated, the compensating cam rotated concurrently. The points gap was measured with a feeler gage and found to be 0.004 inches. (Photo No. 26) The

Photo No. 26: Close up view of right magneto's measured point gap of 0.004 inches. (S&T)

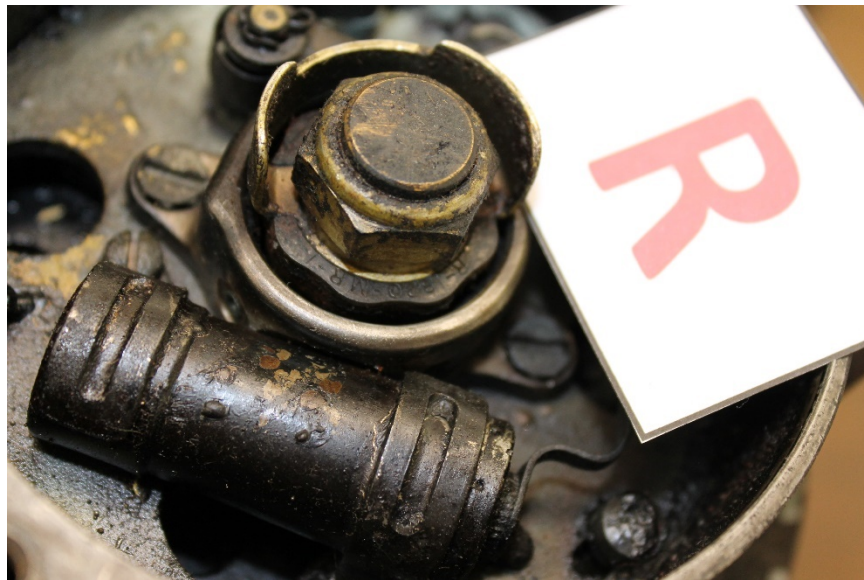
compensating cam was corroded. When the surface of the compensating cam was cleaned, it was noted that it was marked 'R 1820 MR-1.' (Photo No. 27)

Photo No. 27: Close up view of right magneto's compensating cam showing it is marked R-1820 MR-1. (S&T)

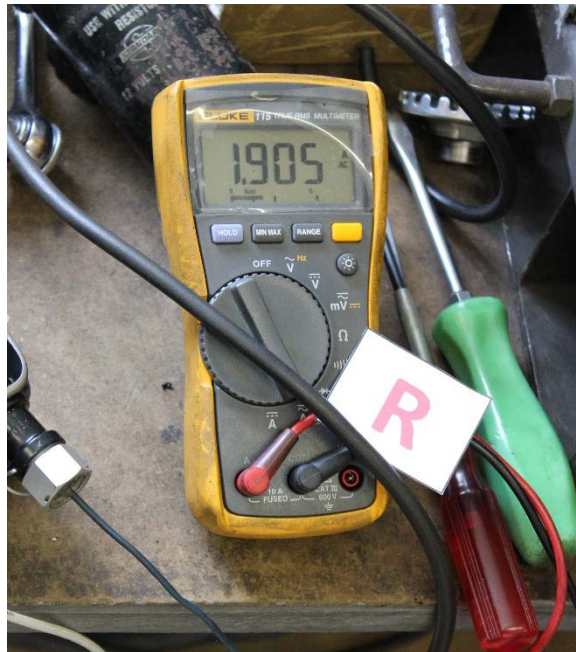
No. 29) According to S & T, visually, it appeared that the right magneto's magnet had gotten hotter than the magnet in the left magneto.

Photo No. 29: View of right magneto's multimeter reading of magnet's primary output of 1.905 amperes. (S&T)

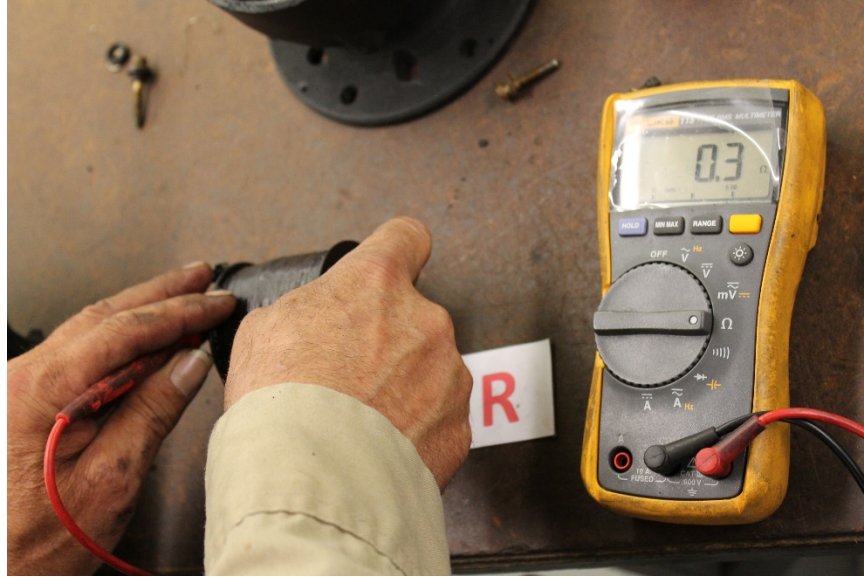
After the right magneto was removed from the test bench, the coil assembly was removed from the magneto. The coil assembly primary coil resistance was 0.3 ohms and the secondary coils resistance was 3,879 ohms. (Photos No. 30 and 31, respectively)

Photo No. 30: Right magneto coil assembly's primary coil resistance was 0.3 ohms. (S&T)

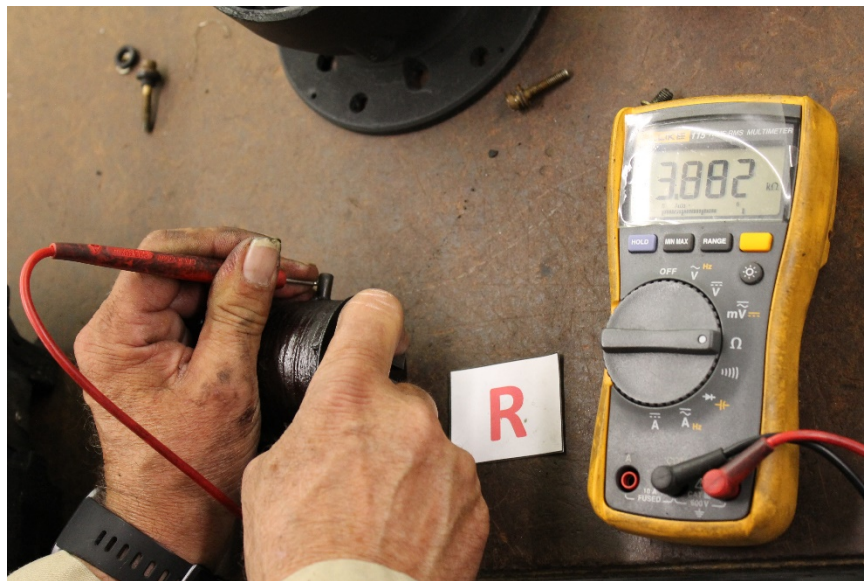
Photo No. 31: Right magneto coil assembly's secondary coil resistance was 3,882 ohms. (S&T)

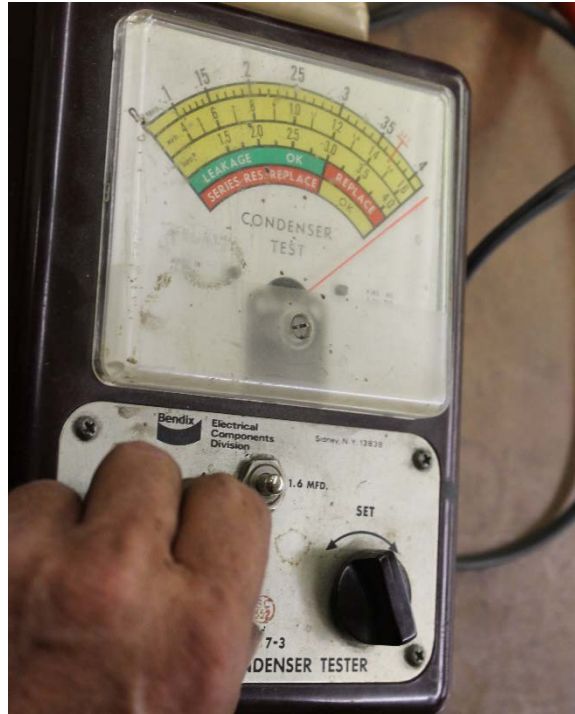
The condenser was checked for resistance and leakage with a primary condenser tester. The test showed that the right magneto condenser was good for resistance and not good for leakage. The needle was straddling the line between good and not good for leakage. According to S&T, they reject condensers when the needle is straddling the line. (Photos Nos. 32 and 33, respectively) The condenser had some leakage of solder from one end.

Photo No. 32: View of right magneto's condenser test showing the resistance was good. (S&T)

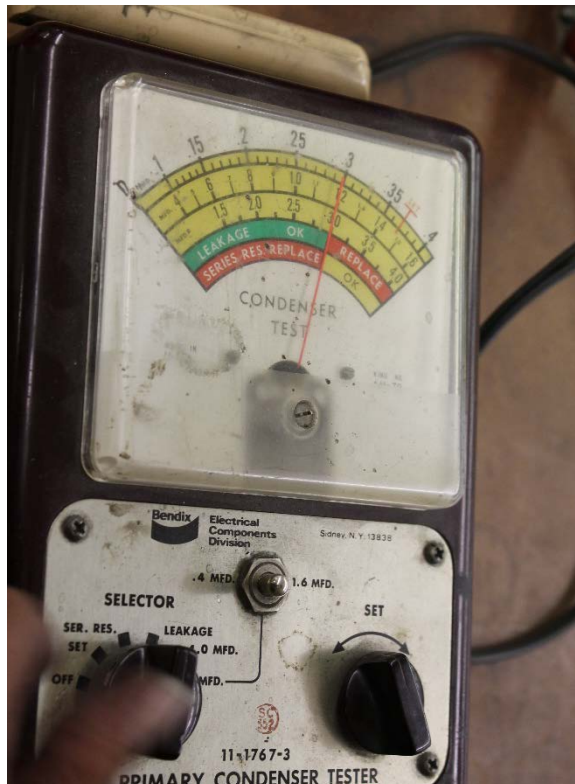
Photo No. 33: View of left magneto's condenser test showing the leakage was not acceptable. (S&T)

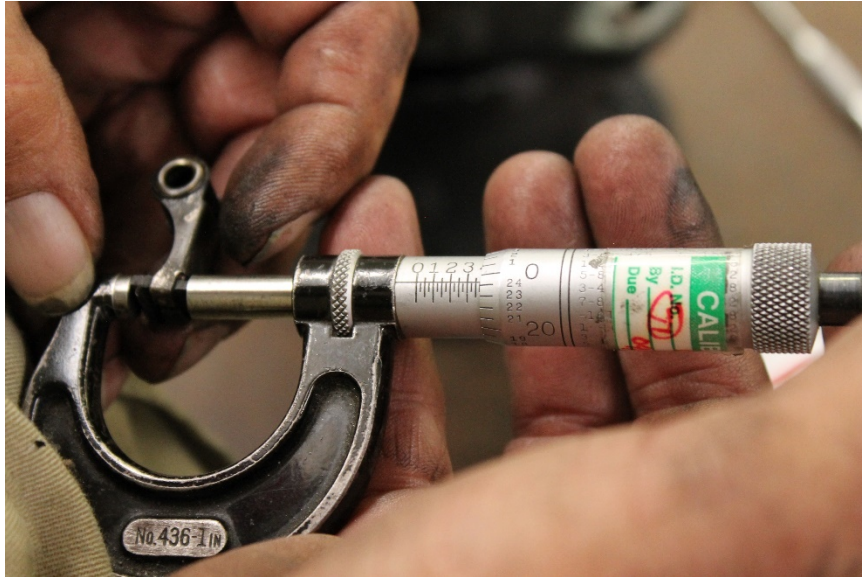
The cam follower was removed from the magneto and the contact surface thickness was measured with a micrometer. The thickness was 0.374 inches. (Photo No. 34)

Photo No. 34: View showing the measurement of the left magneto's cam follower at 0.374 inches. (S&T)

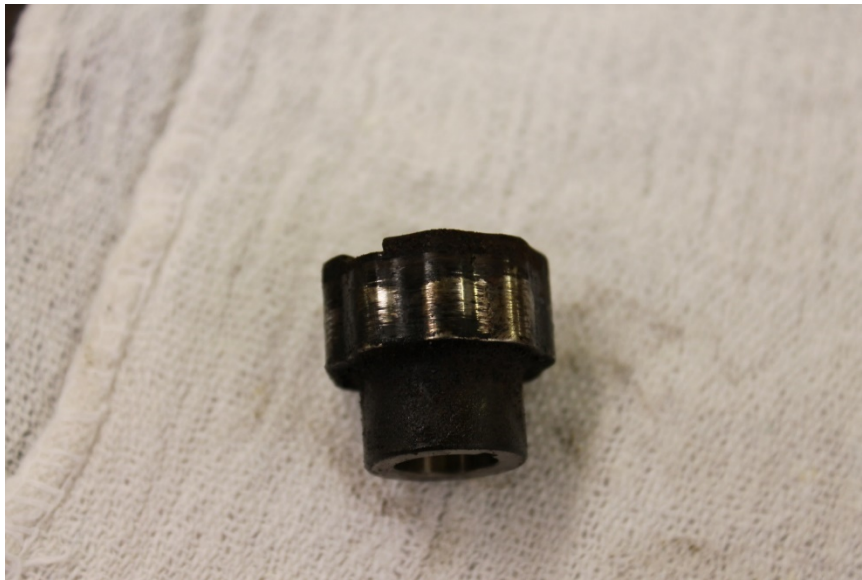
The visual examination of the cam compensator showed that it was corroded and the wear surface where it was contacted by the cam follower was worn and scored. (Photo No. 35)

Photo No. 35: Close up of right magneto's compensator cam showing wear and scoring on the cam lobes. (S&T)

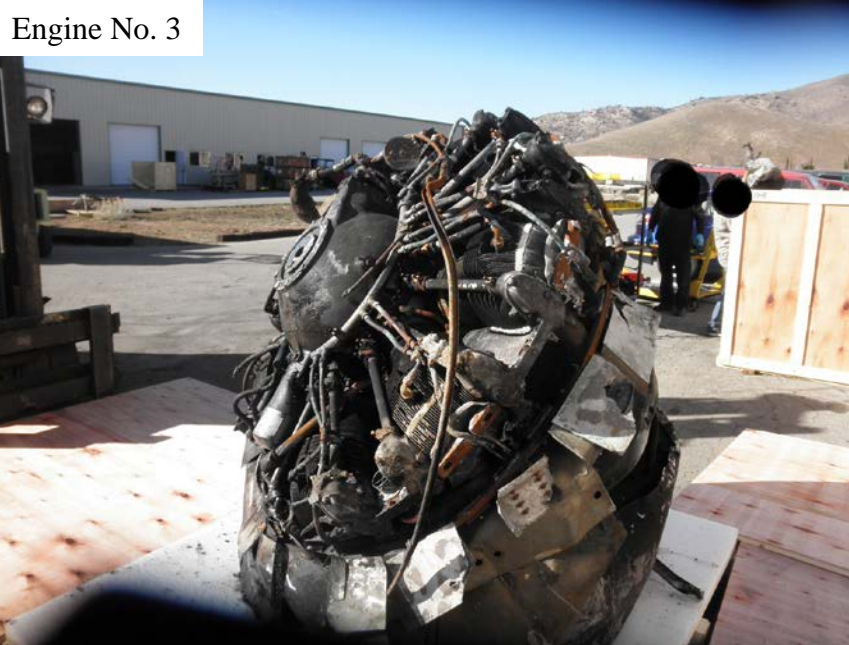
There were pieces of airframe structure such as the engine mount, cowling supports, and cowl flaps still attached to the engine. (Photo No. 37) The front and the rear of the engine were sooted. The engine had evidence of having been exposed to a fire with the heat resistant covering on the oil and fuel lines charred and partially burned away. The rear of the engine appeared to have been bent to the left. (Photos Nos. 38 and 39) The intake tubes to the Nos. 8, 9, and 1 cylinders were crushed and had a hole punched in the rear of the tube. The left and right exhaust manifolds were in place, but were bent and crushed. The air deflector in back of the cylinders was in place. The propeller shaft was in place, but was cut off flush to the front of the nose case. (Refer to Photos Nos. 37 and 38)

Photo No. 37: View of No. 3 engine after it was uncrated showing airframe structure still attached.

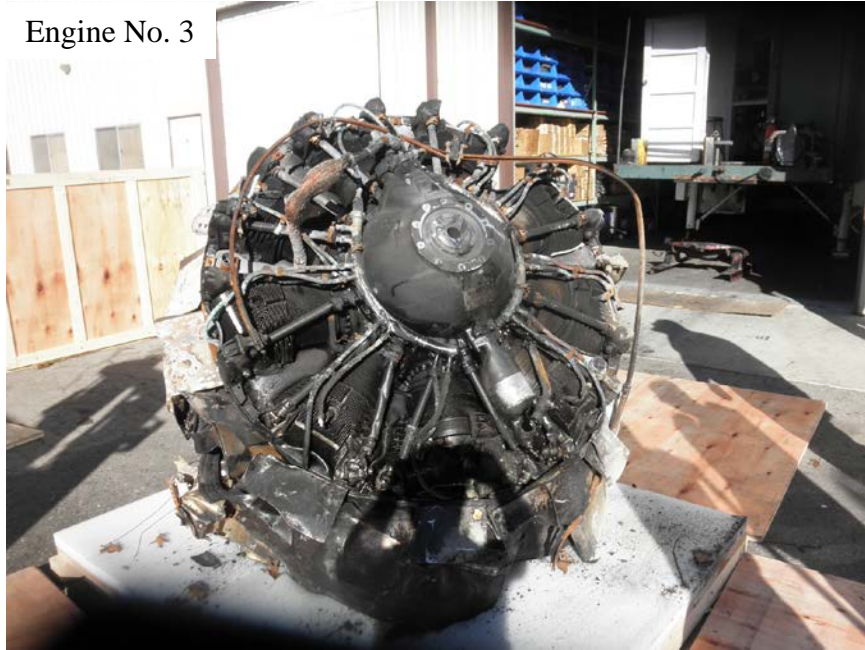
Engine No. 3

Photo No. 38: View of front of No. 3 engine showing sooting and propeller shaft cut off flush to nose case.

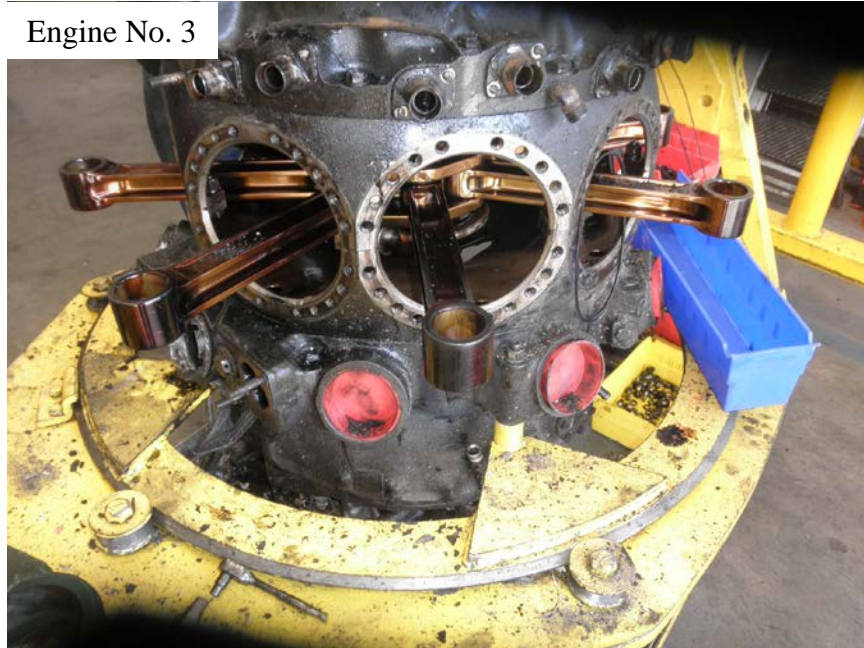
Engine No. 3

The crankcase was intact. (Photo No. 43) All nine cylinders were in place on the crankcase. (Refer to Photo No. 38)

Photo No. 43: View of the crank case showing that it was intact.

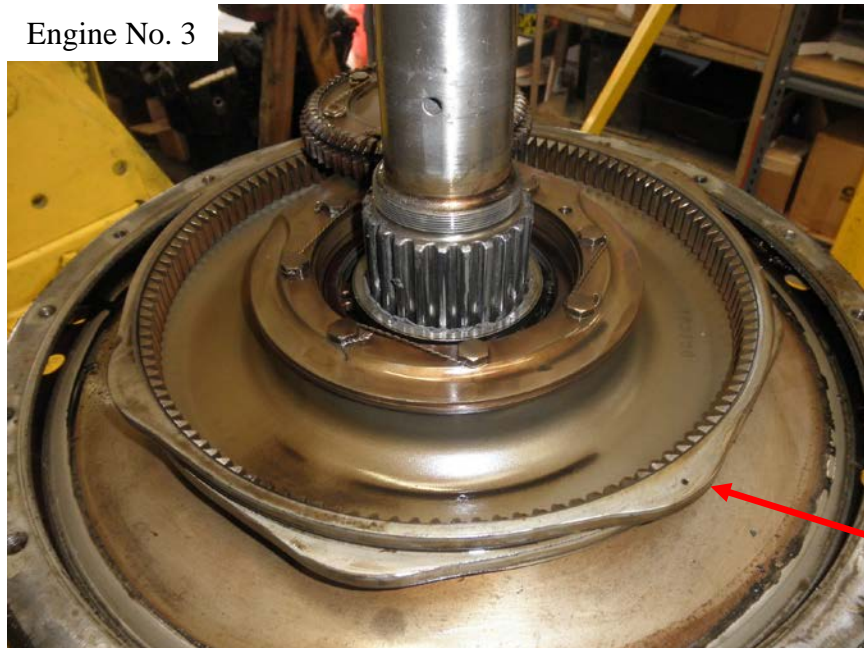
Engine No. 3

The cam ring was intact and undamaged. (Photo No. 44) All of the valve lifter bodies were intact and undamaged. The rollers on all of the valve body lifters were in place, intact, and turned freely.

Photo No. 44: View of cam ring showing that it was intact and undamaged.

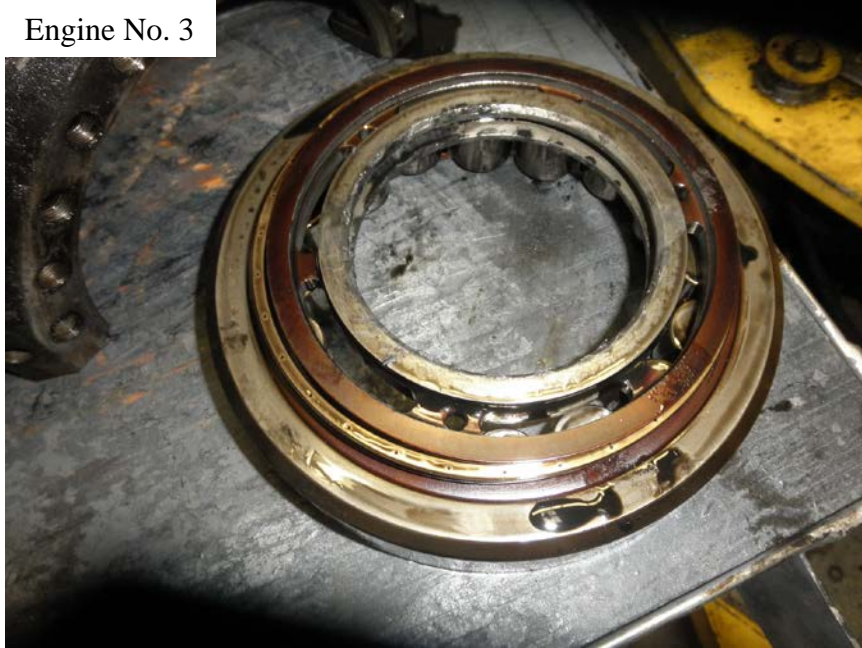
Engine No. 3

have any damage. (Photo No. 46) The crank shaft front and rear bearings were intact and rotated freely and smoothly. (Photos Nos. 47 and 48) The piston pin bearing on the master rod and the piston pin and wrist pin bearings on all of the articulating rods did not have any damage. (Photos Nos 49 and 50)

Photo No. 47: View of front crank shaft bearing showing that it was intact and the rollers were in place.

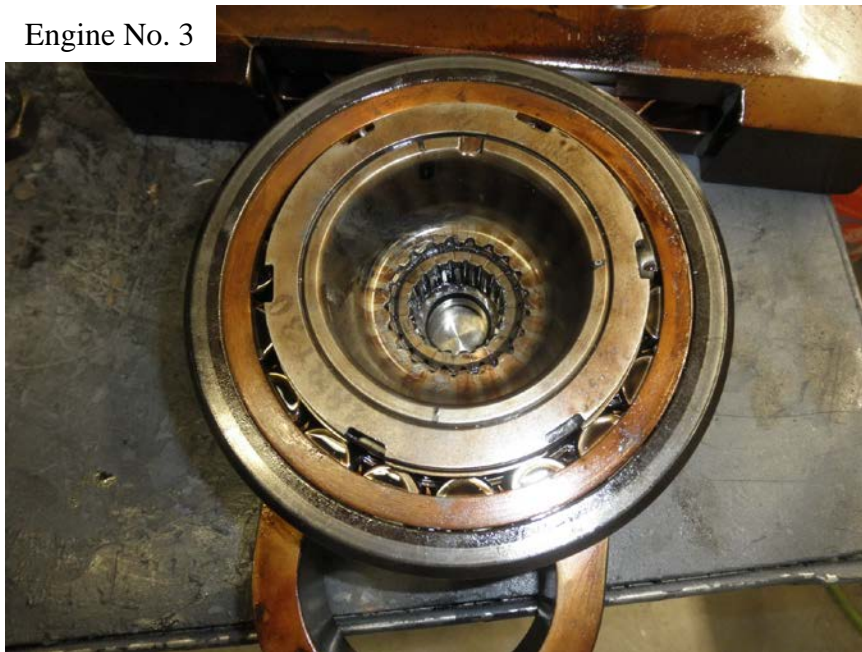
Engine No. 3

Photo No. 48: View of rear crank shaft bearing showing that it was intact and the rollers were in place.

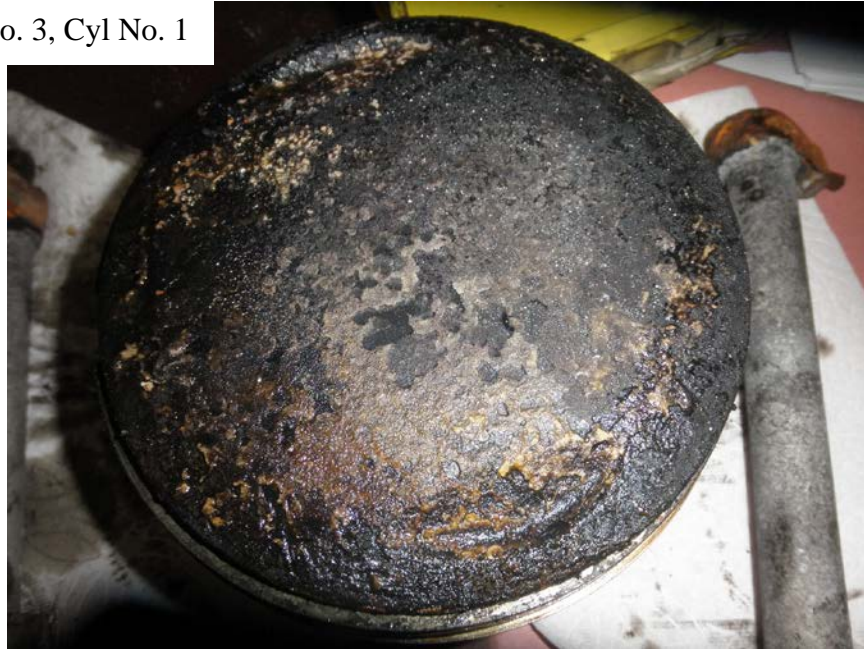
Eng No. 3, Cyl No. 1

The No. 1 piston was connected to the master rod with the piston pin and the piston pin buttons were in place. The piston pin partially slipped off of the master rod when the cylinder was removed from the crank case. The piston pin did not have any damage. The piston was intact and all of the piston rings were in place and intact. The head of the piston was black in color. (Photos Nos. 53, 54, 55, and 56)

Photo No. 54: Close up view of No. 1 cylinder's piston head showing that it was intact and had a dark color.

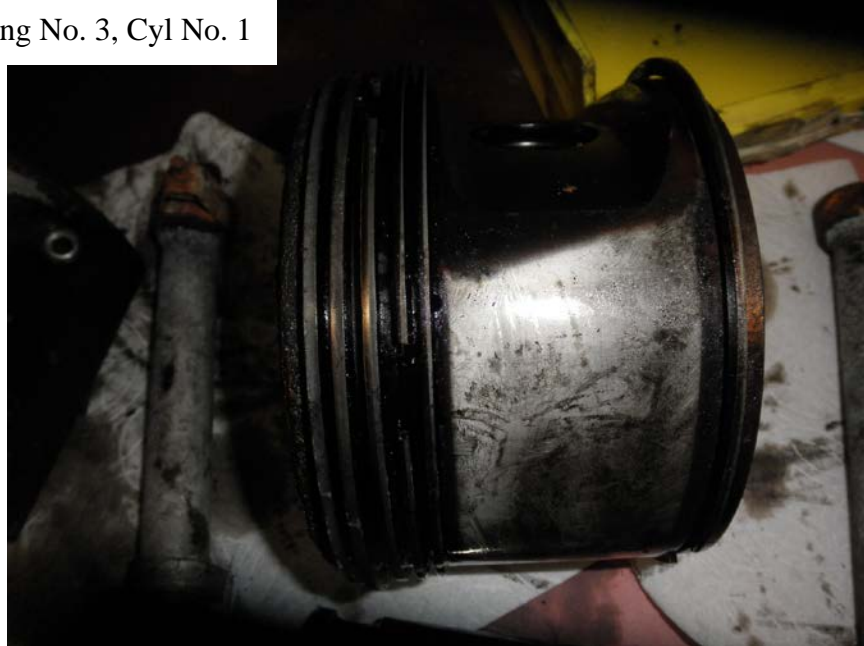
Eng No. 3, Cyl No. 1

Photo No. 56: Close up view of side of No. 1 cylinder's piston showing the rings were in place.

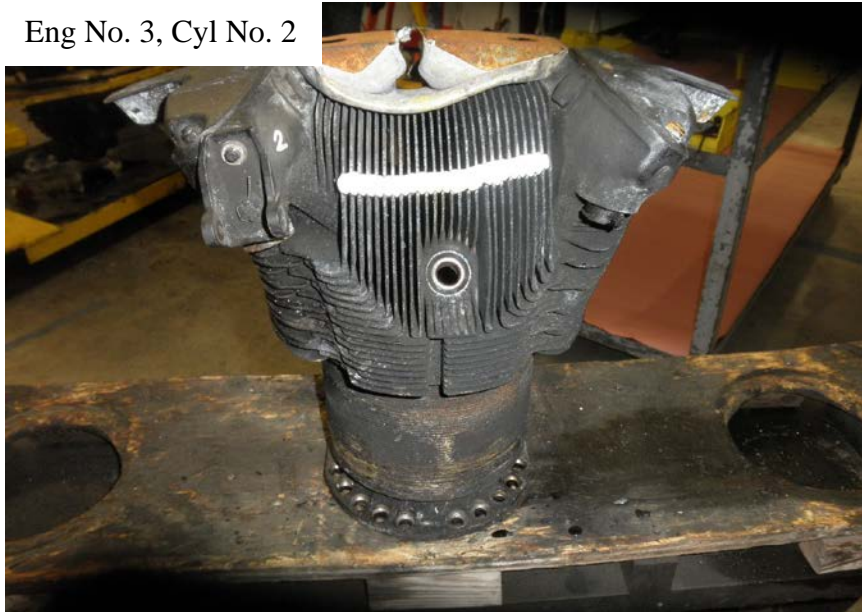
Eng No. 3, Cyl No. 2

The No. 2 cylinder barrel was in place on the crank case (Refer to Photo No. 38) and the cylinder head was in place and intact. The intake and exhaust rocker arm covers were in place on the cylinder head and did not appear to have any damage. (Photos Nos. 58 and 59) The spark plugs were in place and the ignition leads were still attached.

Photo No. 58: View of front of No. 2 cylinder showing it was intact with the head in place and intact, and the intake and exhaust rocker arm covers were in place.

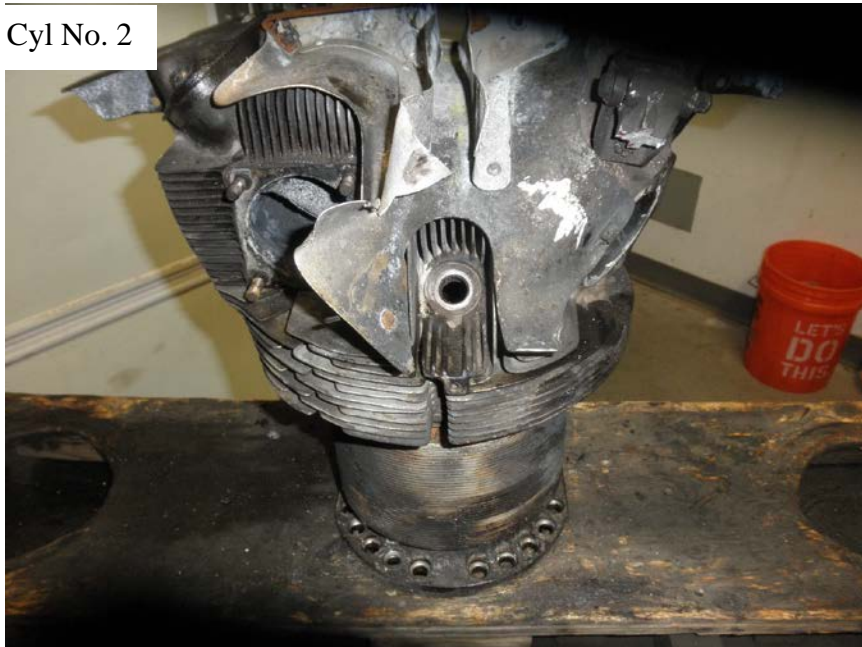
Eng No. 3, Cyl No. 2

Photo No. 59: View of rear of No. 2 cylinder showing it was intact with the head in place and intact, and the intake and exhaust rocker arm covers were in place.

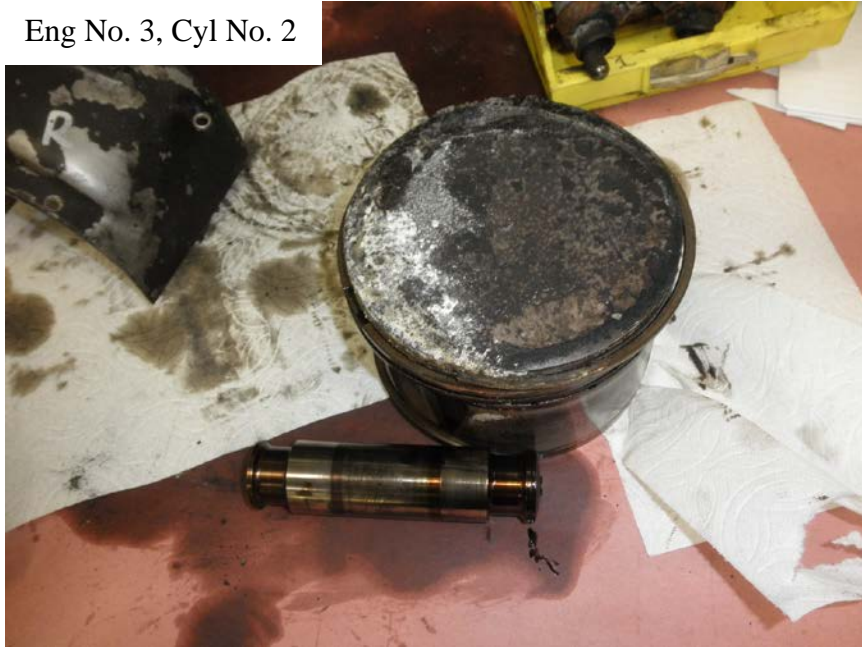
Eng No. 3, Cyl No. 2

Photo No. 60: View of the No. 2 cylinder's piston and wrist pin showing that they were undamaged.

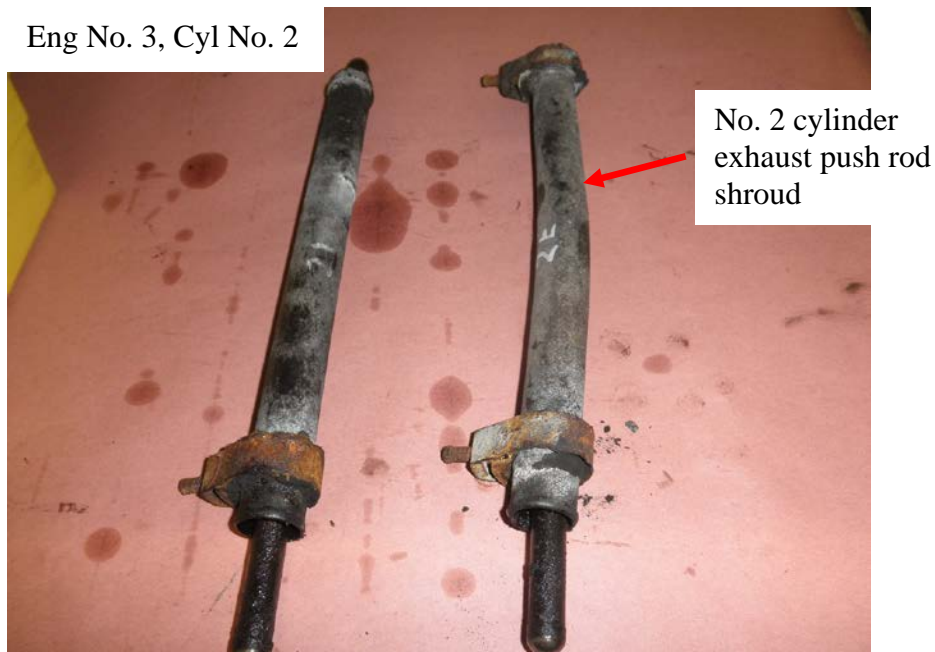
Eng No. 3, Cyl No. 2

All of the intake and exhaust push rods and their respective shrouds were in place except for the No. 5 cylinder. The No. 5 cylinder's intake push rod shroud was still in place, but the exhaust push rod shroud was missing. The No. 2 cylinder's exhaust shroud was bent, although the respective push rod was straight. (Refer to Photo No. 61) The No. 4 cylinder's intake push rod shroud had a hole in the middle of the shroud and the outer end of the push rod was bent over. The push rod was stuck in the tube. The No. 4 cylinder's exhaust shroud was straight, but the push rod was bent in the middle. The No. 6 cylinder's exhaust push rod was bent at the outer end although the shroud was straight. Although the push rod shrouds remained in place, the shrouds inner and outer connectors were either partially or completely burned away. Most of the push rod shrouds had the paint burned off.

Photo No. 61: View of the two push rod shrouds and push rods showing the exhaust push rod shroud was bent slightly.

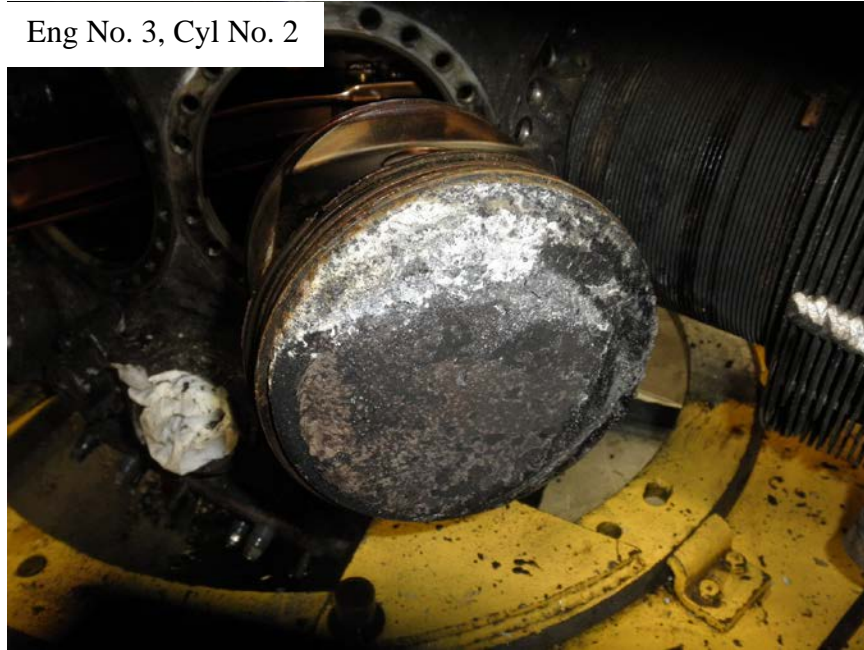
Eng No. 3, Cyl No. 2

The No. 2 piston was connected to the articulating rod with the piston pin and the piston pin buttons in place. The piston was intact and all of the piston rings were in place and intact. The head of the piston was mostly black in color with small gray- and white-colored areas. (Photos Nos. 60, 61, 62, 63, and 64)

Photo No. 62: Close up of No. 2 cylinder's piston head showing that it was intact and had a dark color with small gray- and white-colored areas.

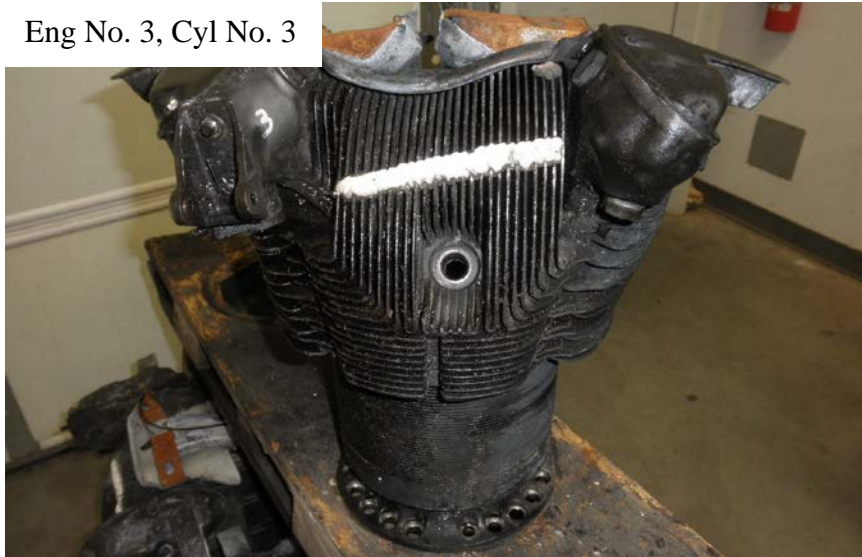
Eng No. 3, Cyl No. 3

Photo No. 66: View of front of No. 3 cylinder showing it was intact with the head in place and intact, and the intake and exhaust rocker arm covers were in place.

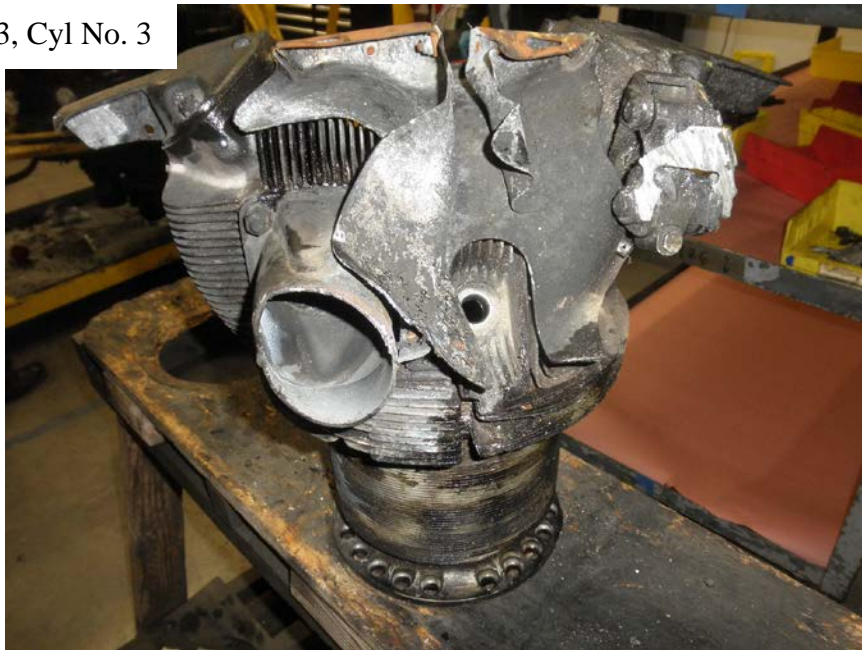
Eng No. 3, Cyl No. 3

Photo No. 67: View of rear of No. 3 cylinder showing it was intact with the head in place and intact, and the intake and exhaust rocker arm covers were in place.

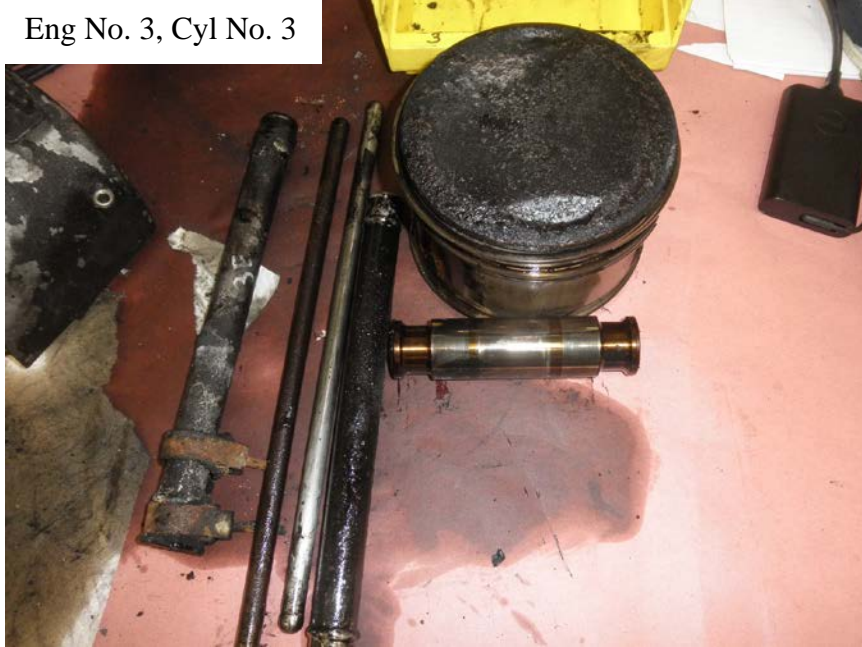
Eng No. 3, Cyl No. 3

Photo No. 68: View of No. 3 cylinder's piston, wrist pin, push rods, and push rod shrouds.

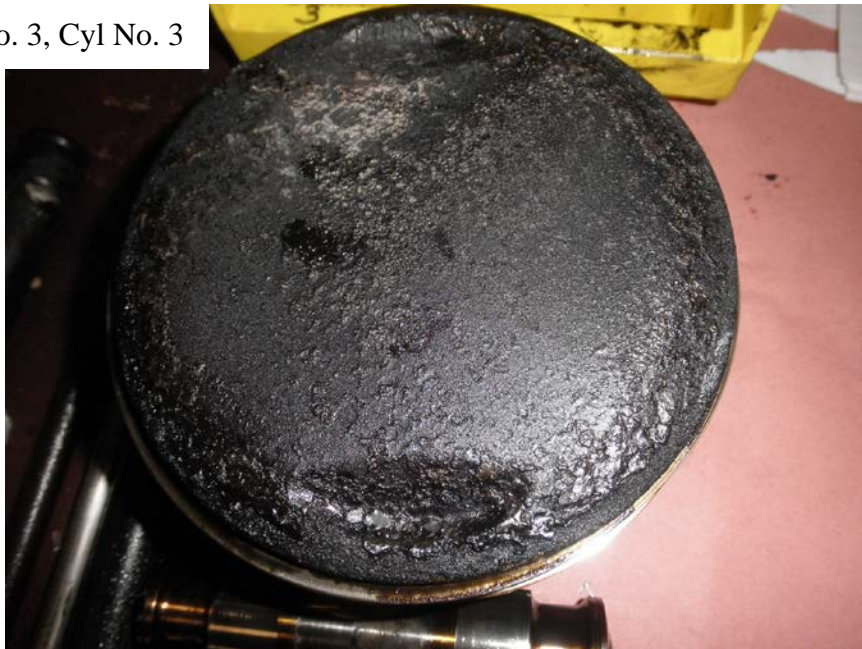
Eng No. 3, Cyl No. 3

Photo No. 69: Close up view of No. 3 cylinder's piston head showing that it was intact and had a dark color.
