NATIONAL TRANSPORTATION SAFETY BOARD
OFFICE OF AVIATION SAFETY
WASHINGTON, D.C. 20594

POWERPLANTS GROUP CHAIRMAN'S FACTUAL REPORT

NTSB ID No.: ERA20MA001

Location: Bradley International Airport, Windsor Locks, Connecticut
Date: October 2, 2019
Time: 0953 eastern daylight time
Aircraft: Boeing B-17G, N93012, Collings Foundation

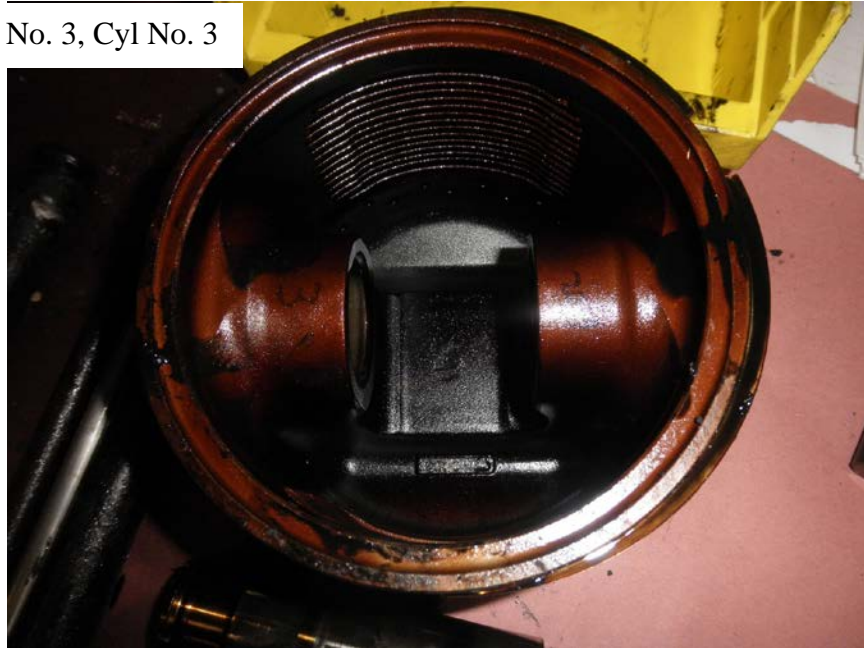
Eng No. 3, Cyl No. 3

Photo No. 70: Close up of the underside of the No. 3 cylinder's piston showing that it was undamaged.

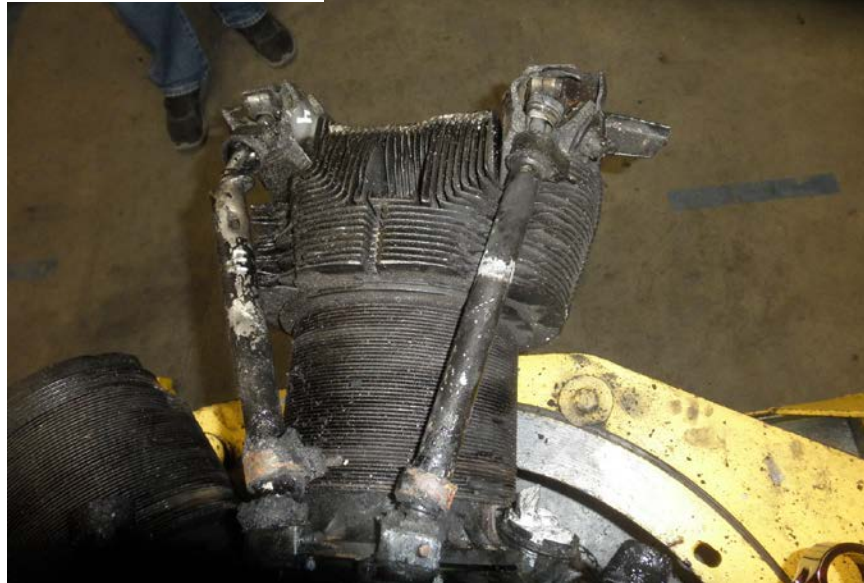
Eng No. 3, Cyl No. 4

The No. 4 cylinder barrel was in place on the crank case (Refer to Photo No. 38) and the cylinder head was in place and intact. (Photos Nos. 73 and 74) The cylinder head's intake and exhaust rocker arm assemblies were broken open on the front and the rocker arm covers were broken open and partially missing exposing the rocker arms. (Photos Nos. 75 and 76) The two rocker arms were in place and intact. The spark plugs were in place and the ignition leads were still attached.

Photo No. 73: View of front of No. 4 cylinder showing it was intact with the head in place and intact except for the rocker arm assemblies and covers that were broken.

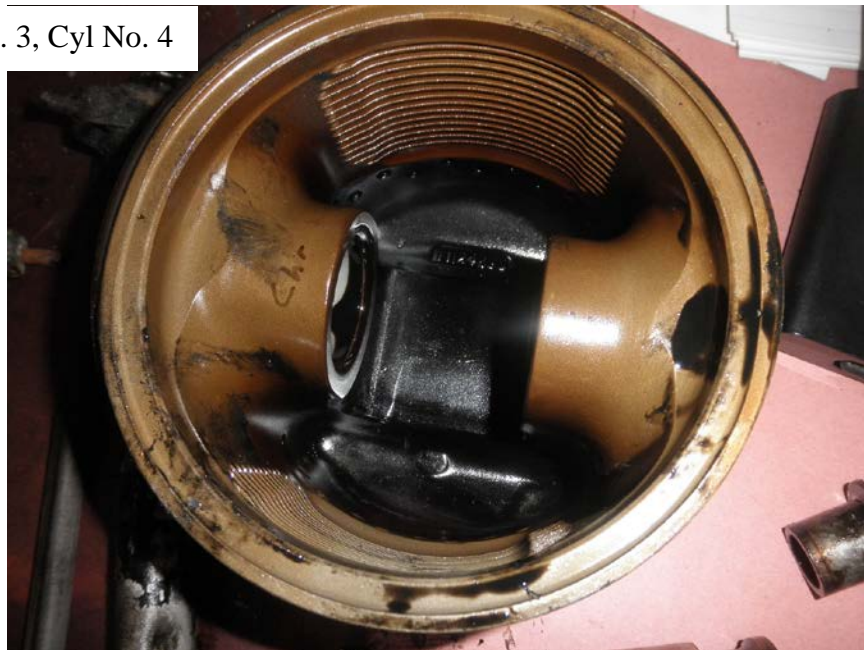
Eng No. 3, Cyl No. 4

Photo No. 78: Close up view of the underside of the No. 4 cylinder's piston.

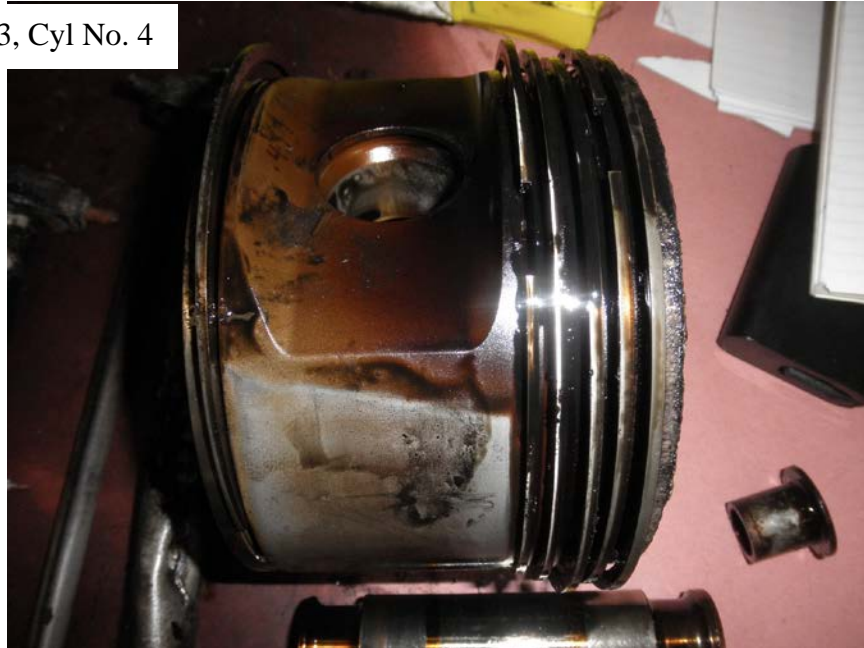
Eng No. 3, Cyl No. 4

Photo No. 79: Close up view of the side of No. 4 cylinder's piston showing all of the rings were in place and intact.

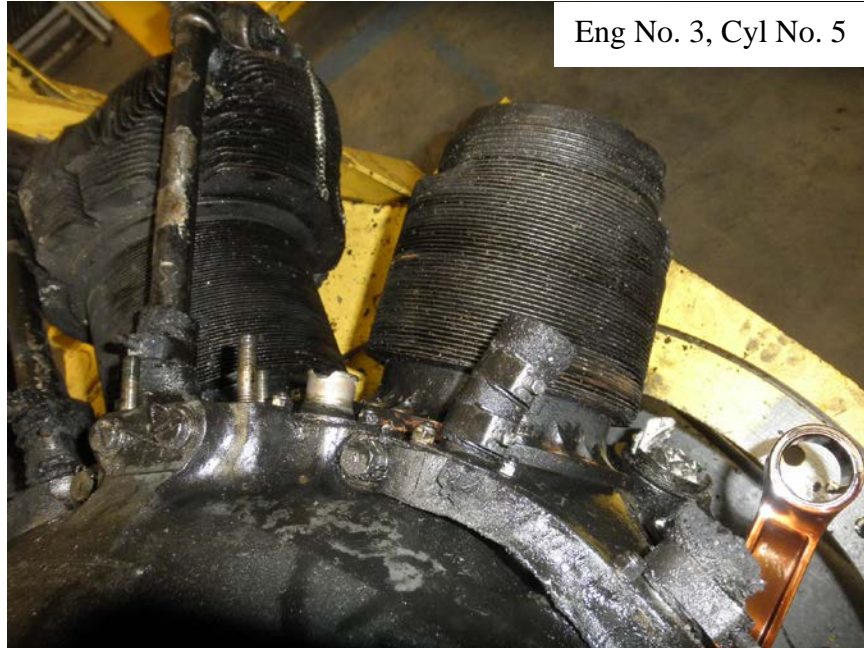
Eng No. 3, Cyl No. 5

The No. 5 cylinder barrel was in place on the crank case. (Photo No. 82) The cylinder head was broken up into three pieces and partially separated from the barrel when the engine was uncrated and then came completely off of the barrel during the removal of the airframe components. (Photos Nos. 83, 84, and 85) The front of the cylinder head and the rocker arm covers were broken open and partially missing exposing the rocker arms. The two rocker arms were in place and intact. The spark plugs were in place in the threaded inserts and the ignition leads were still attached.

Photo No. 82: View of No.5 cylinder barrel in place on the crankcase.

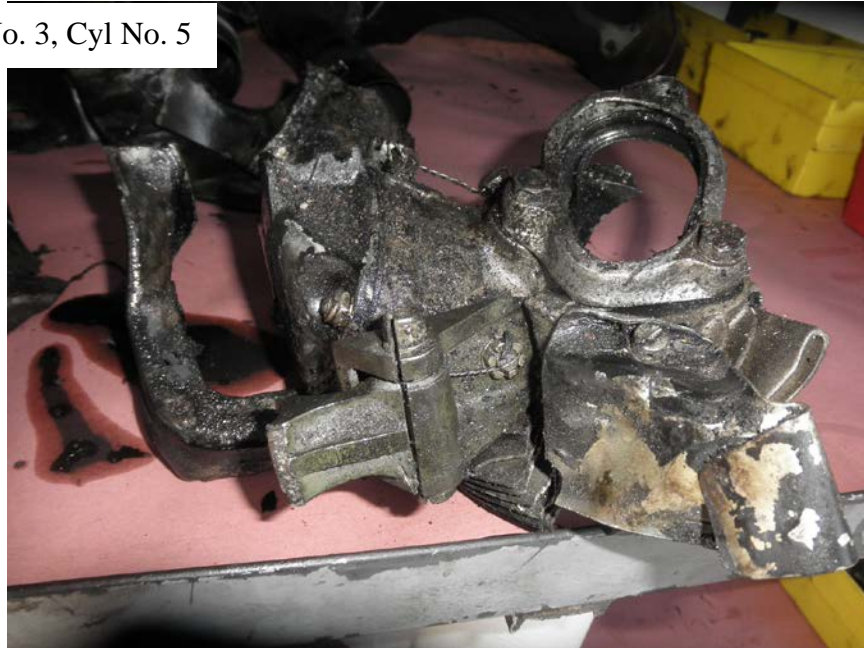
Eng No. 3, Cyl No. 5

Photo No. 84: Broken piece of No. 5 cylinder head.

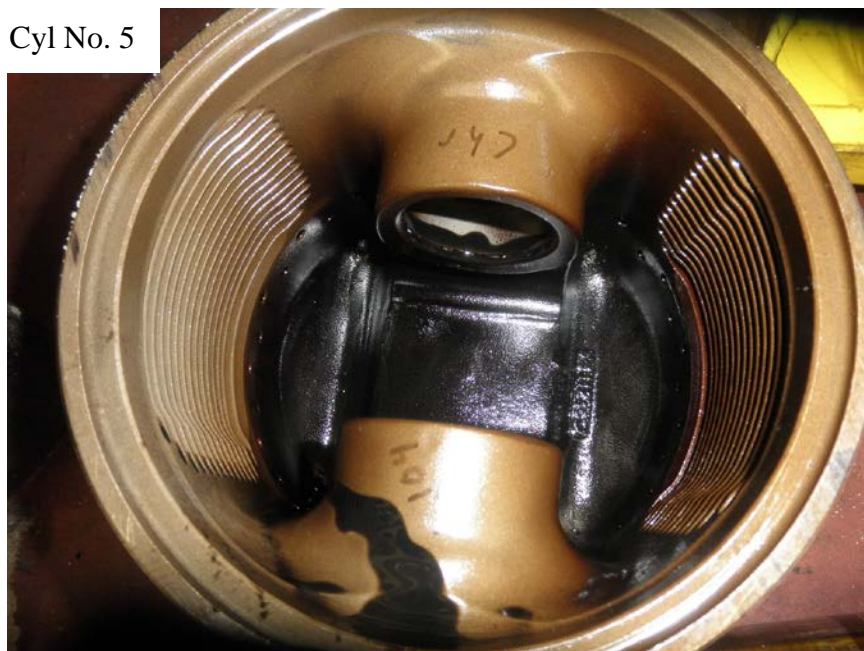
Eng No. 3, Cyl No. 5

Photo No. 87: View of underside of No. 5 cylinder's piston.

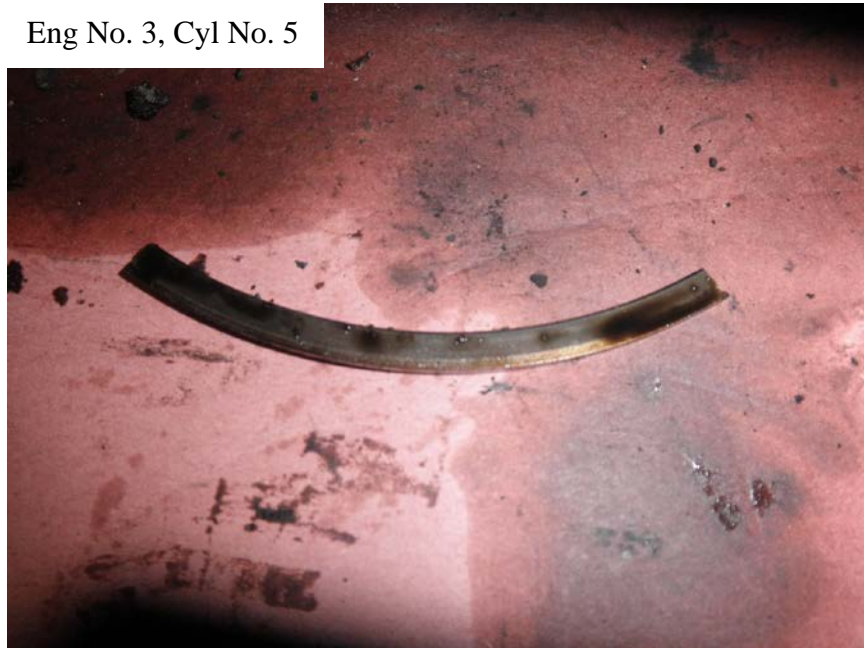
Eng No. 3, Cyl No. 5

Photo No. 89: Broken piece of piston from No. 5 cylinder's piston.

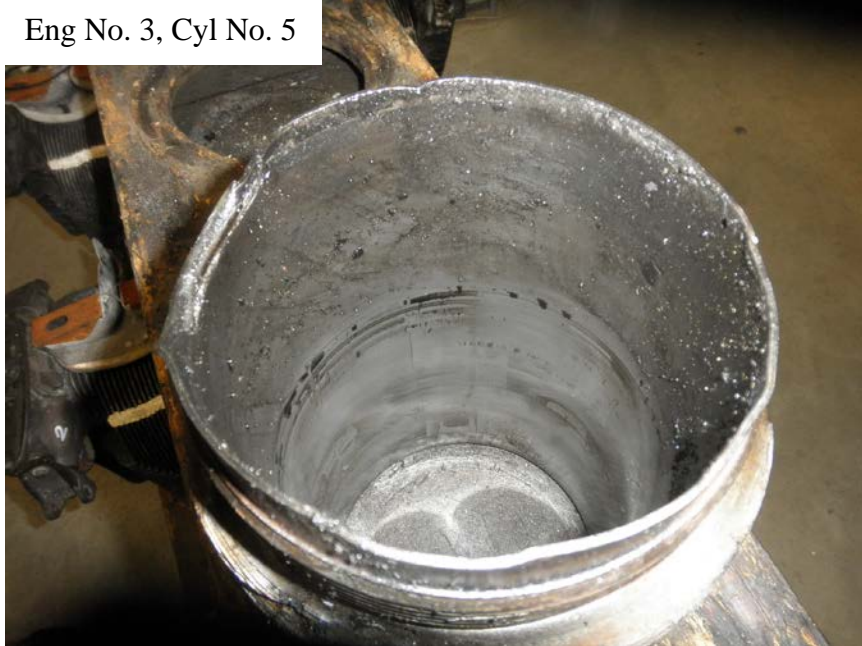
Eng No. 3, Cyl No. 5

Photo No. 90: View of top of No. 5 cylinder barrel showing metal fragments.

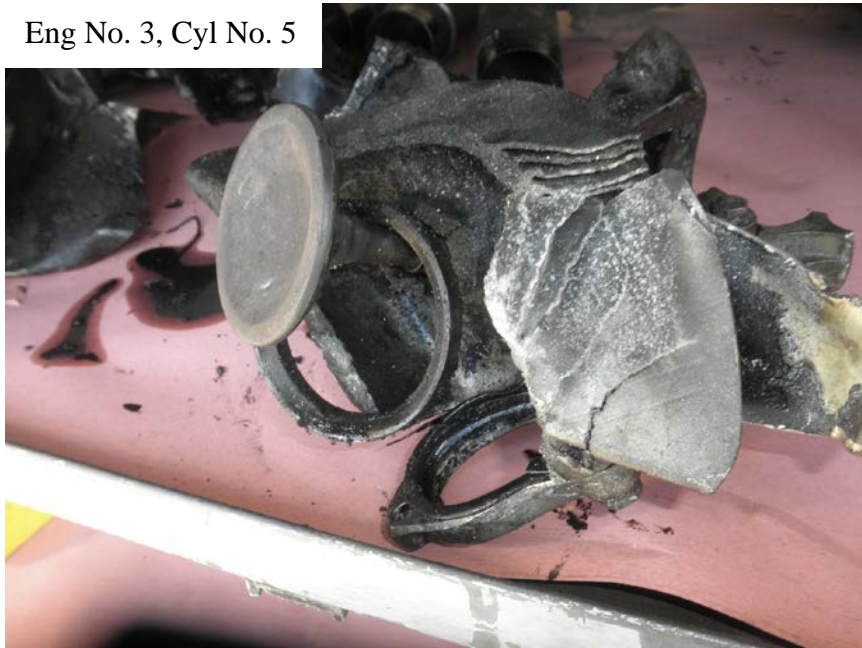
Eng No. 3, Cyl No. 5

The cylinder barrel was intact and the inner surface did not have any damage. There were metal fragments at the top of the barrel. (Photo No. 90) The intake valve was bent in the stem, but the head of the valve remained attached. The intake valve seat was loose around the valve stem and was bent up. The exhaust valve was still in place and was in the closed position centered on the valve seat. (Photos Nos. 91 and 92)

Photo No. 91: View of piece of No. 5 cylinder head with bent intake valve.

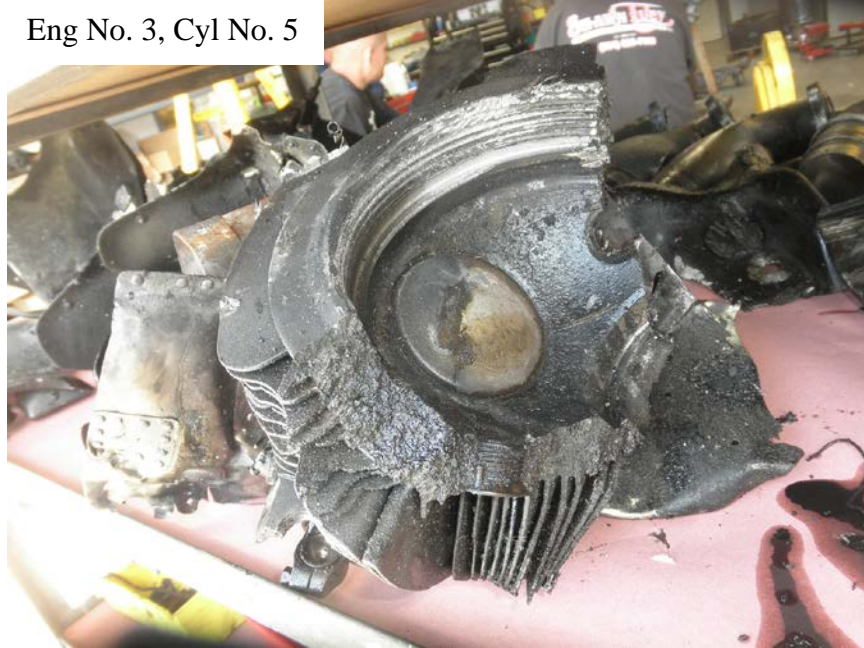
Eng No. 3, Cyl No. 5

Photo No. 92: View of piece of No. 5 cylinder head with exhaust valve in place.

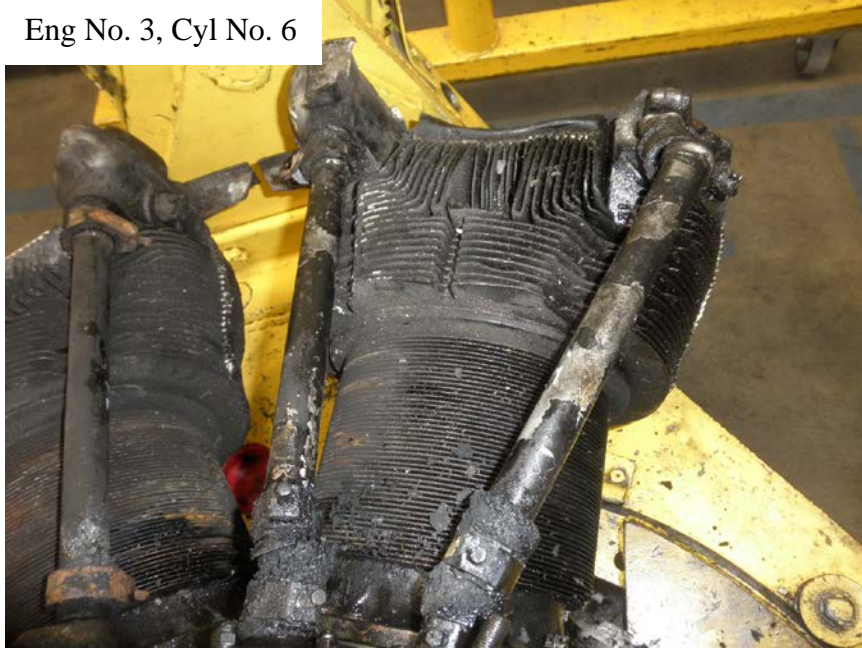
Eng No. 3, Cyl No. 6

Photo No. 93: View of the front of No. 6 cylinder showing that it was in place on the crankcase and that it was intact with the head in place.

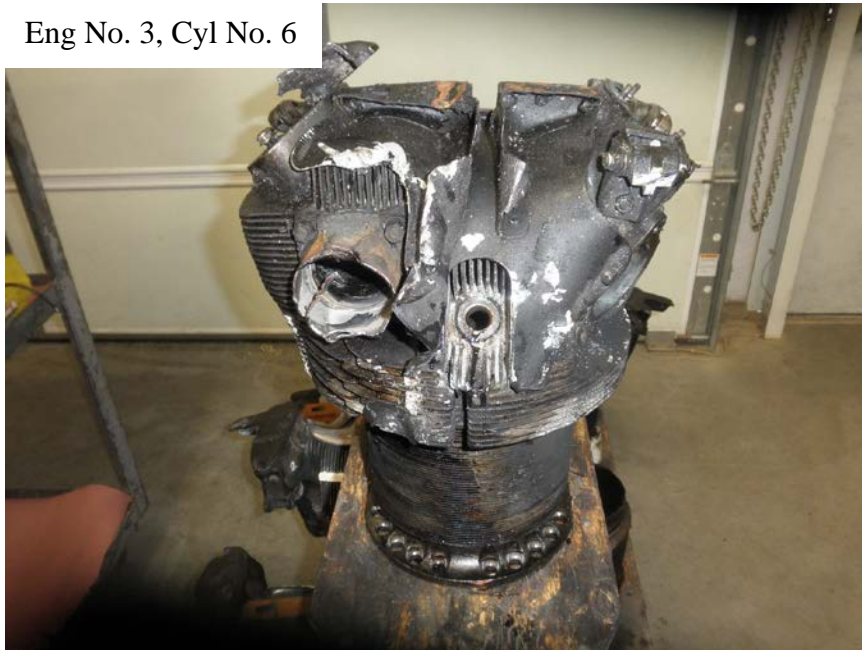
Eng No. 3, Cyl No. 6

Photo No. 94: View of the rear of No. 6 cylinder showing that it was intact with the head in place.

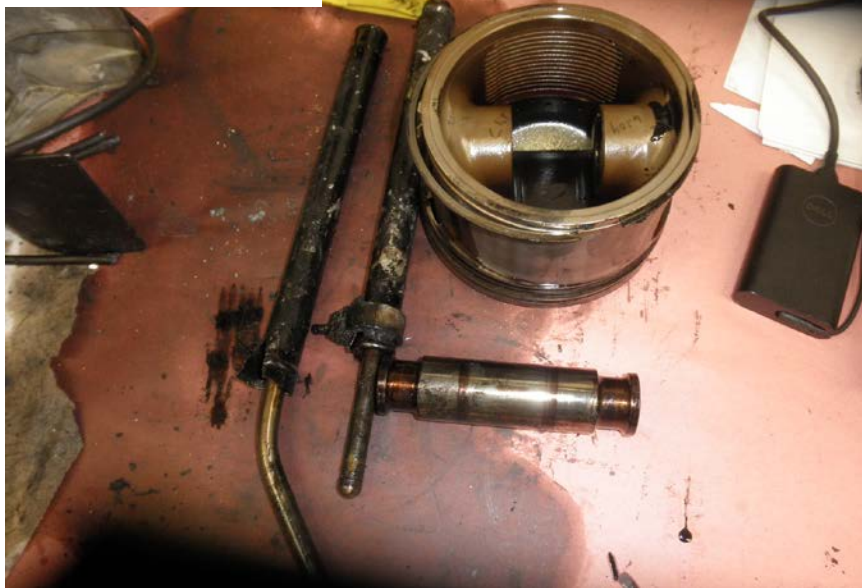
Eng No. 3, Cyl No. 6

Photo No. 97: View of the underside of the No. 6 cylinder piston and the piston pin.

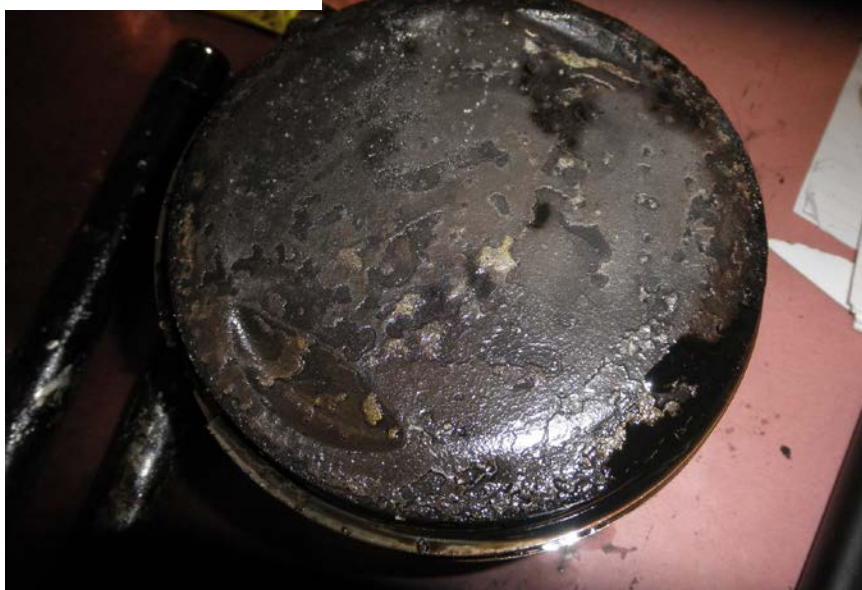
Eng No. 3, Cyl No. 6

Photo No. 98: Close up view of the head of the No. 6 cylinder piston showing the dark gray color.

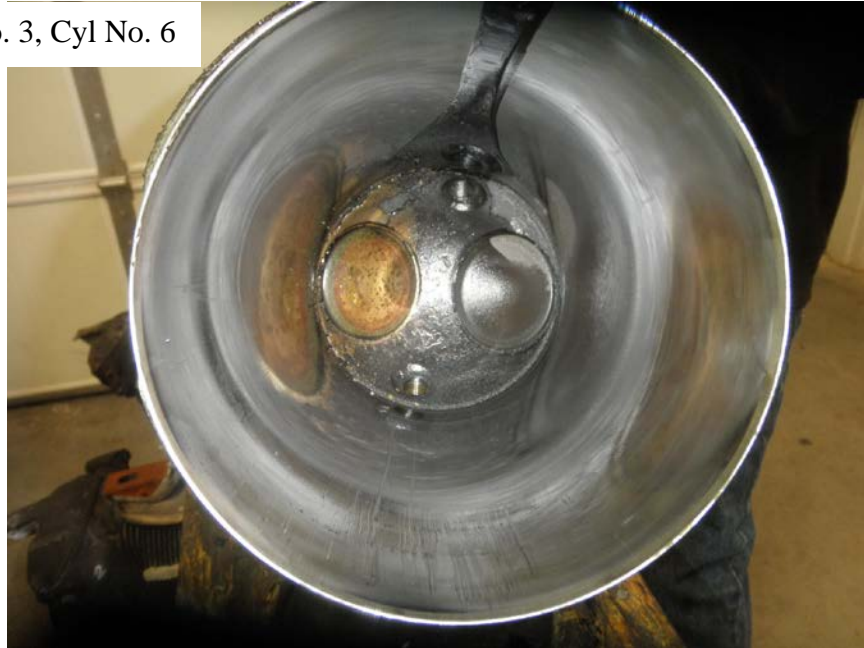
Eng No. 3, Cyl No. 6

Photo No. 99: View of the inside of the No. 6 cylinder showing no damage to the barrel and the two valves centered in place in the closed position.

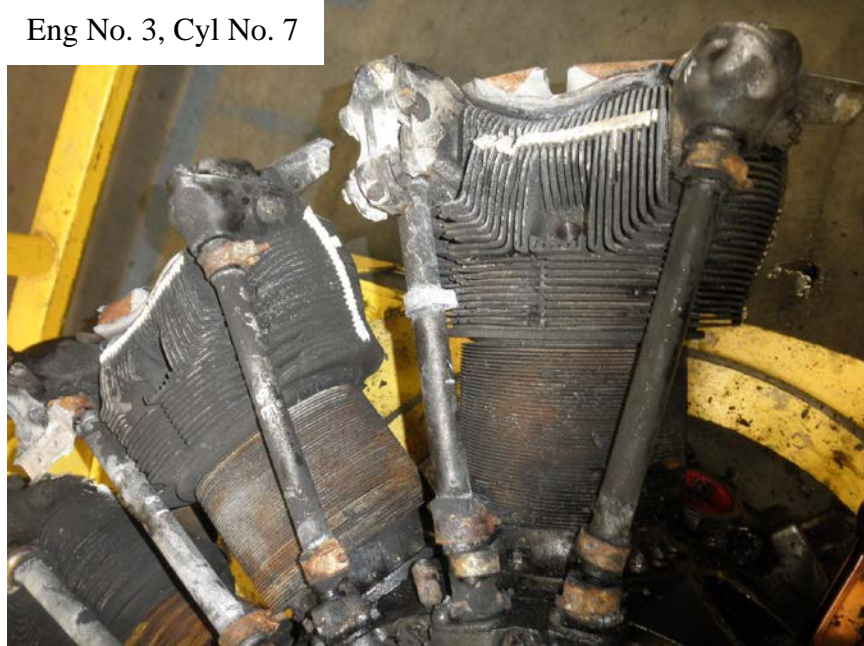
Eng No. 3, Cyl No. 7

Photo No. 100: View of the front of No. 7 cylinder showing that it was in place on the crankcase and that it was intact with the head in place.

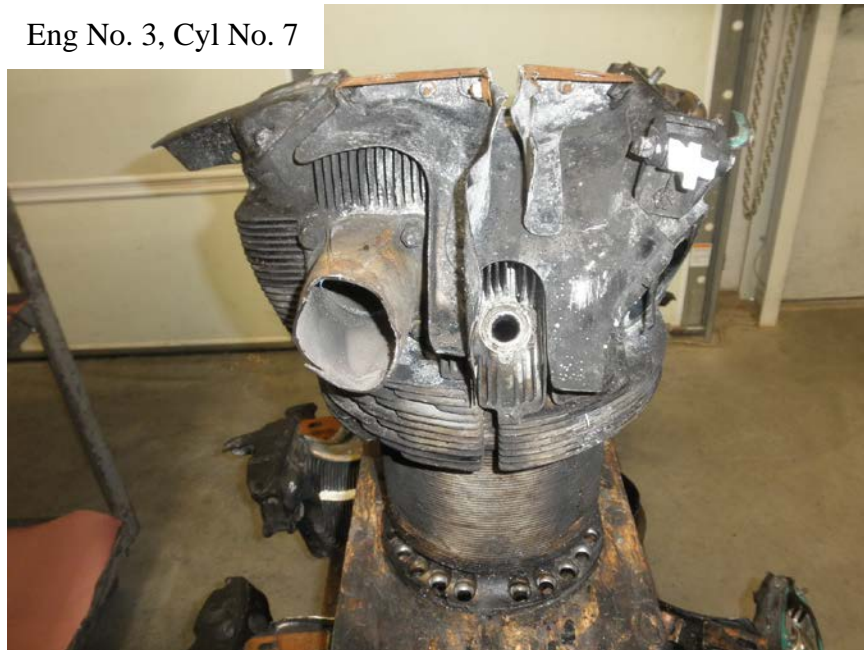
Eng No. 3, Cyl No. 7

Photo No. 101: View of the rear of No. 7 cylinder showing that it was intact with the head in place.

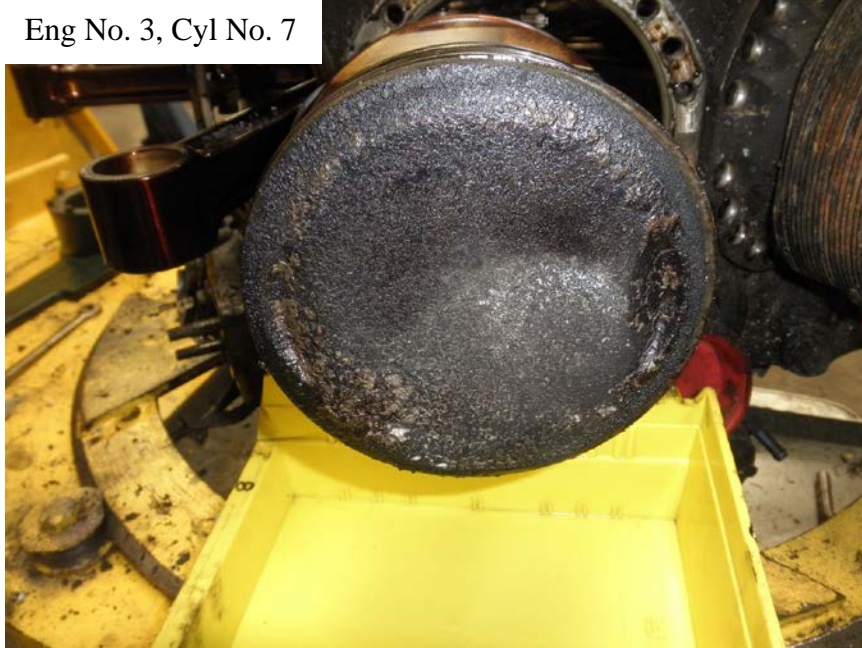
Eng No. 3, Cyl No. 7

Photo No. 102: View of the head of the No. 7 cylinder's piston showing that it was intact.

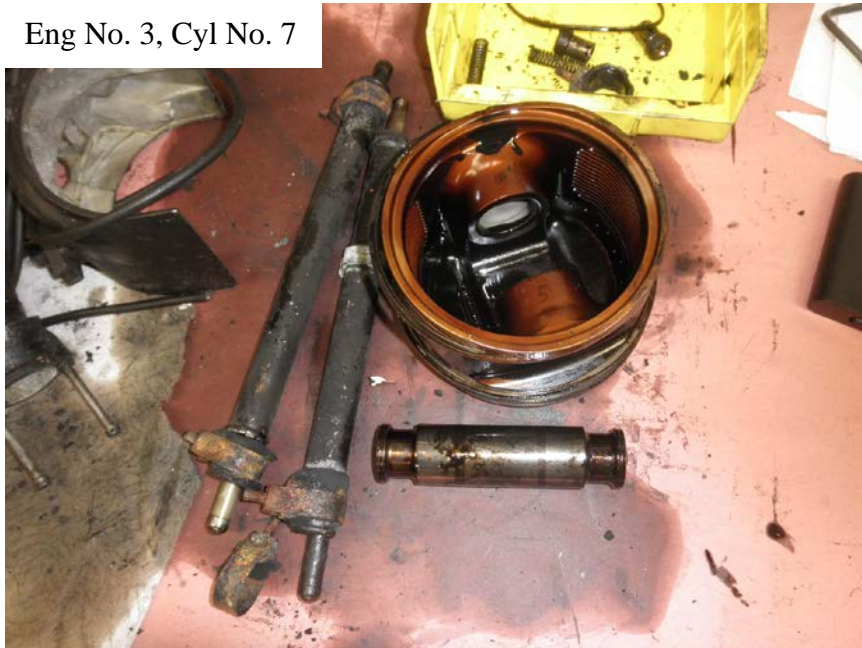
Eng No. 3, Cyl No. 7

Photo No. 103: View of the underside of the No. 7 cylinder's piston, the piston ring, and push rod shrouds with push rods.

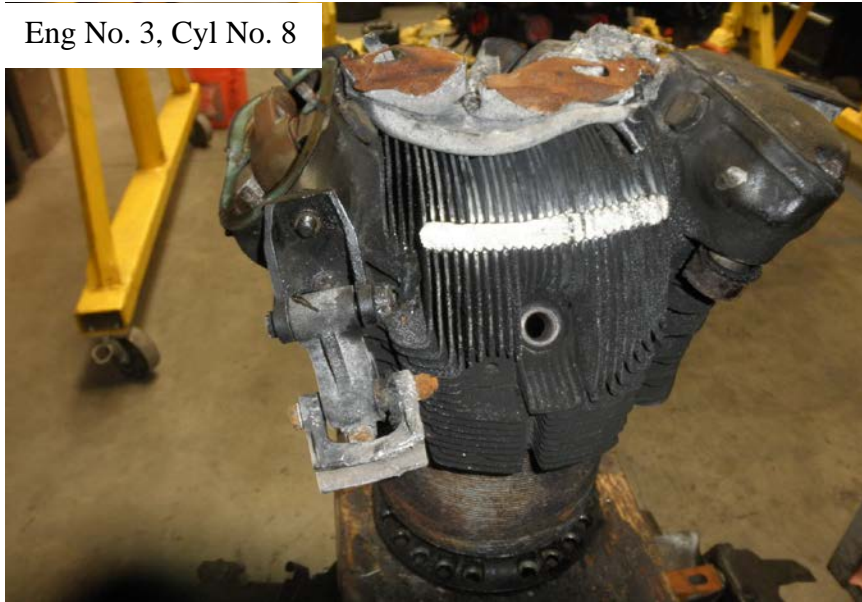
Eng No. 3, Cyl No. 8

Photo No. 106: View of the front of No. 8 cylinder showing that it was intact with the head in place.

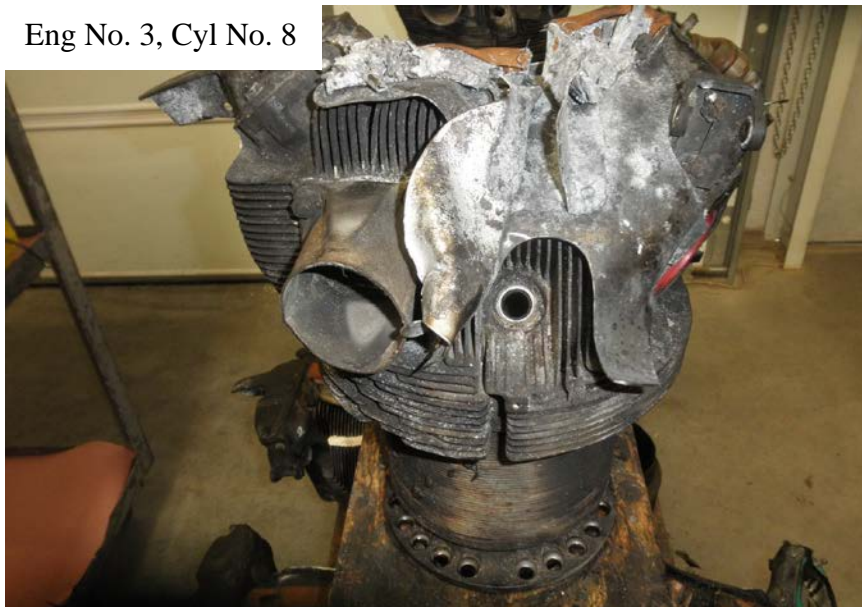
Eng No. 3, Cyl No. 8

Photo No. 107: View of the rear of No. 8 cylinder showing that it was intact with the head in place.

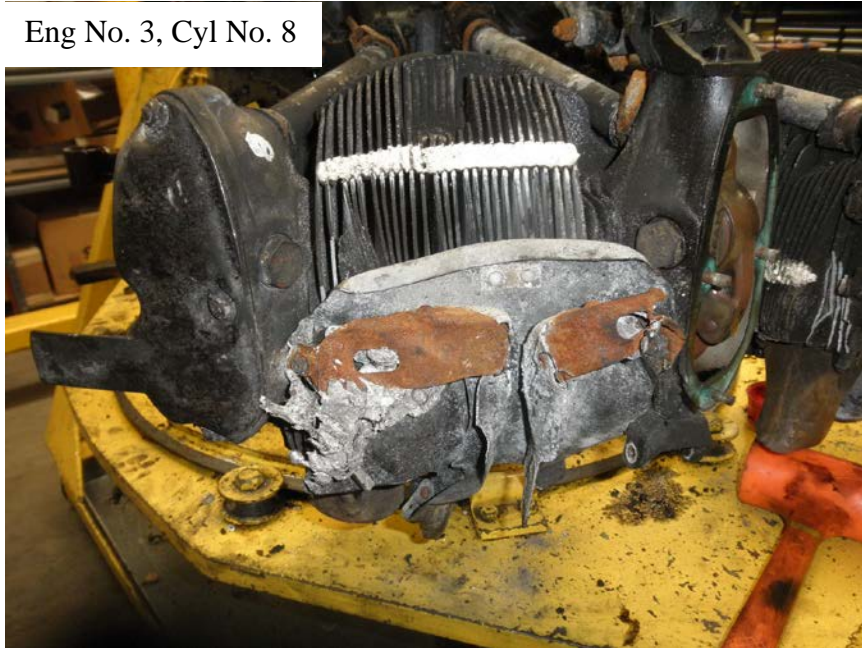
Eng No. 3, Cyl No. 8

The No. 8 cylinder barrel was in place on the crank case and the cylinder head was in place and intact. (Refer to Photo No. 38) The intake and exhaust rocker arm covers were in place on the cylinder head and did not appear to have any damage. There was metal slag on the cylinder head between the two rocker arm assemblies. (Photos Nos. 106, 107, and 108) The spark plugs were in place and the ignition leads were still attached.

Photo No. 108: View of the No. 8 cylinder head showing the metal slag.

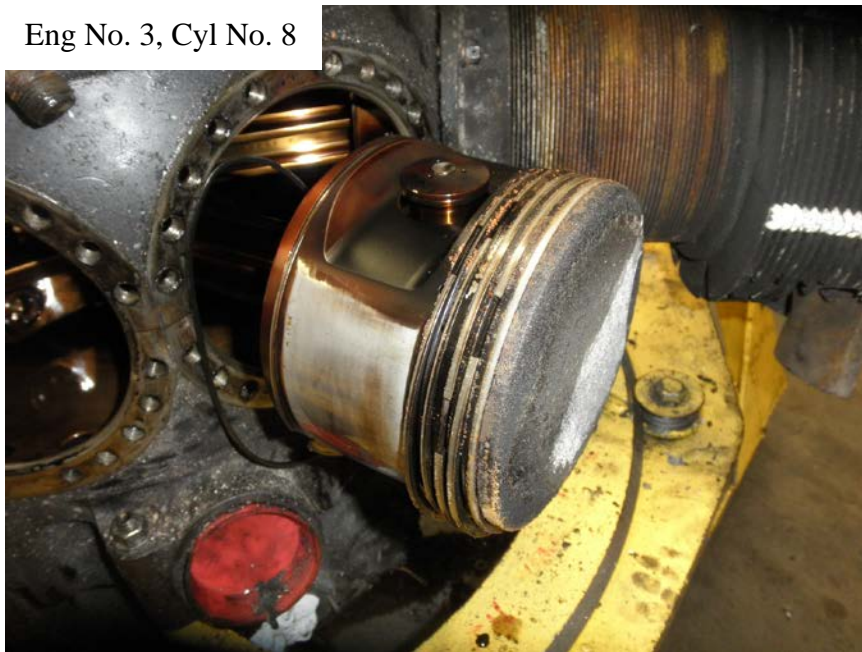
Eng No. 3, Cyl No. 8

Photo No. 109: View of No. 8 cylinder's piston showing that it was intact.

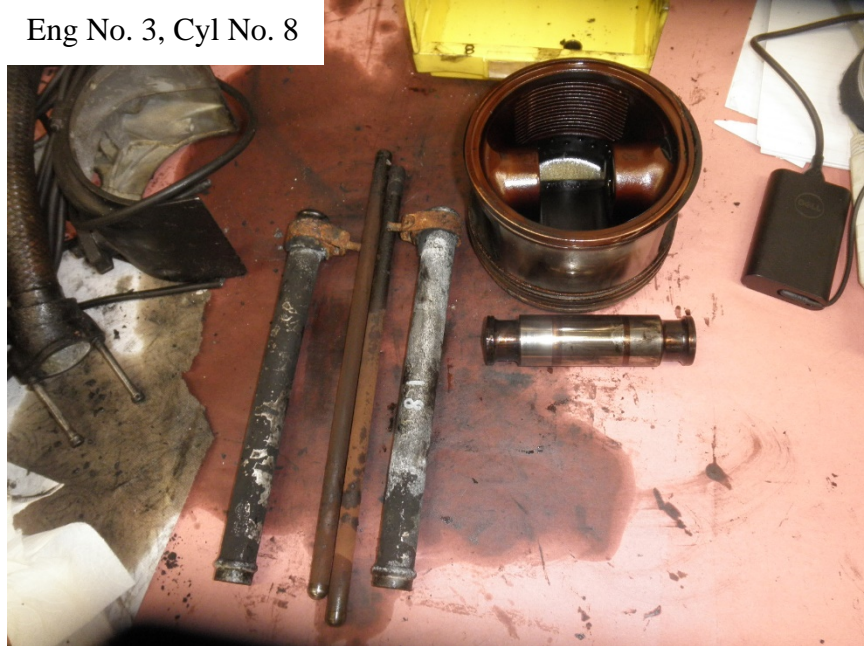
Eng No. 3, Cyl No. 8

Photo No. 110: View of the underside of the No. 8 cylinder's piston, the piston pin, push rod shrouds, and the push rods.

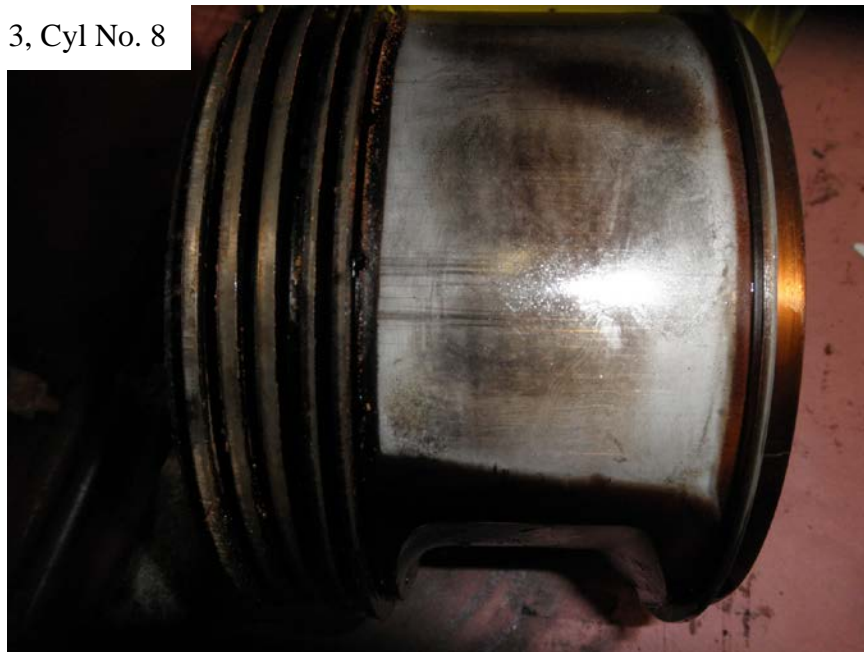
Eng No. 3, Cyl No. 8

Photo No. 111: Close up view of the side of the No. 8 cylinder's piston showing the rings were in place.

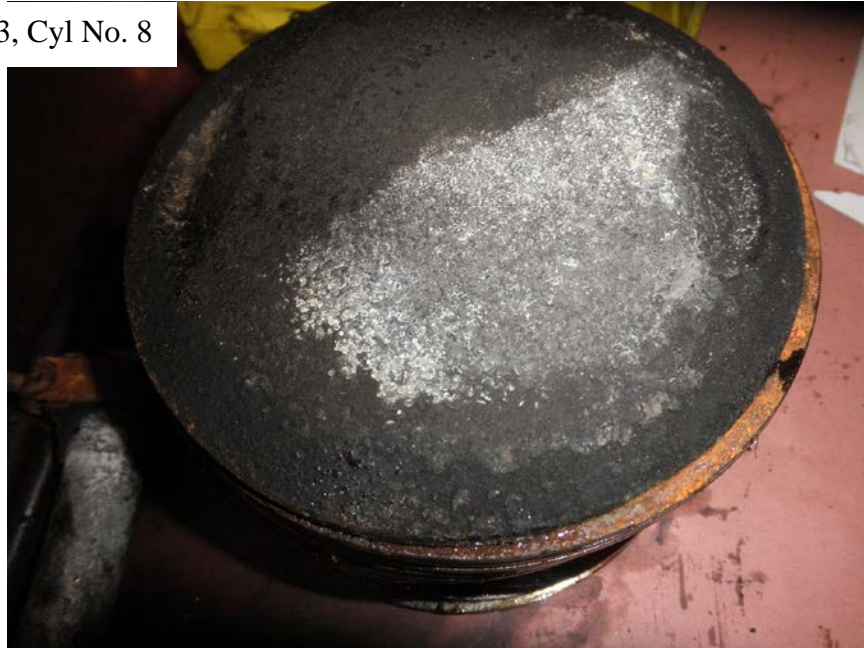
Eng No. 3, Cyl No. 8

Photo No. 112: Close up view of the head of the No. 8 cylinder's piston showing it to be mostly a dark color with a light colored area.

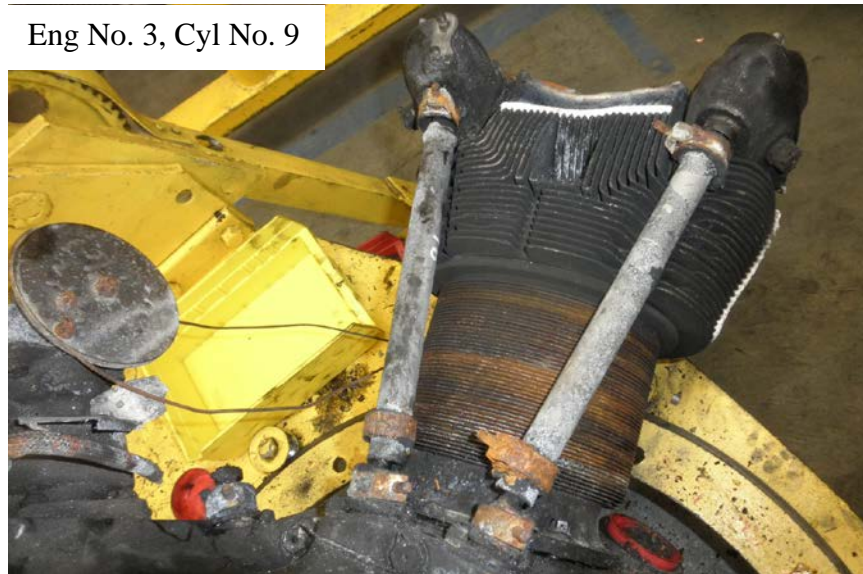
Photo No. 114: View of the front of No. 9 cylinder showing that it was intact with the head in place.

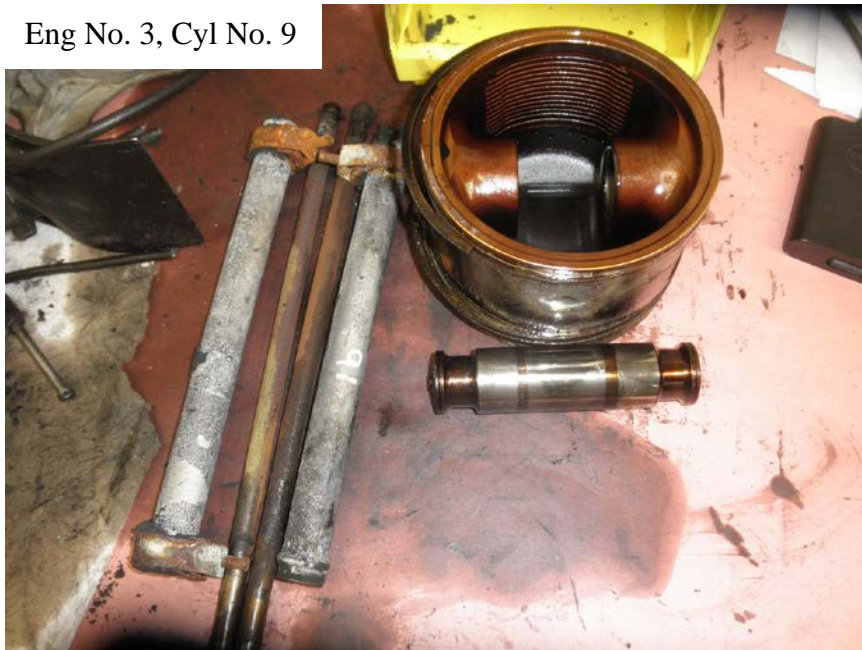
Eng No. 3, Cyl No. 9

Photo No. 117: View of the underside of the No. 9 cylinder's piston, the piston pin, push rod shrouds, and the push rods.

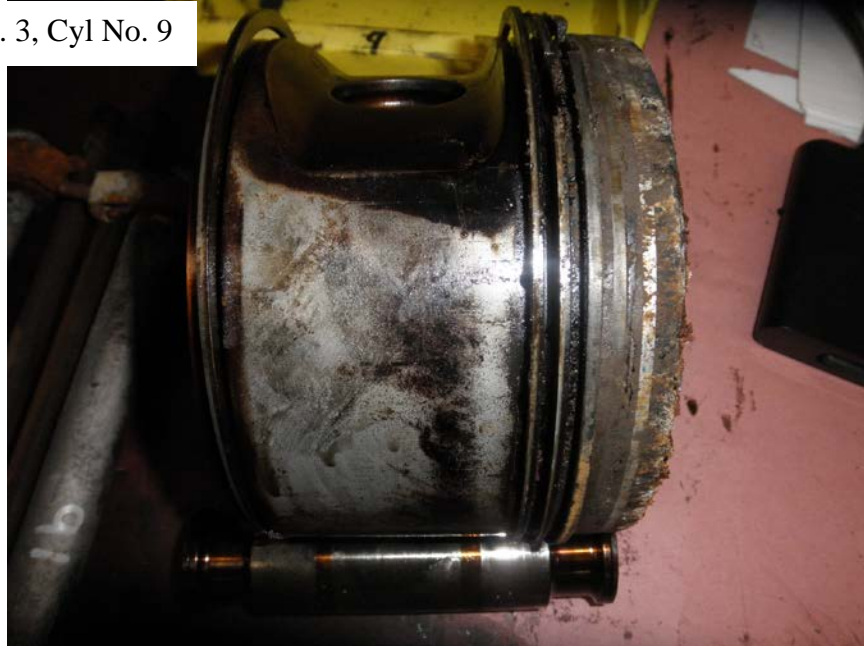
Eng No. 3, Cyl No. 9

Photo No. 118: Close up view of the side of the No. 9 cylinder's piston showing the rings were in place.

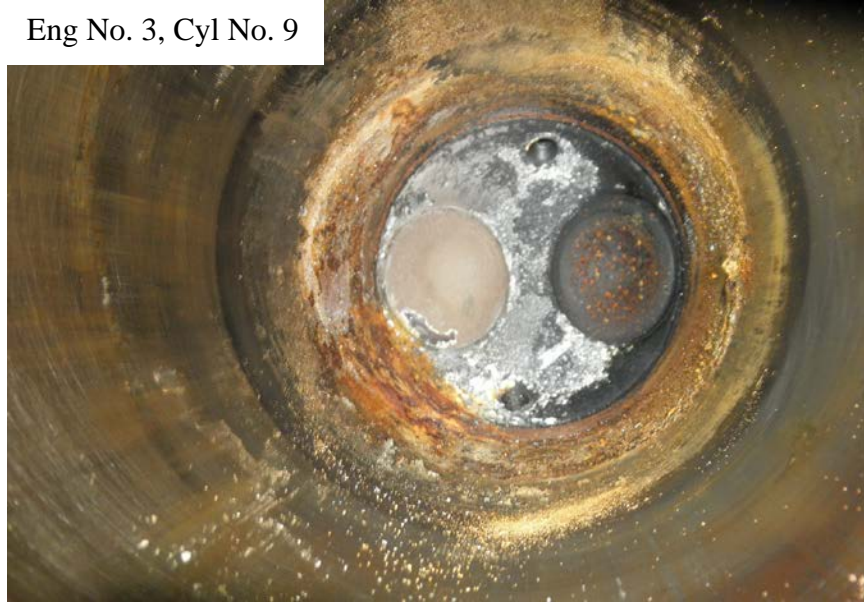
Eng No. 3, Cyl No. 9

The cylinder barrel was intact. The inner surface of the cylinder barrel was corroded. The two valves were in place in the closed position centered on the valve seats. The valves did not have any damage. (Photo No. 120)

Photo No. 120: View inside of the No. 9 cylinder's barrel showing the corrosion and that the two valves were in place in the closed position.

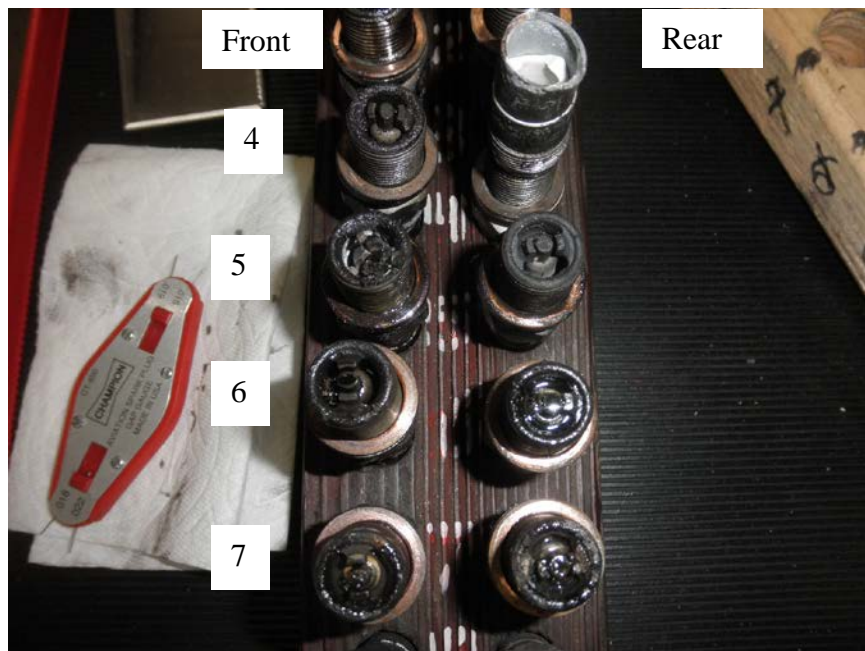
4	The tip was fouled with lead and oil. The insulator was a light color. The center of the electrode was eroded.	>0.022	The tip of the plug did not have any lead or oil fouling. The insulator was a light color. The center electrode appeared to be consistent with new plug. The top of the spark plug was broken off. The associated washer was heat discolored. According to Vintage Radial, the condition of this plug and the associated washer was consistent with detonation.	>0.022 Front 0.022 Rear
5	The center electrode was bent over against the side of the tip. One of the side electrodes was bent over. The tip was wet. The insulator was cracked.	---	The insulator was a dark gray color. There was heavy carbon build up on the tip. There was no lead or oil fouling on the tip.	>0.022 Front 0.018 Rear
6	The tip was fouled with oil and lead. The insulator was a dark color.	>0.022	The tip was fouled with oil. The insulator was a dark color.	0.022

Photo No. 122: No. 3 engine's spark plugs for cylinders Nos. 4, 5, 6, and 7.

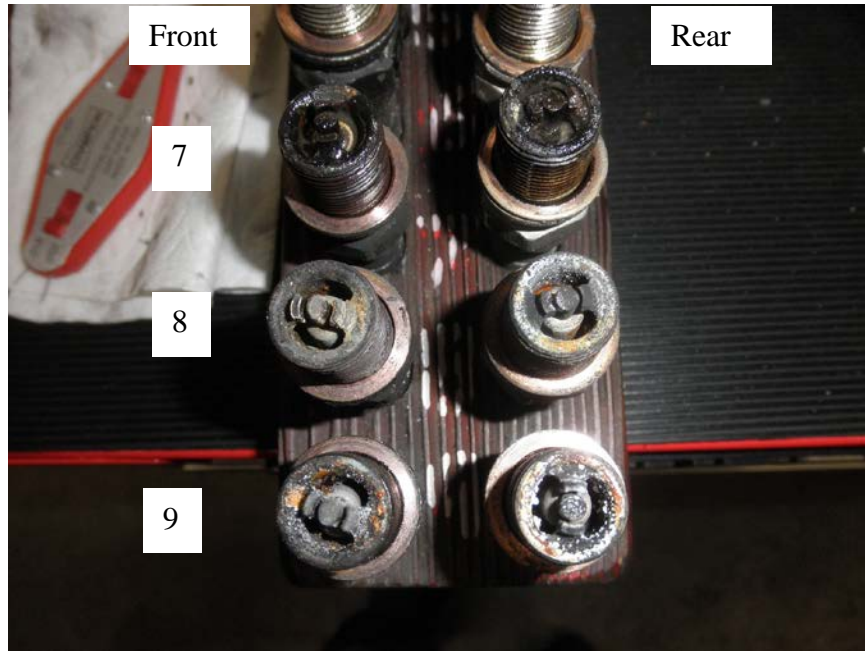
Photo No. 123: No. 3 engine's spark plugs for cylinders Nos. 7, 8, and 9.

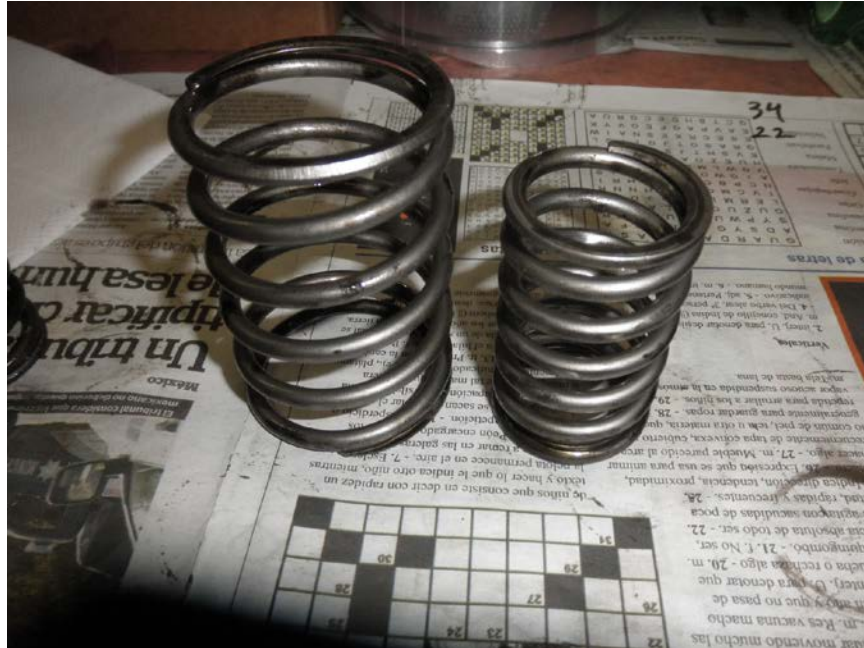
During the disassembly of the cylinder heads to remove the intake valves, it was noted that there were two rather than three valve springs. The force to compress the two and three spring configuration was measured. The force to compress the inner and outer springs of the two spring configuration was 115 and 88 pounds, respectively, for a total of 203 pounds. The force to compress the inner, middle, and outer springs was 95, 71, and 53 pounds respectively, for a total of 219 pounds. (Photos Nos. 124 and 125)

Photo No. 124: View of two valve springs that were found in the No. 3 engine's cylinders.

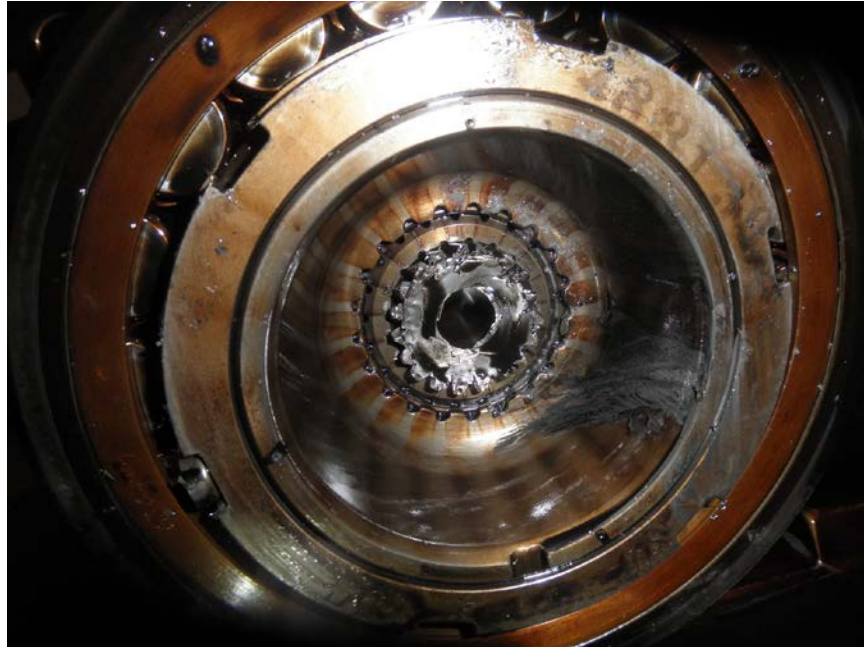
The accessory drive gear shaft was broken in the splines.¹⁰ The splines were twisted slightly in the clockwise direction adjacent to the break. (Photos Nos. 126, 127, and 128) An examination of the fracture surface by NTSB metallurgists confirmed that it was a torsional fracture.¹¹

Photo No. 126: View of fractured forward end of accessory drive gear shaft in end of crankshaft.

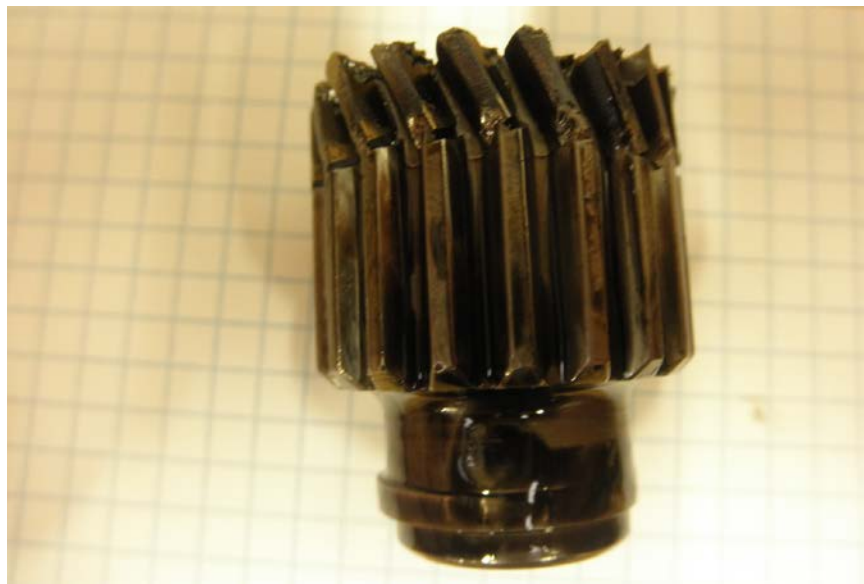
Photo No. 127: View of side of aft end of accessory drive gear shaft showing splines at fractured end twisted slightly.

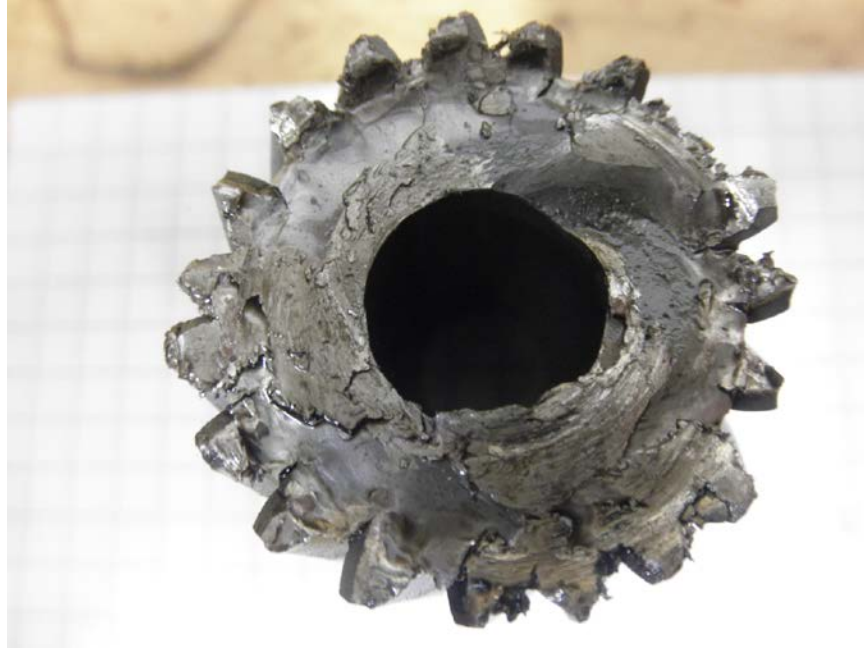
Photo No. 128: Close up view of fracture surface on aft end of accessory drive gear shaft.
