NATIONAL TRANSPORTATION SAFETY BOARD
OFFICE OF AVIATION SAFETY
WASHINGTON, D.C. 20594

POWERPLANTS GROUP CHAIRMAN'S FACTUAL REPORT

NTSB ID No.: ERA20MA001

Location: Bradley International Airport, Windsor Locks, Connecticut
Date: October 2, 2019
Time: 0953 eastern daylight time
Aircraft: Boeing B-17G, N93012, Collings Foundation

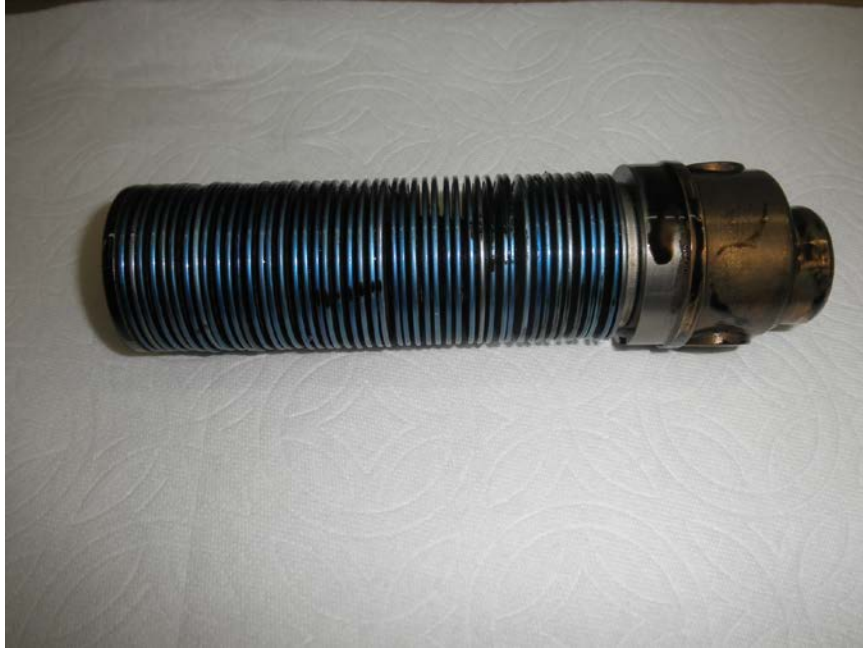
Photo No. 130: The No. 3 engine's Cuno oil filter after the filter housing was removed.

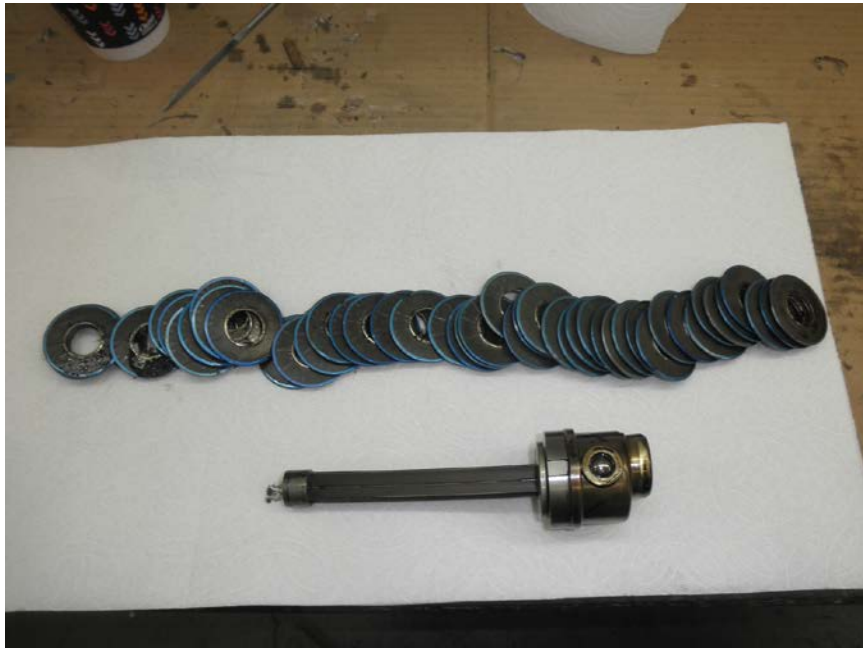
Photo No. 131: The No. 3 engine's Cuno oil filter elements after they were unstacked.

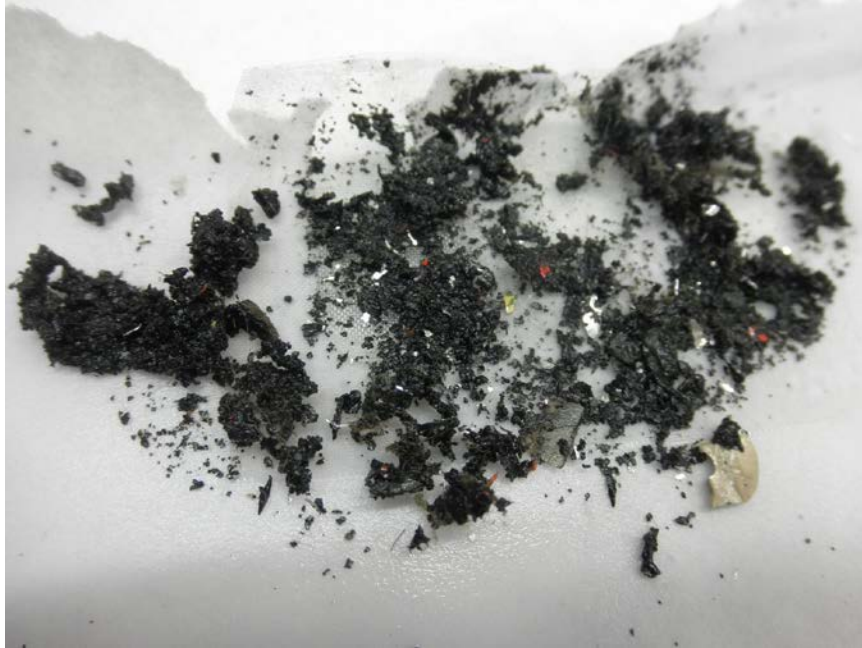
The Cuno oil filter was removed from the rear of the crankcase.¹² The filter was disassembled. (Photos Nos. 129, 130, and 131) The filter elements were flushed out and they had a small amount of small black and silver colored particles as well as a piece of tan colored plastic. (Photo No. 132) When touched with a magnet, all of the silver colored particles stuck to the magnet.¹³

¹³ According to Vintage Radial, the amount of metal found in the filter was typical.

Photo No. 132: Debris that was flushed from the No. 3 engine's Cuno oil filter.

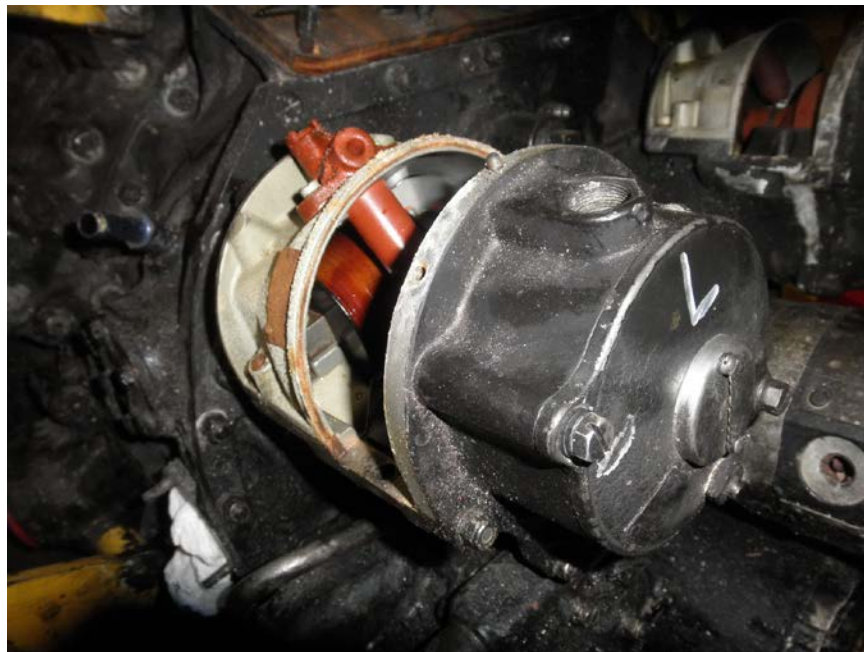
Photo No. 134: Close up view of left magneto housing showing it was intact.

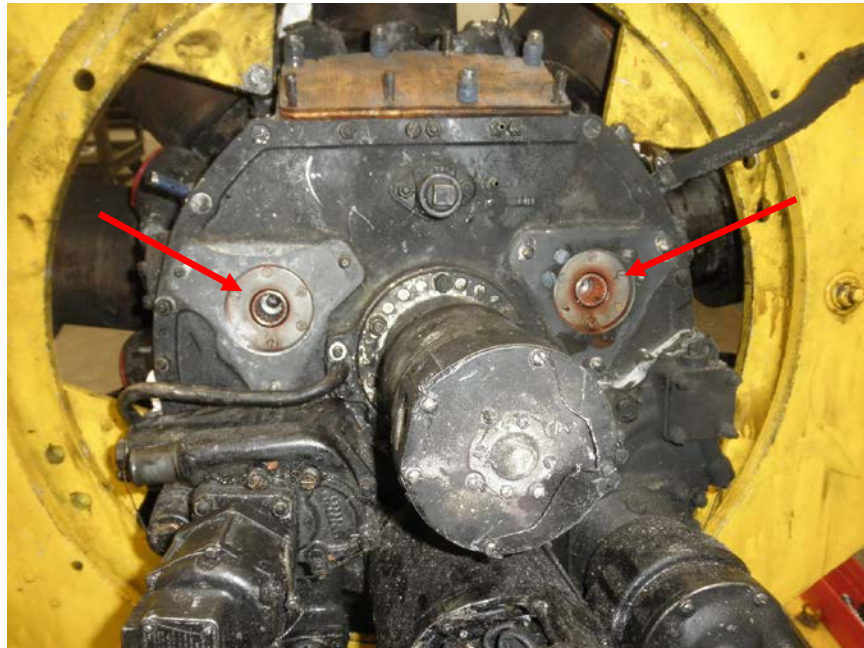
Photo No. 138: View of the left and right magneto drives showing a red material on the drives with more being on the right than on the left.

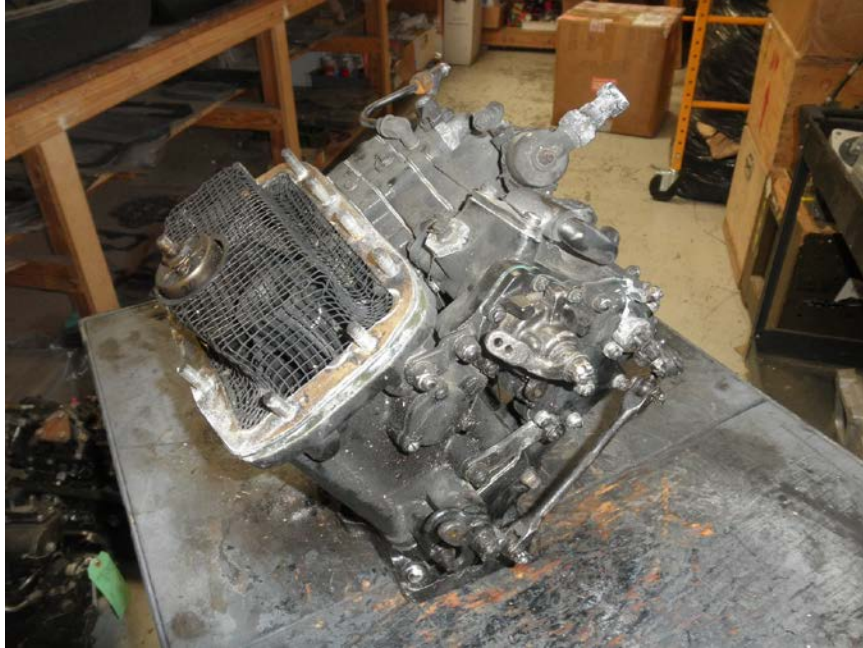
Photo No. 140: No. 3 engine's carburetor.

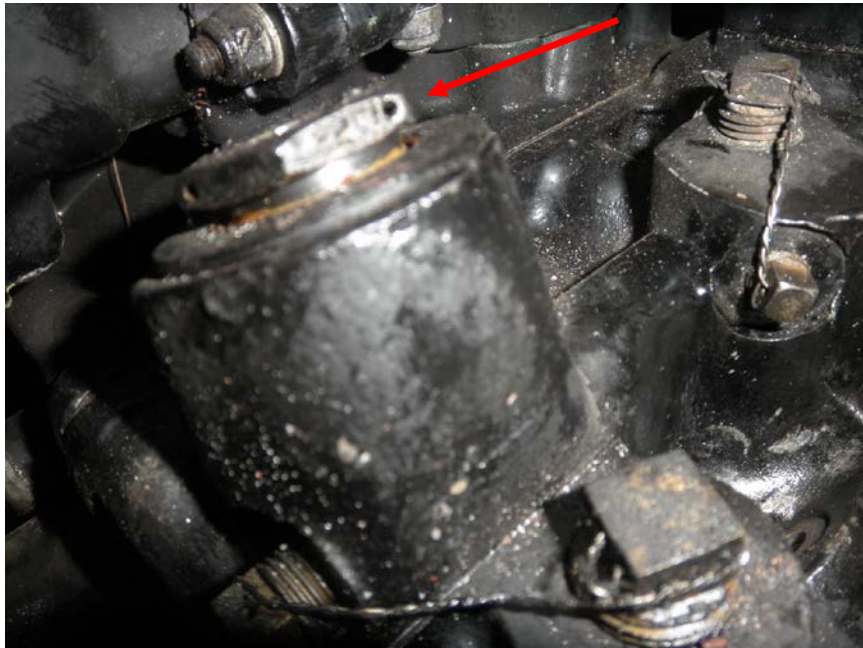
Photo No. 141: Close up of the No. 3 engine's carburetor vent adapter nut showing that it was not safety wired.

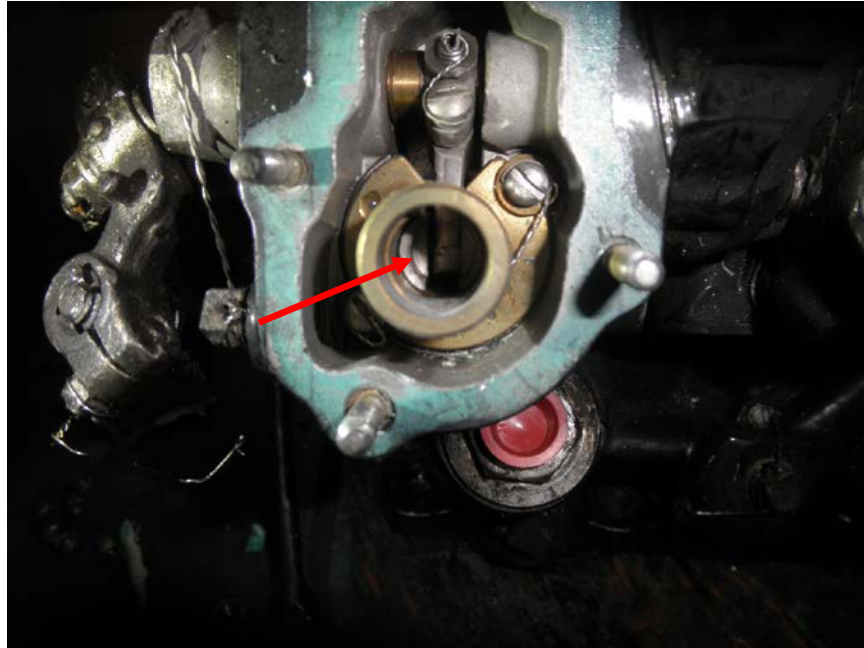
The carburetor was a Stromberg Injection Carburetor Model PD-12-H2, SN 561943 A. (Photo No. 139) The carburetor was securely in place on the back of the engine. When it was attempted to shake the carburetor to see if it was loose on the engine, it would not move. The carburetor was removed from the engine and taken to Vintage Carburetors, Tehachapi, California, where it was tested in the presence of members of the Powerplants Group. (Photo No. 140) The as-received examination of the carburetor revealed the vent adapter nut was not safety wired. (Photo No. 141) In addition, the jet and idle valve chambers both had evidence of corrosion that according to Vintage Carburetor was consistent with water in the fuel. (Photo No. 142)

Photo No. 142: Close up view of No. 3 engine's carburetor idle jet chamber showing corrosion.

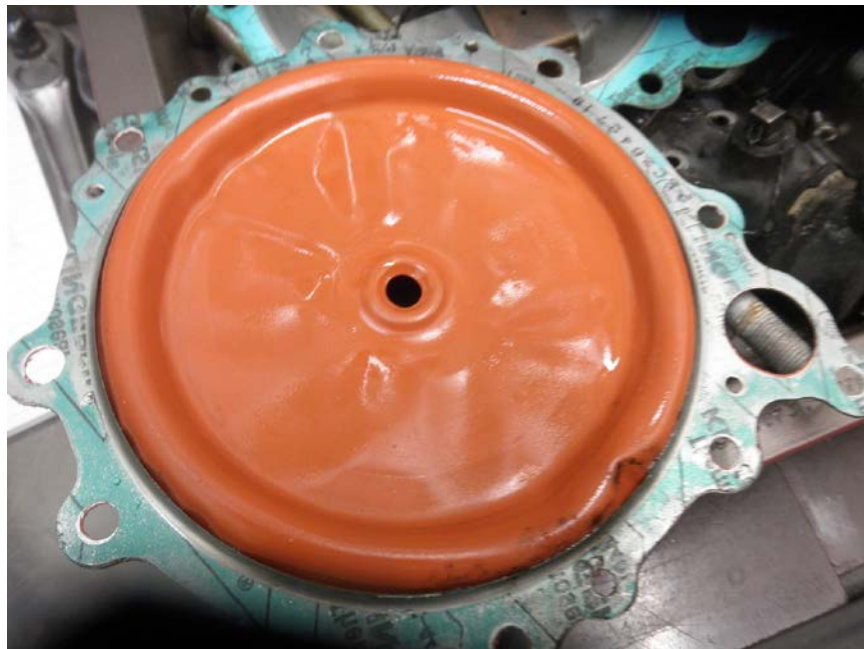
Photo No. 144: View of typical diaphragm showing it was intact.

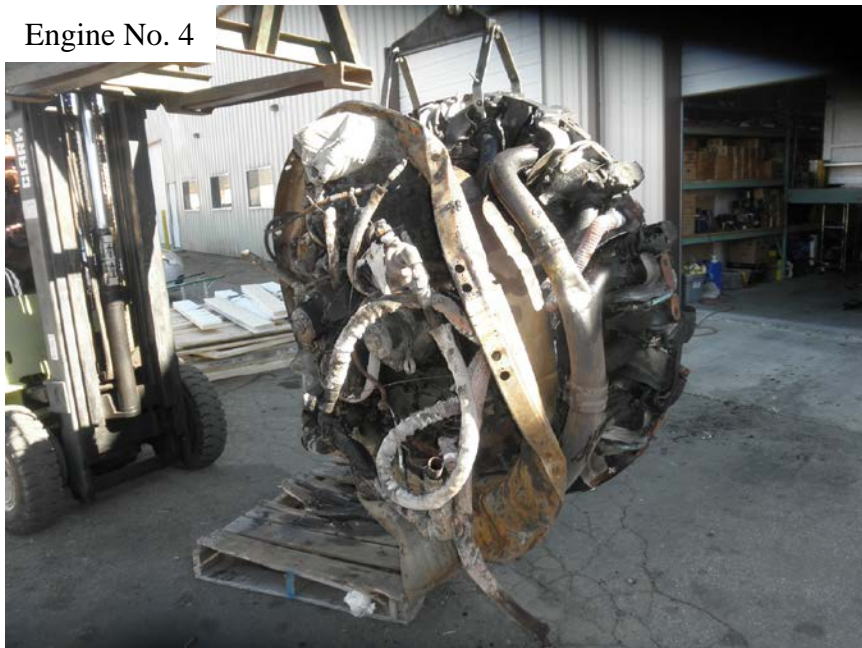
Engine No. 4

There were pieces of airframe structure such as cowling supports and cowl flaps still attached to the engine. The engine had evidence of having been exposed to a fire with the heat resistant covering on the oil and fuel lines partially burned away as well as the paint on the left magneto. The air deflector in back of the cylinders was bent and buckled all the way around. The propeller shaft was in place, but was cut off flush to the front of the nose case. The left and right exhaust manifolds were still in place. The left exhaust manifold was bent forward and buckled between about 6 and 9 o'clock. The right hand manifold intact, but was dented at about 2:30 o'clock. (Photos Nos. 146 and 147)

Photo No. 147: View of rear of No. 4 engine showing fire damage and some airframe structure still attached.

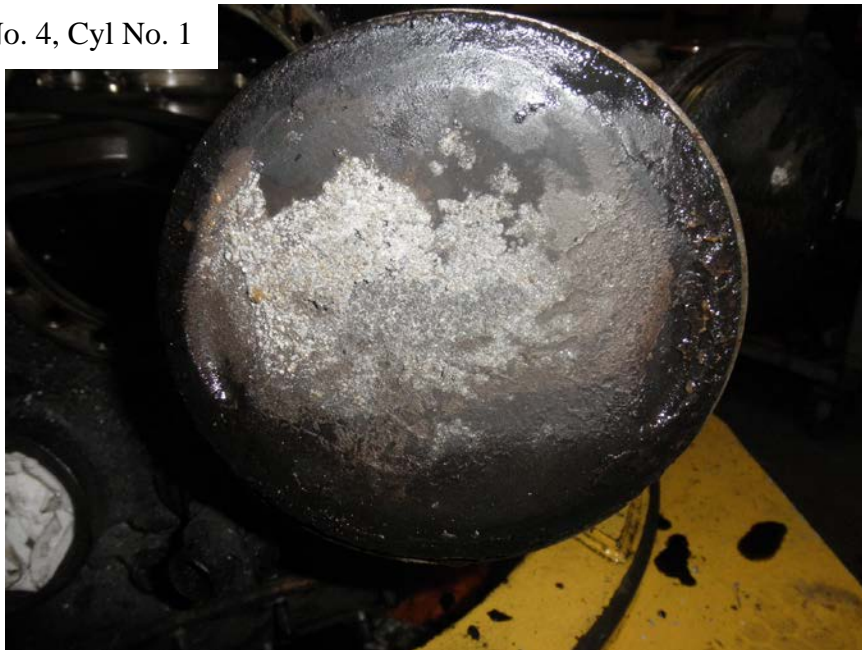
Eng No. 4, Cyl No. 1

head of the piston had a white-colored deposit that appeared to be flaking off. (Photos Nos. 156, 157, and 158)

Photo No. 157: Close up view of the No. 1 cylinder's piston head showing the white-colored deposit.

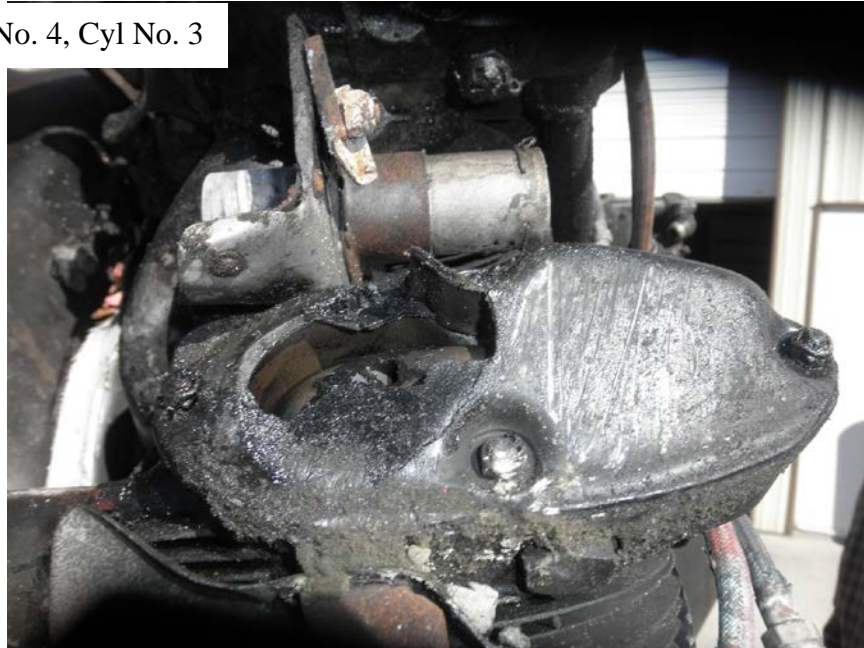
Eng No. 4, Cyl No. 3

The No. 3 cylinder barrel was in place on the crank case and the cylinder head was in place on the cylinder barrel. (Refer Photo No. 151) The intake valve rocker arm cover was in place and intact. The exhaust valve rocker arm cover was in place, but the aft end of the cover was broken open exposing the rocker arm that was intact. (Photo No. 164) The spark plugs were in place and the ignition leads were still attached.

Photo No. 164: Close up view of the No. 3 cylinder's exhaust rocker arm cover showing the hole in the cover.

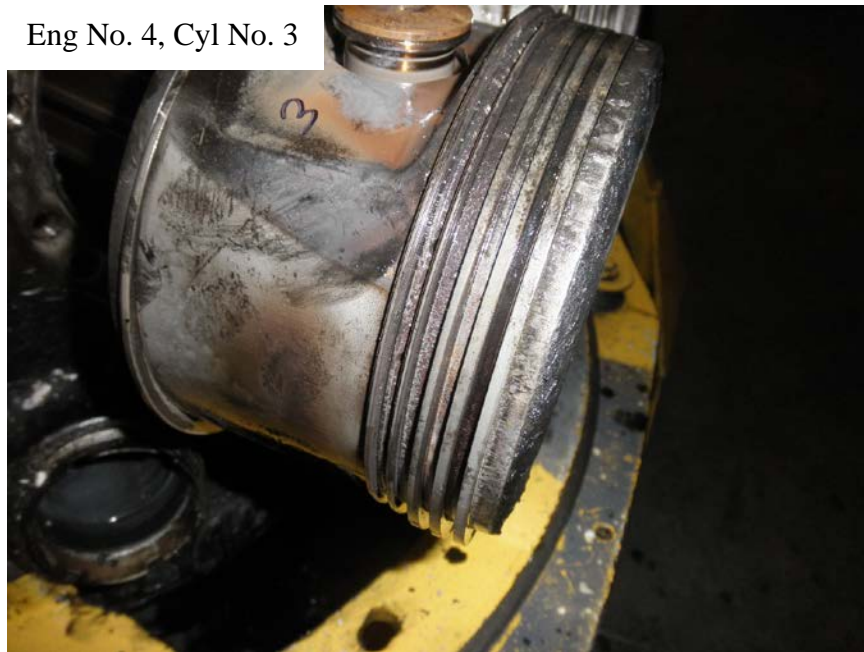
Eng No. 4, Cyl No. 3

The No. 3 piston was connected to the articulating rod with the piston pin and the piston pin buttons were in place. The piston was intact and all of the piston rings were in place and intact. There were small metal particles trapped on the sides of the piston between the rings. The head of the piston was a dark gray color. (Photos Nos. 165, 166, and 167)

Photo No. 165: View of No. 3 cylinder's piston in place on the articulating rod showing that the piston was intact and that all of the piston rings were in place.

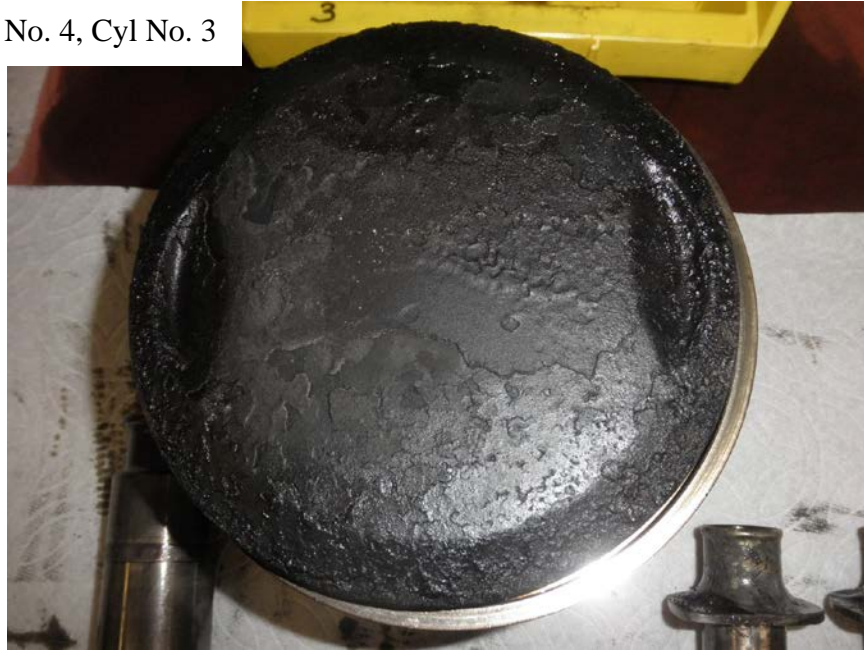
Eng No. 4, Cyl No. 3

Photo No. 166: Close up view of the No. 3 piston's head showing the dark gray color.

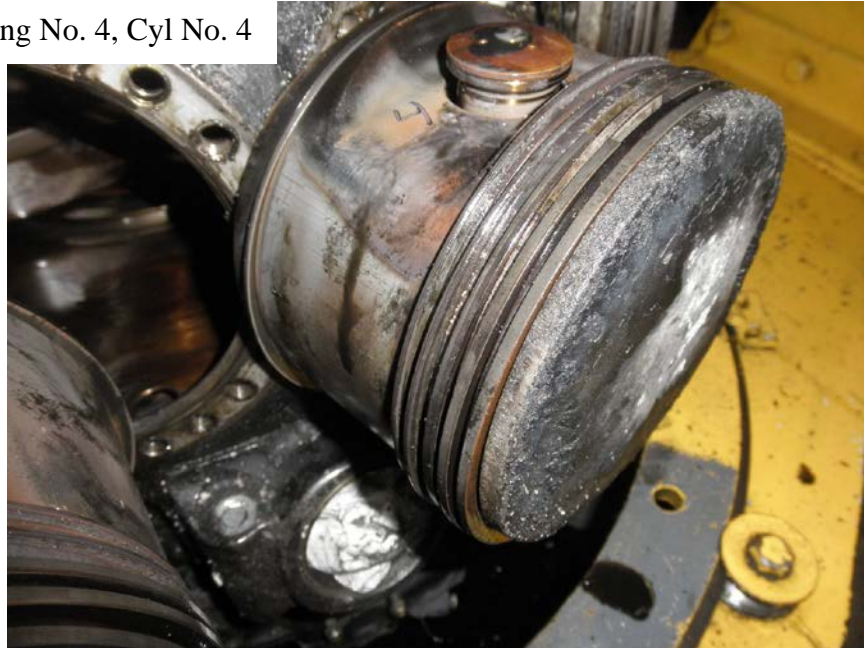
Eng No. 4, Cyl No. 4

The No. 4 piston was connected to the articulating rod with the piston pin and the piston pin buttons were in place. The piston was intact and all of the piston rings were in place and intact. There were small metal particles trapped on the sides of the piston between the rings. The head of the piston was a dark gray-color. (Photos Nos. 169, 170, and 171)

Photo No. 169: View of No. 4 cylinder's piston in place on the articulating rod showing that the piston was intact and that all of the piston rings were in place.

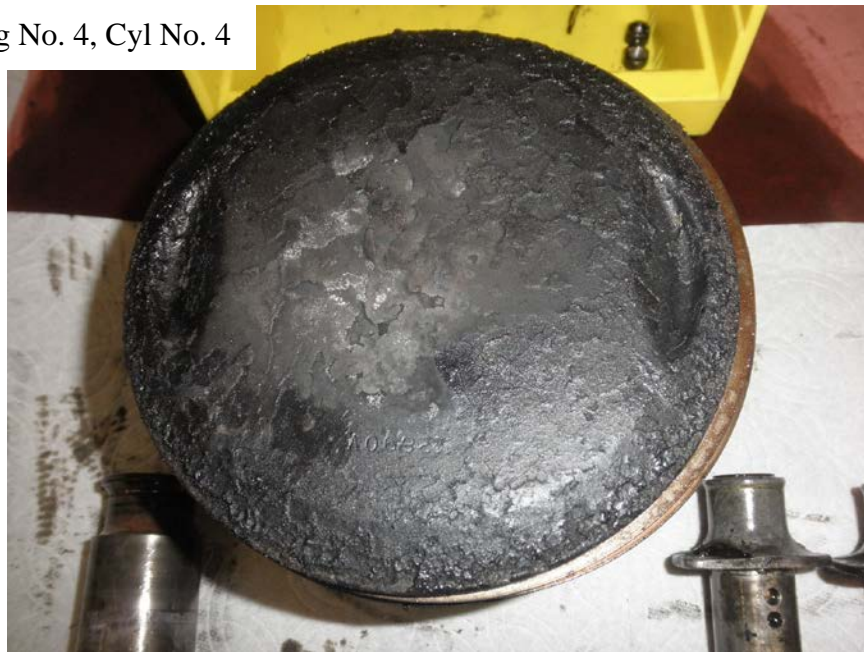
Eng No. 4, Cyl No. 4

Photo No. 170: Close up view of the No. 4 piston's head showing the dark gray color.

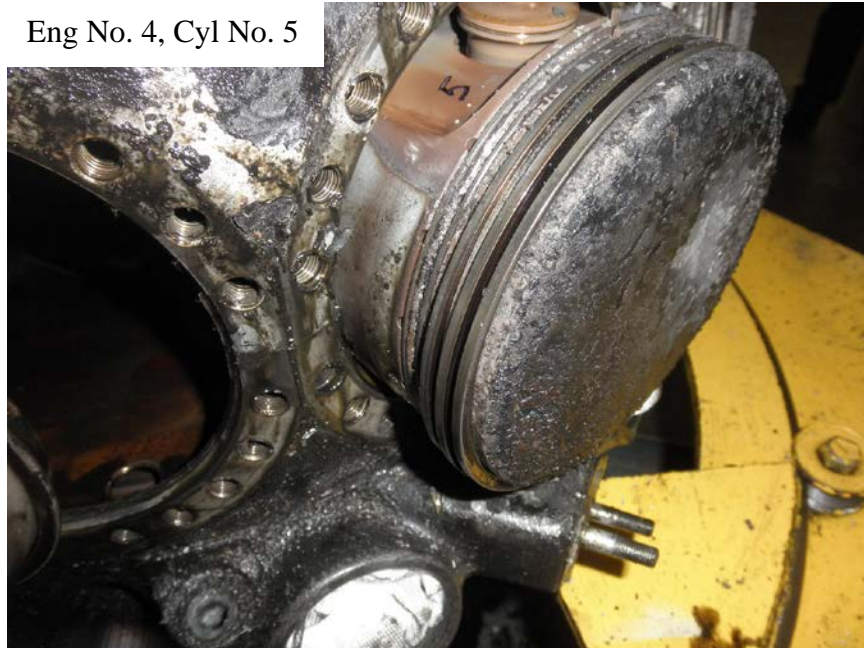
Eng No. 4, Cyl No. 5

The No. 5 piston was connected to the articulating rod with the piston pin and the piston pin buttons were in place. The piston was intact and all of the piston rings were in place and intact. There were small metal particles trapped on the sides of the piston between the rings. The head of the piston was a dark gray color. (Photos Nos. 173, 174, and 175)

Photo No. 173: View of No. 5 cylinder's piston in place on the articulating rod showing that the piston was intact and that all of the piston rings were in place.

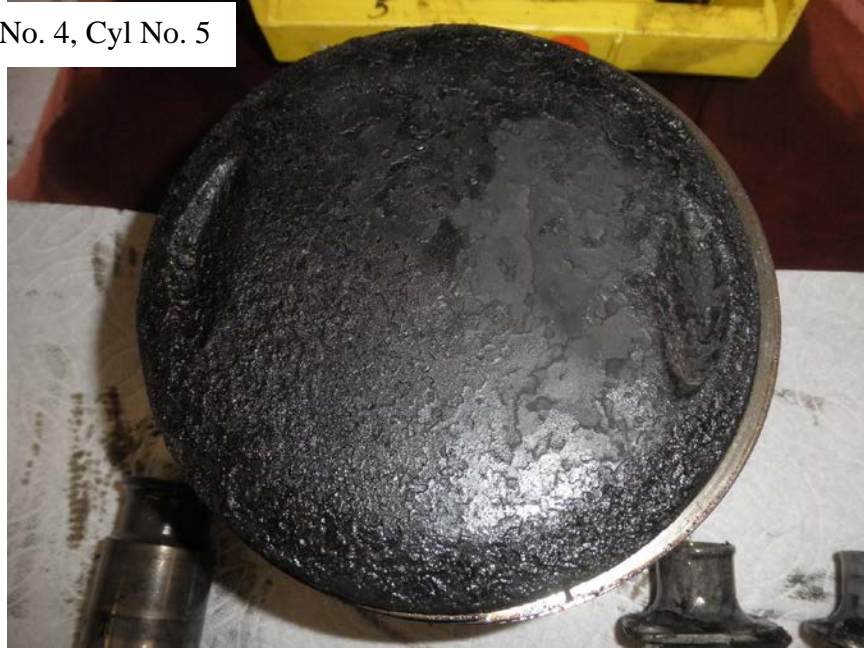
Eng No. 4, Cyl No. 5

Photo No.174: Close up view of the No. 5 piston's head showing the dark gray color.

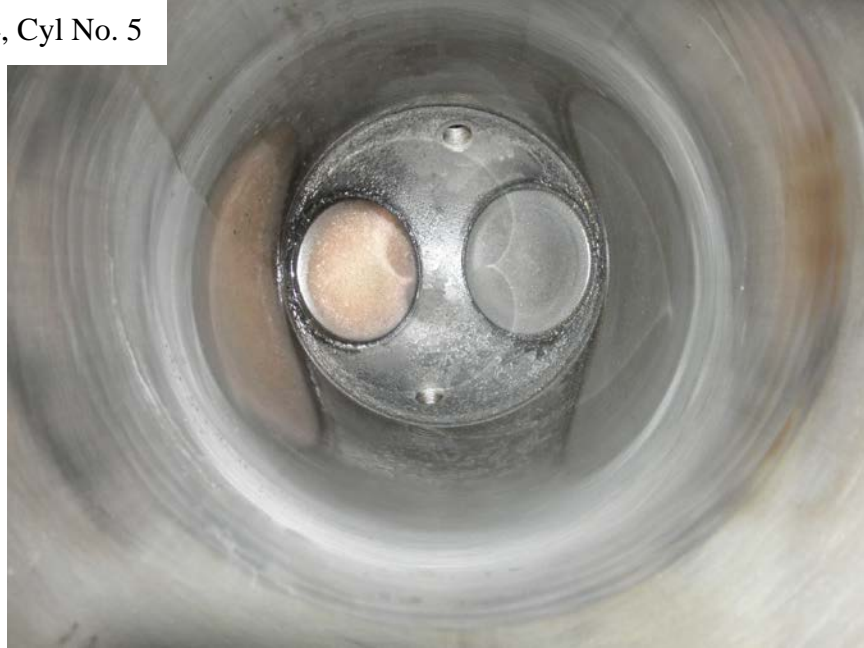
Eng No. 4, Cyl No. 5

The cylinder barrel was intact and the inner surface did not have any damage. There were metal fragments on the cylinder barrel walls. The two valves were in place in the closed position centered on the valve seats. The valves did not have any damage. (Photo No. 176)

Photo No. 176: View of the inside of the No. 5 cylinder showing no damage to the barrel and the two valves were centered in place in the closed position.

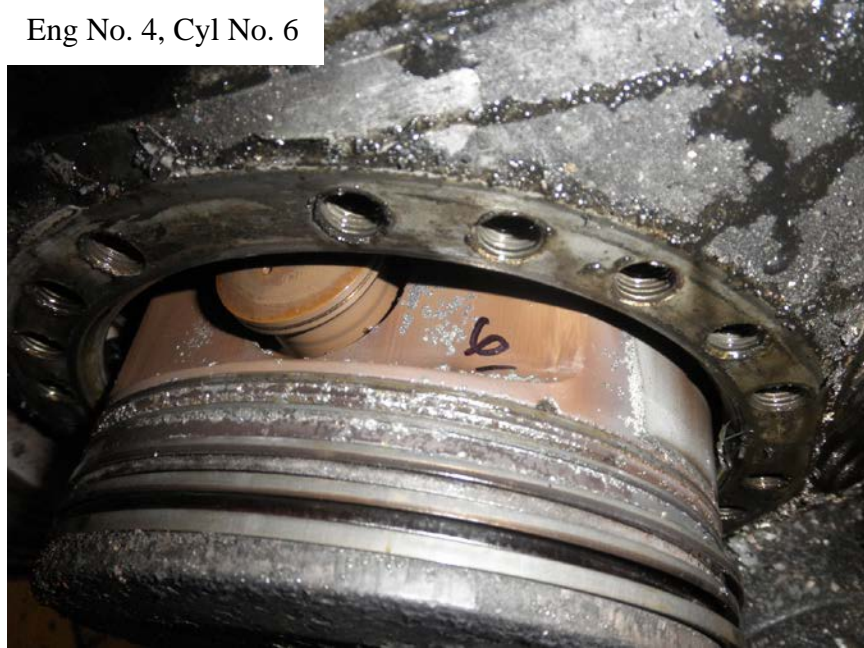
Eng No. 4, Cyl No. 6

The No. 6 piston was connected to the articulating rod with the piston pin and the piston pin buttons were in place. The piston was intact and all of the piston rings were in place and intact. There were small metal particles trapped on the sides of the piston between the rings. The head of the piston was a gray color that appeared to flaking off in the center exposing patches of white. (Photos Nos. 177, 178, and 179)

Photo No. 177 View of No. 6 cylinder's piston in place on the articulating rod showing that the piston was intact and that all of the piston rings were in place.

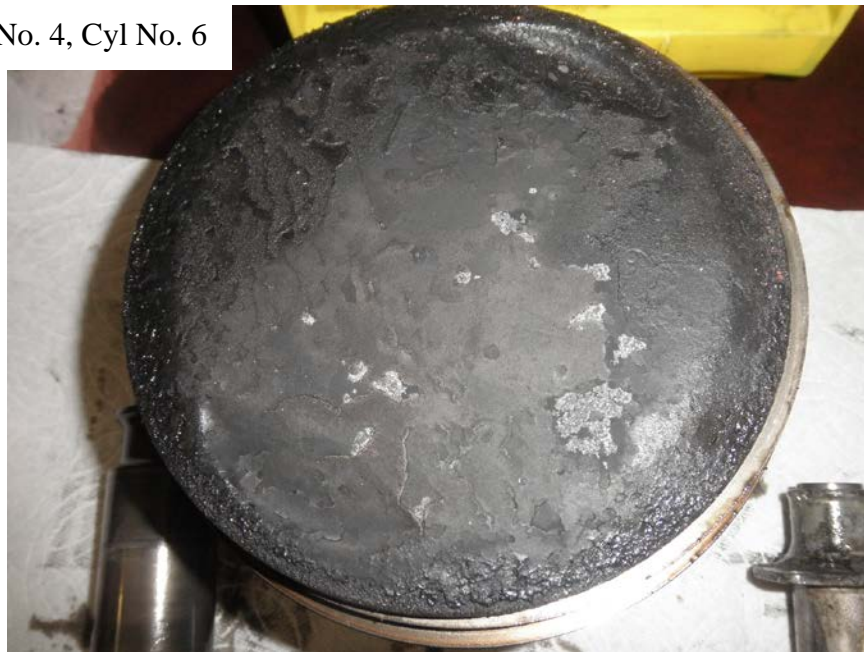
Eng No. 4, Cyl No. 6

Photo No. 178: Close up view of the No. 6 piston's head showing the gray color.

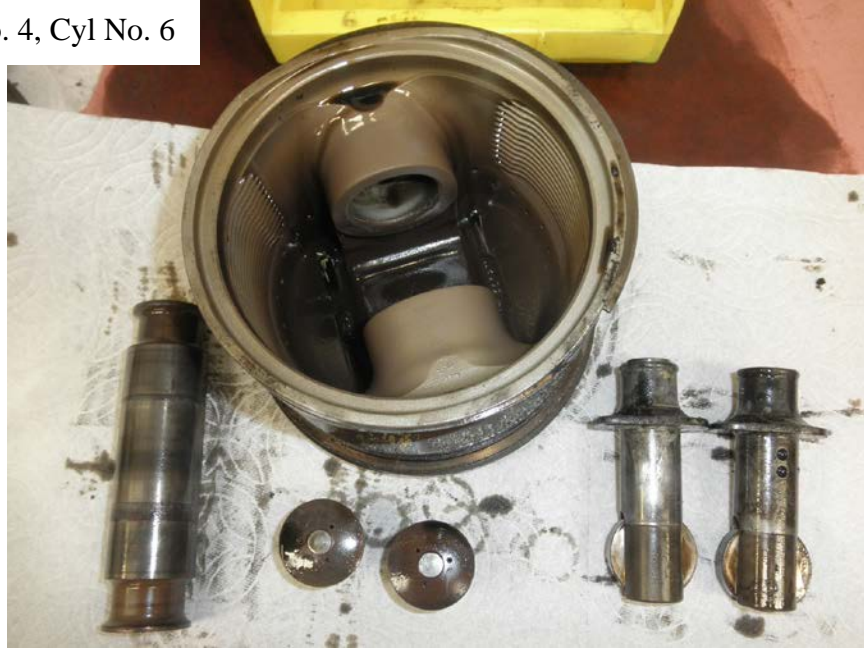
Eng No. 4, Cyl No. 6

Photo No. 179: View of underside of No. 6 cylinder's piston along with the piston pin, piston pin buttons, and the cam followers showing all were intact and undamaged.

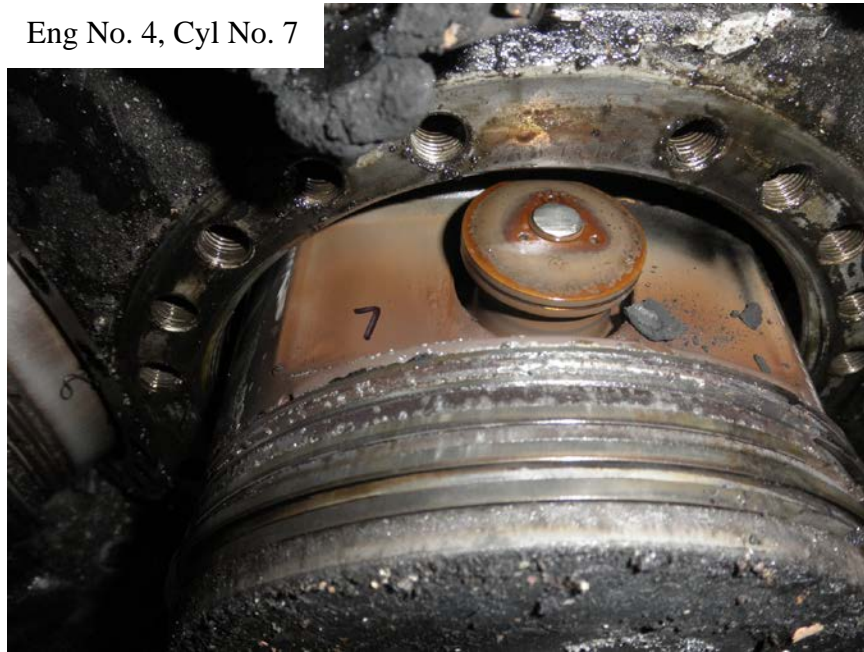
Eng No. 4, Cyl No. 7

The No. 7 piston was connected to the articulating rod with the piston pin and the piston pin buttons were in place. The piston was intact and all of the piston rings were in place and intact. There were small metal particles trapped on the sides of the piston between the rings. The head of the piston was a dark gray color. (Photos Nos. 181, 182, and 183)

Photo No. 181: View of No. 7 cylinder's piston in place on the articulating rod showing that the piston was intact and that all of the piston rings were in place. Also shown are small metal particles in the piston rings.

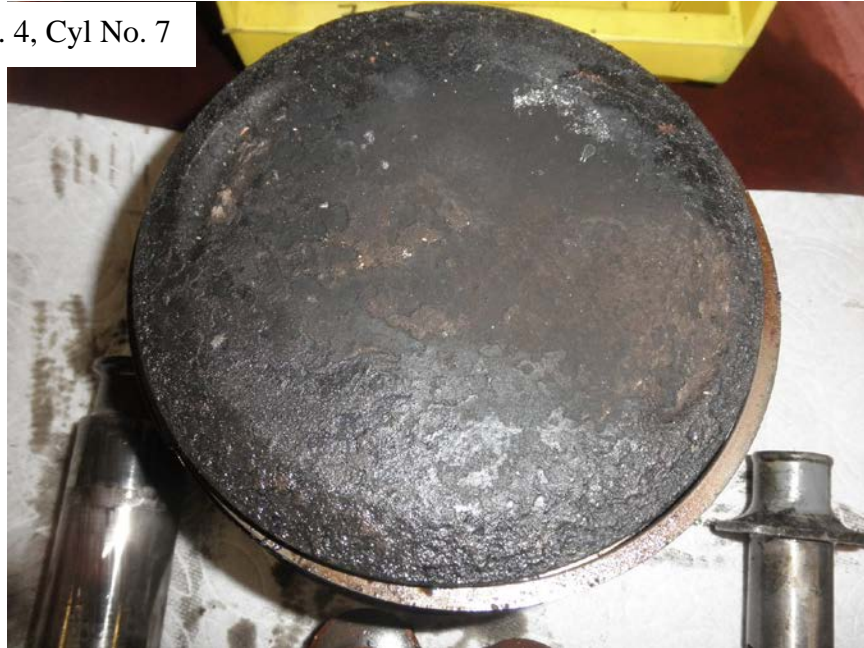
Eng No. 4, Cyl No. 7

Photo No. 182: Close up view of the No. 7 piston's head showing the dark gray color.

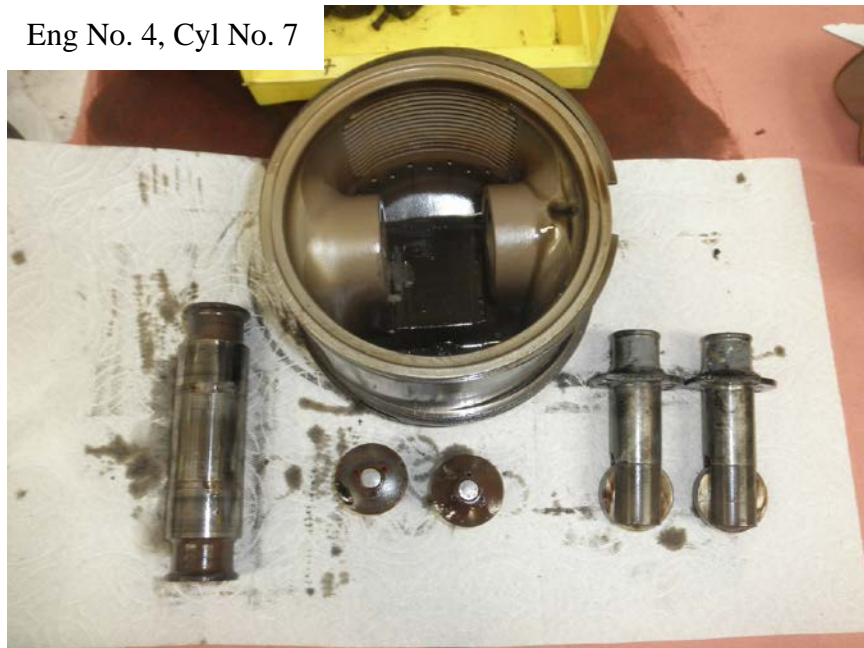
Eng No. 4, Cyl No. 7

Photo No. 183: View of underside of No. 7 cylinder's piston along with the piston pin, piston pin buttons, and the cam followers showing all were intact and undamaged.

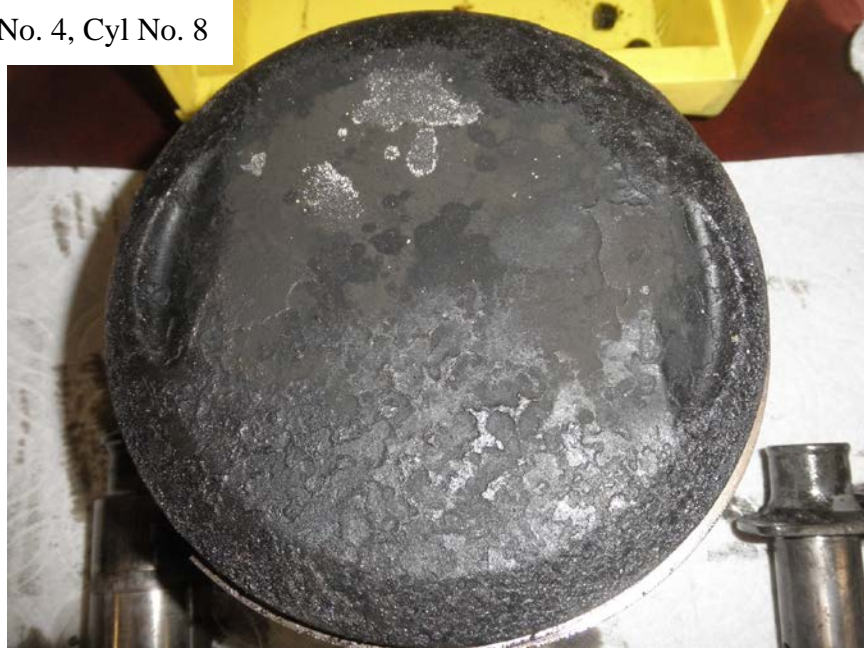
Eng No. 4, Cyl No. 8

Photo No. 187: Close up view of the No. 8 piston's head showing the dark gray color with the white-colored patches.

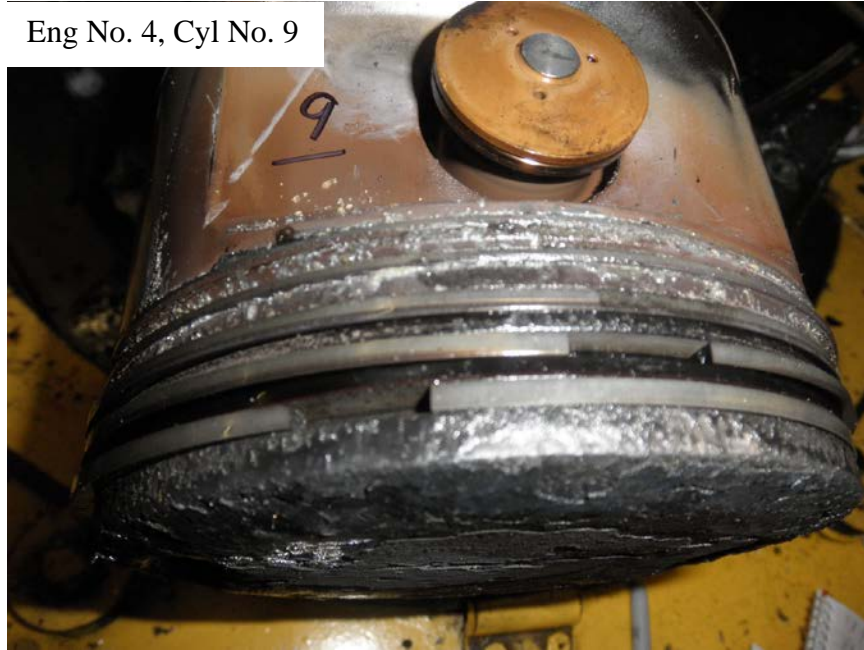
Eng No. 4, Cyl No. 9

The No. 9 piston was connected to the articulating rod with the piston pin and the piston pin buttons were in place. The piston was intact and all of the piston rings were in place and intact. There were small metal particles trapped on the sides of the piston between the rings. The head of the piston was a dark gray-color. (Photos Nos. 190, 191, and 192)

Photo No. 190: View of No. 9 cylinder's piston in place on the articulating rod showing that the piston was intact and that all of the piston rings were in place. Also shown are small metal particles in the piston rings.

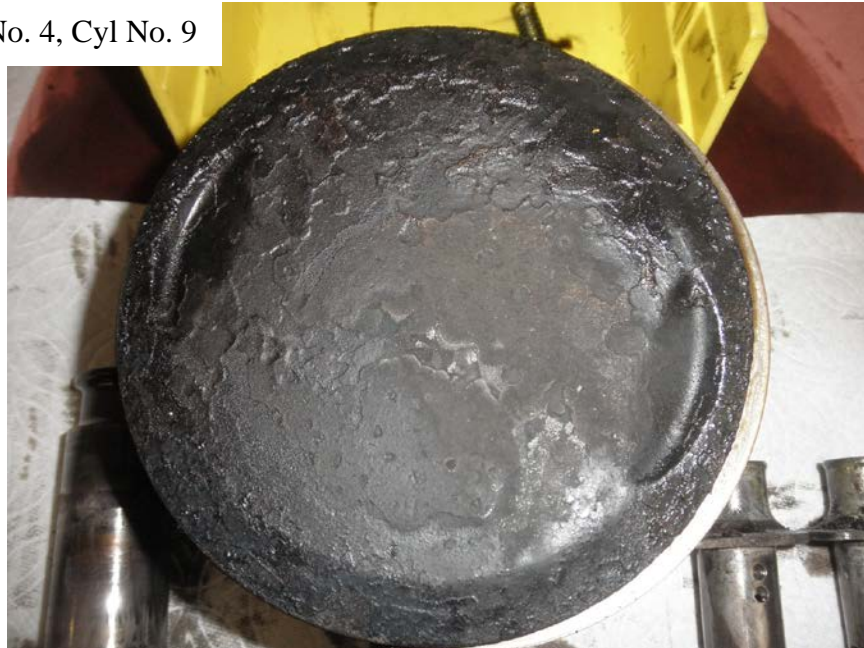
Eng No. 4, Cyl No. 9

Photo No. 191: Close up view of the No. 8 piston's head showing the dark gray color.

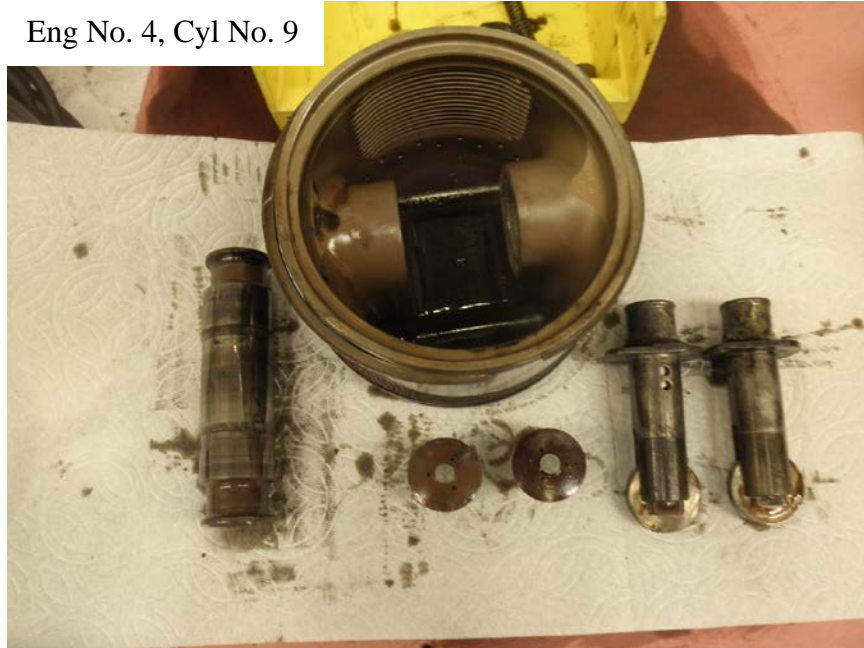
Eng No. 4, Cyl No. 9

Photo No. 192: View of underside of No. 9 cylinder's piston along with the piston pin, piston pin buttons, and the cam followers showing all were intact and undamaged.

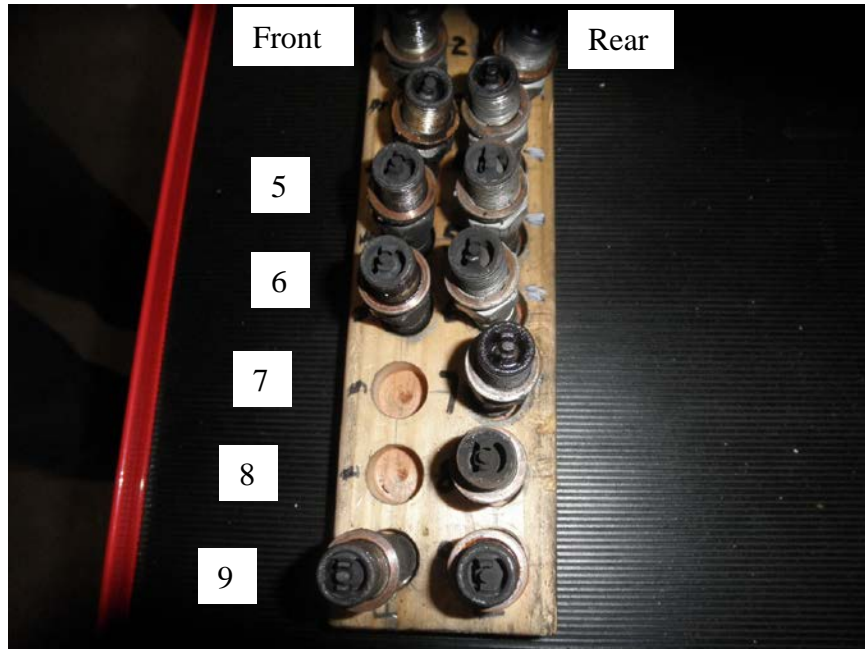
The electro gap on all of the plugs were checked. All of the plugs had a gap that was in excess of 0.022 inches except the No. 1 front plug and No. 7 rear plug that were within the manufacturer's recommended gap of 0.016 to 0.022 inches. Table 3 lists the visual condition and gap measurements for each of the No. 4 engine's spark plugs. (Photos Nos. 194 and 195)

6	The insulator was cracked. There were heavy carbon deposits and some lead deposits on the tip. The insulator was a dark color.	>0.022	The tip did not have any oil deposits or carbon build up. The insulator was a light gray color.	>0.022
7	Missing		There were heavy oil deposits on the tip and the tip was fouled with lead deposits.	0.022

8	Missing		There were white specks on the tip that is consistent with detonation. There were lead deposits on the tip and insulator. The insulator was a dark color.	>0.022
9	There were no lead or oil deposits on the tip. The insulator was a dark color.	>0.022	There were small white specks on the insulator that was consistent with detonation. There were no lead or oil deposits on the tip. The insulator was a dark color.	>0.022

Photo No. 195: No. 4 engine's front and rear spark plugs from cylinders Nos. 5 through 9.

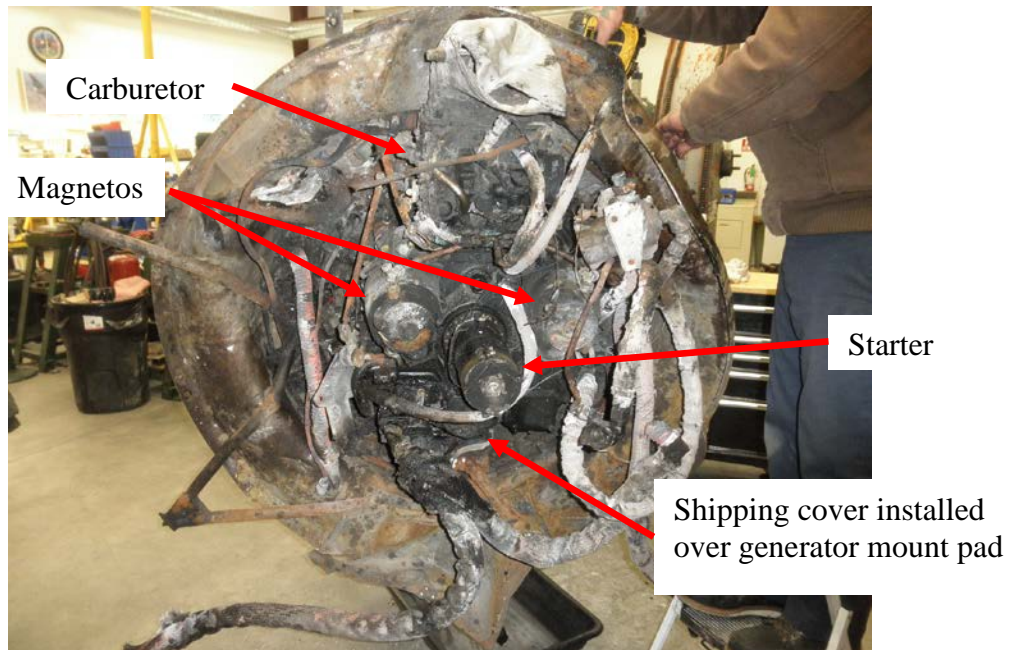
The left and right magnetos (Refer to Section 1.0 for further details on the No. 4 engine's magnetos), starter, and carburetor were still in place on the back of the engine. The generator was not installed and the drive pad had a shipping cover installed. (Photo No. 196)

Photo No. 196: Aft side of No. 4 engine showing components still installed.

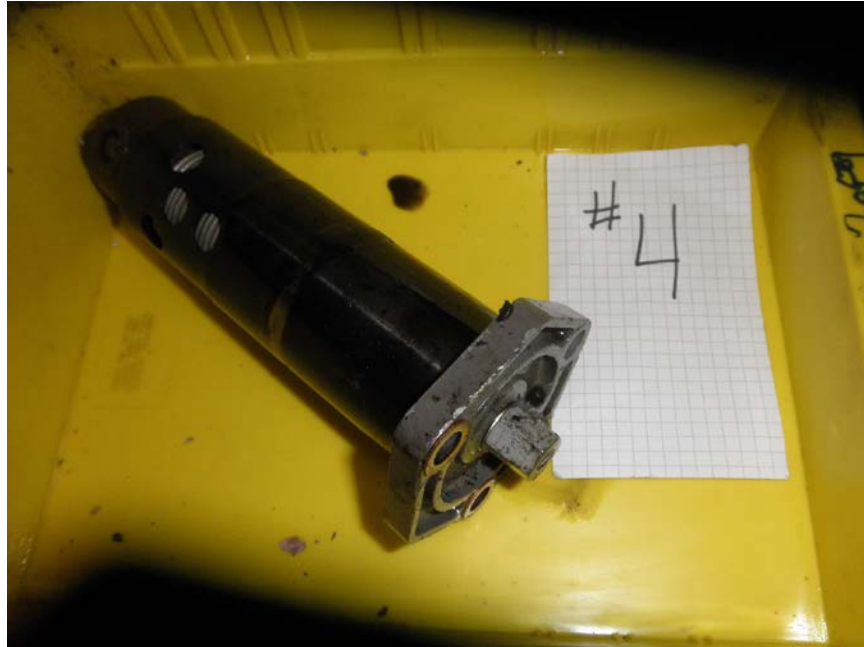
Photo No. 197: No. 4 engine's Cuno filter after it was removed from the engine.

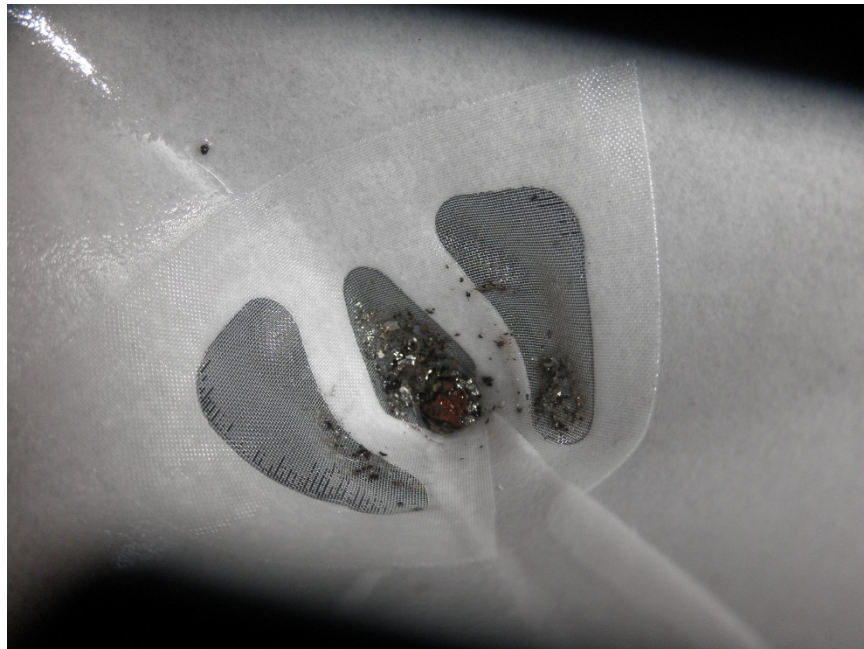
The Cuno oil filter was removed from the rear of the crank case. (Photo No. 197)
The filter was disassembled. The filter elements were flushed out and they had a small amount of small brown and silver colored particles. (Photo No. 198) When touched with a magnet, all of the silver colored particles stuck to the magnet.

Photo No. 198: Debris that was flushed out of the No. 4 engine's Cuno filter.

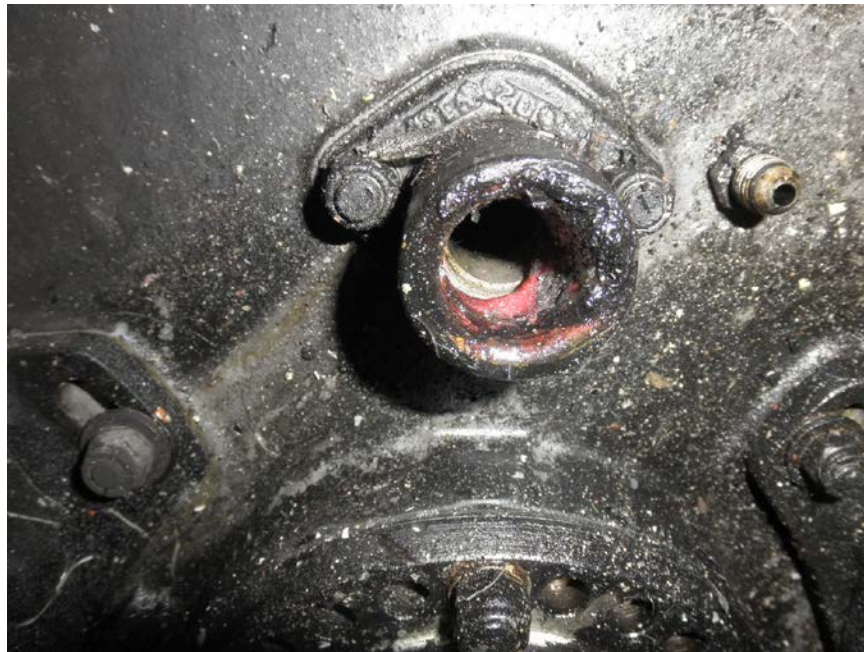
The supercharger vent port had the remains of a plastic cap melted inside the port. (Photo No. 199) When the supercharger impeller was rotated, the left and right magneto drive gears rotated concurrently.

Photo No. 199: No. 4 engine's supercharger vent port with the remains of a plastic cap in the port.

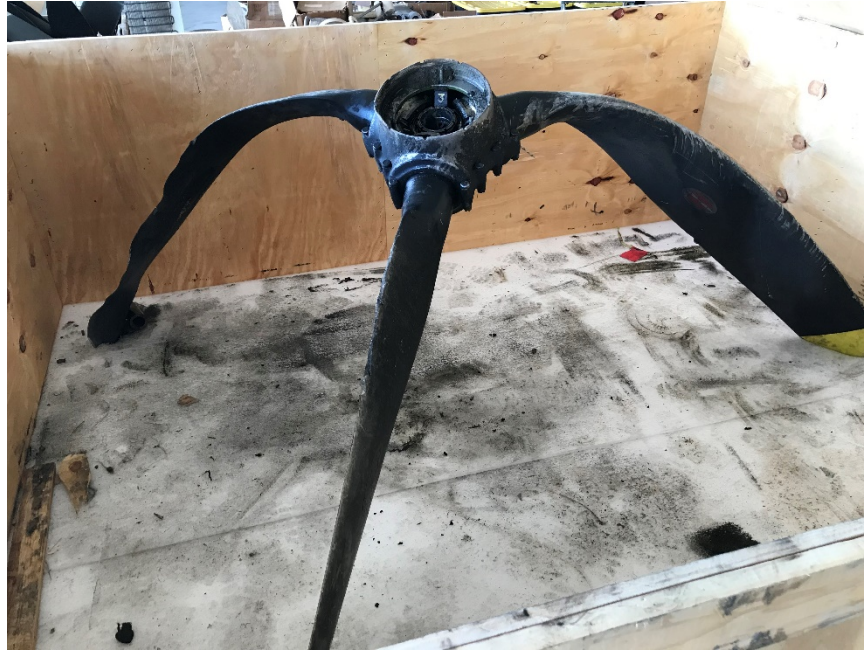
The propeller was received with all three blades in place on the spider hub. (Photo No. 200) The dome was separated from the spider hub, but was received with the propeller.

Photo No. 200: No. 3 propeller as received with all three blades in place, but with the dome separated from the spider hub.
