NATIONAL TRANSPORTATION SAFETY BOARD
OFFICE OF AVIATION SAFETY
WASHINGTON, D.C. 20594

POWERPLANTS GROUP CHAIRMAN'S FACTUAL REPORT

NTSB ID No.: ERA20MA001

Location: Bradley International Airport, Windsor Locks, Connecticut
Date: October 2, 2019
Time: 0953 eastern daylight time
Aircraft: Boeing B-17G, N93012, Collings Foundation

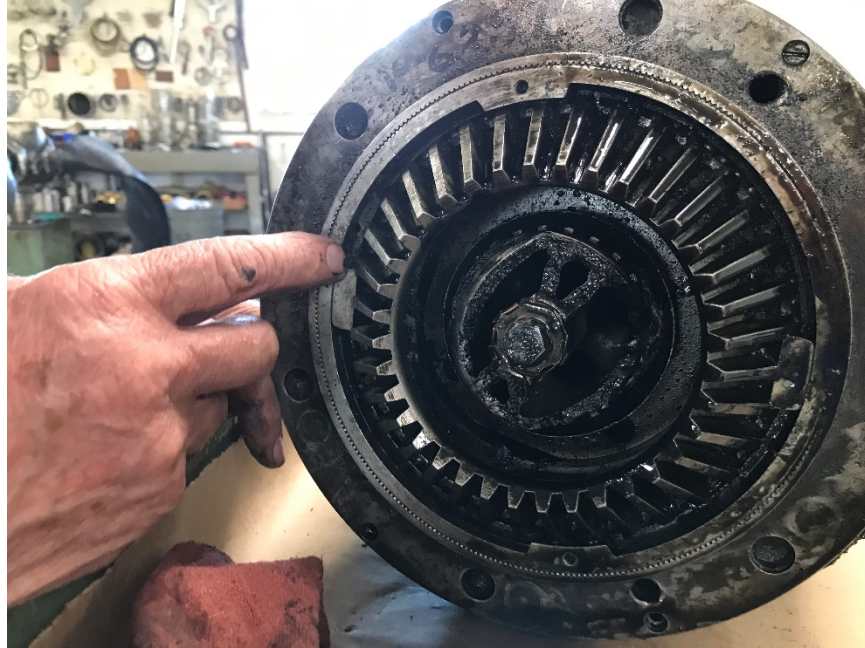
The top of the dome was crushed inward slightly. The gear at the base of the dome was intact. (Photo No. 201) The cams in the dome could not be removed. According to Maxwell, the dome was in the service bulletin (SB) 473 configuration that utilized three indexing pins. (Photo No. 202) The dome stop rings were in the low pitch position. The gear on the dome was at 20°, which is the low pitch stop position. (Photo No. 203)

Photo No. 201: View of base of propeller dome showing gear was intact.

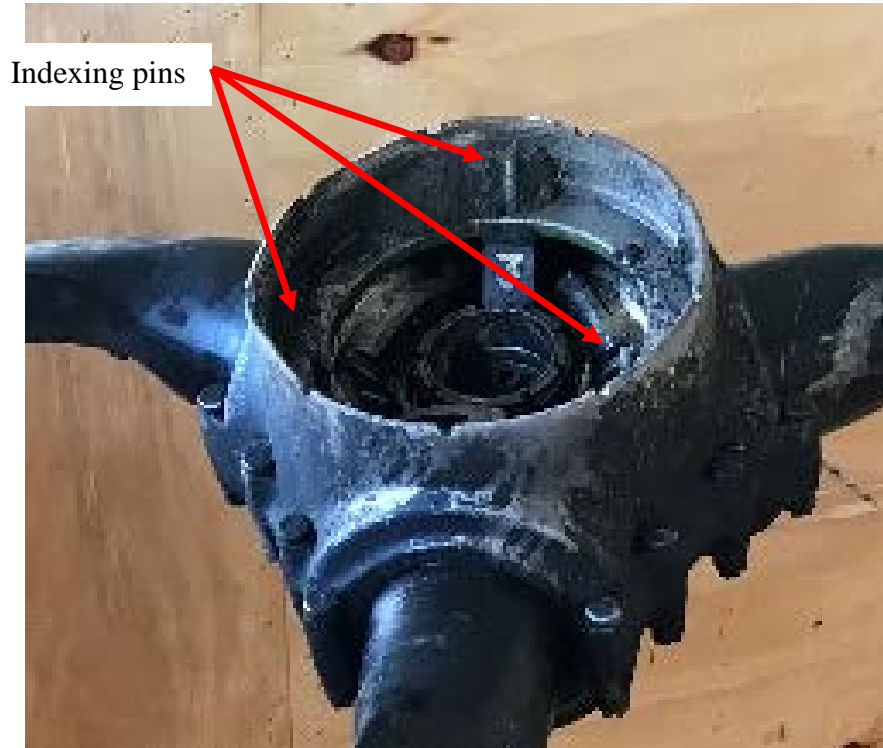
Photo No. 202: Enlarged view of propeller hub showing SB 473 three-pin configuration.

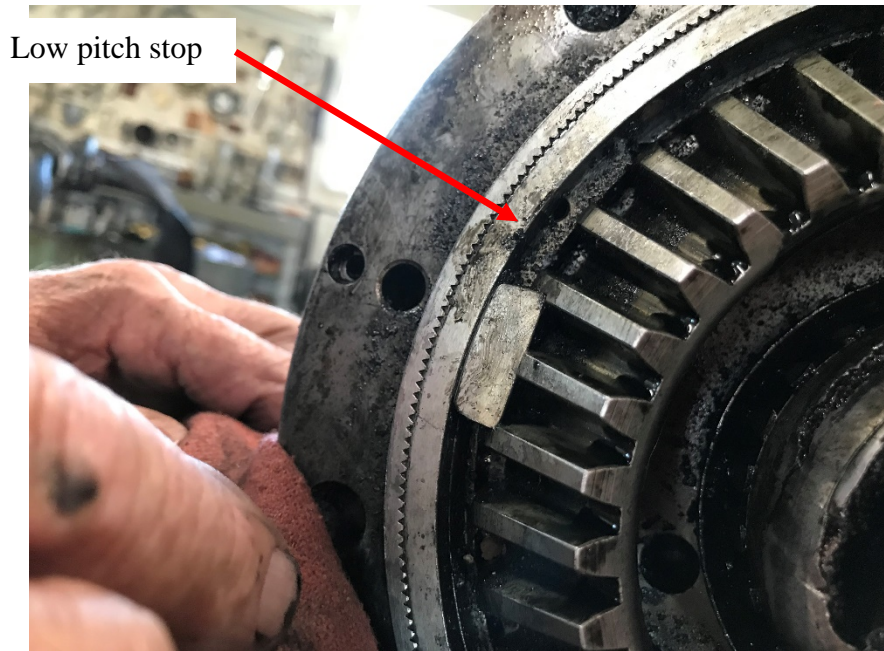
Photo No. 203: Close up view of base of dome showing the gear was at the low pitch stop.

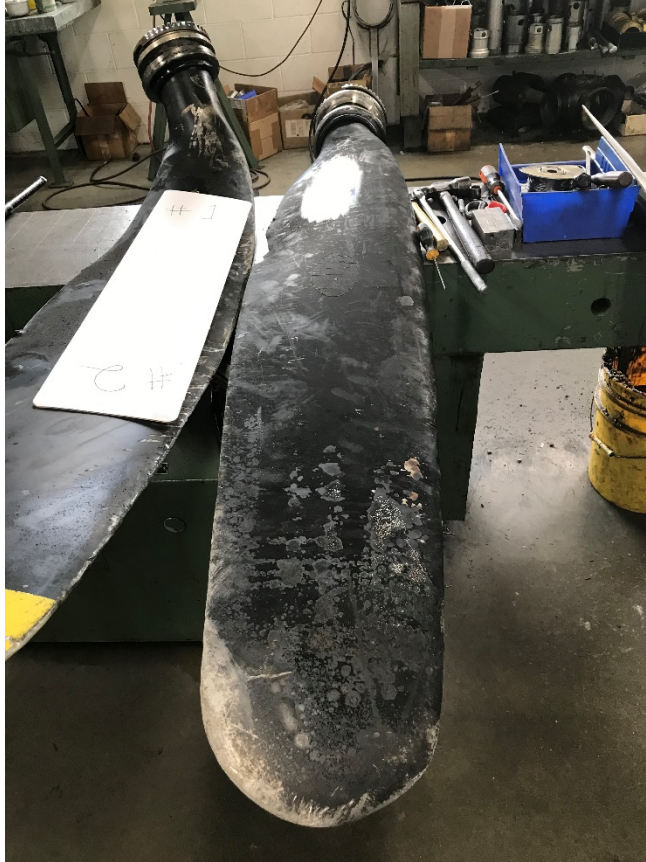
Blade No. 1 was full length and was essentially straight with a slight bend to the camber side. The paint at the tip of the blade was blistered and charred. The logo on the face of the blade was charred. (Photo No. 204) The blade had nicks and dents along leading edge between about 46 and 52 inches from the blade butt. There was material missing from the trailing edge between about 25 and 29 inches from the blade butt. The blade was rotated so that it was about 180° from the feathered position. The gear segment at the base of the blade was broken at the low pitch position. (Photo No. 205) The screws at the base of the blade were in place and intact. The bearing halves were intact with all of the rollers in place. (Photo No. 206)

Photo No. 204: View of blade No. 1 showing it was full length and essentially straight with the thermal damage along the camber side.

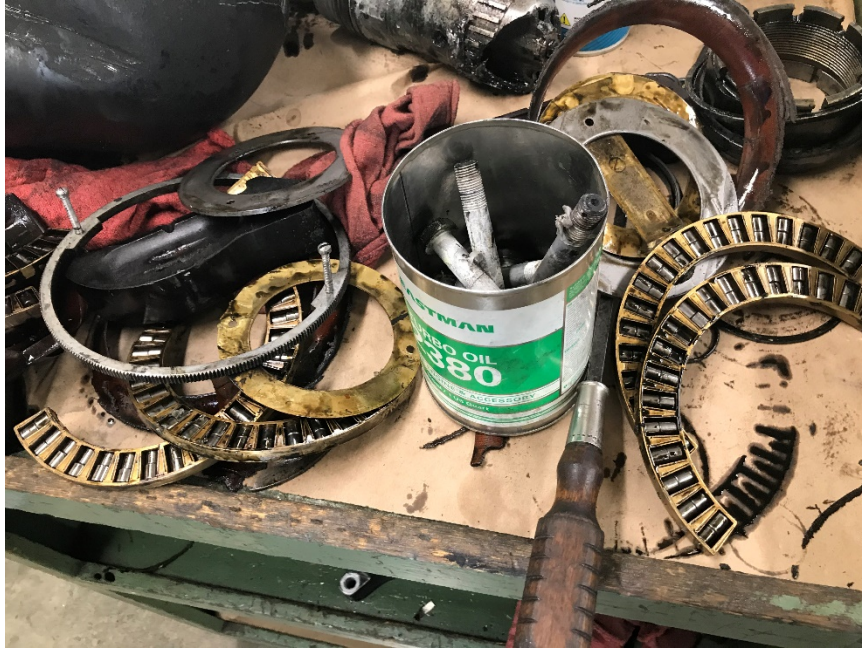
Photo No. 206: Picture of the propeller bearing segments showing they were intact with the rollers in place.

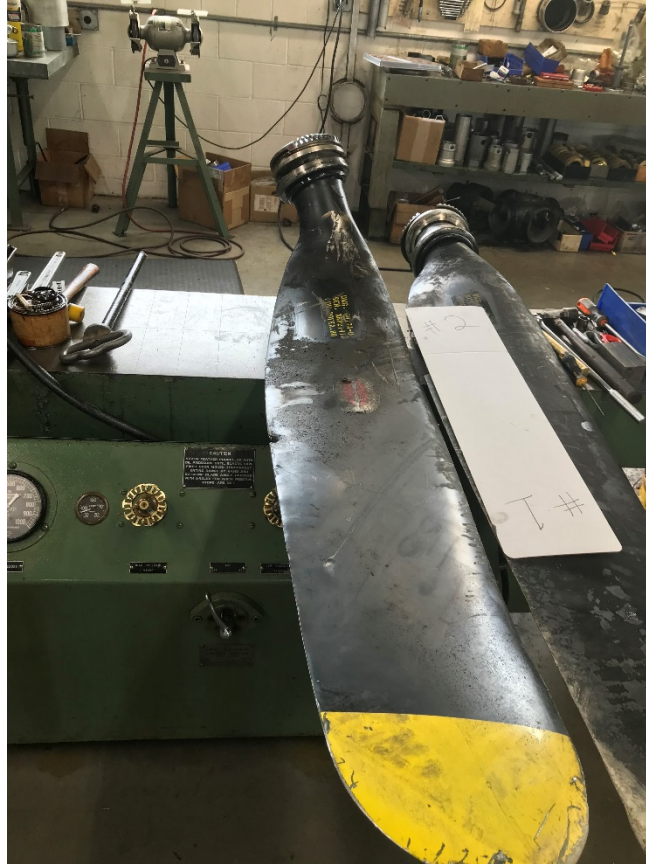
Blade No. 2 was full length and was rotated backwards to its normal operating position. The blade was bent back towards the camber side at about 7-inches from the blade butt. There were nicks and dents along the leading edge and the trailing edge was gouged at about 36-inches from the blade butt. The paint on the blade did not appear to have any thermal damage although the bottom of the Hamilton Standard logo appeared to charred slightly. (Photo No. 207) The gear segments were intact and were not rotated. The screws at the base of the blade were in place and intact. (Photo No. 208) The bearing halves were intact with all of the rollers in place. (Refer to Photo No. 206)

Photo No. 207: View of blade No. 2 camber side showing the blade full length and the bend as well as no thermal damage.

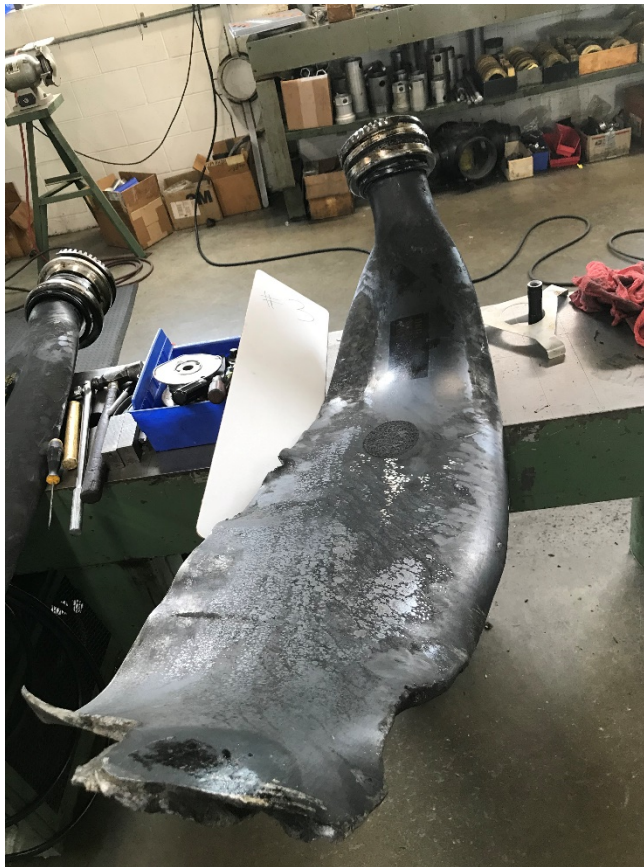
Blade No. 3 was missing the tip. The blade was rotated so that it was about 270° from the feathered position. The blade was bent back towards the camber side at about 12-inches from the blade butt. (Photo No. 209) The blade's leading and trailing edges had nicks and dents. The gear segments were intact. The screws at the base of the blade were in place and intact. The paint on the blade was blistered and charred. The Hamilton Standard logo on the blade face was also charred. (Photo No. 210) The bearing halves were intact with all of the rollers in place. (Refer to Photo No. 206)

Photo No. 209: View of blade No. 3 showing the missing piece of the tip and the bend to the camber side as well as the thermal damage.

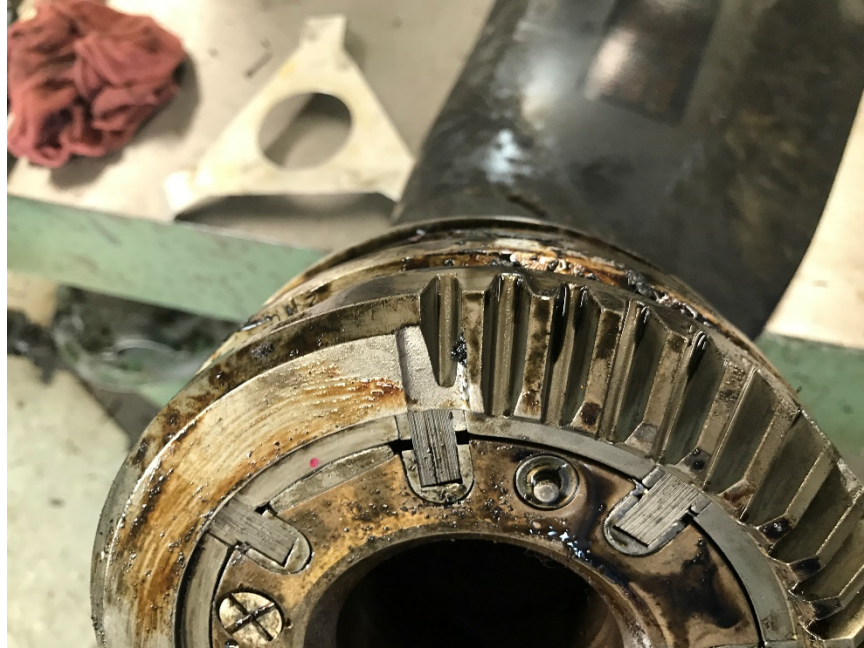
Photo No. 210: Close up of No. 3 blade butt showing the gear segment was intact and the screws in place.

According to Maxwell, the damage to the No. 3 propeller was consistent with the propeller being in the normal operating position.

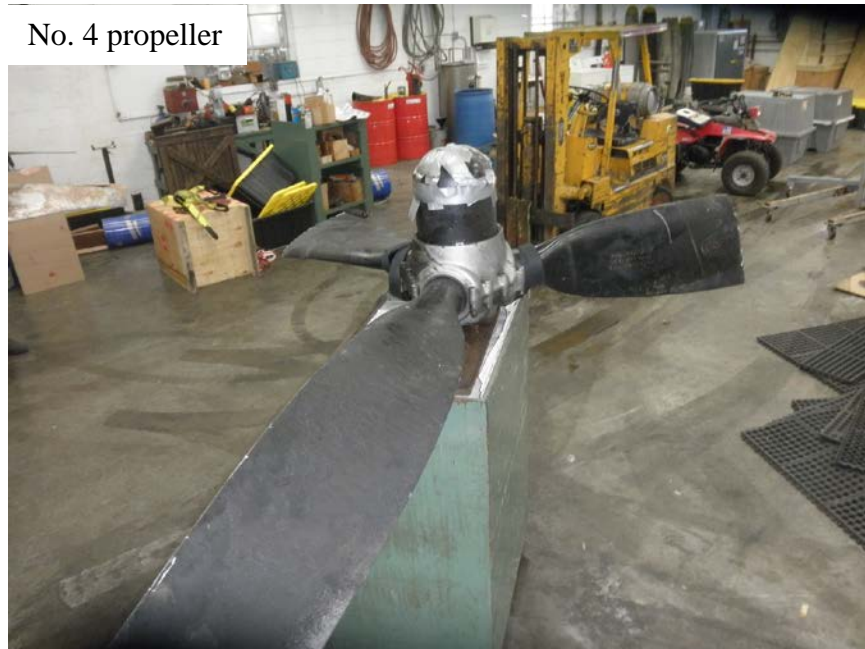
The propeller was complete with the dome and all three propeller blades in place on the spider hub. There were two blades that were cut to facilitate shipping the propeller. (Photo No. 211) The tips of the blades were received with the rest of the propeller.

Photo No. 211: View of No. 4 propeller as received with two blades cut off.

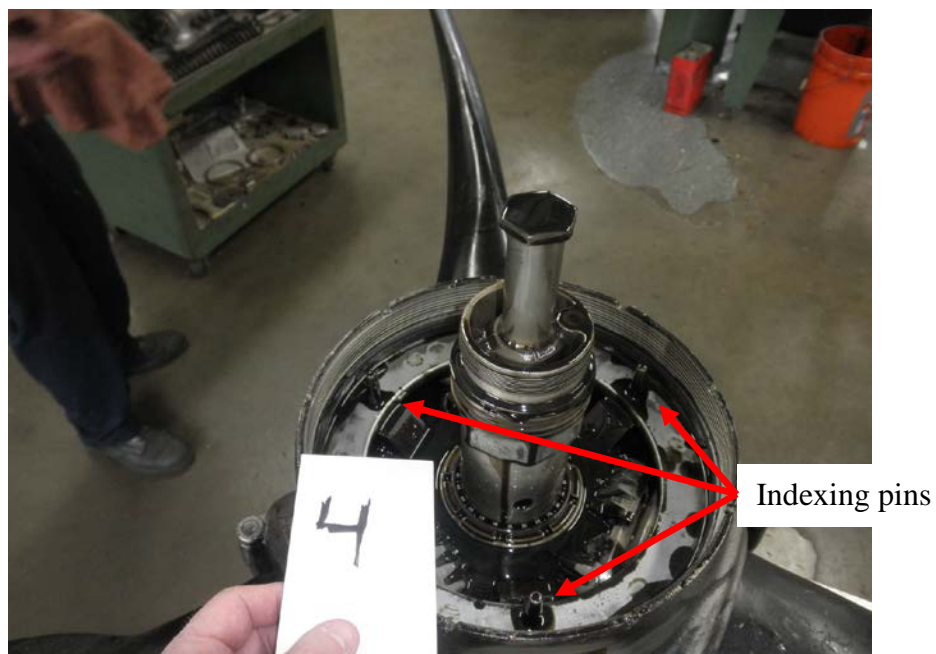
The dome was intact. The top of the dome was crushed inward and buckled slightly. The dome retaining nut was tight. According to Maxwell, the dome was in the SB 473 configuration. (Photo No. 212) The gear at the base of the dome was intact. (Photo No. 213) The gear on the dome was almost to the feather pitch stop. (Photo No. 214) The barrel supports were in place and intact. The dome was not disassembled further.

Photo No. 212: View of No. 4 propeller barrel showing the three indexing pins configuration.

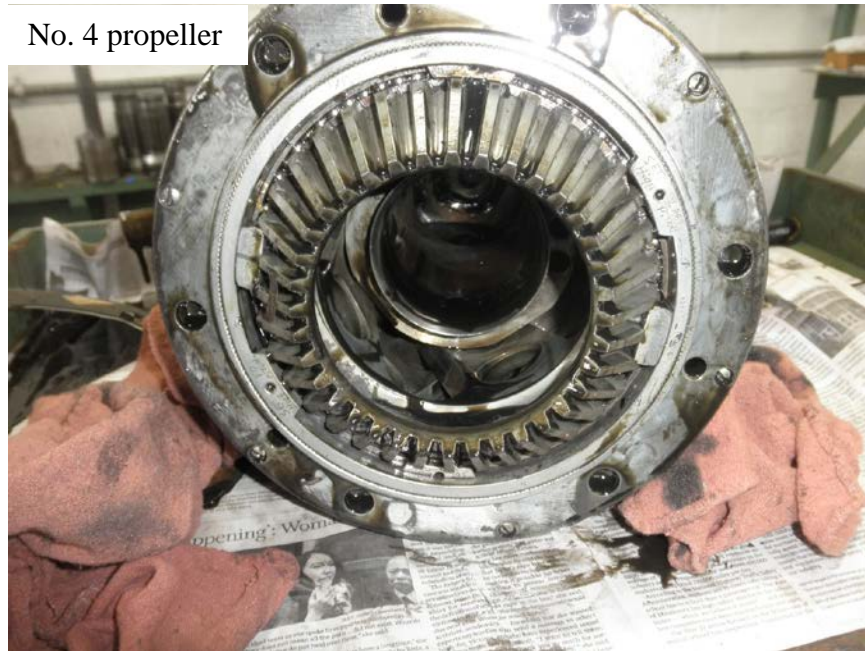
Photo No. 213: View of base of No. 4 propeller dome showing the gear ring was intact.

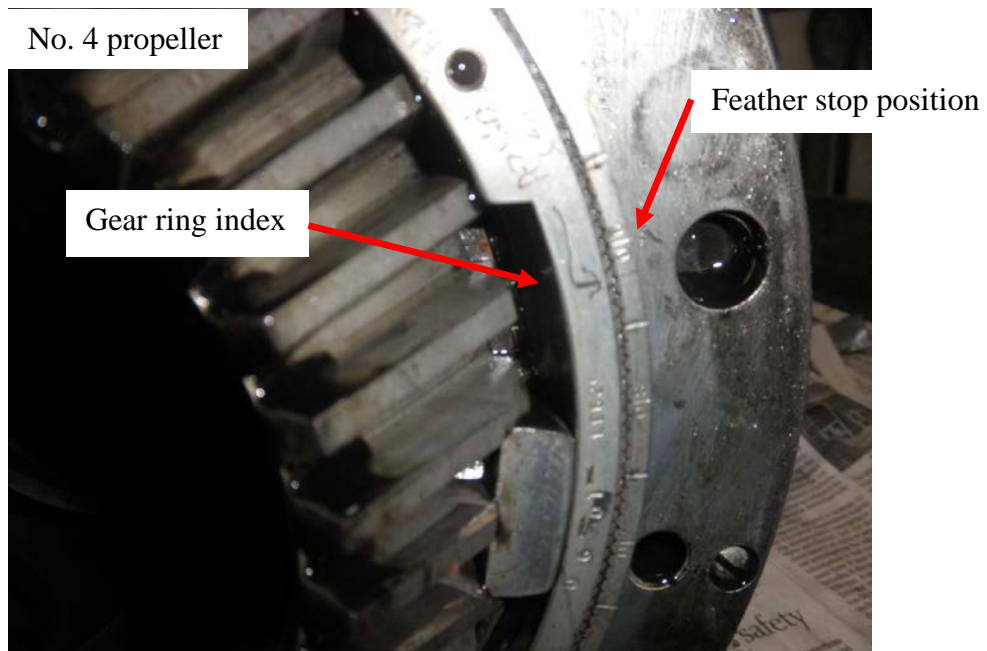
Photo No. 214: Close up view of the gear ring showing that it was rotated almost to the feather stop.

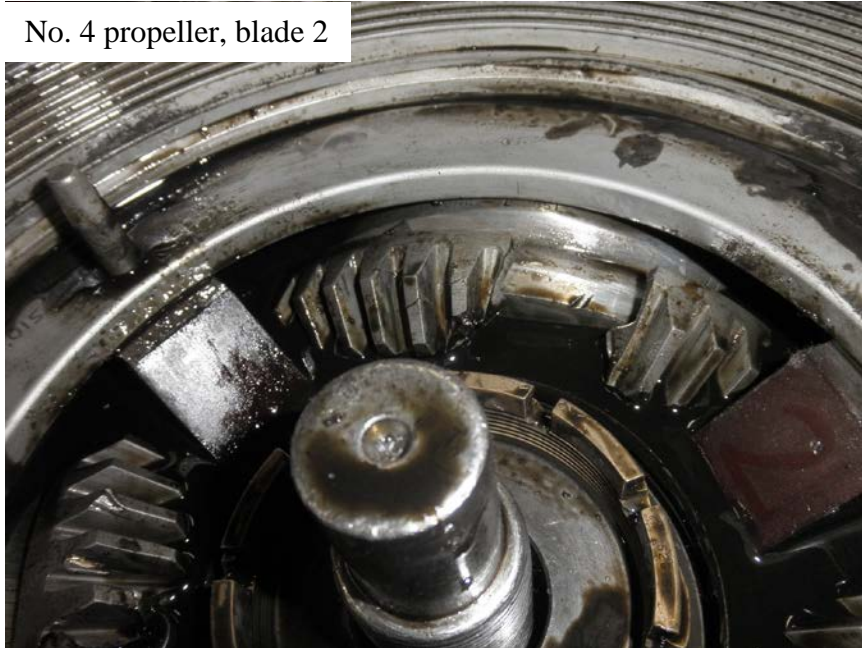
No. 4 propeller, blade 2

Blade No. 2 was full length and was in the feathered position. The blade was essentially straight. The blade had small nicks on the leading edge about 54, 56, and 59-inches from the collar. The camber side of the blade from the midspan area outboard to the tip was blistered. The gear was broken. (Photo No. 216) The gear was rotated. The screws were in place in the gear ring, but were sheared off flush to the underside of the ring. The chafing ring was broken. The bearing halves were intact with all of the rollers in place.

Photo No. 216: Close up view of No. 4 propeller, No. 2 blade's gear ring showing it was fractured.

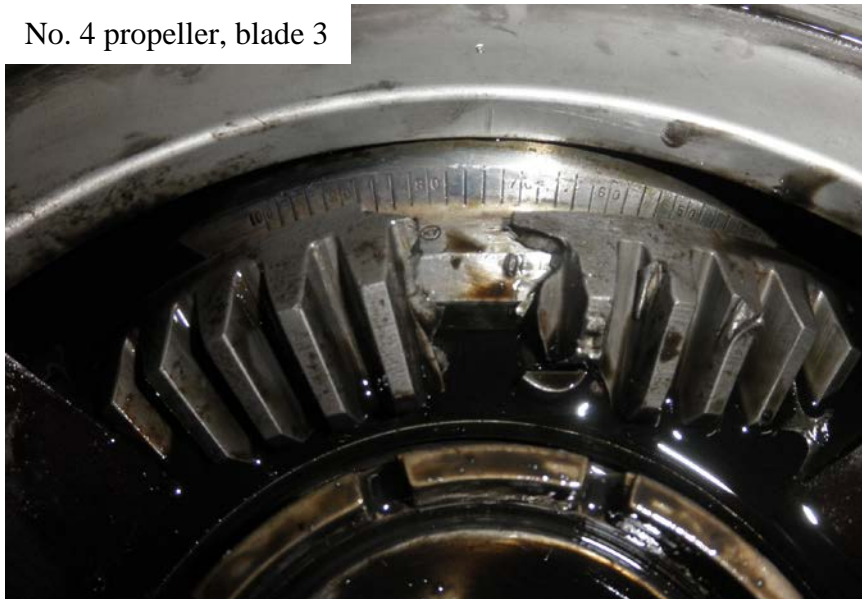
No. 4 propeller, blade 3

Blade No. 3 was full length and was backward from its normal position.¹⁶ The blade was essentially straight. The gear was in its normal position, but it broken in line with the leading edge of the blade. (Photo No. 217) The screws were in place in the gear ring. The chafing ring was broken. The bearing halves were intact with all of the rollers in place.

Photo No. 217: Close up view of No. 4 propeller, No. 3 blade's gear ring showing it was fractured.
