ALERT SERVICE BULLETIN

407-11-95

407

UPPER LEFT LONGERON (CHANNEL) 206-031-314-037/-177 AND SPARE ASSEMBLY 206-031-314-219B, INSPECTION OF.

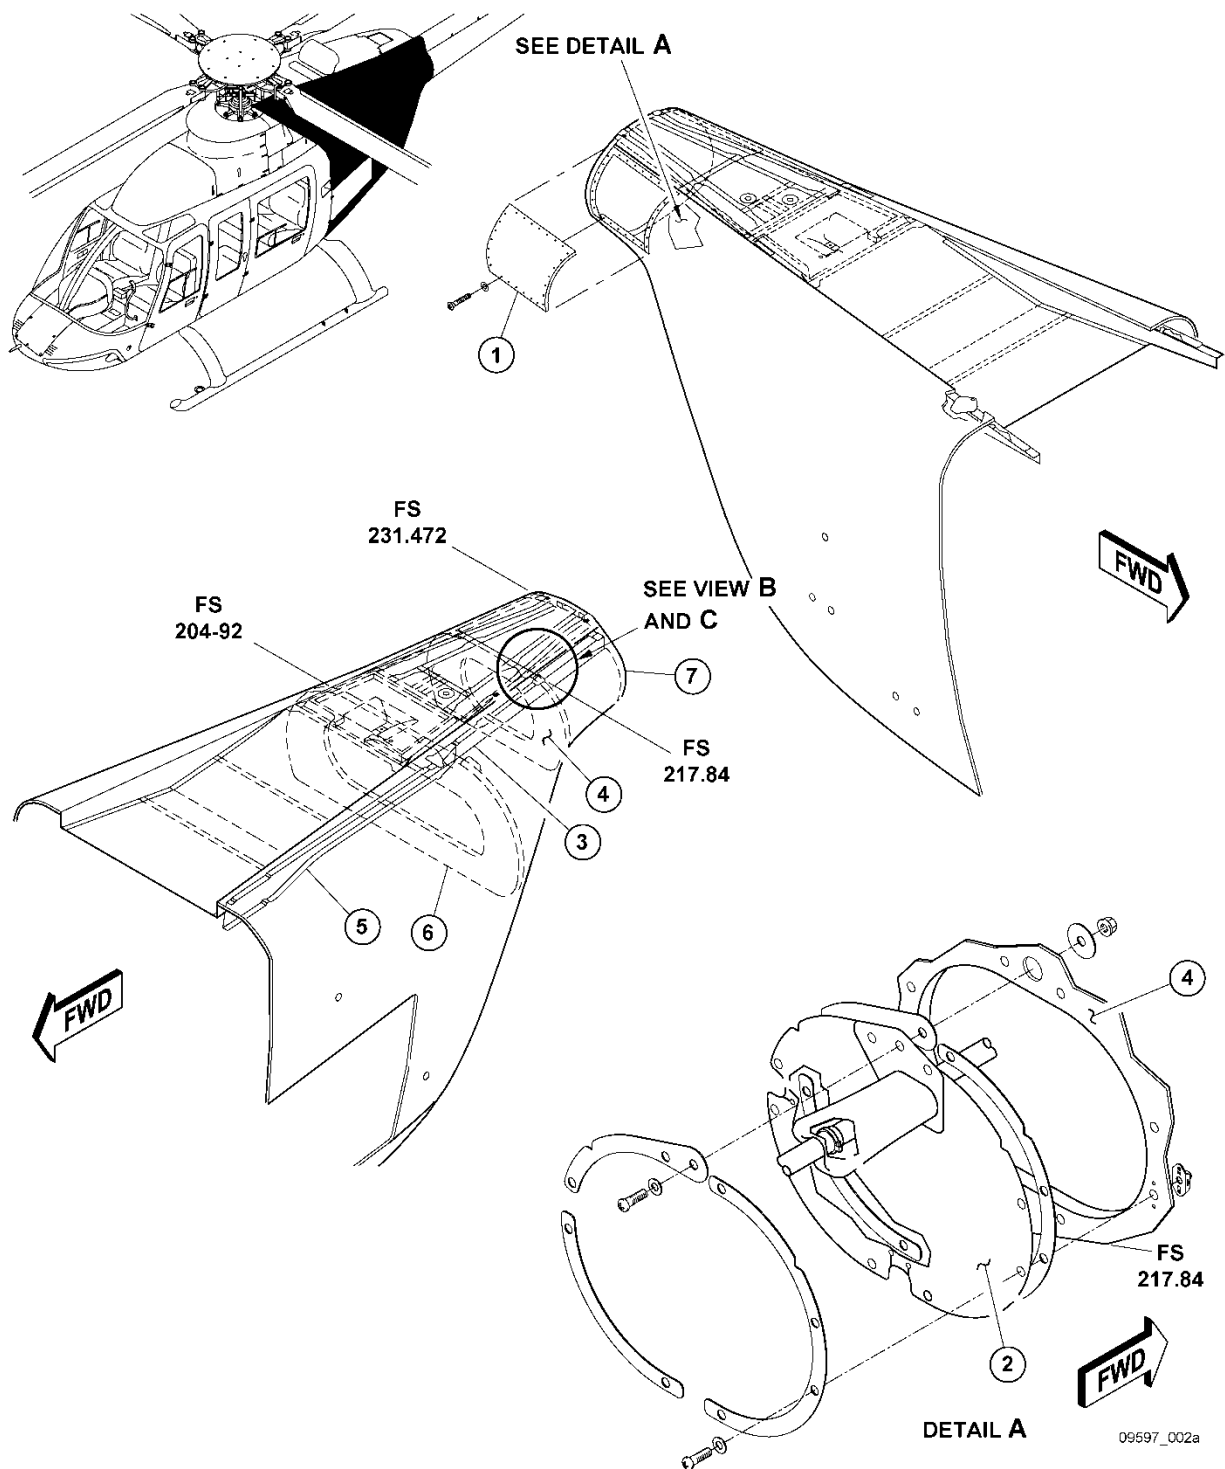
Figure 1 - Inspection of Aft Fuselage Upper Skin

To benefit the replacement of the 50 flight hour inspection intervals by 150 flight hour inspection intervals, the longeron (3, Figure 2) and the top skin (5, Figure 1) must be free of defects and shall not carry any type of repair.

- b. If damage is found in any of the parts listed above, contact Product Support Engineering with details.
9. If no defects are found, reinstall a new upper skin (5, Figure 1) if applicable, the splice (8, Figure 2, View C) and the air dam cover (2) (407-MM, Chapter 53). Apply sealant where needed except in Area 1 and Area 2 as shown where further recurring inspection will have to be performed.

10. Install the tailboom access panel (1) and the oil cooler blower fairing (7, Figure 1).
11. Make an entry in helicopter logbook and historical service records indicating compliance with PART II of this bulletin.
