NATIONAL TRANSPORTATION SAFETY BOARD

Group Chairman's Factual Report

HIGHWAY FACTORS

HWY22FH001

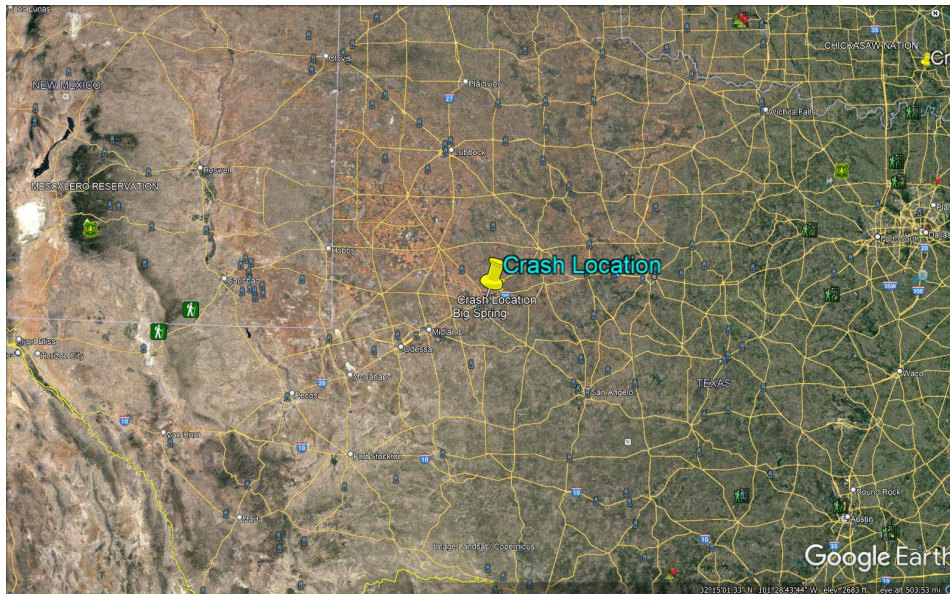
Figure 1. View of crash location, approximately 225 miles west of the Dallas-Fort Worth area.

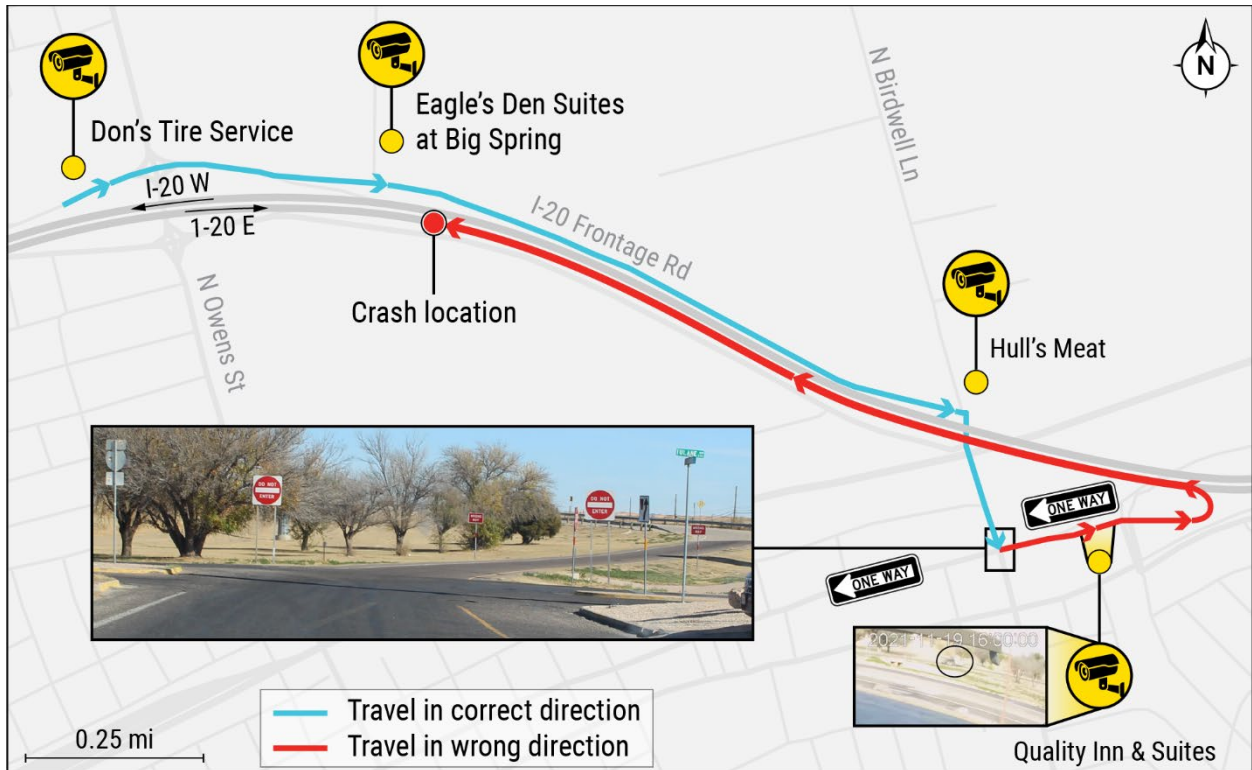
Figure 2. This figure shows a Google image annotated with four yellow circles and a red circle. The yellow circles show where security video cameras documented the Ford pickup driver's route of travel. The circle on the lower right and red line show where the wrong-way driver entered I-20 and the red circle indicates the crash area. The inset shows the signage, and the video screenshot shows the wrong-way driver entering the exit ramp.

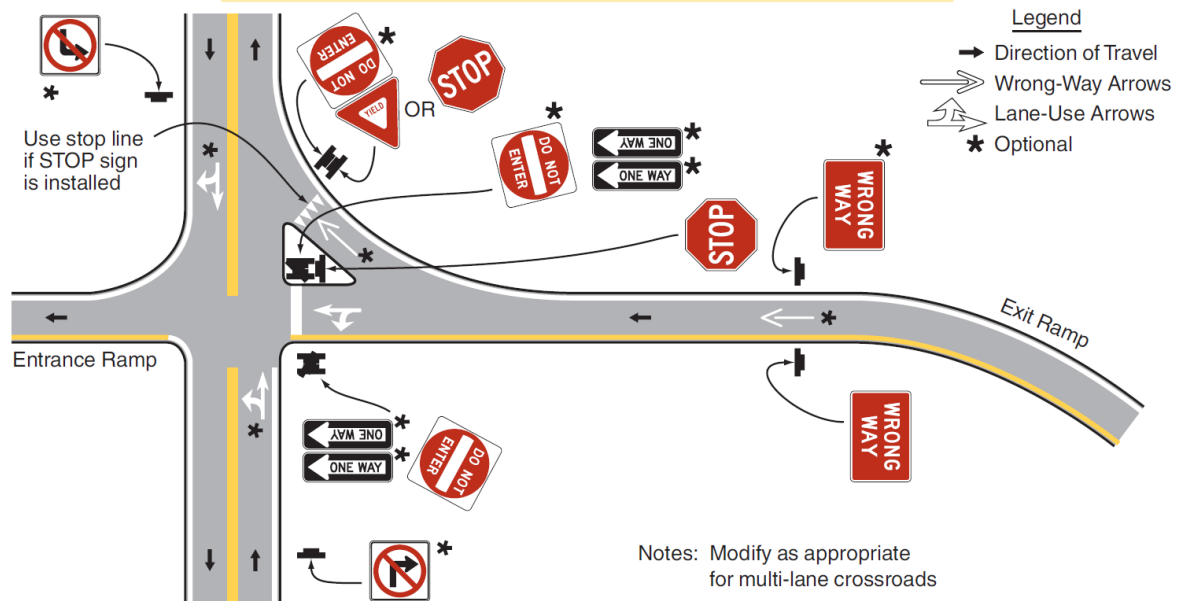
Figure 2B-18. Example of Application of Regulatory Signing and Pavement Markings at an Exit Ramp Termination to Deter Wrong-Way Entry

Figure 9. View of TXMUTCD figure 2B-18 which provides example applications on signing exit ramp termination to deter wrong-way entry.

Only one DO NOT ENTER sign and one WRONG WAY sign are required to be installed on the right-hand side of the road. The additional DO NOT ENTER sign and WRONG WAY sign that were installed on the left-hand side of the road were optional features that TXDOT chose to install.⁹
