Dive Survey 31Oct @ Sandfill Dock, St Thomas

Damage observations

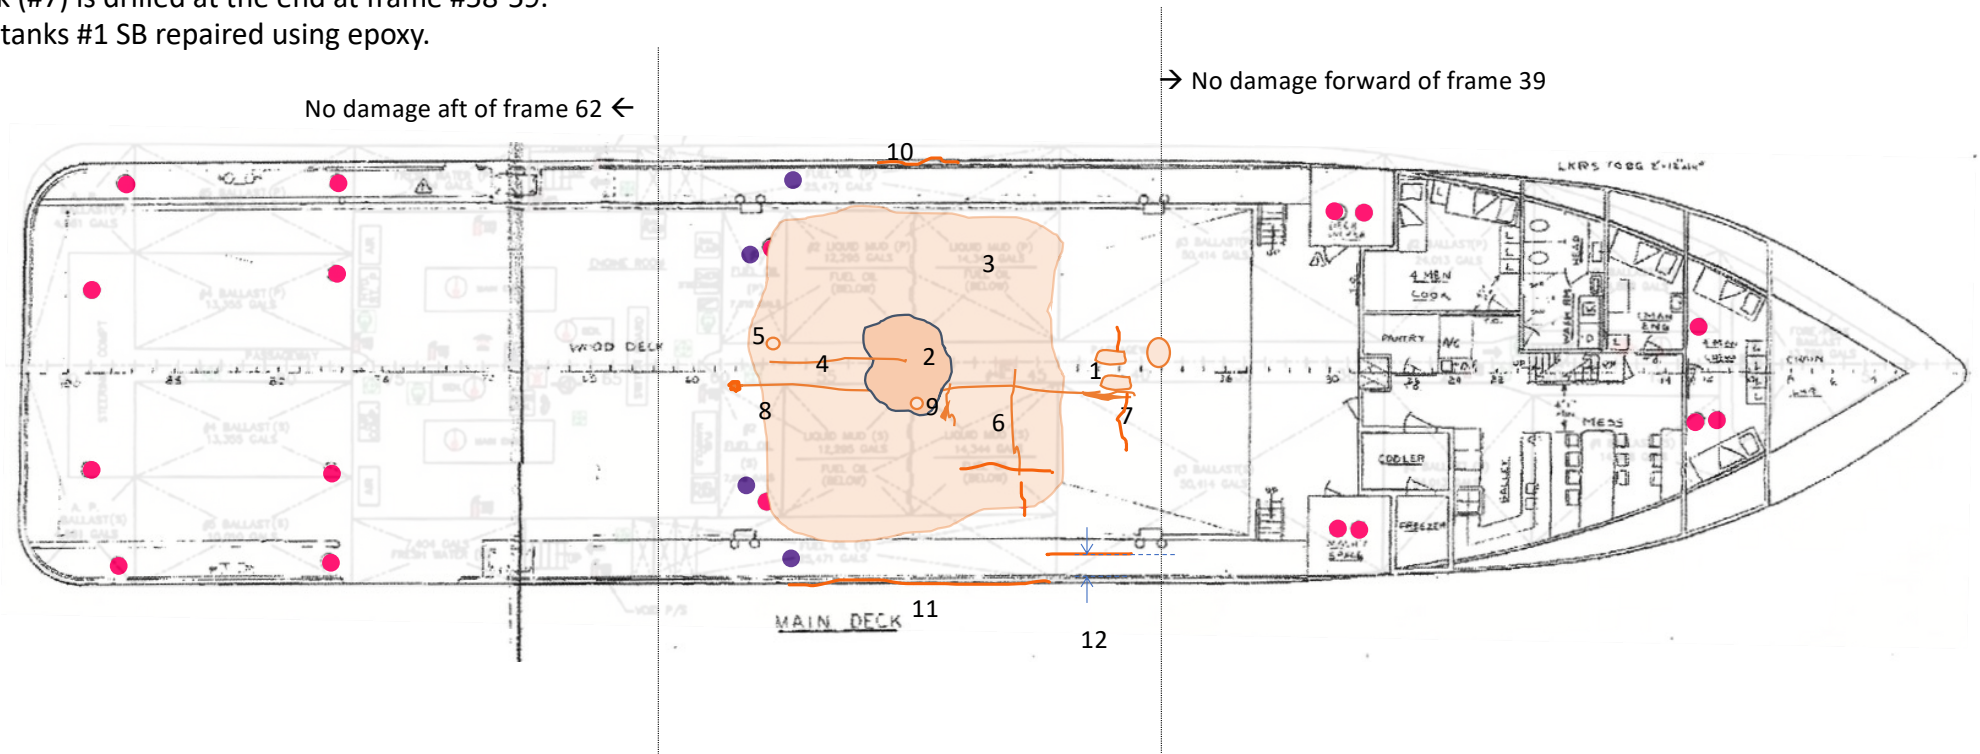
1. @ frame 40: 2 major dents up to 1 feet deep, of which the PS is open (approx 2ft long and 4" wide) and SB no cracks visible at the indentation. Located in the passageway.

2. @ frame 49-53: midship 1 ft deep indentation of approx 6 ft wide and 6ft in length
3. @ frame 43-59: area of ex-grounding touching the seabed, overall damage in this full area.

4. @ frame 50-57: area in passageway which is dented and caused breached to other tanks. Repaired with epoxy to minimise water ingress to adjacent tanks.

5. In FO Daytank PS plugged one pipe and placed epoxy from the passageway onto a hair crack (currently full)
6. Area on SB side bottom various cracks found amongst transverse cracks.

7. @ frame 41-59: Long crack which starts 17" from ER Bulkhead forward, starting as a small crack and opening over the length till a larger opening at frame #40 (6"x6").

8. Crack (#7) is drilled at the end at frame #58-59.
9. Mudtanks #1 SB repaired using epoxy.

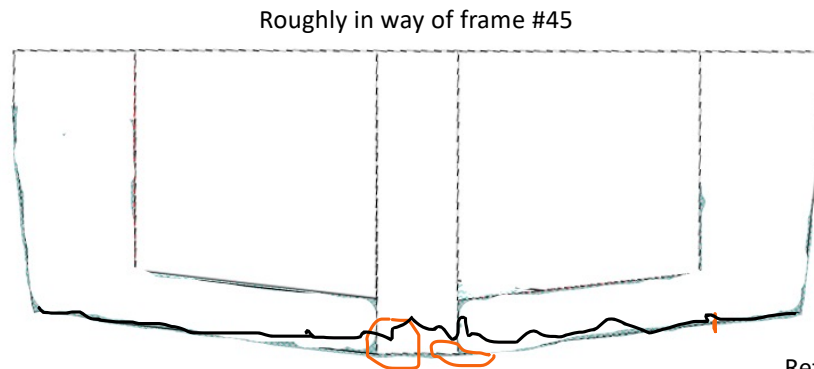
Ref 11. SB Chine is cracked and

8. Crack (#7) is drilled at the end at frame #58-59.
9. Mudtanks #1 SB repaired using epoxy.
10. Indentation on the PS chine
11. Serious indentation up to 8" on the SB chine with a longitudinal crack, length 5ft 8".
12. @ frame 43: 3ft off the side shell, a crack is found.
13. PS rudder has a small bent and one blade on the PS-propellor is bent.

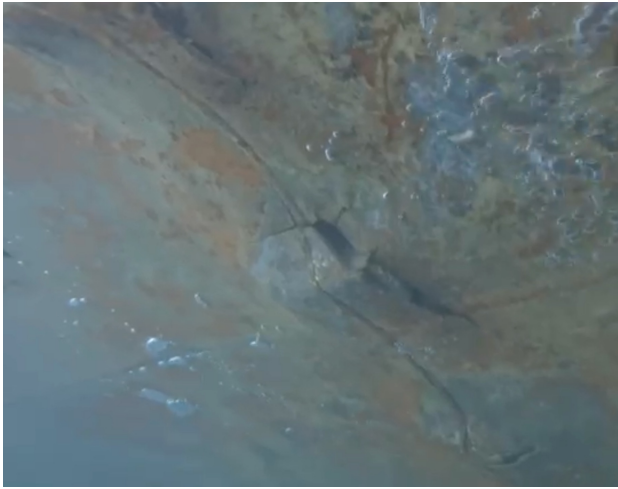
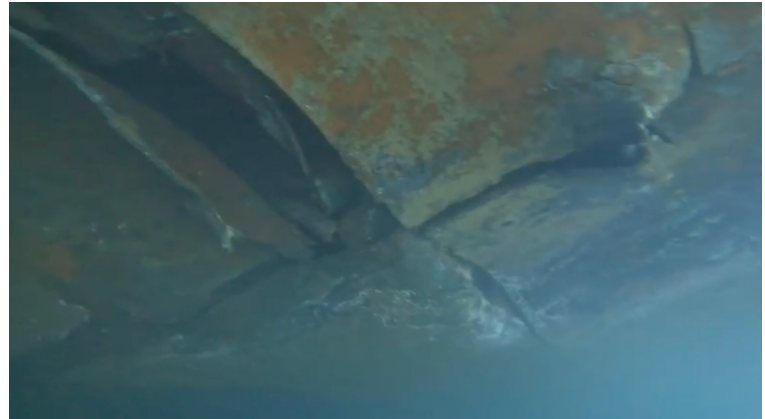
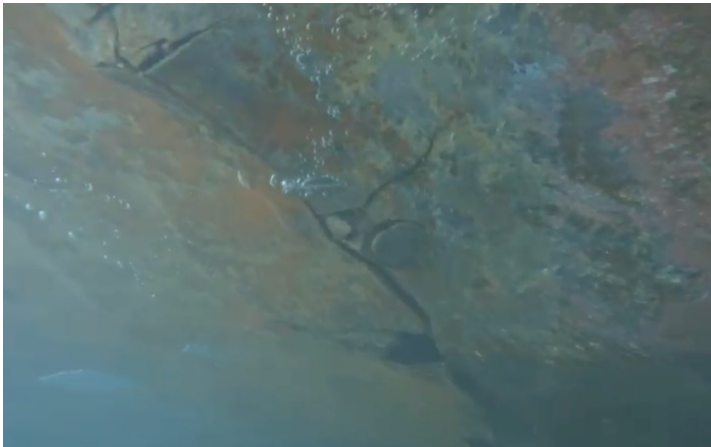
1. Pushed up bottom plating
2. Bottom view with indentation
3. Crack between two longitudinal longer cracks. (around frame 45)
