**Bridge Factors Photographs 1 through 111**

**Miami, FL**

**HWY18MH009**

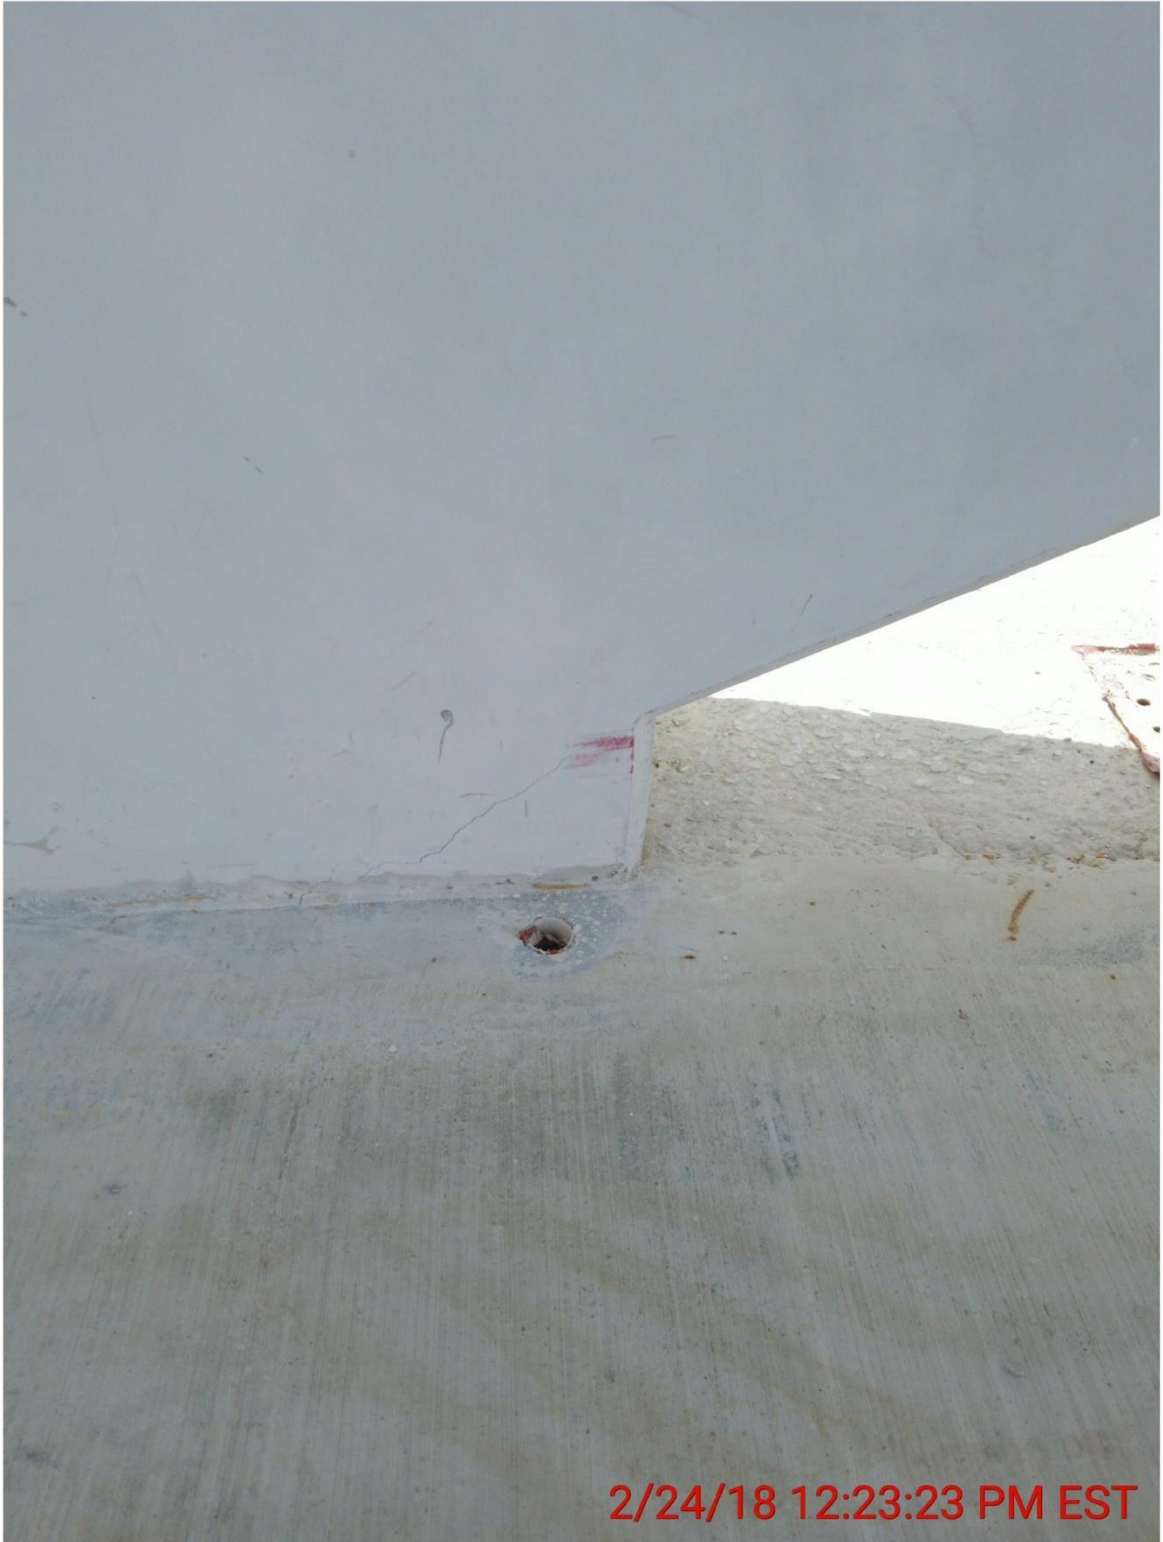
Bridge Factors Photo 36 – View of crack at the bottom of diagonal support #2 on north side looking to the south in casting yard on 2/24/18 at 12:23:23 p.m. (Source: Munilla Construction Management, MCM)

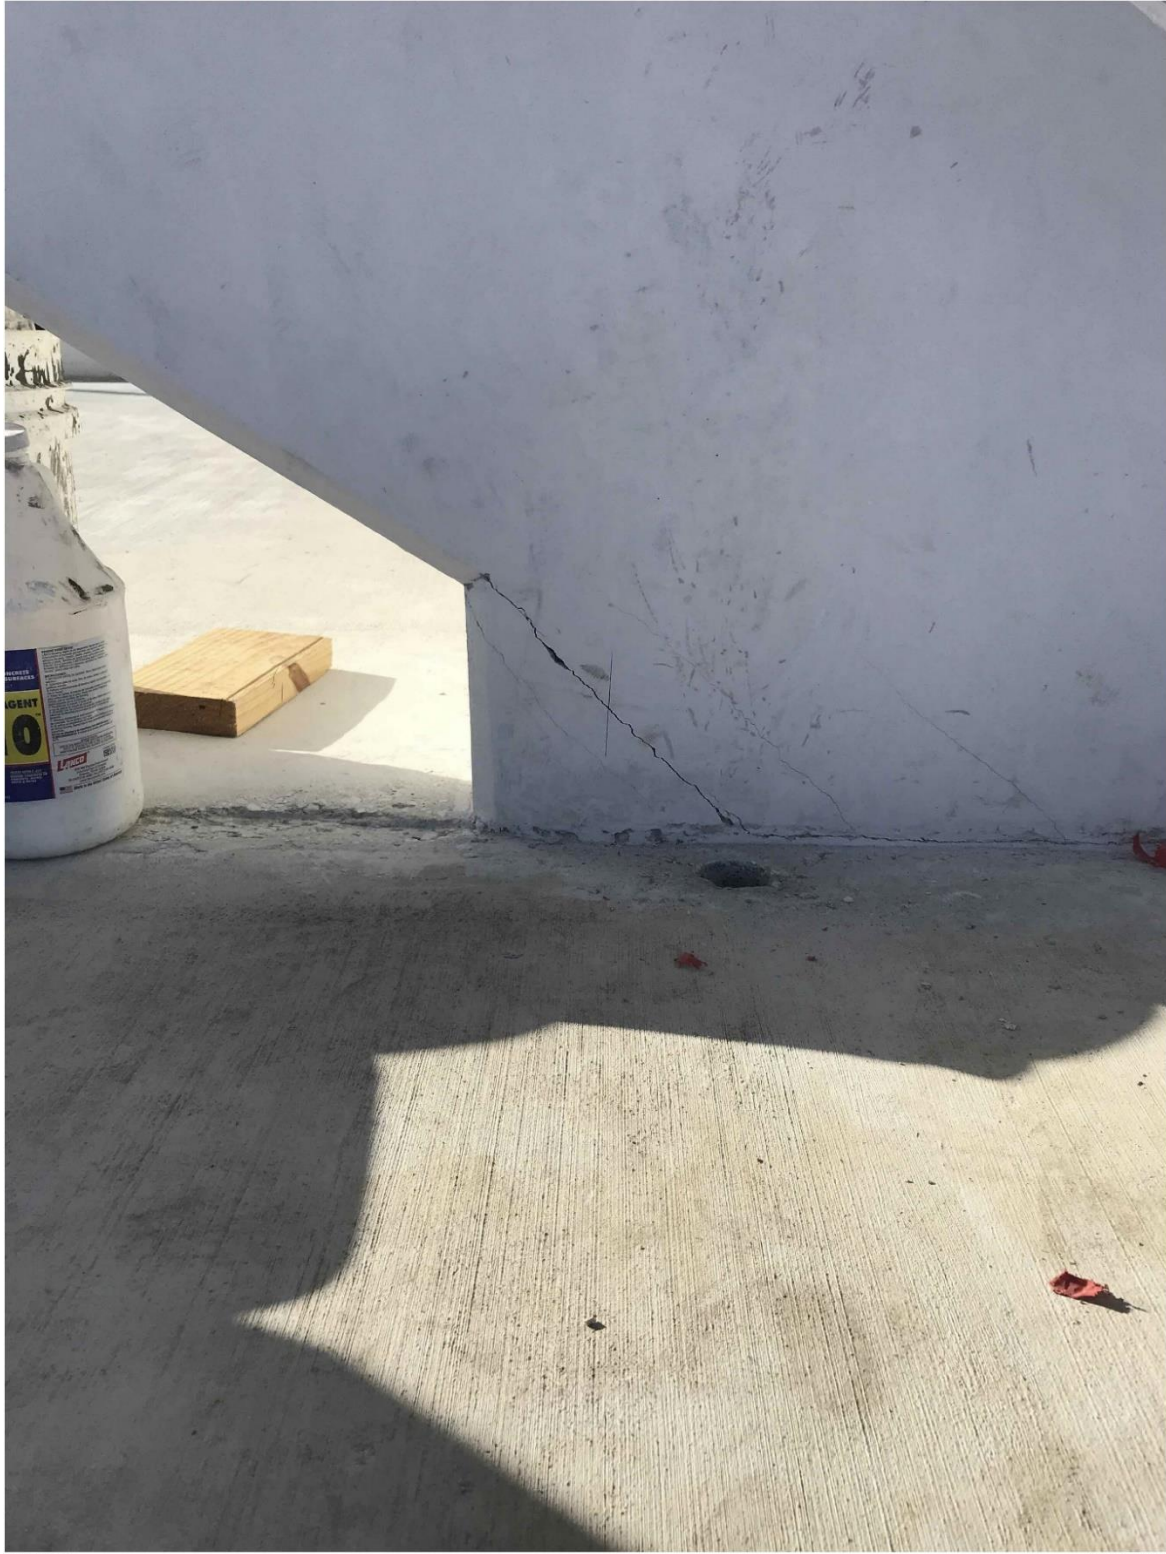
Bridge Factors Photo 42 – View of crack at the bottom of diagonal support #11 on north side looking to the south in casting yard on 2/26/18 at 8:38:16 a.m. (Source: Munilla Construction Management, MCM)

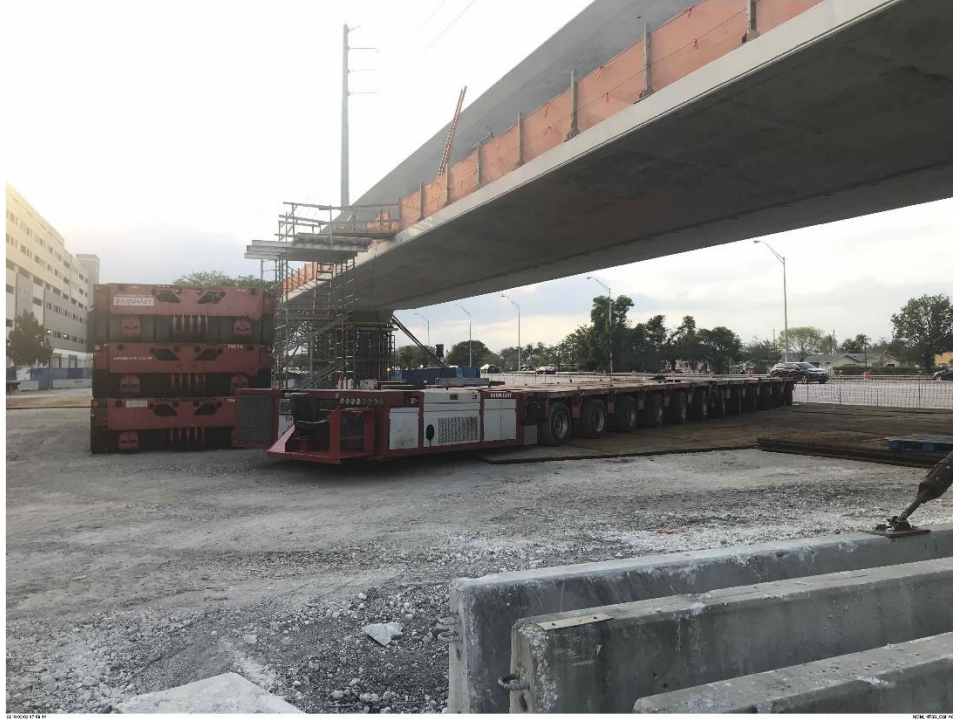
Bridge Factors Photo 47 – View of Barnhart Crane and Rigging equipment arriving on-scene on 3/2/18 at 5:19:44 p.m. (Source: Munilla Construction Management, MCM)

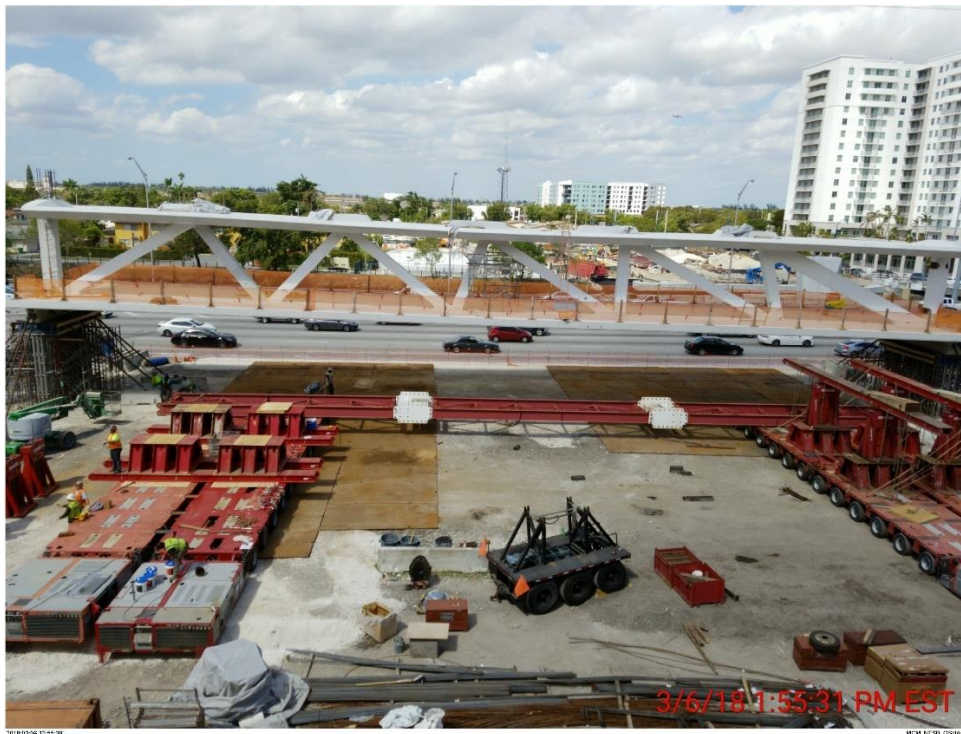
Bridge Factors Photo 48 – View of main span with partial set up of SPMT units located in foreground on 3/6/18 at 1:55:31 p.m. (Source: Munilla Construction Management, MCM)

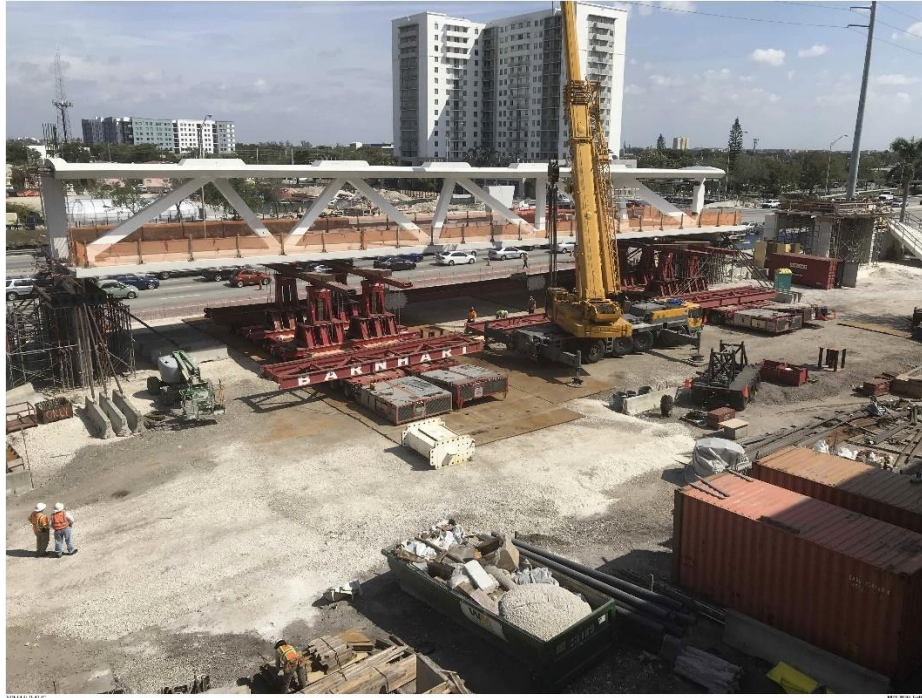
Bridge Factors Photo 49 – View of main span with set up of unattached SPMT units located underneath on 3/7/18 at 10:42:24 a.m. (Source: Munilla Construction Management, MCM)

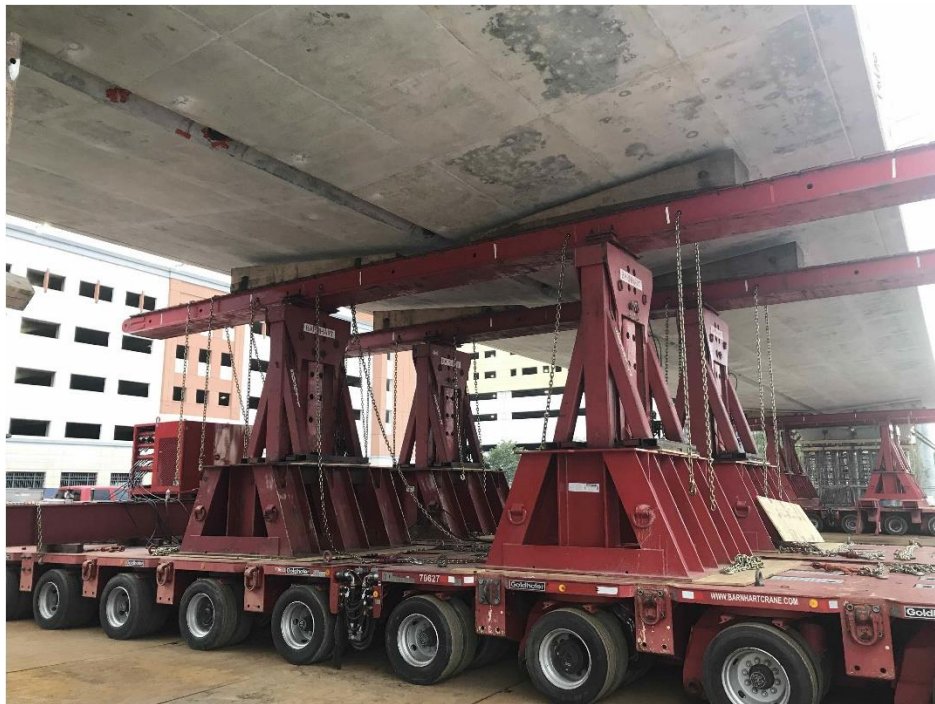
Bridge Factors Photo 50 – View of unattached SPMT with oak crane mats with a taper to match the profile of the bottom flange of the bridge span on 3/9/18 at 7:38:03 a.m. (Source: Munilla Construction Management, MCM)

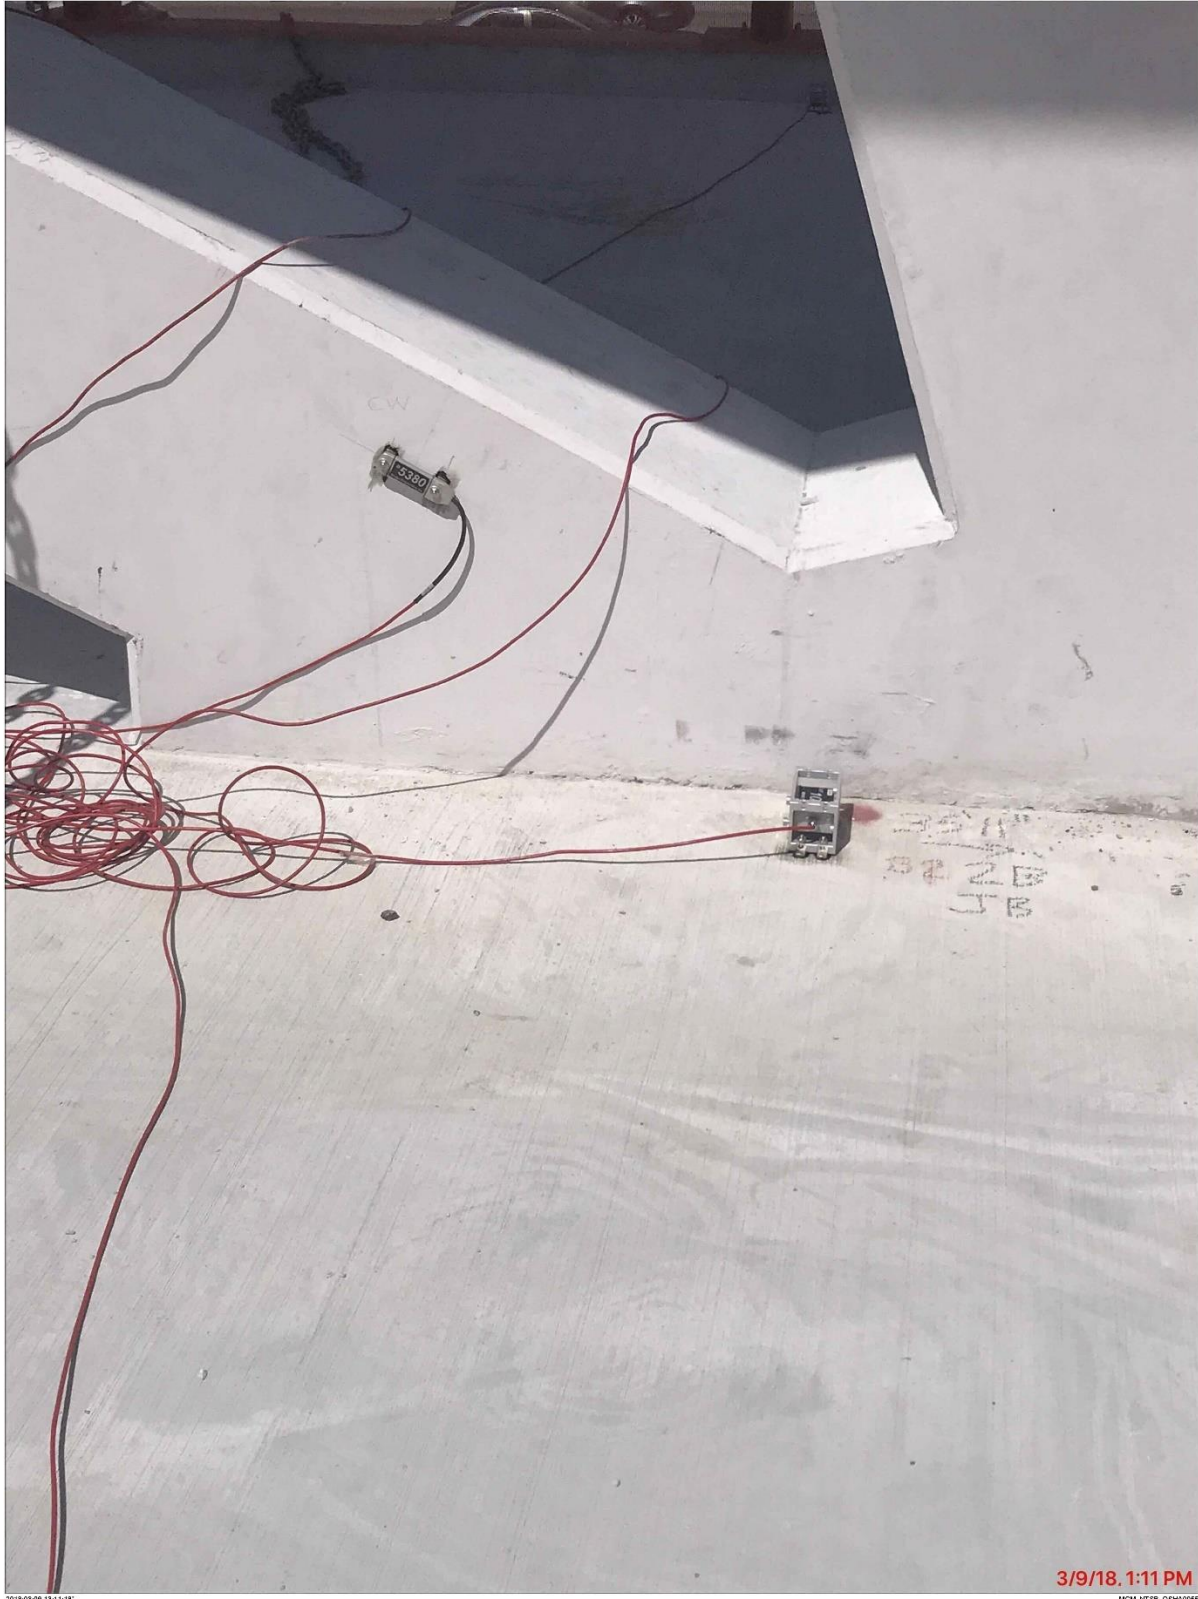
Bridge Factors Photo 51 – View of strain transducer and rotation sensor on main span during move on 3/9/18 at 1:11 p.m. (Source: Munilla Construction Management, MCM)

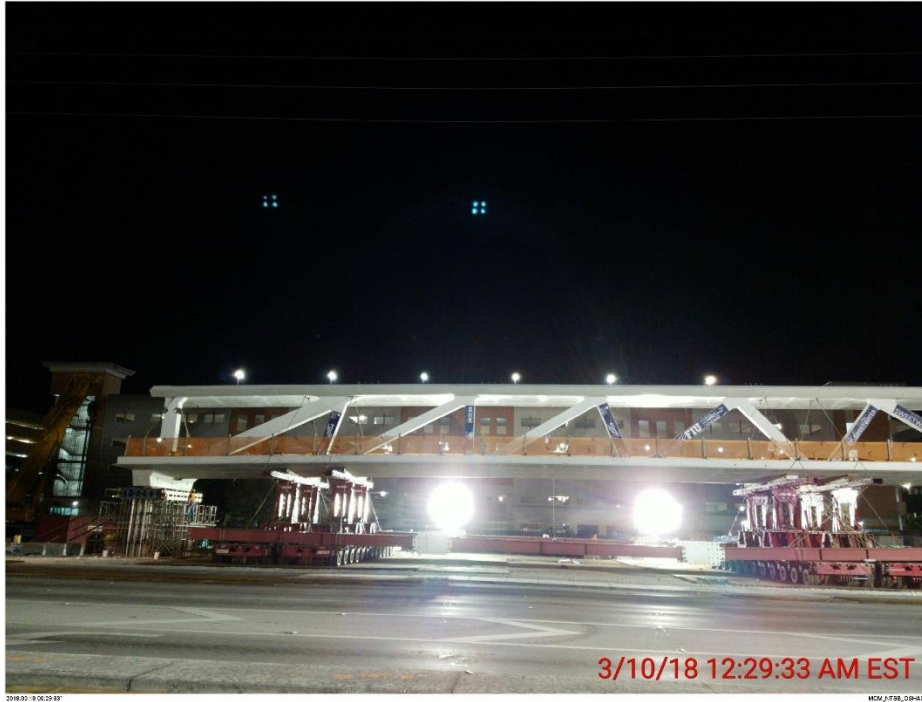
Bridge Factors Photo 52 – View of test move to transport main span on SPMT units on 3/10/18 at 12:29:33 a.m. Actual move began approximately 4:30 a.m. (Source: Munilla Construction Management, MCM)

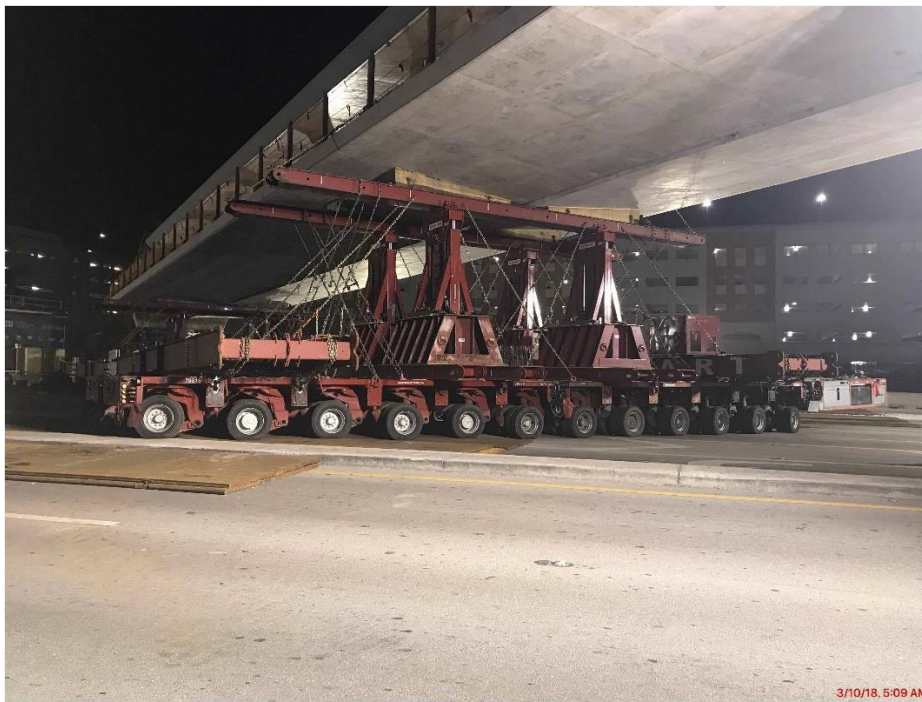
Bridge Factors Photo 53 – View of main span being transported on SPMT units across travel lanes of SW 8<sup>th</sup> Street on 3/10/18 at 5:09 a.m. (Source: Munilla Construction Management, MCM)

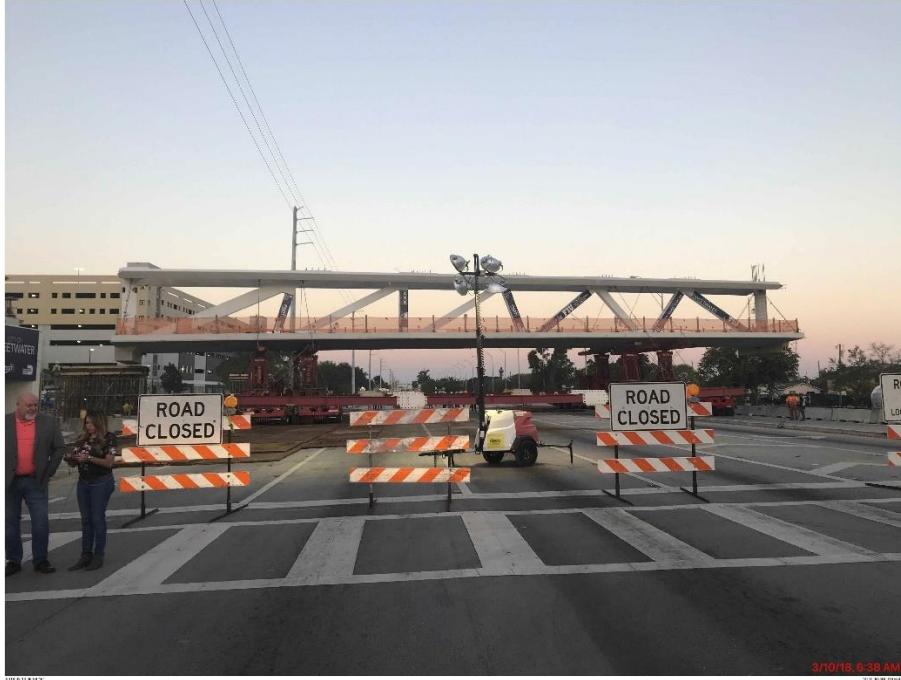
Bridge Factors Photo 54 – View of main span being transported on SPMT units west of permanent piers looking to the west on 3/10/18 at 6:38 a.m. (Source: Munilla Construction Management, MCM)

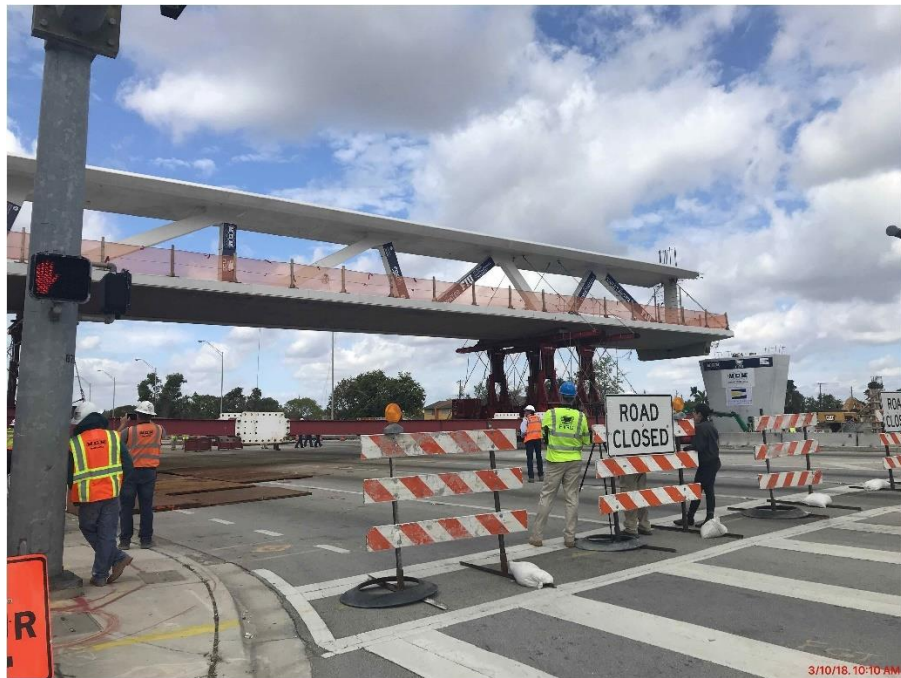
Bridge Factors Photo 55 – View of main span being transported on SPMT units immediately west of permanent piers looking to the northwest on 3/10/18 at 10:10 a.m. (Source: Munilla Construction Management, MCM)

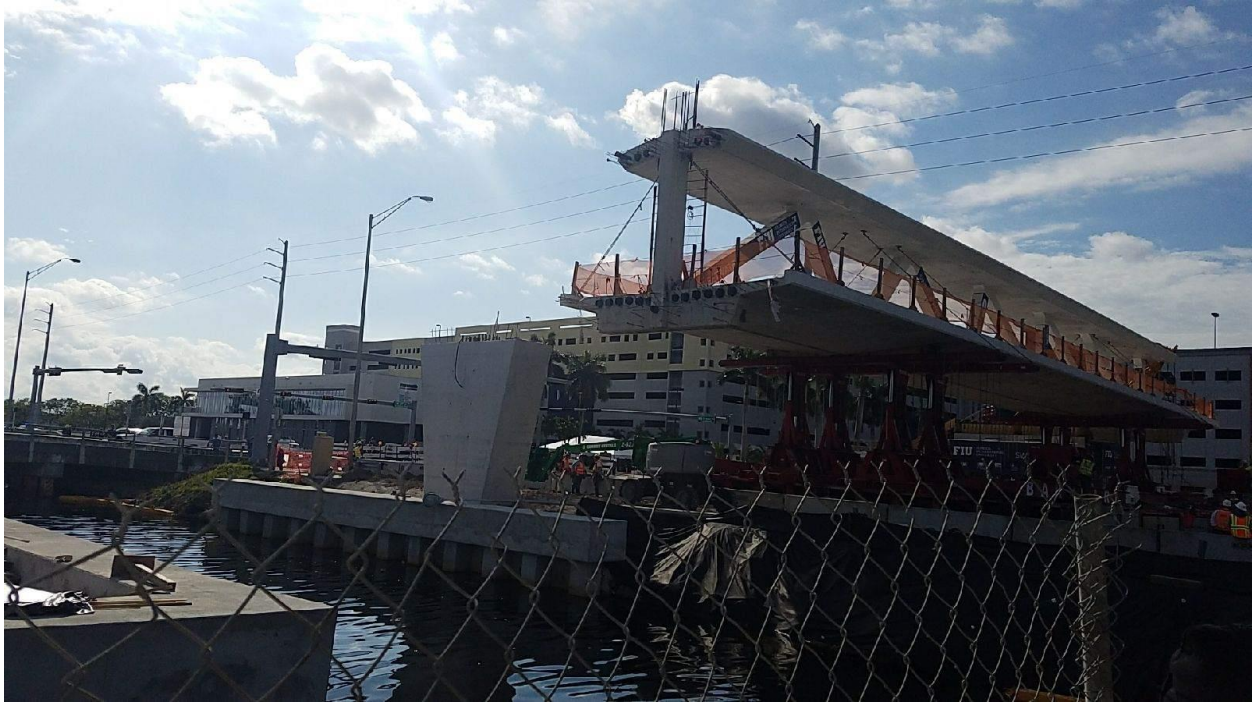
Bridge Factors Photo 56 – View of main span being transported on SPMT units immediately west of permanent piers looking to the southeast toward north face of Diaphragm II on 3/10/18 (Source: Structural Technologies, LLC)

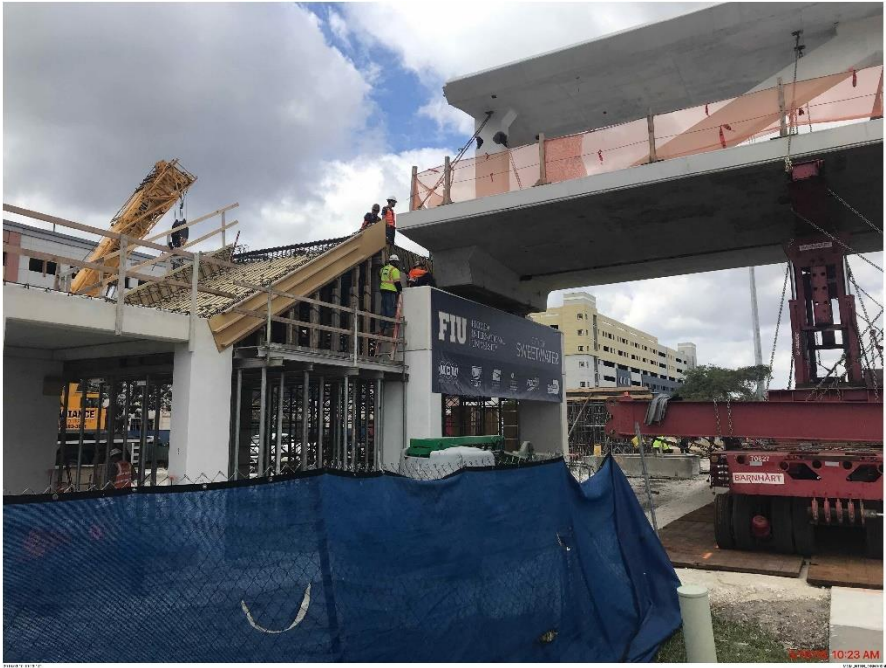
Bridge Factors Photo 57 – View of Diaphragm I, south end of main span, just prior to placement on south pier looking to the west on 3/10/18 at 10:23 a.m. (Source: Munilla Construction Management, MCM)

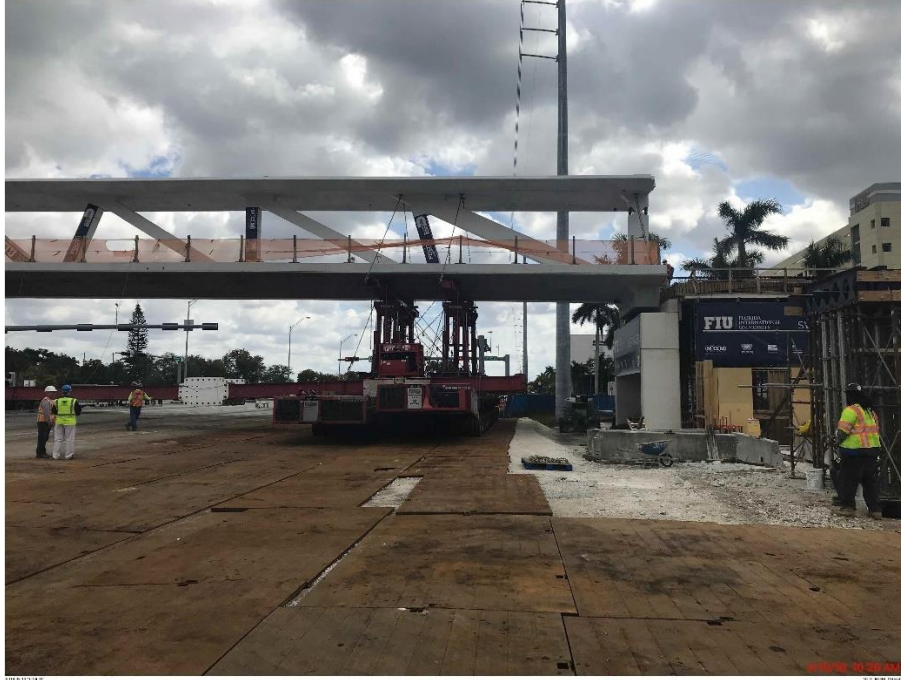
Bridge Factors Photo 58 – View of Diaphragm I, south end of main span, just prior to placement on south pier looking to the east on 3/10/18 at 10:26 a.m. (Source: Munilla Construction Management, MCM)

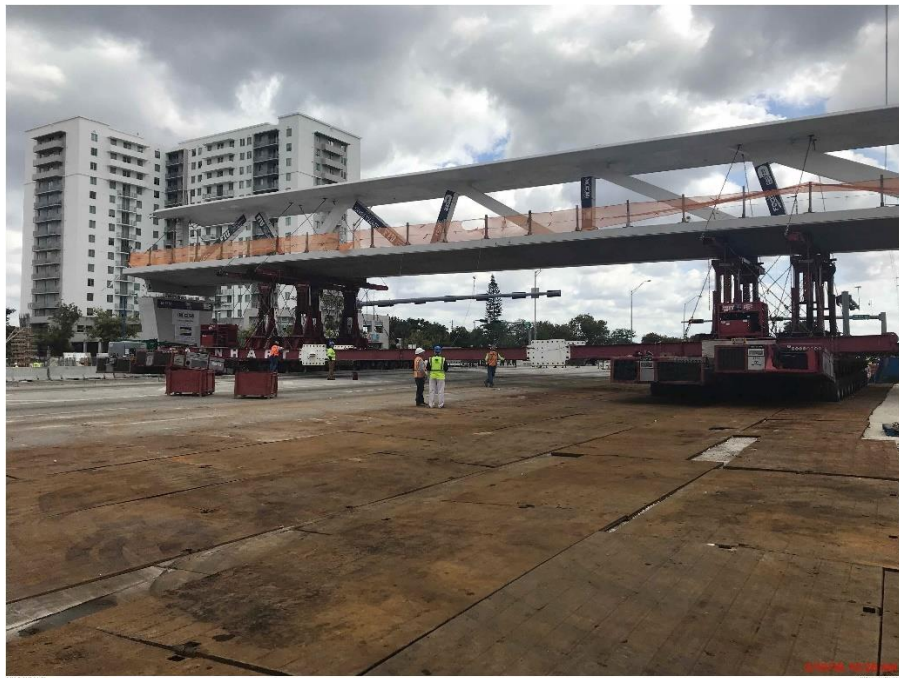
Bridge Factors Photo 59 – View of Diaphragm II, north end of main span, just prior to placement on pylon pier looking to the northeast on 3/10/18 at 10:26 a.m. (Source: Munilla Construction Management, MCM)

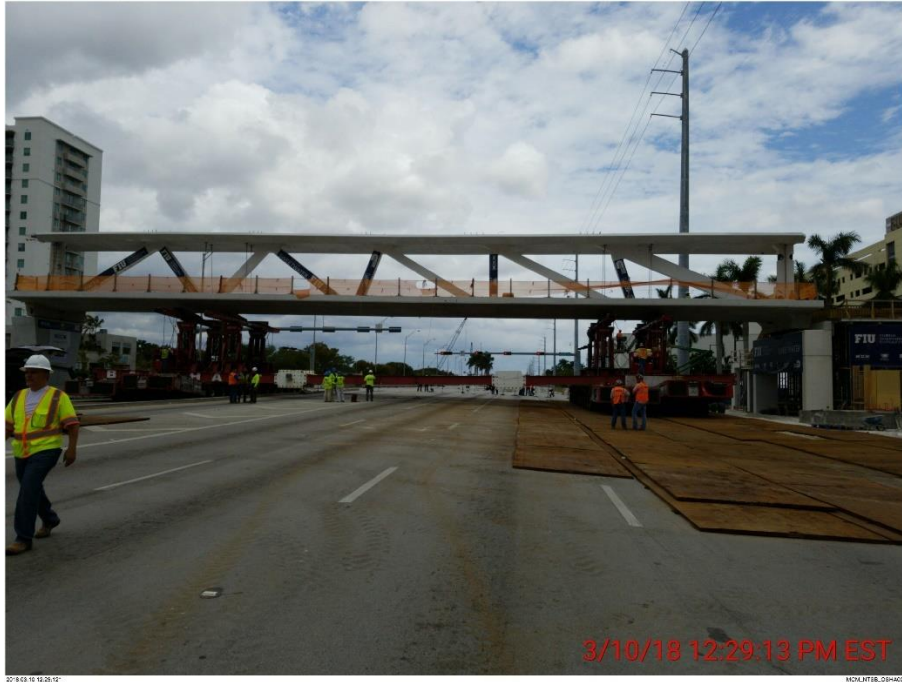
Bridge Factors Photo 60 – View of main span on permanent piers with chains detached from SPMT units on 3/10/18 at 12:29:13 p.m. Actual move complete approximately 12:30 p.m. (Source: Munilla Construction Management, MCM)

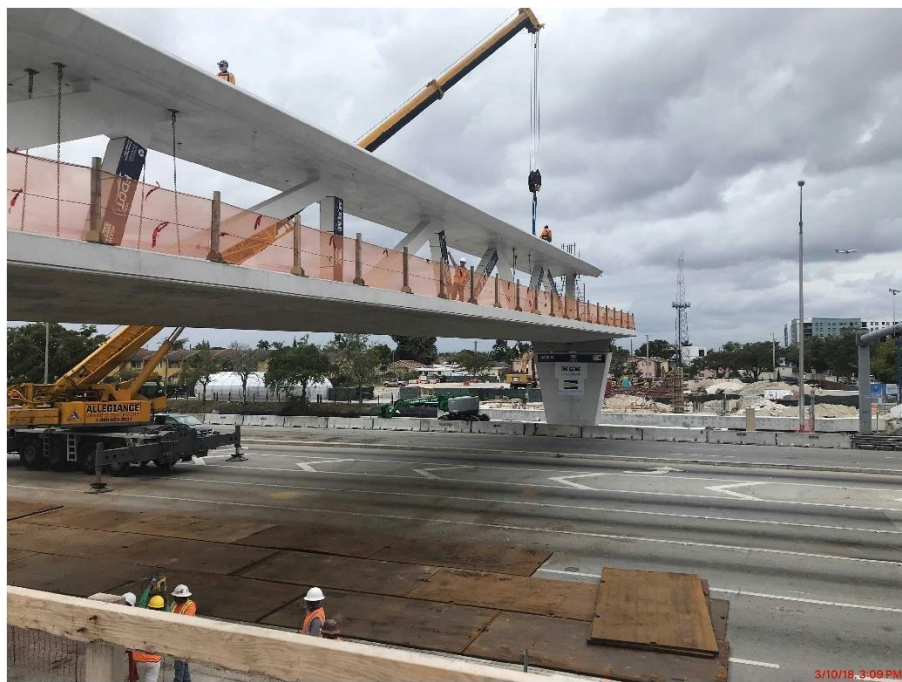
Bridge Factors Photo 61 – View of main span on permanent piers with SPMT units removed below on 3/10/18 at 3:09 p.m. Personnel working on top of canopy with crane hovered over diagonal support #11 (Source: Munilla Construction Management, MCM)

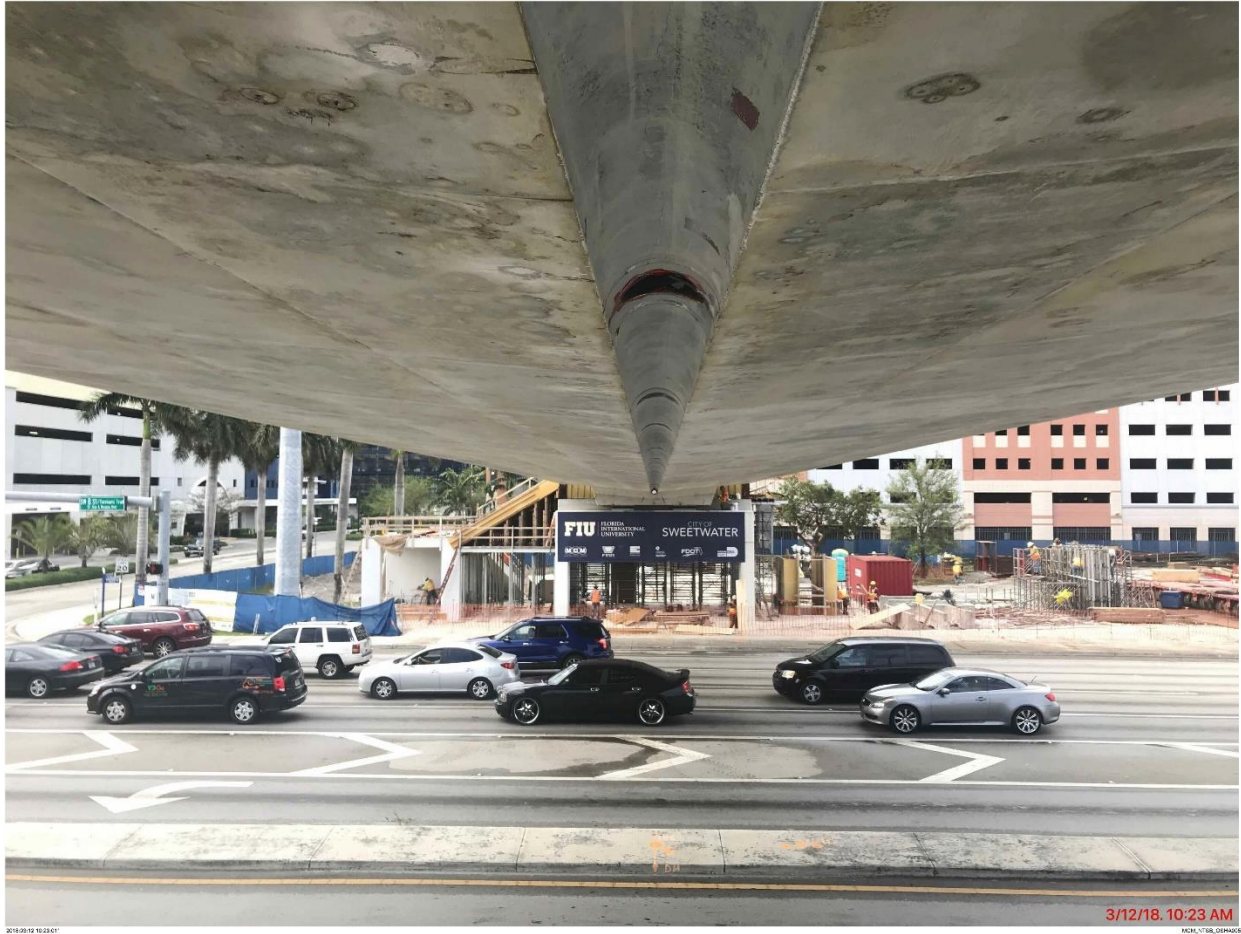
Bridge Factors Photo 72 – View of cut-out for drain pipe under deck looking to the south on 3/12/18 at 10:23 a.m. (Source: Munilla Construction Management, MCM)

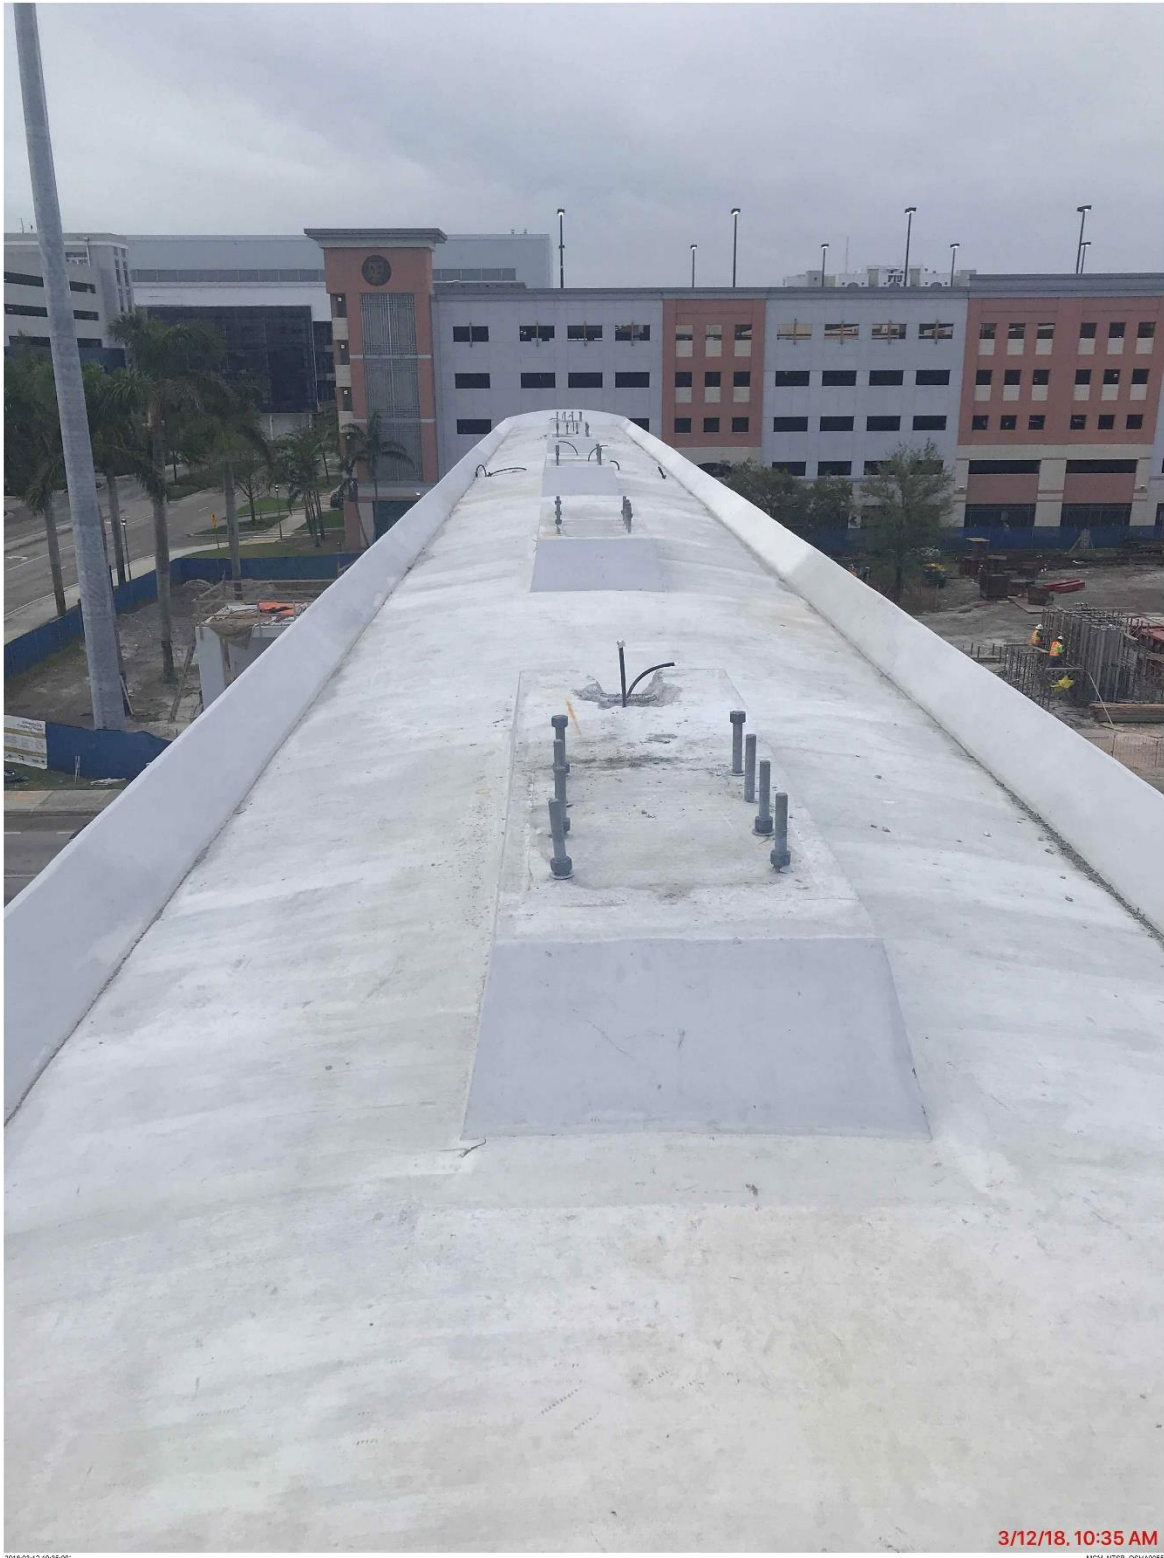
Bridge Factors Photo 73 – View of top of canopy looking to the south and chiseled concrete in blister for destressing diagonal support #11 on 3/12/18 at 10:35 a.m. (Source: Munilla Construction Management, MCM)

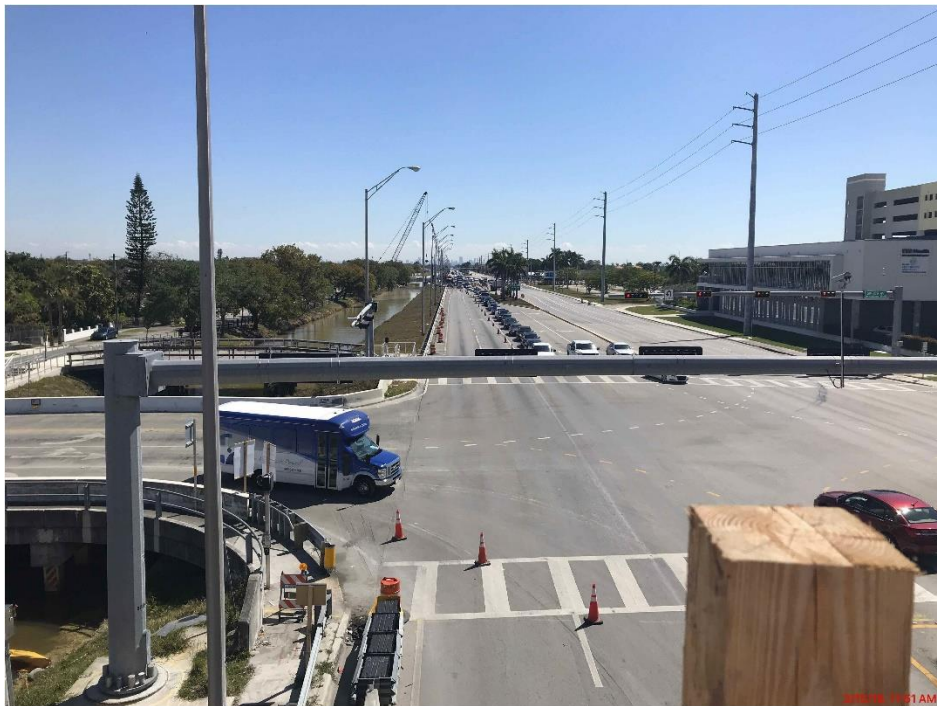
Bridge Factors Photo 105 – View of two of the three westbound lanes closed looking to the east to allow for a crane to be used during the restressing of diagonal support #11 on 3/15/18 at 11:51 a.m. (Source: Munilla Construction Management, MCM)

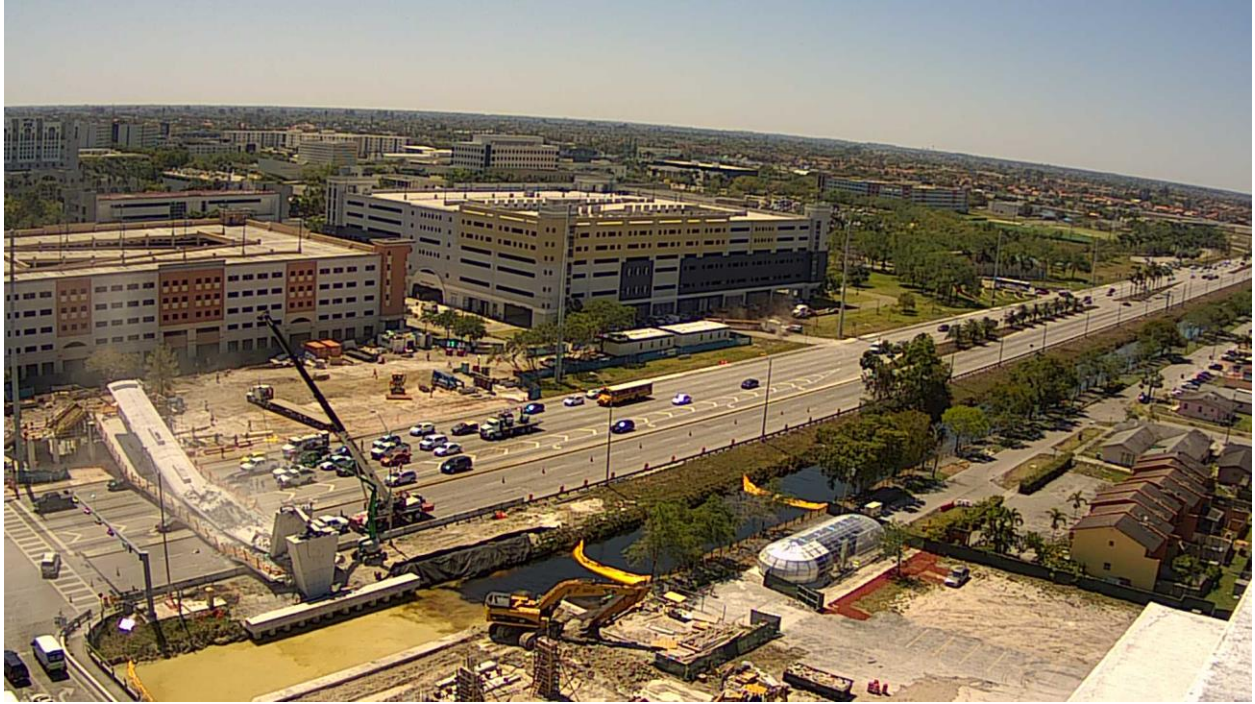
Bridge Factors Photo 106 – View of collapsed pedestrian bridge looking to the southwest on 3/15/18 at approximately 1:47 p.m. (Source: FIU)

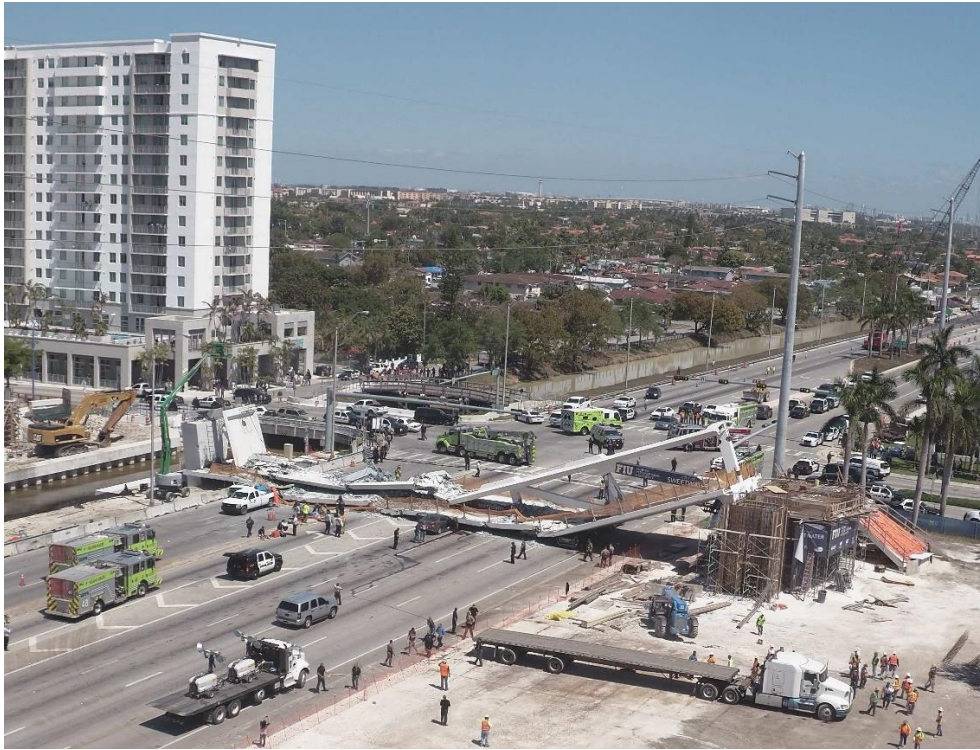
Bridge Factors Photo 107 – View of collapsed pedestrian bridge looking to the northeast (Source: FIU)

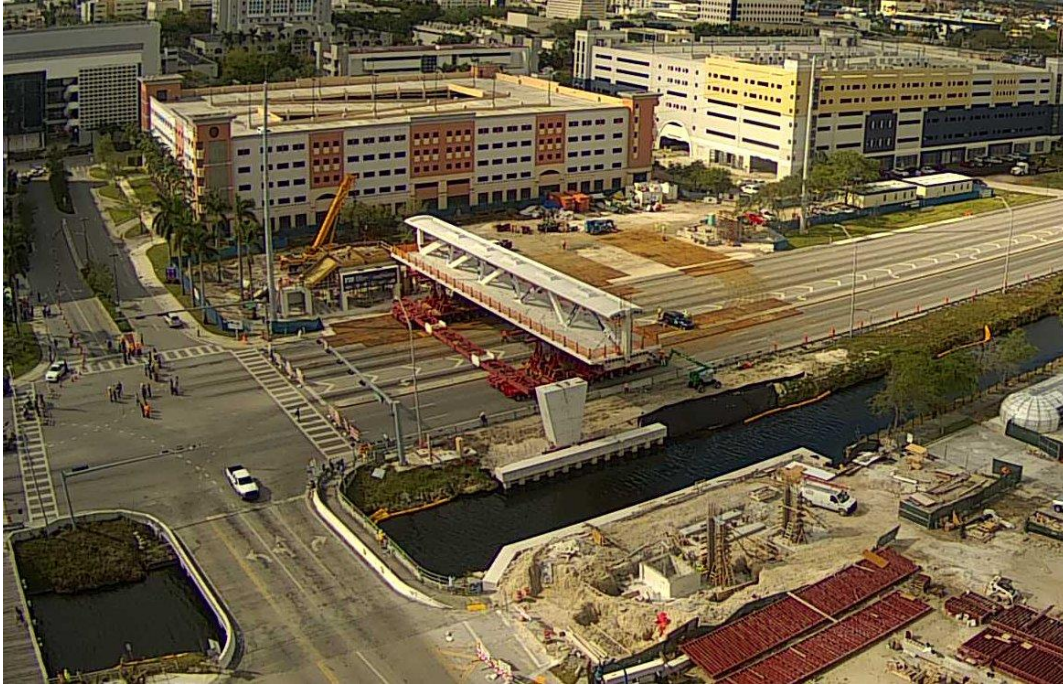
Bridge Factors Photo 108 – View of transporters moving the pedestrian bridge into place on the bridge piers looking to the southwest (Source: FIU)

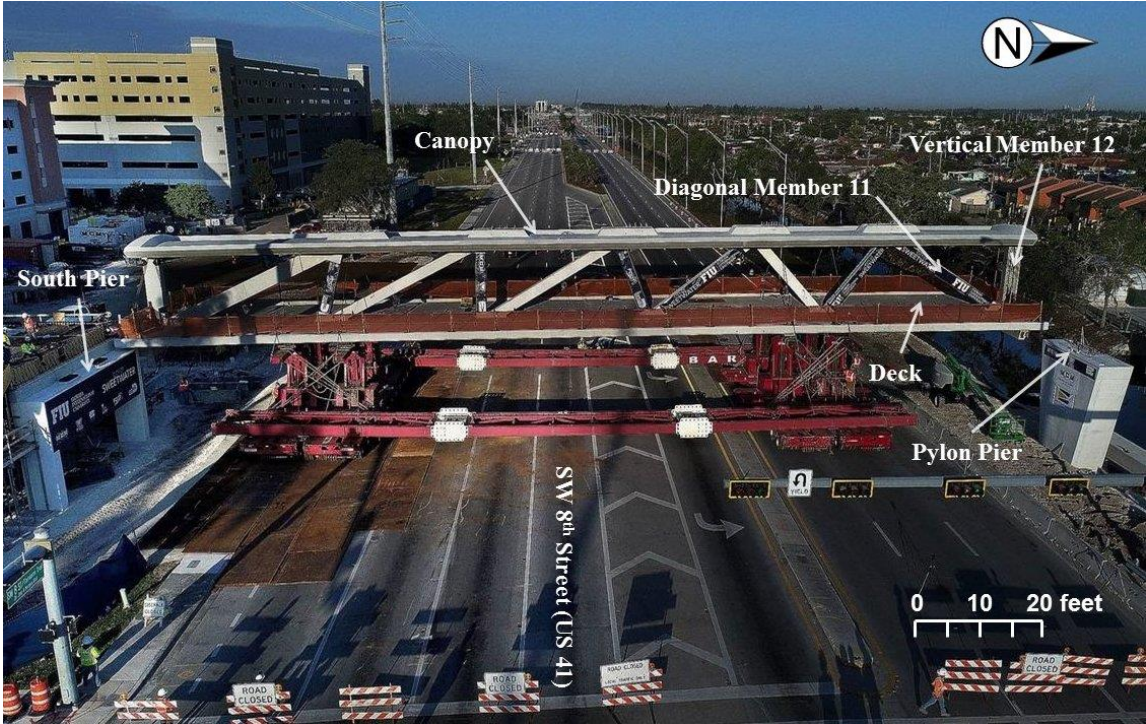
Bridge Factors Photo 109 – View of main span being moved on March 10, 2018, prior to placement on the south pier and north pylon pier, looking to the west, labels added by the NTSB (Source: FIU)
