**Bridge Factors Photographs 1 through 111**

**Miami, FL**

**HWY18MH009**

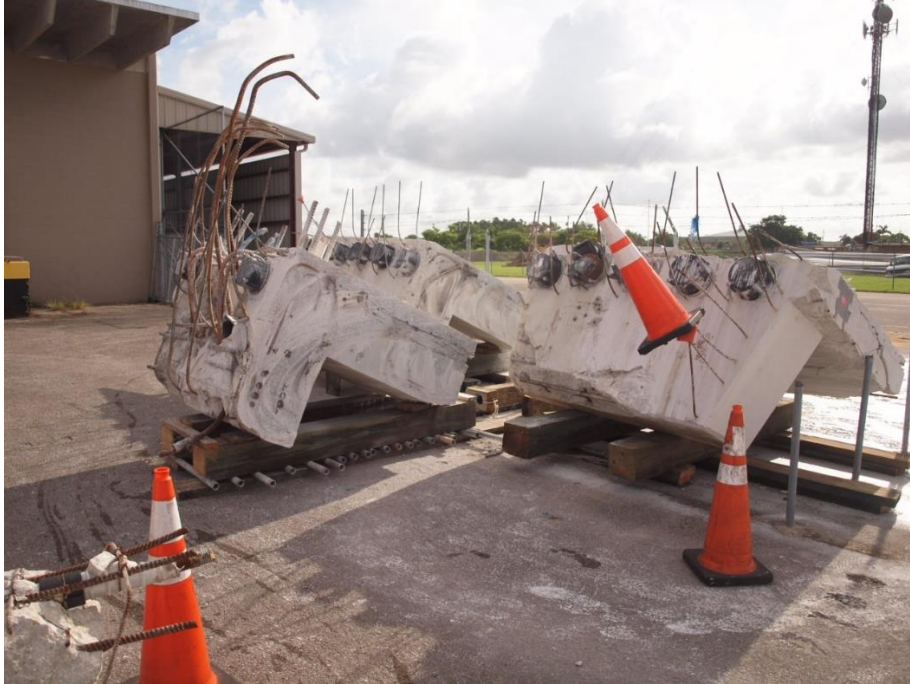
Bridge Factors Photo 110 – View of bridge deck in the vicinity of Node #11 and #12 with center section cut and slid forward for viewing of sample’s internal areas looking to the northeast in FDOT South Dade Maintenance Yard

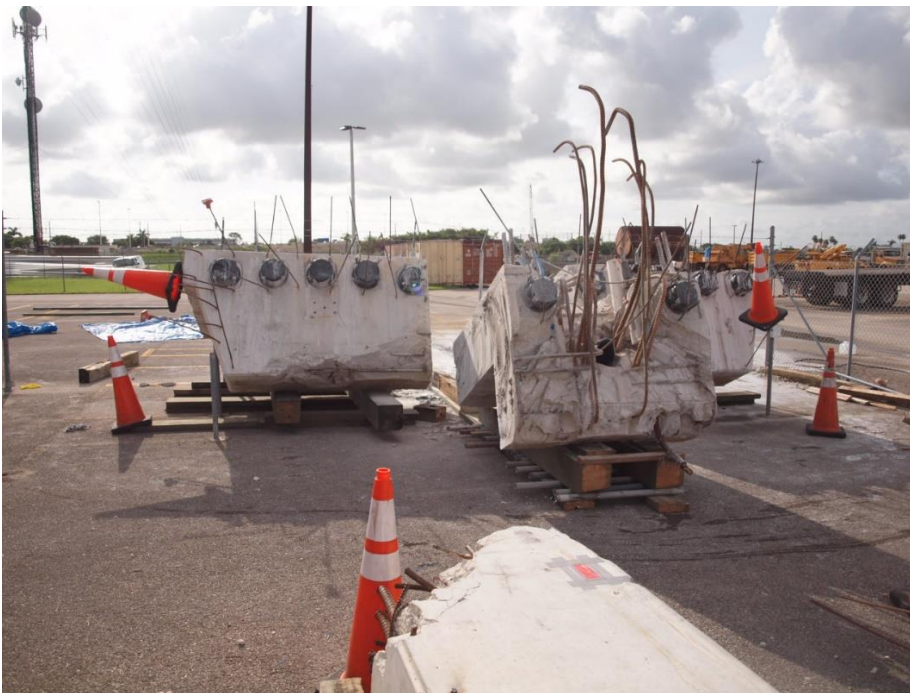
Bridge Factors Photo 111 – View of bridge deck in the vicinity of Node #11 and #12 with center section cut and slid forward for viewing of sample’s internal areas looking to the east in FDOT South Dade Maintenance Yard
