National Transportation Safety Board

DCA24MM031

BRIDGE PROTECTION SYSTEMS

Group Chair's Factual Report

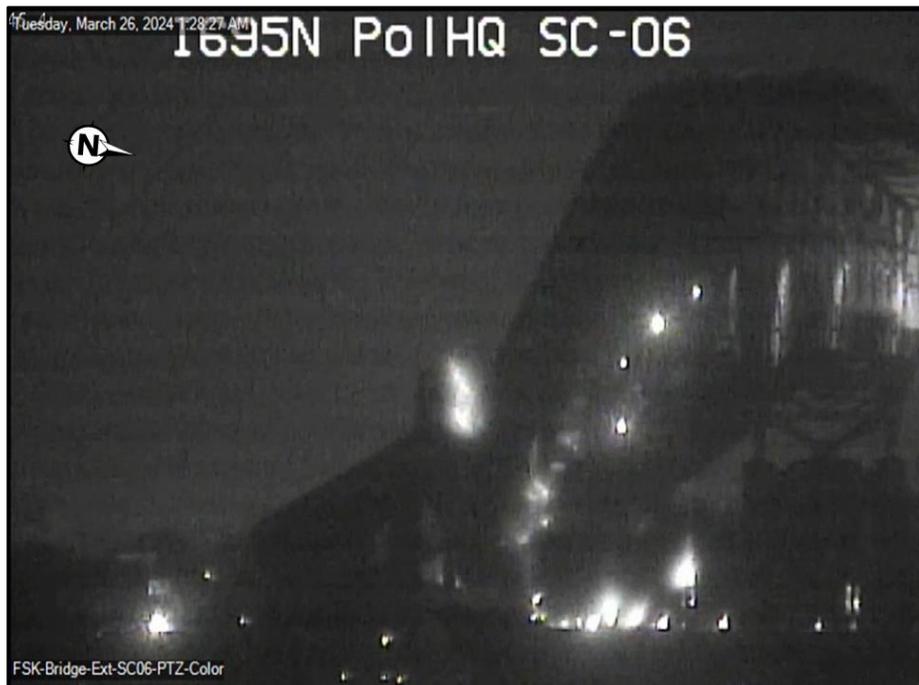
Figure 32. MDTA video depicting the second impact to the northwest column of Pier 17.

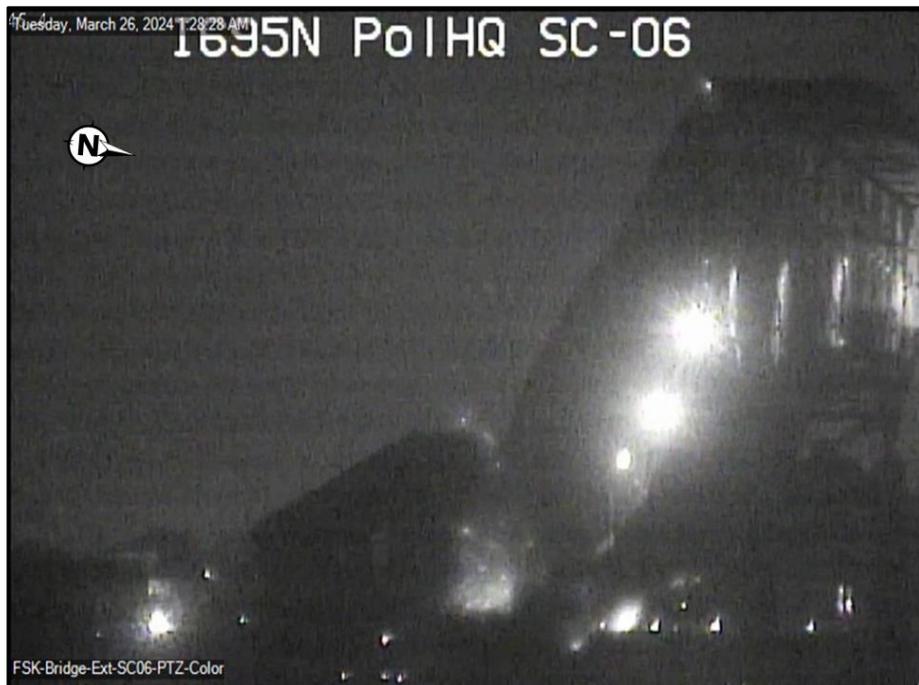
Figure 34. MDTA video depicting the collapse of Pier 17, Span 17, Span 18, and the steel truss.

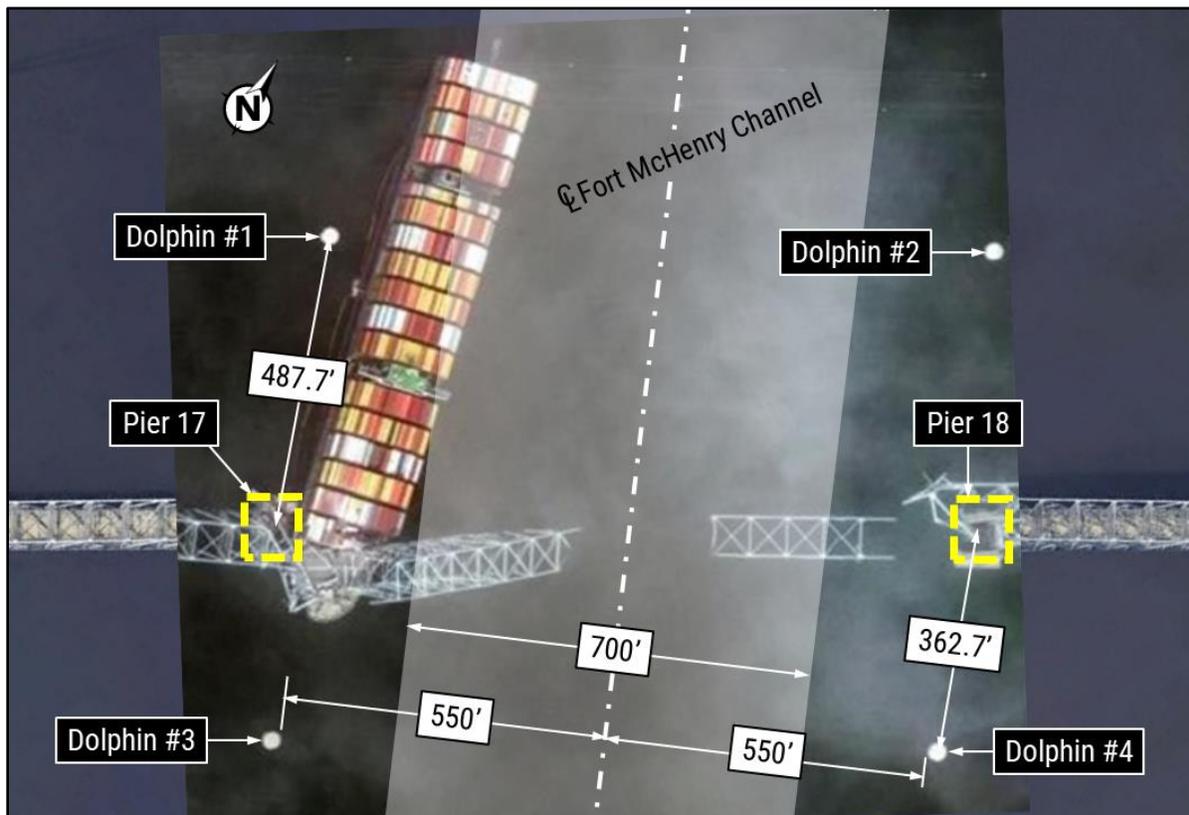
Approximately 13 seconds after the starboard bow of the *Dali* impacted Pier 17, Pier 17 collapsed resulting in the subsequent collapse of the entire steel truss (including Span 17, Span 18, and Span 19), Pier 19, Pier 20, Pier 21, Span 20, Span 21, and Span 22. During the collision sequence, the *Dali* did not interact with any of the four dolphins or their rubber fenders protecting Pier 17 and Pier 18. Both fendering systems surrounding Pier 17 and Pier 18 were damaged during the collapse of the truss spans of the bridge when components of the truss spans impacted portions of the fenders as the components fell into the water.

Figure 39 illustrates the final rest position of the *Dali* and the locations of the four dolphins that protected Pier 17 and Pier 18.

Figure 39. Navigation channel and locations of the dolphins (source: Maxar and Google Earth revised).

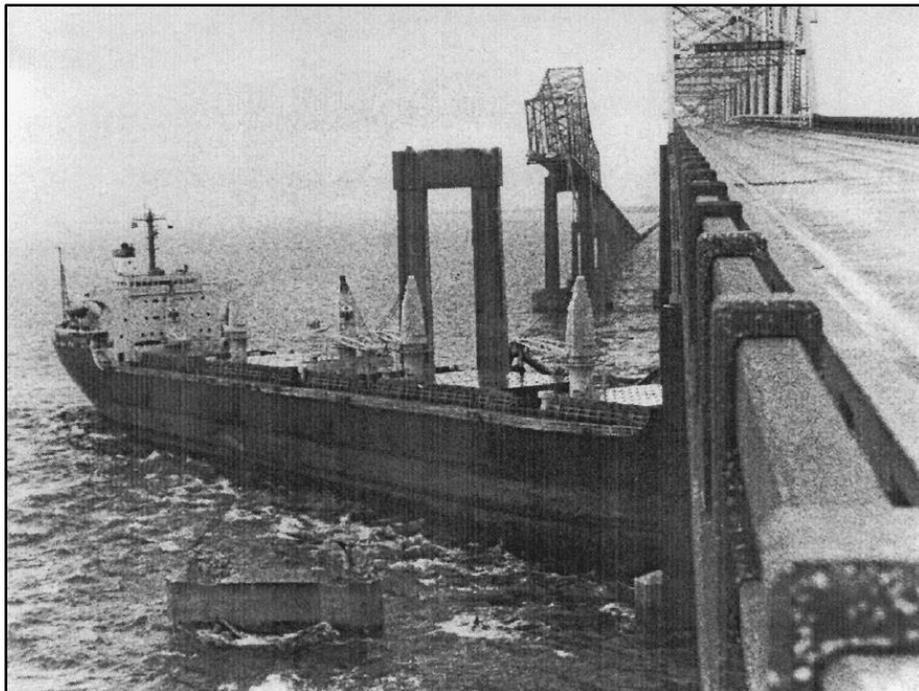
As a result of the collision, the support pier was destroyed and about 1,297 feet of bridge deck and superstructure fell from a height of about 150 feet into the bay. A Greyhound bus, a small pickup truck, and six automobiles fell into the bay and 35 persons died. Repair costs were estimated at about \$30 million for the bridge and about \$1 million for the *Summit Venture*.

Figure 63: View of the collapsed western span of the Sunshine Skyway Bridge looking to the north.

Following the collapse, the new protection system for the Sunshine Skyway Bridge included the following taken from the 2009 AASHTO *Guide Specifications and Commentary for Vessel Collision Design of Highway Bridges*, 2nd Edition:⁵⁹

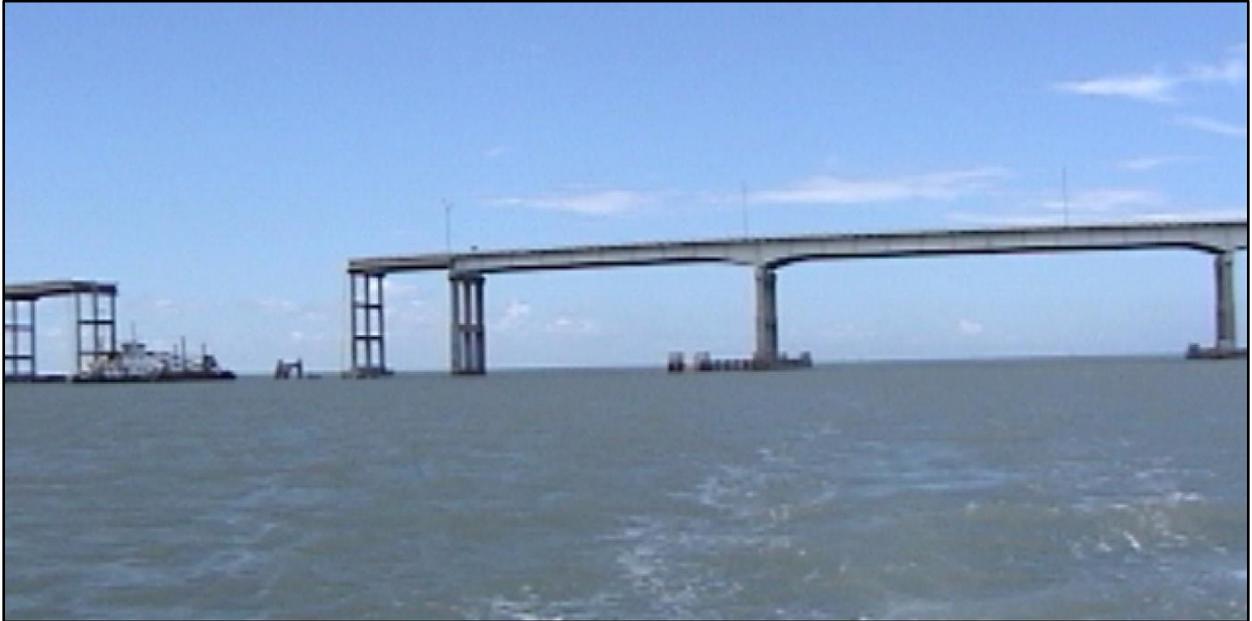
The collision caused two sections of the causeway (approximately 160 feet long and 85 feet above the water) to collapse. Ten passenger vehicles either fell with the collapsing sections or drove off the end of the remaining structure of the roadway resulting in eight fatalities. A third adjacent section of the causeway collapsed later that day in the afternoon.

Figure 66: View of the main shipping channel and collapsed portion of the Queen Isabella Causeway looking to the north.

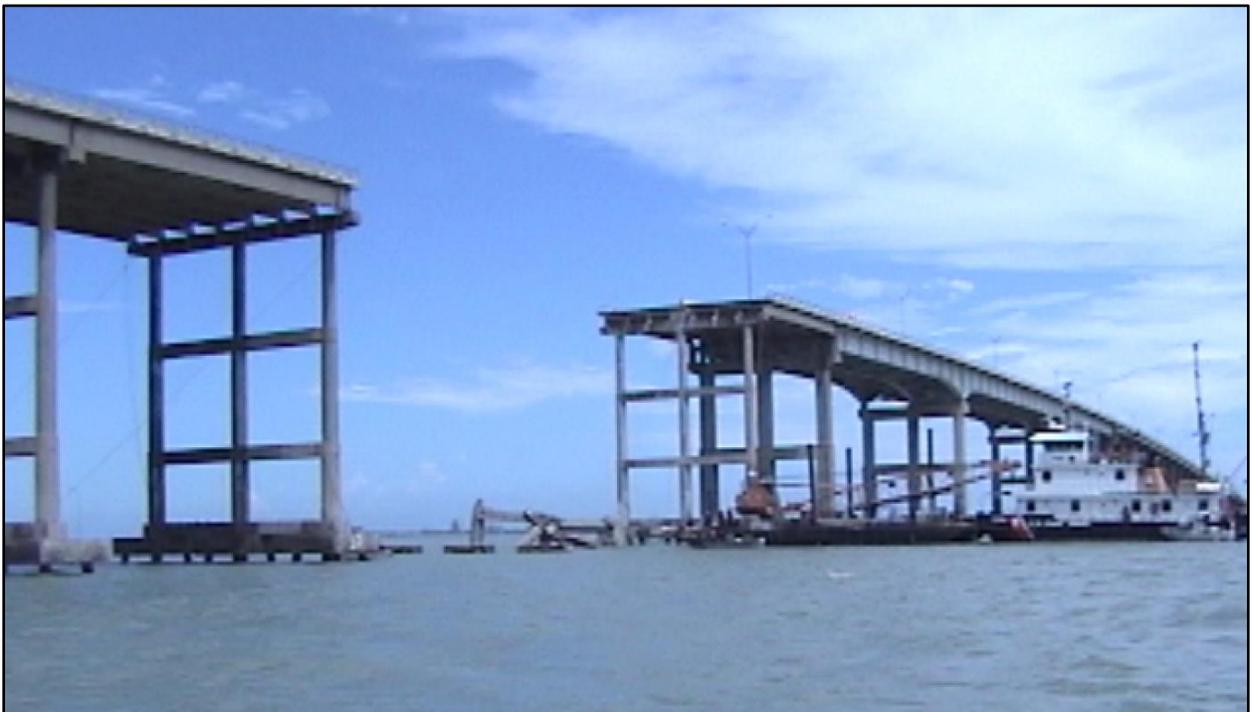
Figure 67: View of the collapsed Queen Isabella Causeway bridge bent and adjacent undamaged bents looking to the northeast.

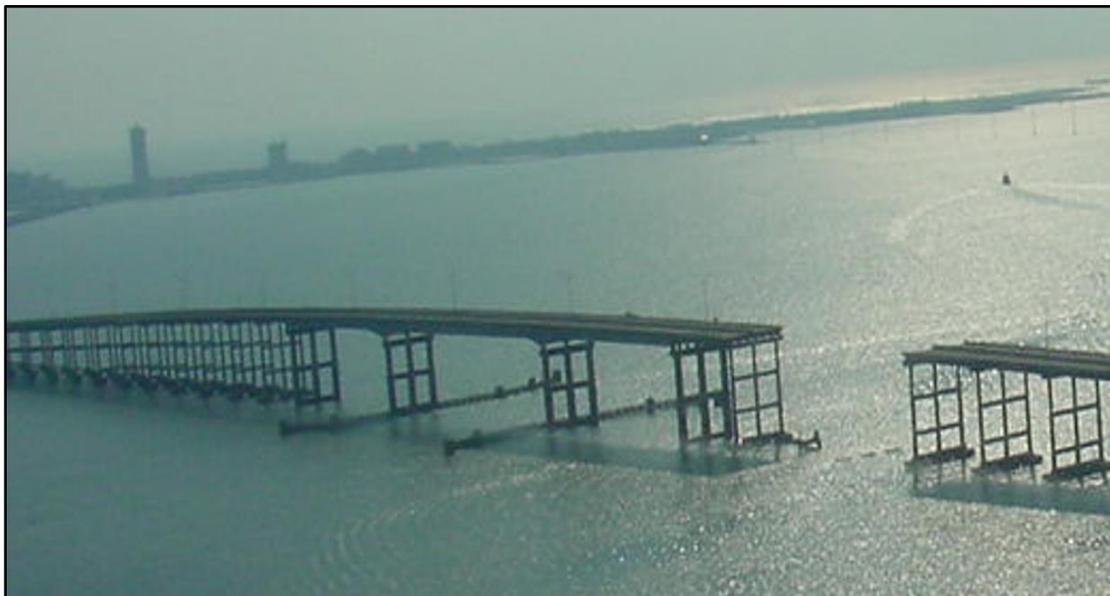
Figure 70 is a view of the collapsed portion of the Queen Isabella Causeway looking to the southeast illustrating no dolphins existed to protect the bridge bents at the highest sections of the causeway.

Figure 70: Collapsed portion of the Queen Isabella Causeway (source: TxDOT).

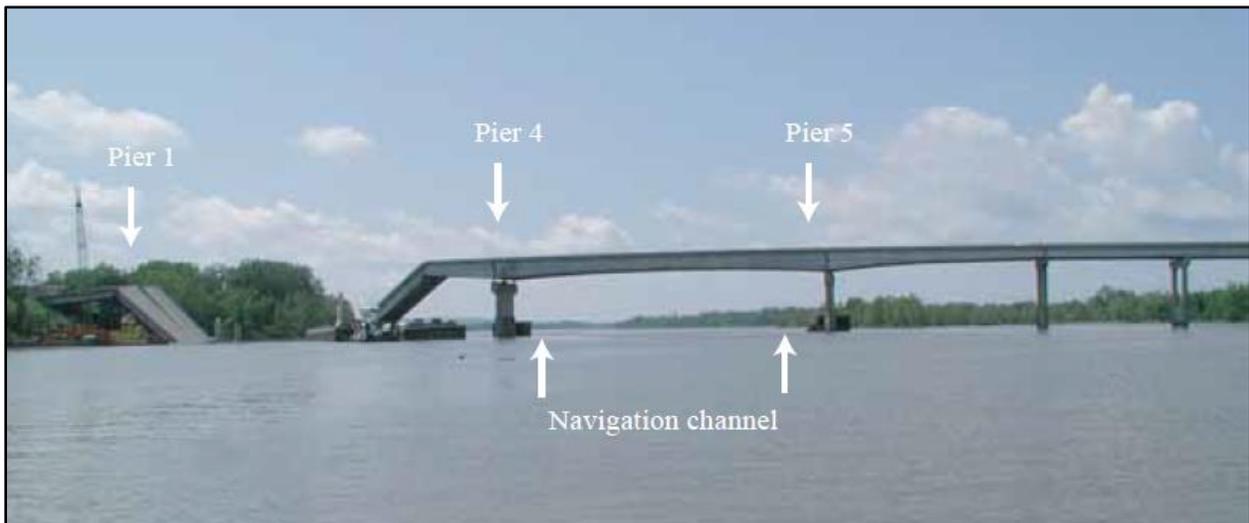
The impact collapsed a 503-foot section of the bridge, which fell into the river and onto the barges below. According to witnesses, highway traffic continued to drive into the void in the bridge created by the collapsed spans. When traffic stopped, eight passenger vehicles and three truck tractor-semitrailer combinations had fallen into the river or onto the collapsed portions of the bridge. The accident resulted in 14 fatalities and 5 injuries and caused an estimated \$30.1 million in damage to the bridge, including the operation of detours, and \$276,000 in damage to the barges.

Figure 73 is a view of the collapsed portion of the I-40 bridge downstream from the approach to the bridge illustrating the navigation channel looking to the northwest.

Figure 73: Collapsed portion of the I-40 bridge.

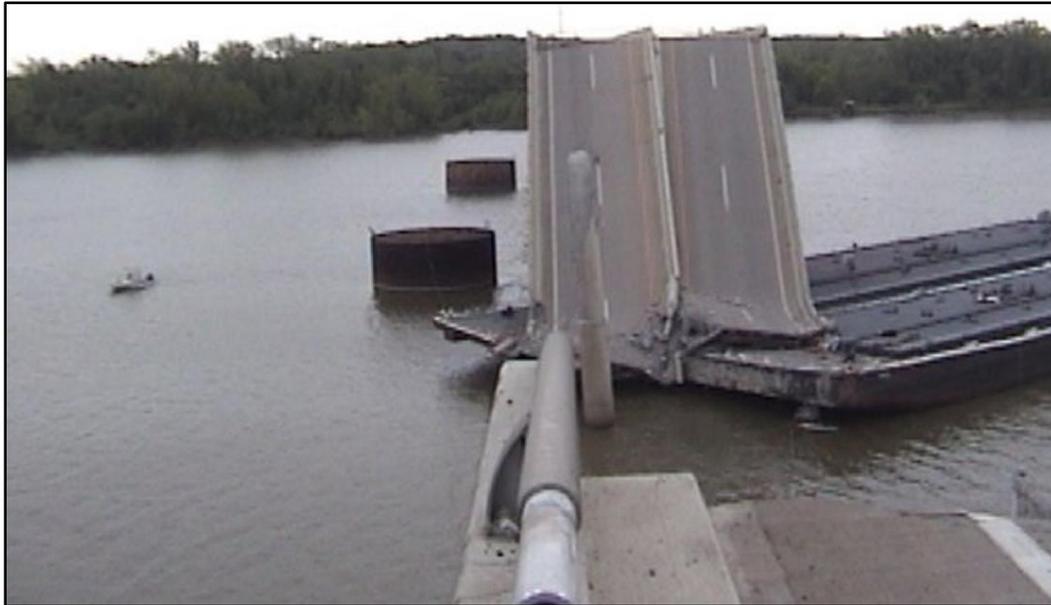
Figure 74 is a view of the collapsed portion of the I-40 bridge illustrating the 40 feet diameter dolphins protecting the piers of the navigational channel upstream of the bridge and the collapsed section resting on the barges downstream of the bridge looking to the north.

Figure 74: Collapsed portion of the I-40 bridge illustrating dolphins protecting the piers.

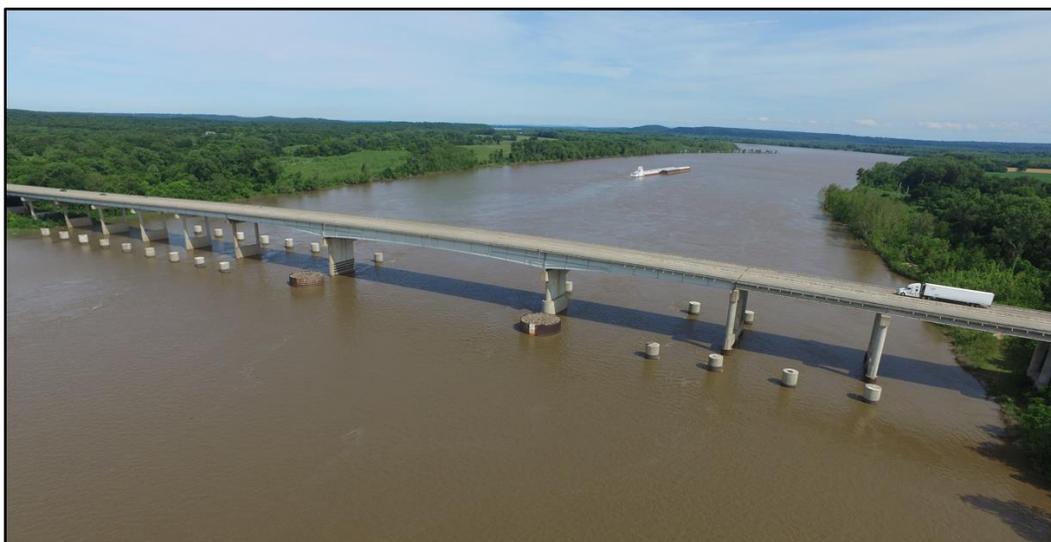
Figure 75: Aerial view of the new pier protection system for the I-40 bridge (source: Oklahoma Department of Transportation).

Figure 75 is an aerial view of the new pier protection system for the I-40 bridge that consists of 12-foot-diameter dolphins that protected almost every pier on the upstream and downstream side of the bridge except for the existing 40 feet diameter dolphins that protected the piers of the navigational channel upstream of the bridge looking to the southeast.

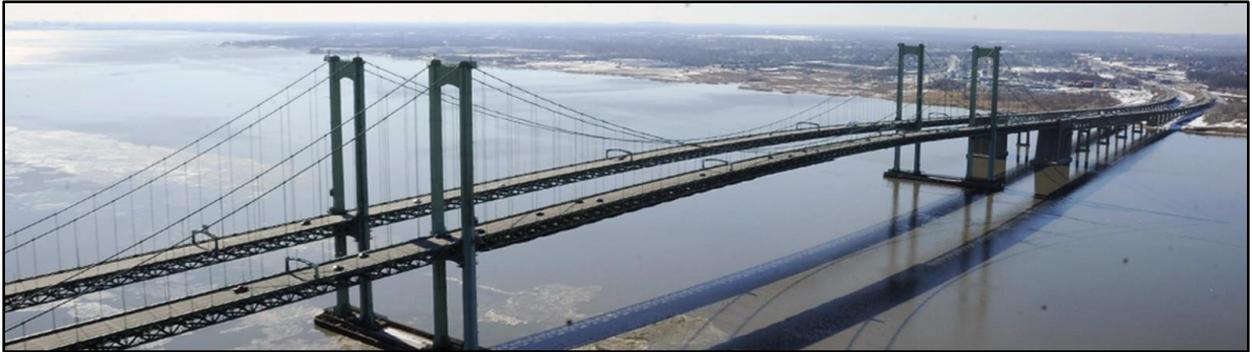
Figure 76: View of the Delaware Memorial Bridge looking to the southeast (source: Modjeski and Masters, Inc.).

The Delaware Memorial Bridge located near Wilmington, Delaware, was owned and operated by the Delaware River and Bay Authority (DRBA). **Figure 76** illustrates a view of the Delaware Memorial Bridge looking to the southeast prior to the construction of additional protections systems.

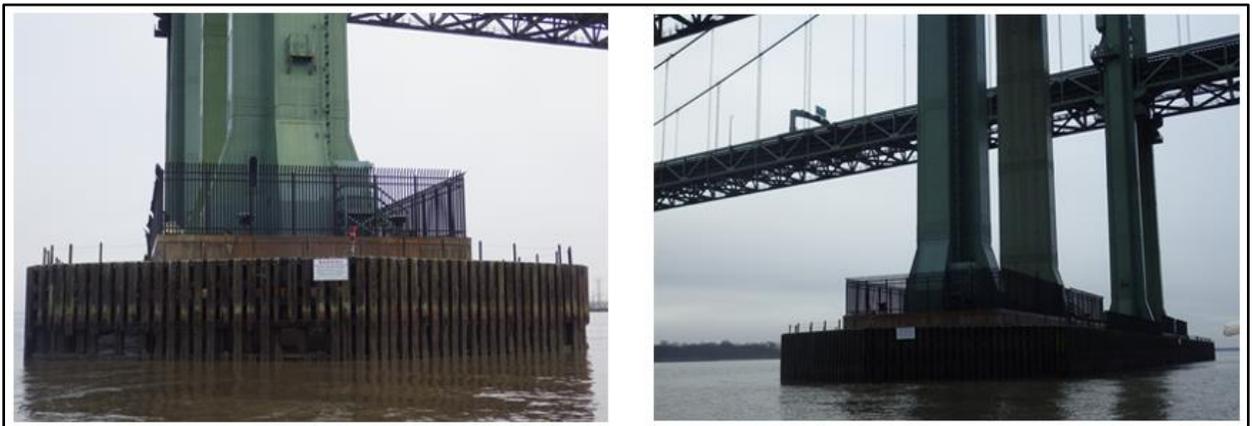
Figure 77: Views of the protection systems for the Delaware Memorial Bridge (source: Modjeski and Masters, Inc.).

Figure 77 illustrates views of the protection systems for the Delaware Memorial Bridge which consisted of a timber and steel fender system around the pier that did not contain dolphins. The fender systems were supported by the piers and was not an independently supported system.

In 2019, due to previous accidents with the bridge, the DRBA performed studies to determine the required protection requirements and protection methods. These studies recommended that a separate protection system be installed to protect the bridge. The new protection system consisted of eight (8) 80-foot-diameter steel sheet pile cell dolphins. The dolphins were to be filled with rock and topped with a

concrete cap. The cost was approximately \$90 to \$100 million to construct the eight dolphins, and two of the eight planned dolphins are currently completed.⁶¹

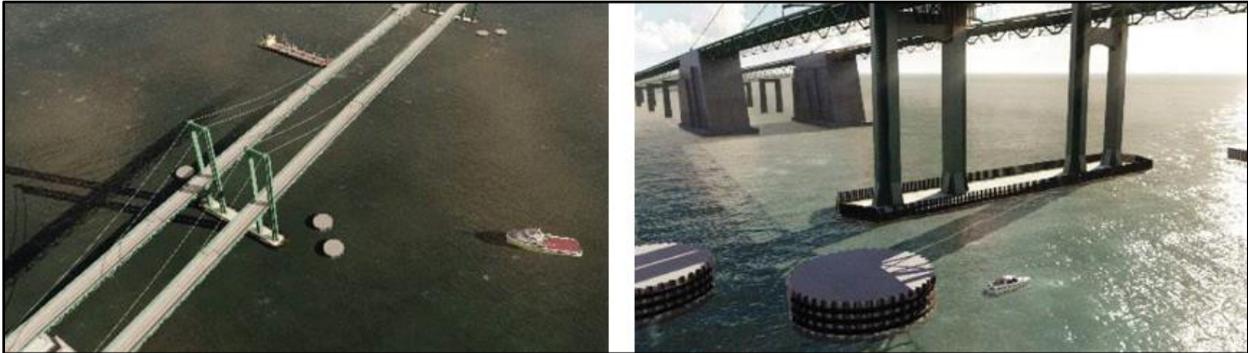
Figure 78: Four of the proposed eight new dolphins added to the protection system for the Delaware Memorial Bridge (source: Modjeski and Masters, Inc.).

Figure 78 and **Figure 79** depict the new 80-foot-diameter dolphins added to the protection system for the Delaware Memorial Bridge
