NATIONAL TRANSPORTATION SAFETY BOARD
Office of Aviation Safety
Washington, D.C. 20594

Airworthiness Sub-Group Chairman's Factual Report

DCA21FA085

Operator: United Airlines
Location: Broomfield, CO
Date: February 20, 2021
Time: 1309 mountain standard time (MST)
Airplane: Boeing 777-222, N772UA

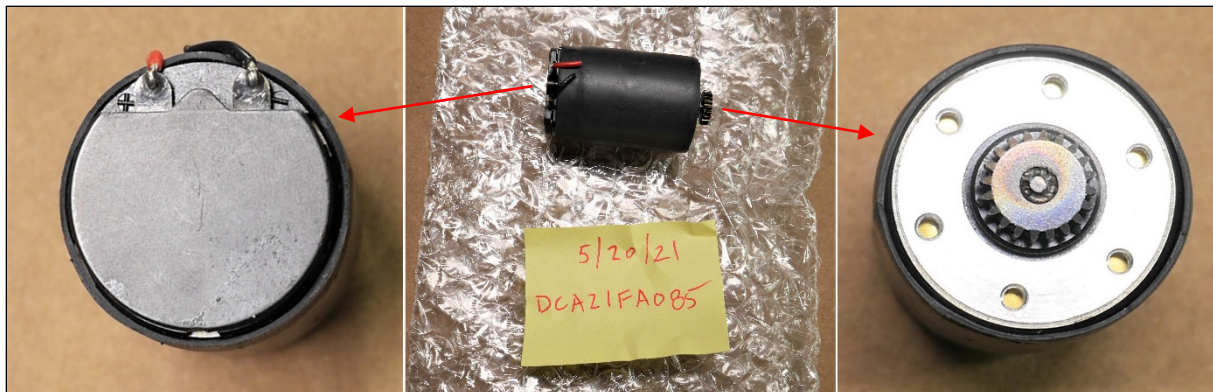
Figure 4: DC motor removed from bag. Pinion gear and back cover also shown.

The bag containing the DC motor was removed from the box. The rest of the parts remained inside the box. The DC motor was removed from the bag and a visual inspection was performed on its overall condition. A yellow post-it note was included in the bag. The black sleeve covering the DC motor housing was intact. Portions of the black and red wires were still present on the terminals. The back cover and pinion gear appeared unremarkable. Figure 4 shows an image of the DC motor removed from the bag. Back cover and pinion gear photographed for condition.

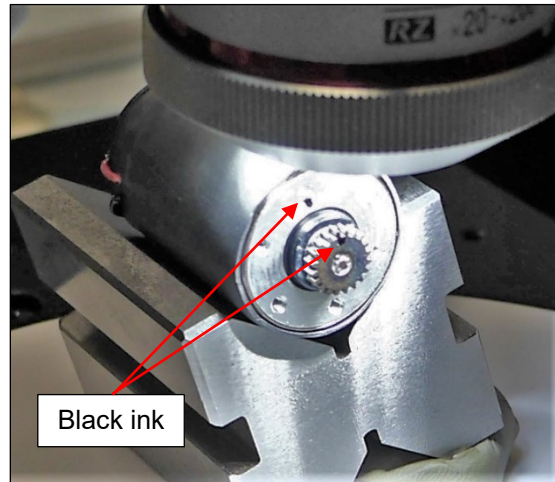
Figure 5: Black ink marked on tooth and housing for alignment.

Black ink was marked on one tooth of the pinion gear and adjacent section of housing for alignment as shown on Figure 5.

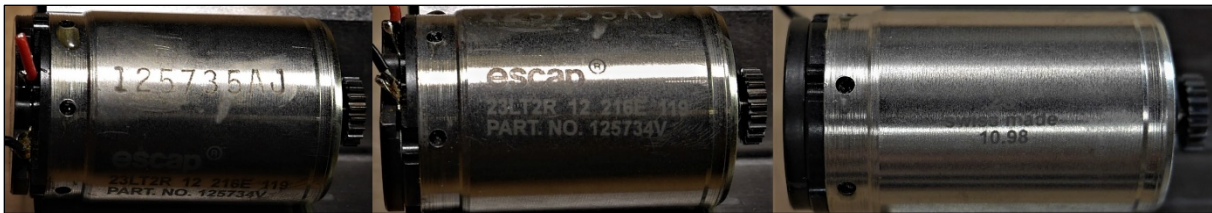
Figure 8: DC motor part markings.

Part markings on the DC motor housing were photo documented as shown on Figure 8.

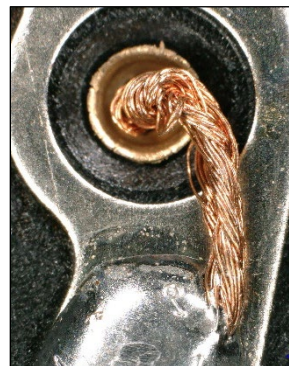
Figure 11: Negative brush wire.

The wire strands on the brushes appeared kinked but no visible strands broken. Figure 10 shows a magnified image of the positive brush wire and Figure 11 shows a magnified image of the negative brush wire.

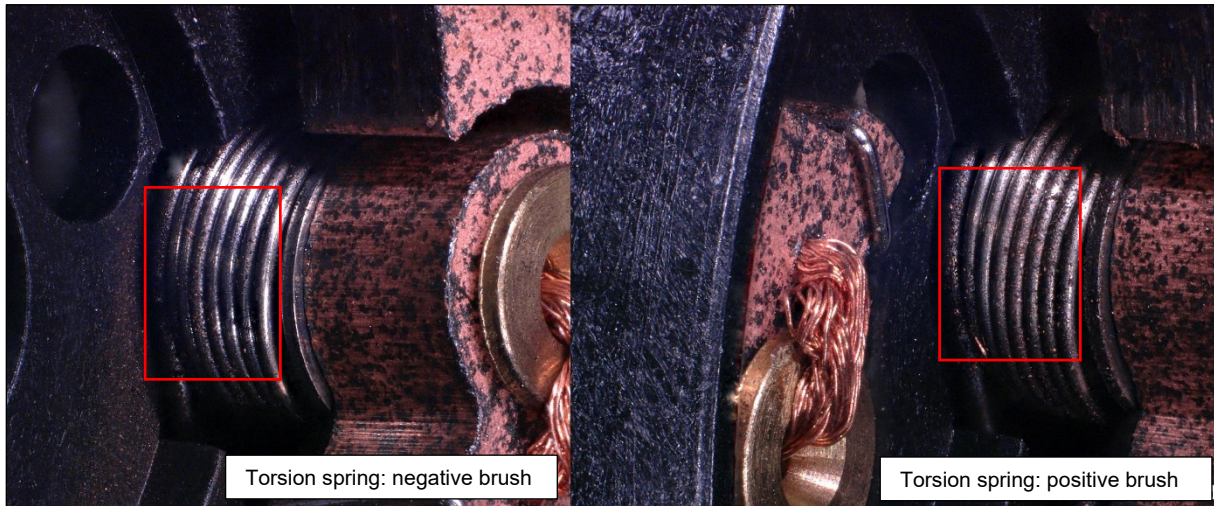
Figure 14: Negative and positive torsion springs.

The windings on each torsion spring were visually counted and yielded eight (8) turns on each brush as shown on Figure 14.

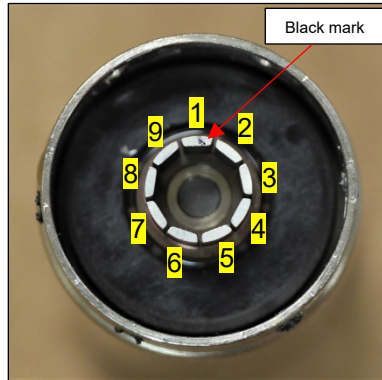
Figure 17: Commutators shown as viewed from the top. One commutator previously marked in black as reference.

One of the commutators contained a black mark at the top surface as shown on Figure 17. Supplier (ITT Aerospace Controls) previously marked the commutator as reference for obtaining resistance values. The commutators were labeled 1 thru 9 for reference.

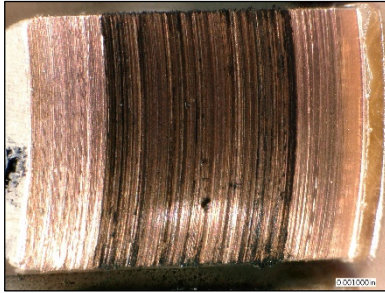
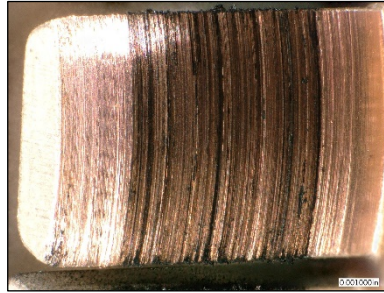
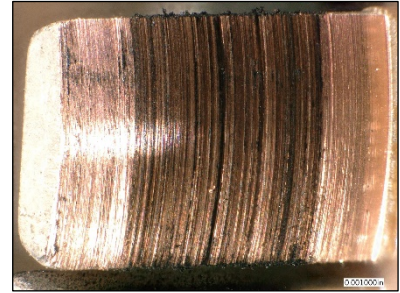
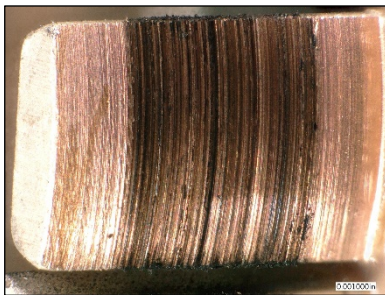
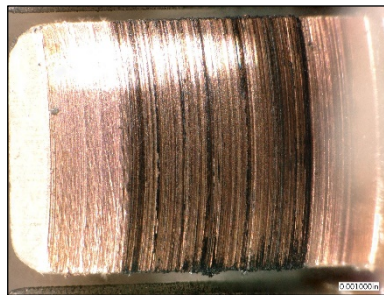
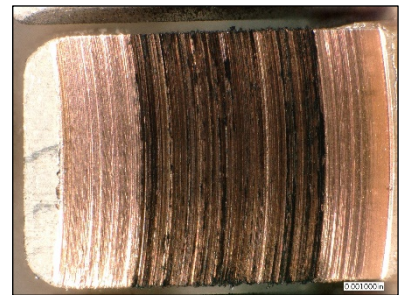
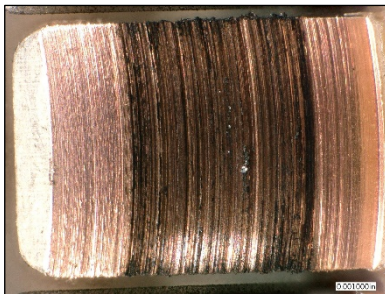
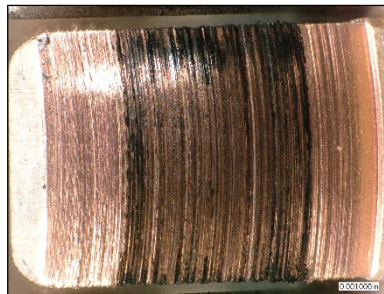
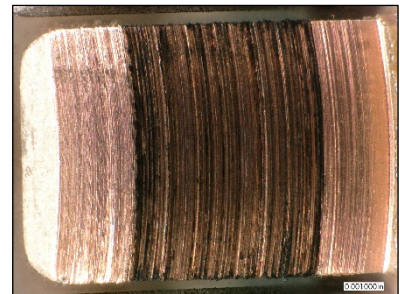
Each commutator surface was examined under magnification as shown on Figure 18 thru 26. Varying amounts of black material were present and confined to the commutator surfaces that are in contact with the brushes.

Black material buildup was present on the edges of the commutators but no bridging observed on adjacent commutators. Figure 27 show a representative image of the black material build up on the commutator edge.

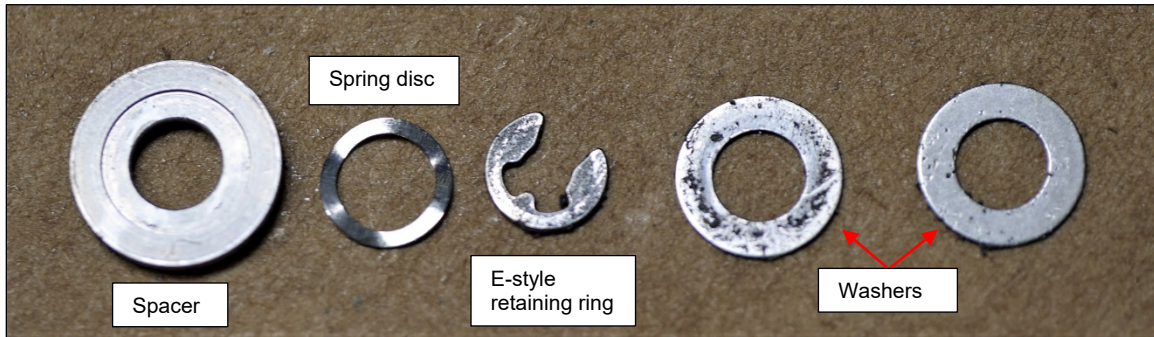
Figure 31: Component located between pinion gear and shaft.

A spacer, spring disc, e-style retaining ring and two washers were located between the shaft and the pinion gear as shown on Figure 31.

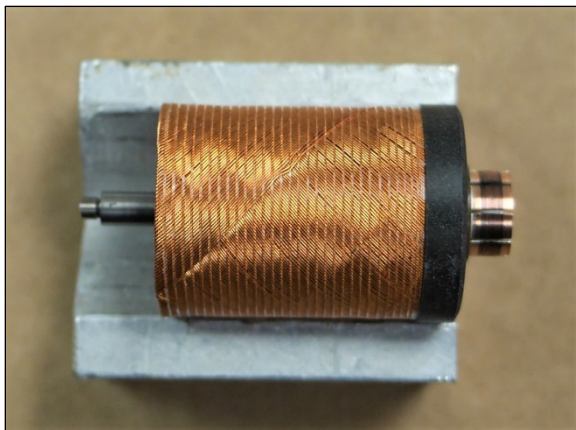
Figure 32: Coil with commutators and shaft attached.

The shaft was pushed out to separate the coil and commutators from the housing (Figure 32). The inner diameter of the coil was inspected under magnification and observed a silver colored particle (Figure 33) measuring 0.006769 inches.

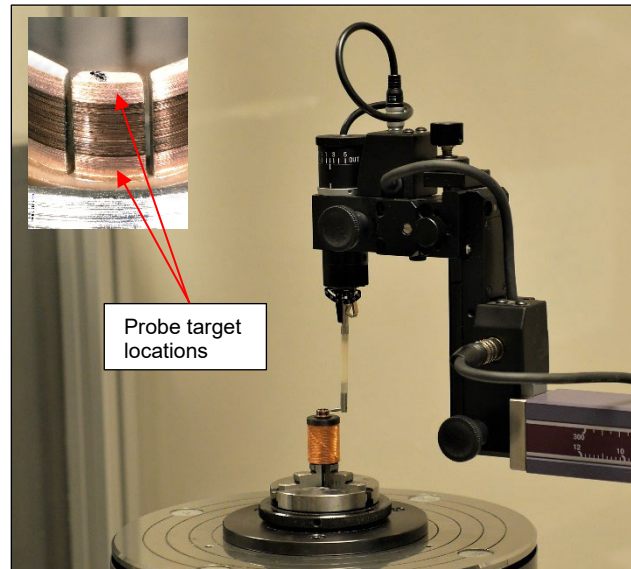
Figure 34: Commutators runout dimensioning.

Roundness profile was obtained on the commutator surfaces as shown on Figure 34. The top and bottom section of the commutators were subjected to roundness testing while the black band materials were avoided for preservation. The purpose of the roundness test was to determine the maximum amount of deviation between commutators.

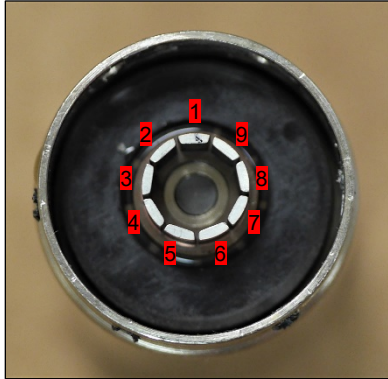
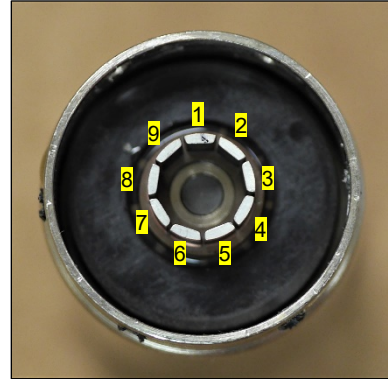
Prior to Boeing EQA performing the examination of the DC motor, ITT supplier performed the terminal resistance measurement for each commutator. Figure 38 shows the ITT supplier commutator numbering and Figure 39 shows the equivalent Boeing EQA commutator numbering. Table 3 shows the recorded resistance values for each commutator.

Commutator Number (ITT Supplier Numbering)	Terminal Resistance (Ohms)	Equivalent Commutator Number (Boeing EQA Numbering)
1	300	1
2	108	9
3	1.06K	8
4	40K	7
5	240K	6
6	285	5
7	97	4
8	3.2K	3
9	138	2

The two commutators with the highest resistance were identified as commutator 6 and 7 based on the Boeing EQA numbering system. The two commutators were separated from the rest of the commutators for black material identification analysis under direction of the NTSB. Figure 40 shows the steps taken in removing the subject commutators.

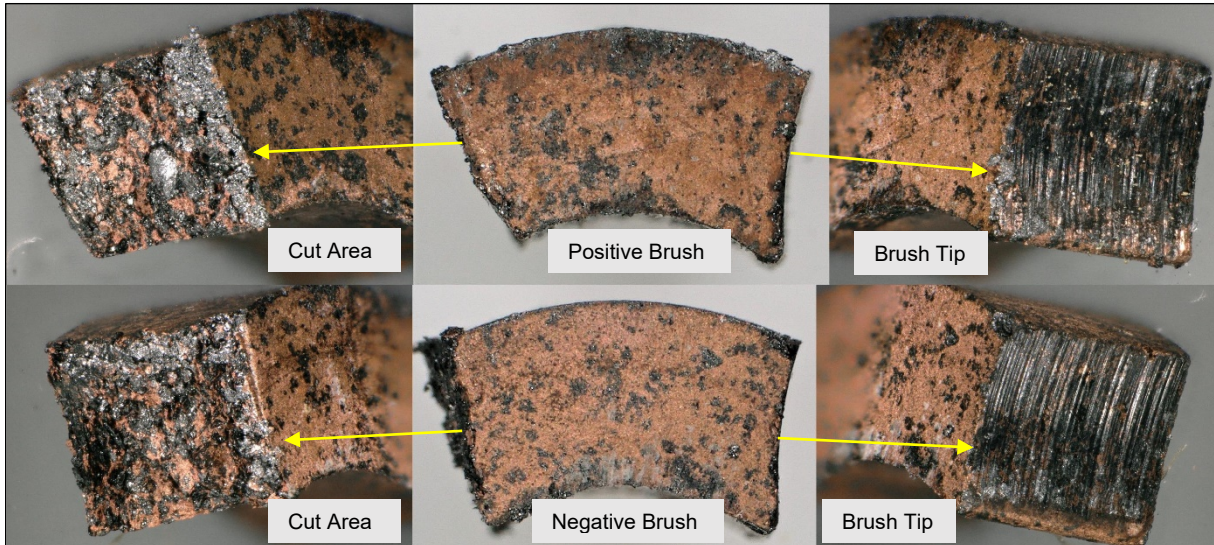
Figure 46: Positive and negative brush cut section.

After separation, conditions of the positive and negative brush were photo documented as shown in Figure 46.

Silicone was the most prevalent organic material identified on the top surfaces of Brushes "P" and "N". No other organic materials were detected. Inorganic materials were occasionally observed. They will be better identified by X-Ray based elemental analysis.

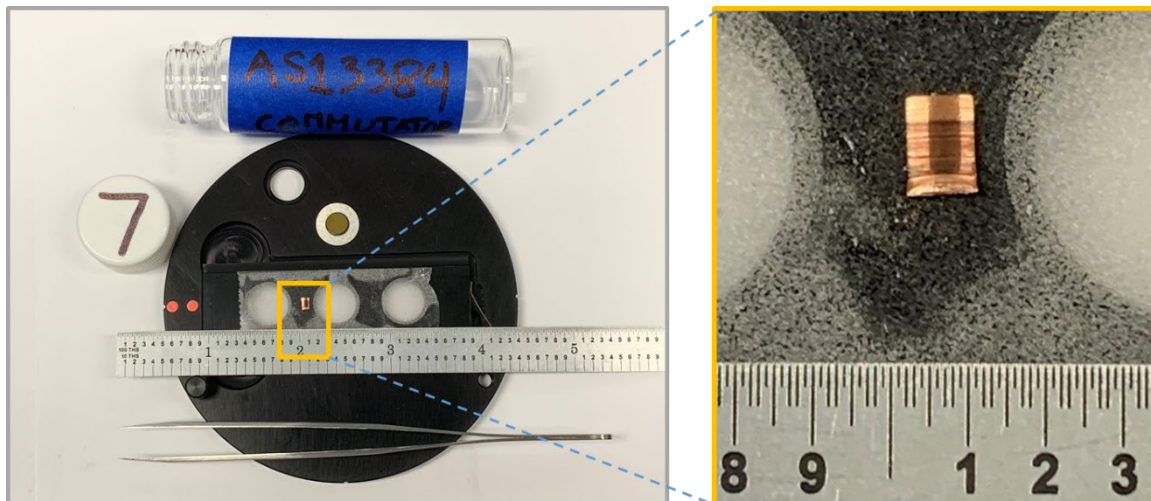
Figure 1. Pieces were transported in vials, handled with tweezers, and held on the sampling platform using double-stick tape.

On all commutators a black colored residue was formed on the surface of interest. The residue is expected from normal use. It was requested to determine what organic material was present on the surface of the commutators (both in the areas with black residue and without). SEM / EDS analysis will be performed subsequently on the commutators.

Each commutator had traces of silicone. The highest concentrations of silicone were observed in locations with dark stripes, though not all dark stripes had silicone.

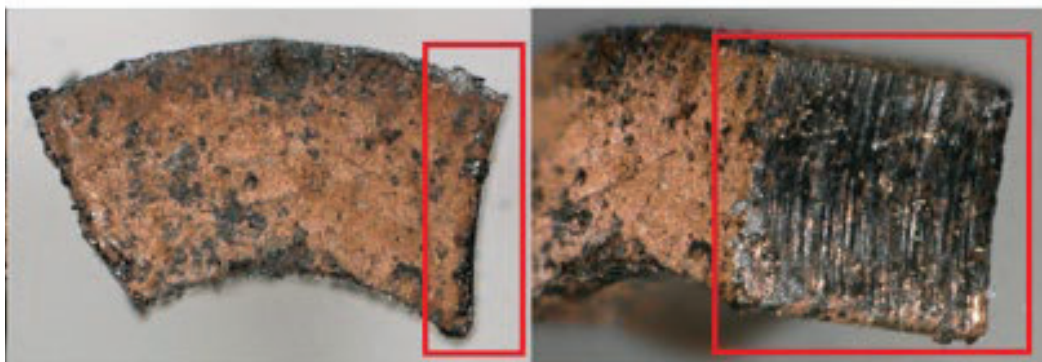
Figure 1. Brushes were small curved rectangular pieces of metal.

Figure 1 shows one Brush sample, labeled "P", with a red box drawn around the end surface to be analyzed. The Brush samples were small pieces of metal, curved and rectangular in shape, approximately 0.10" x 0.05" x 0.05". The surface of interest on both on both Brushes was black with orange colored spots, and consistent parallel grooves.

Surfaces of Brushes N and P showed a consistent residue of silicone. Figure 4 shows a smooth surface of higher and lower peaks of similar shape and location. Spectral features were not correlated to color of the substrate, whether black area or an orange spot.

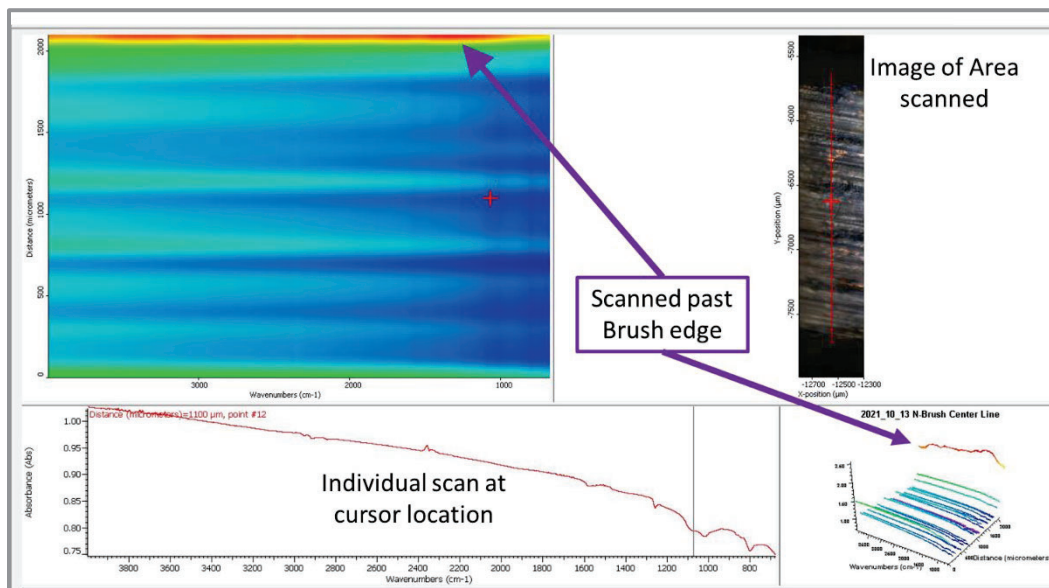
Figure 4. Smooth FTIR contour map of Brush N’s center. The outlier scan noted by the arrow is where data collection went past the Brush.

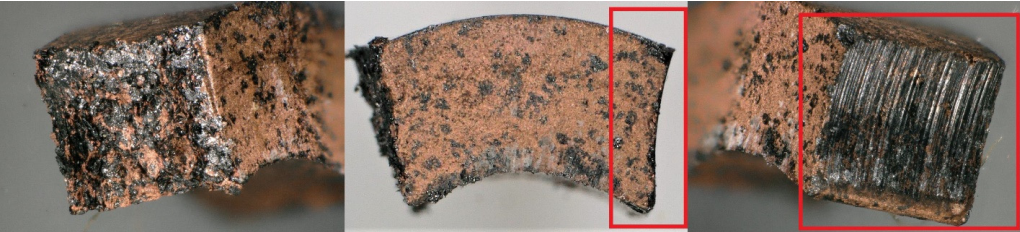
N-Brush

- N-brush and commutator 6 were analyzed by metallography, SEM and STEM.
- Circumferential surface topography was present in the active and inactive regions, indicating it was a pre-existing condition.
- The commutator topography was imprinted on the active brush surfaces.

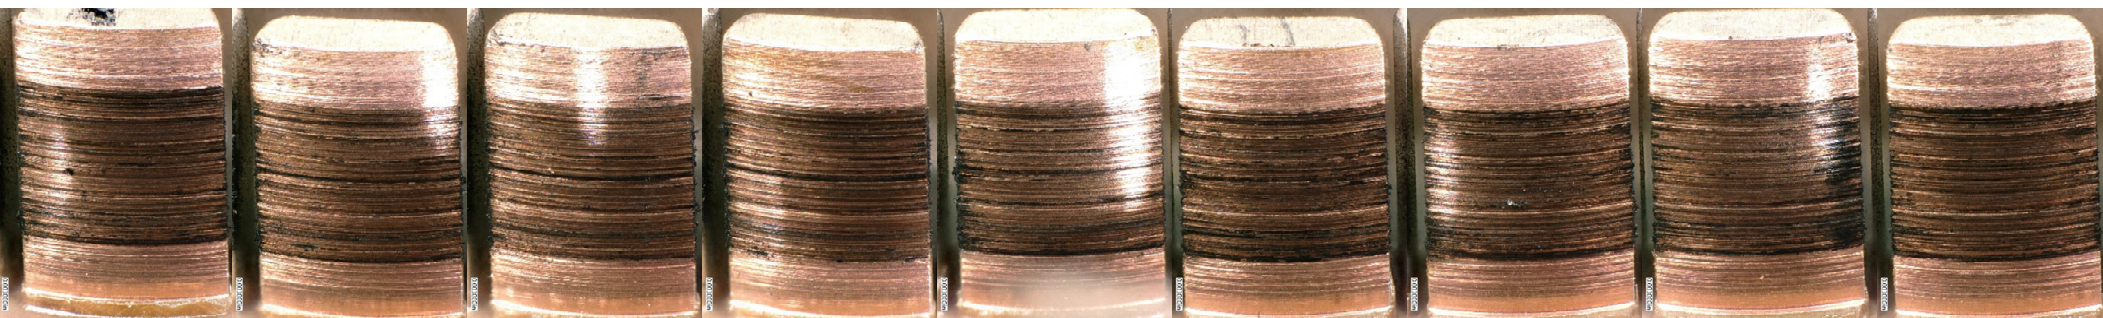
Commutators (resistance values obtained by valve manufacture during component examination):

300Ω

138Ω

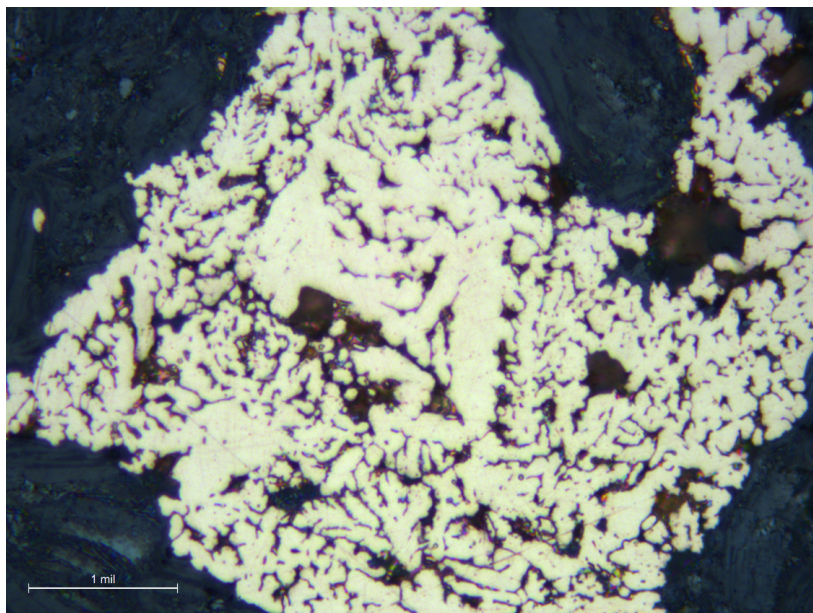
Film Resistance - The fretting debris was generated exclusively from the brushes. The brushes consist of softer unworked copper metal and graphite, whereas the commutator bars are made from wrought copper, further hardened at the surface by a circumferential material-removal operation. The shallow surface recrystallization from the last material-removal operation (likely from the time of manufacture) was readily apparent, indicating no fretting of the commutator surface.

Photomicrograph showing dendritic nature of the electrolytically-deposited brush copper, which would have the hardness of cast copper.

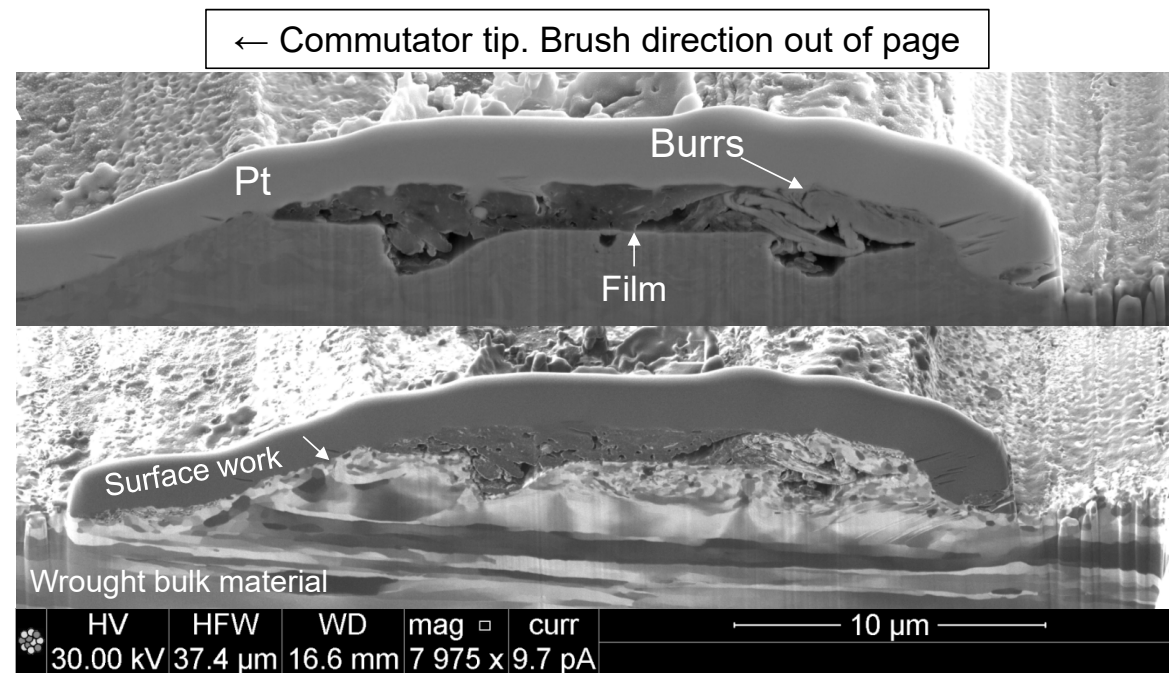
Transverse FIB section of the commutator bar with electron (top) and ion (bottom) beam imaging, showing surface work hardening and associated burrs, and wrought grains in the bulk material.

Film Resistance - Each commutator bar would have a unique surface roughness pattern, which would accelerate the grinding action against the brushes. Burrs on the commutator bar surface were shown to act as a drag force against the brushes.

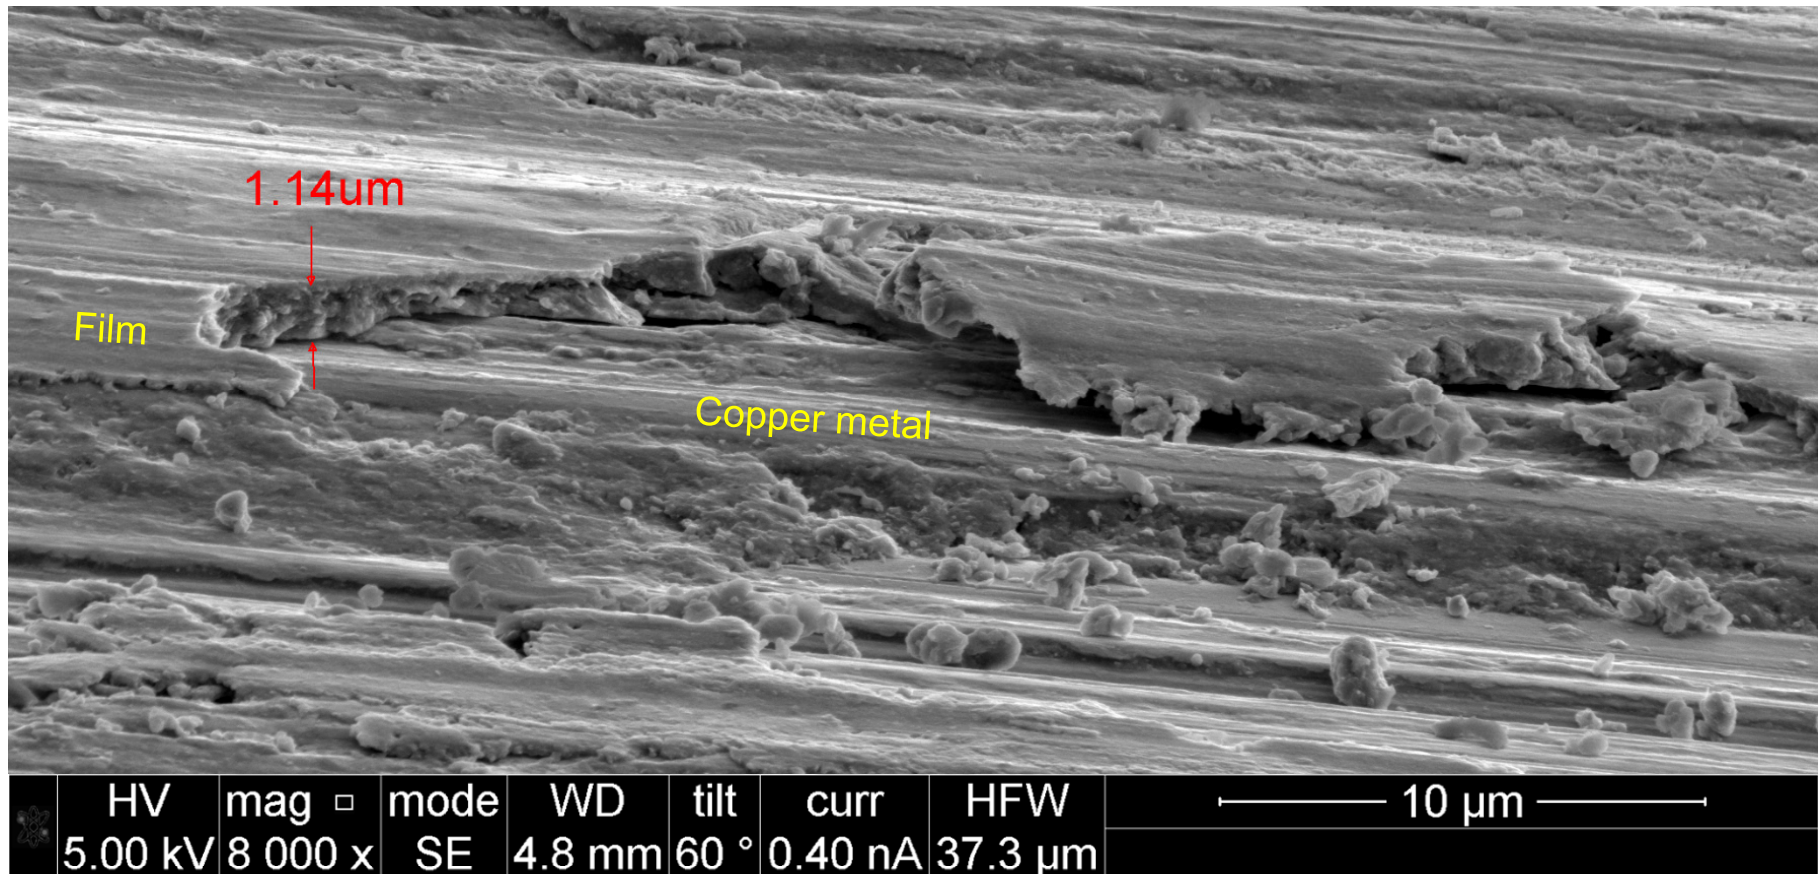
Film Resistance - On the commutator bars, the fretting debris-filled silicone film could potentially grow in thickness sufficient to cover the entirety of the surface at a local level. The film itself had poor contact with the commutator bar.

60° inclined SEM image of the commutator bar looking down the axial direction.

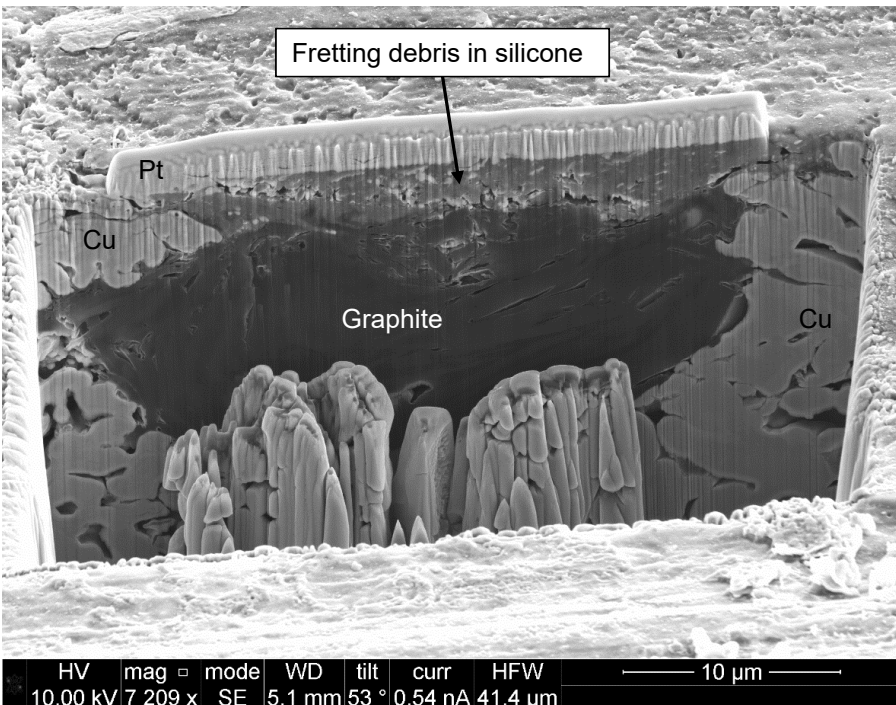
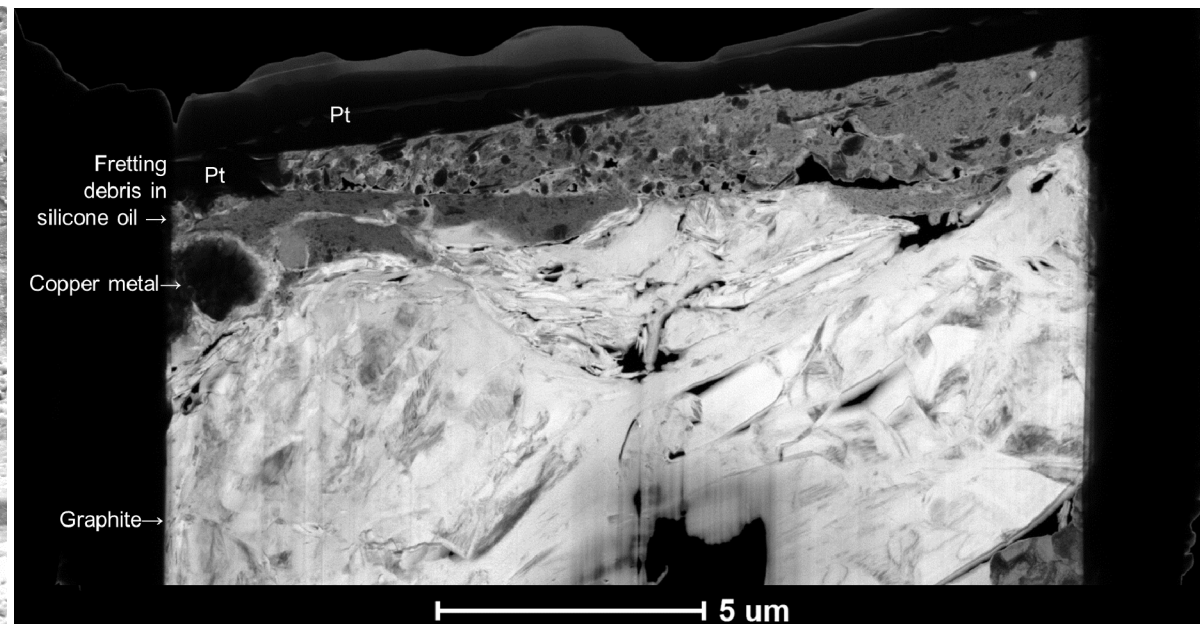
Film Resistance - On the brushes, the fretting debris-filled silicone built up mostly over the graphite and to a lesser extent the copper metal, likely increasing film resistance of each component over time.

Example 2 – A FIB cross-section and STEM liftout on a brush longitudinal to the wear direction shows fretting debris in silicone oil spread over graphite.

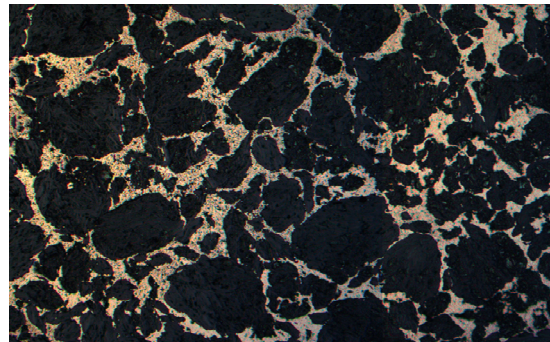
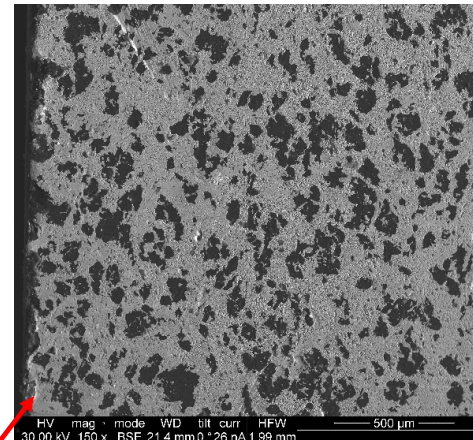
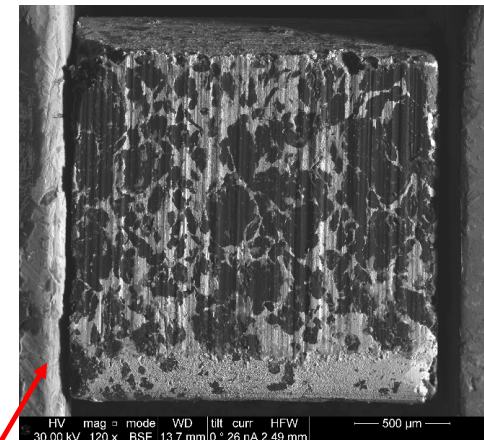
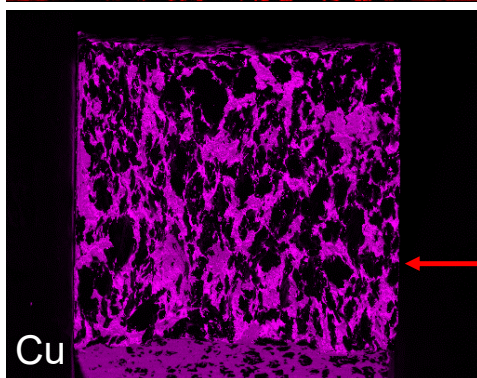
Constriction Resistance - The as-manufactured area percent copper metal on the brush is expected to be around 48-71%. With wear, the surface enrichment of copper metal gave way to the bulk composition of 18% copper metal, increasing constriction resistance.

Bulk: 18% Cu / 82% graphite

OD: 71% Cu / 29% graphite

Working end: 50% Cu* / 50% graphite

Broken end: 48% Cu / 52% graphite

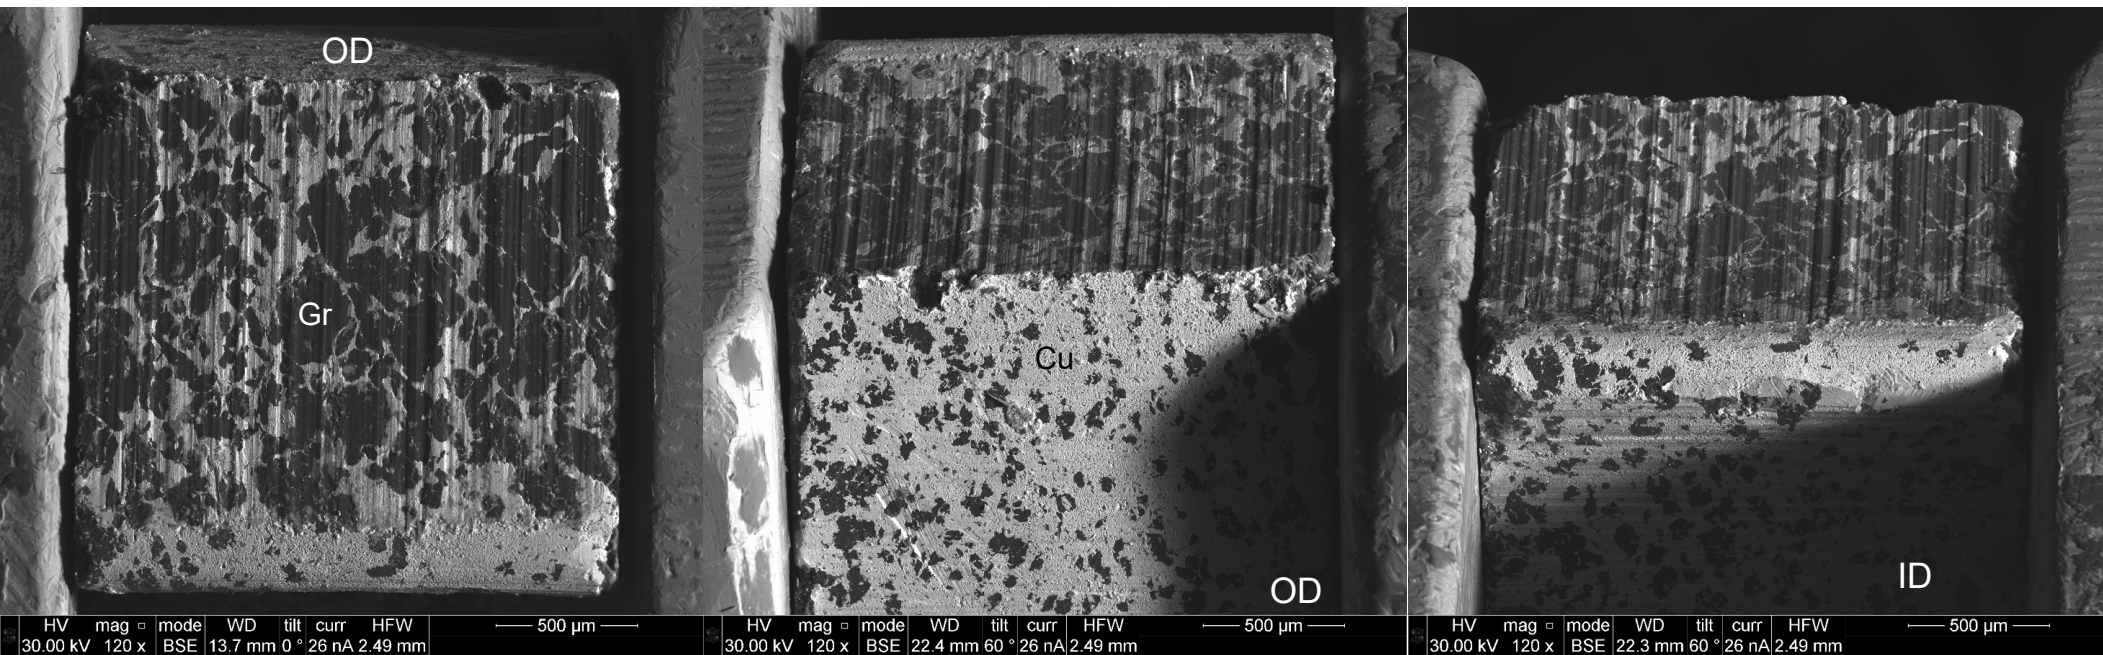
Constriction Resistance - The as-manufactured area percent copper metal on the brush is expected to be around 48-71%. With wear, the surface enrichment of copper metal gave way to the bulk composition of 18% copper metal, increasing constriction resistance.

SEM of the brush shows the working surface has less copper than the outer and inner diameter surfaces.

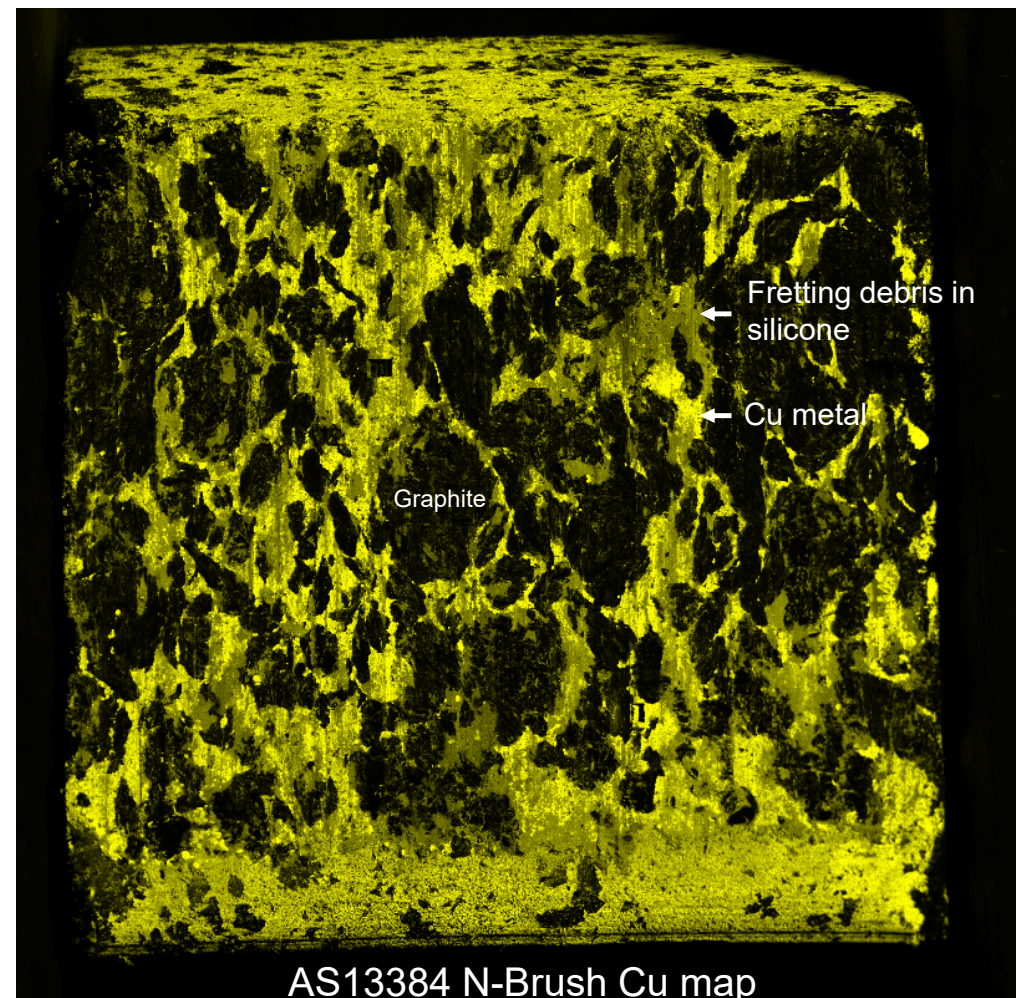
Constriction Resistance - An estimated 6.7% of the brush working surface was copper metal, increasing the constriction resistance beyond that expected by the bulk 18% copper metal.

- An SEM-EDS copper map of the working surface shows brighter and darker regions, both of which are bright in the SEM image and quantified as 50% of the working surface area.
- FIB and STEM analysis have confirmed the bright regions of this map are copper metal, while the dimmer regions are Cu and Cu₂O fretting debris suspended in silicone oil.
- Image analysis of the Cu map shows 86.6% of the copper-rich areas are Cu and Cu₂O fretting debris suspended in silicone, or 43.3% of the entire working surface.
- 13.4% of the copper-rich areas are Cu metal, or 6.7% of the entire working surface.
